Tree Preservation/Conservation Order Application

St Aidan's Catholic Academy

Description of works –

These works have been identified on the Tree Survey carried out by Amenity Tree with the works and TPO application carried out by ATW Tree and Landscaping Specialists LTD.

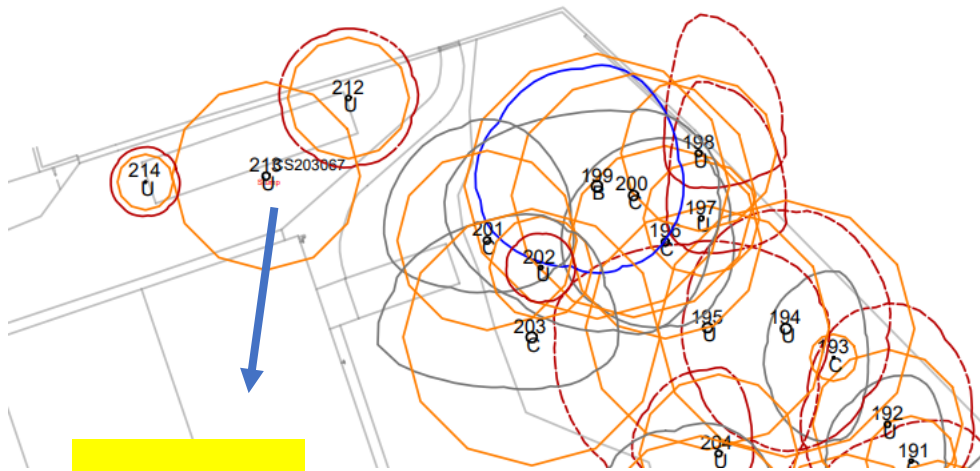
T213 – Black elder - Remove Elder stump to ground level.
