**ENGINEER'S REPORT
ON
EXISTING OUTBUILDING
ON
LAND AT STAMFORD ROAD
MOSSLEY
AS AT
1st FEBRUARY 2024**

A visual inspection of the outbuilding at land at Stamford Road Mossley, was carried out on 1st February 2024 so as to assess its stability in its conversion into a domestic dwelling

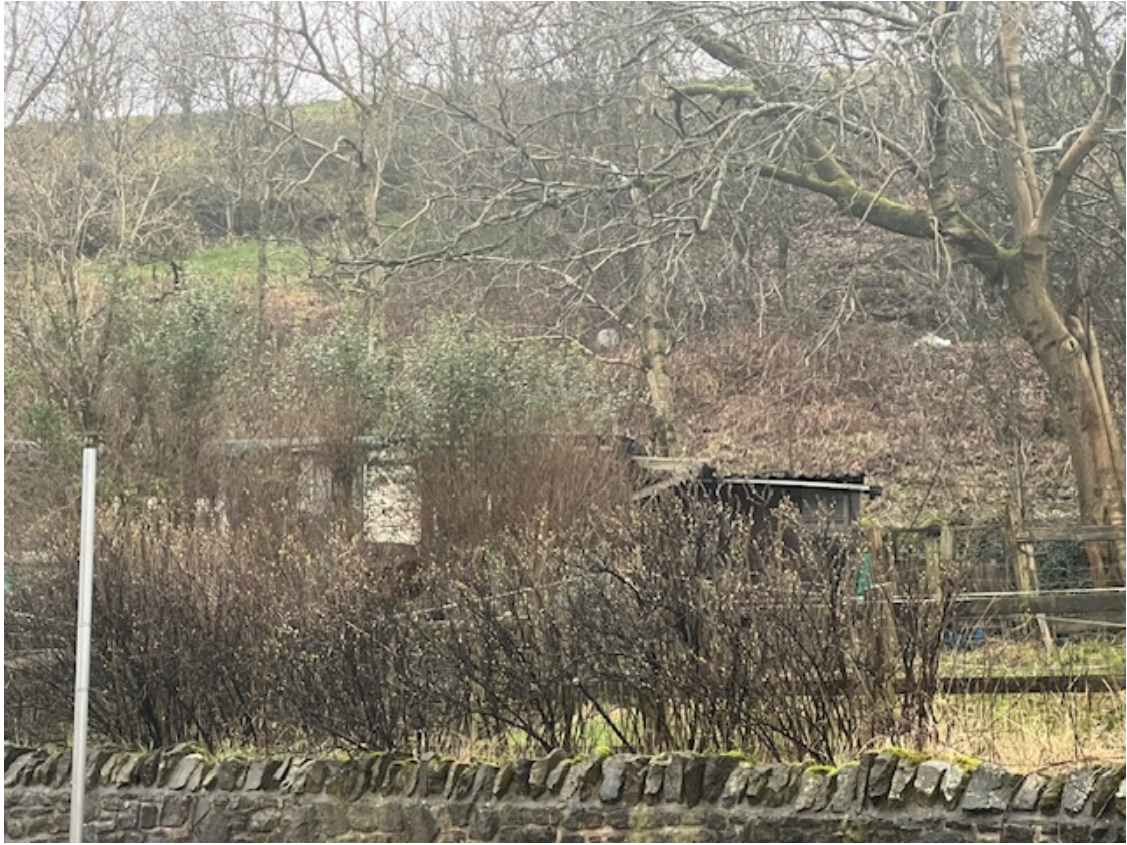
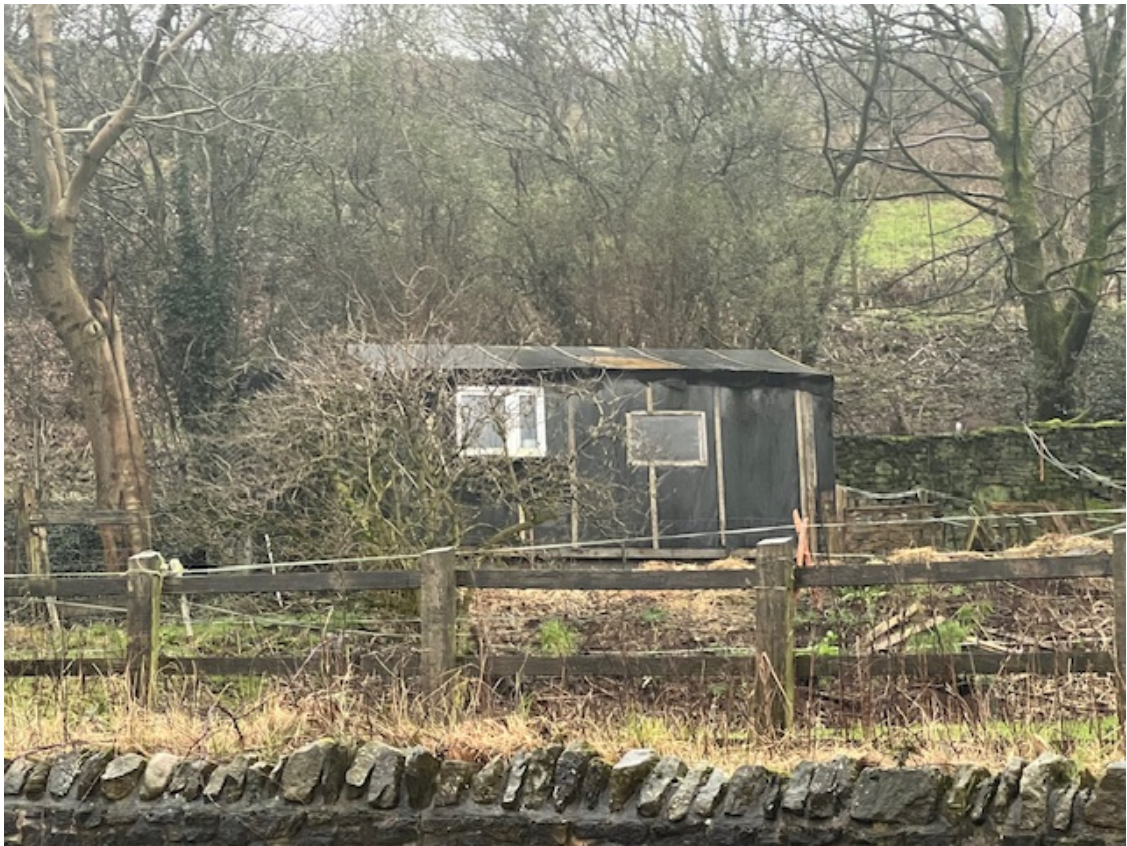
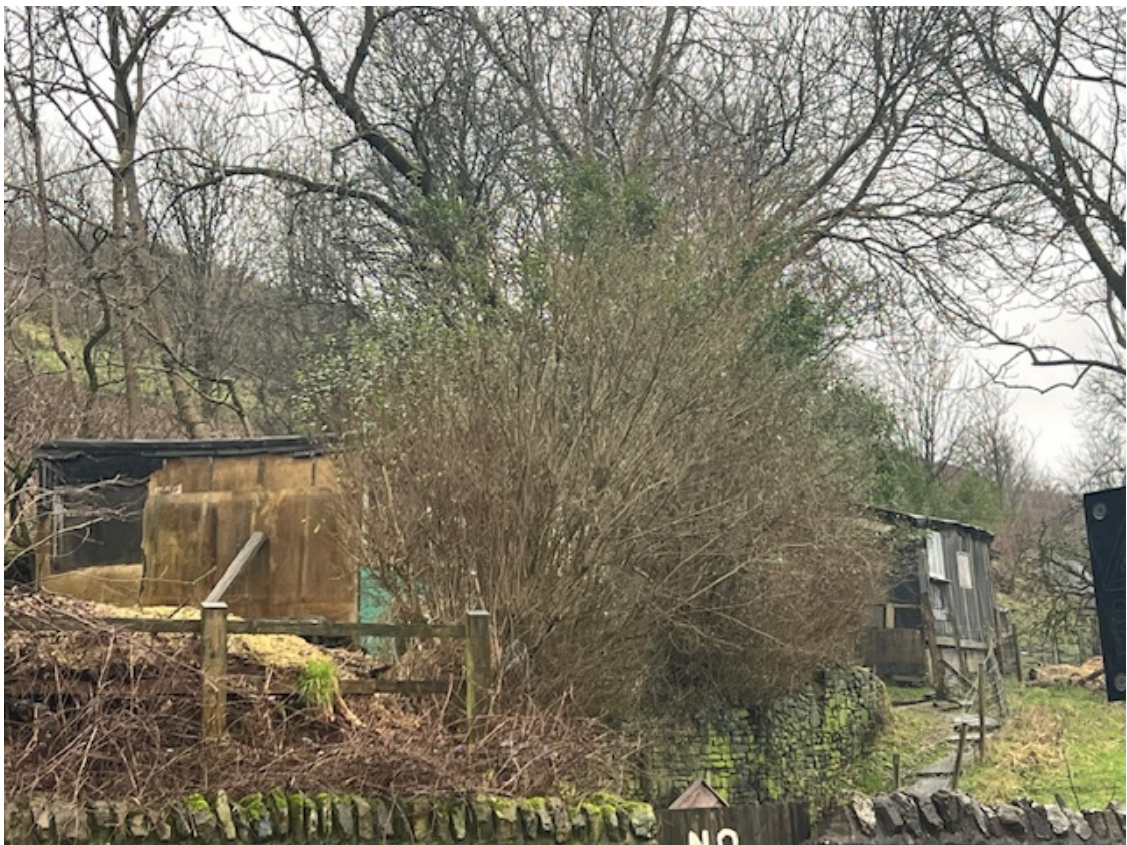
The walls are typically constructed from loadbearing timber studding external clad

Inspecting the wall panels, we found no evidence of settlement or movement.

The existing timber framed walls will be re-clad in timber externally and lined internally with insulation and plasterboard, this will provide a robust external frame typical of a timber framed house. This will allow the roof to be strengthened and cladded in metal cladding as the architects plan.

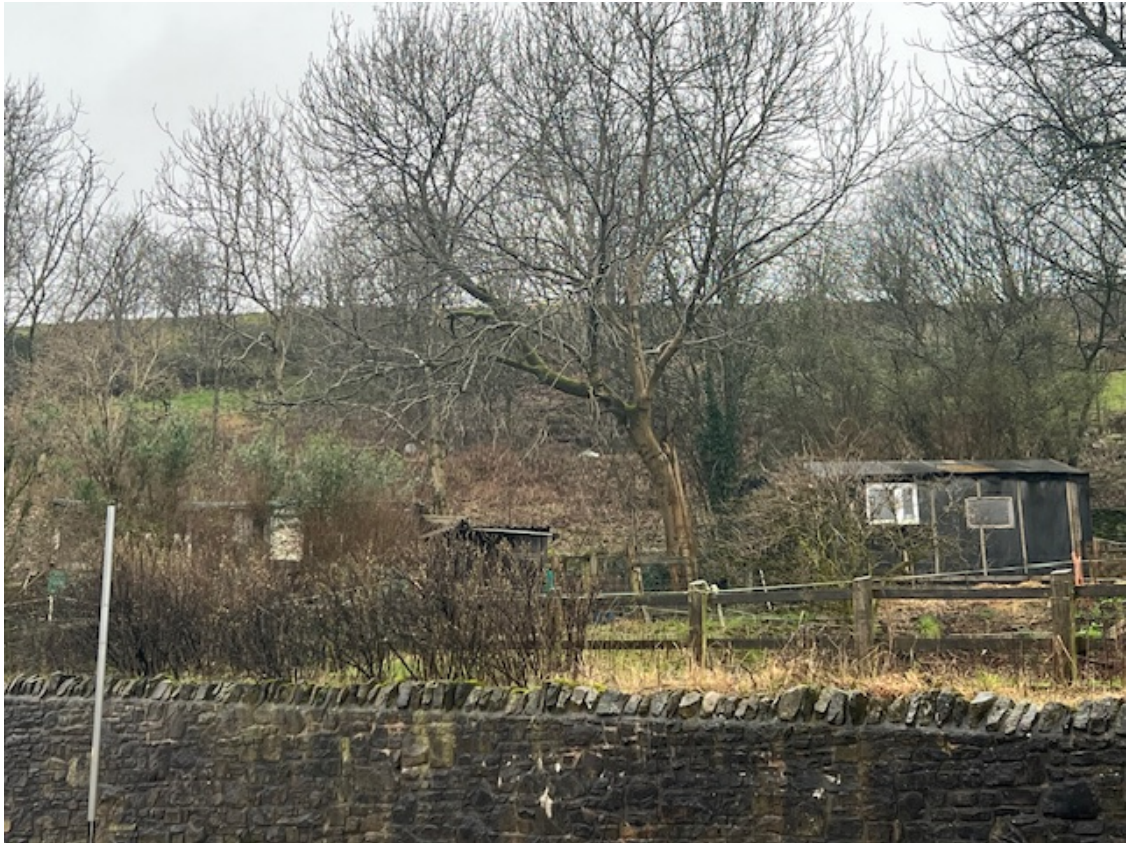
The roof construction is corrugated sheeting overlaying supporting timber purlins. Inspecting the roof construction, we found the same to be structurally sound and showing no signs of movement that would allow the ingress of the elements.
