**Phase 1 Land Contamination  
Risk Assessment**

**Proposed Demolition of Barn &  
Outbuilding and Erection of 1 No.  
Dwelling & Associated Car  
Parking and Retention of  
Countryside to Domestic Garden**

**The Barn, No.9 The Green,  
Croft, Blaby,  
Leicester LE9 3EQ**

**Date: January 2022**

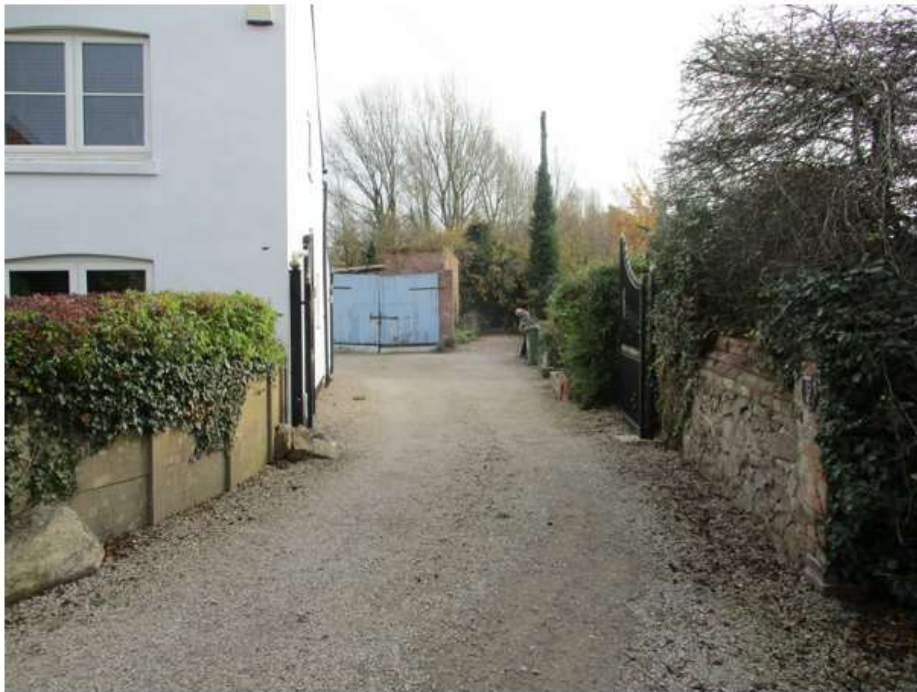
**Photo No.1: Facing SE from the site access showing gravelled site access track**

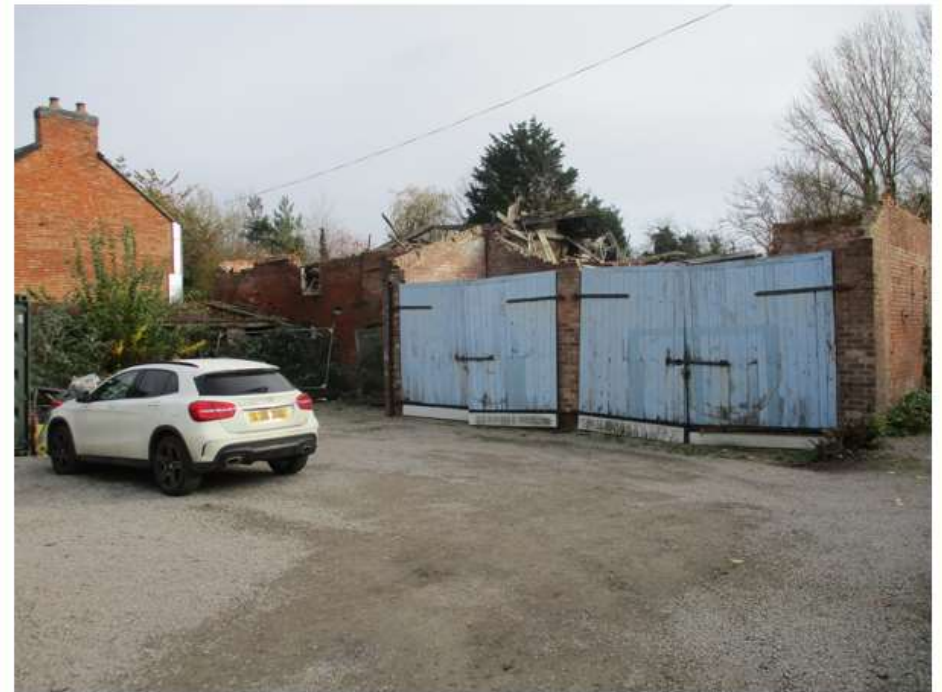
**Photo No.2: Facing east from site access track showing dilapidated barn and parking area**

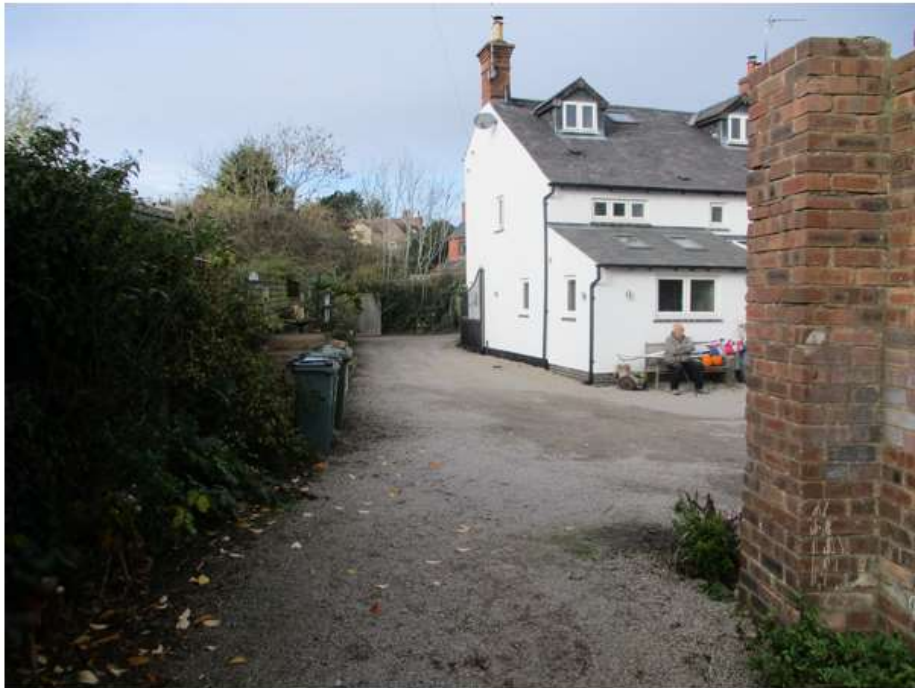
**Photo No.3: Facing slightly NW from adjacent to the barn showing site access and dwelling**

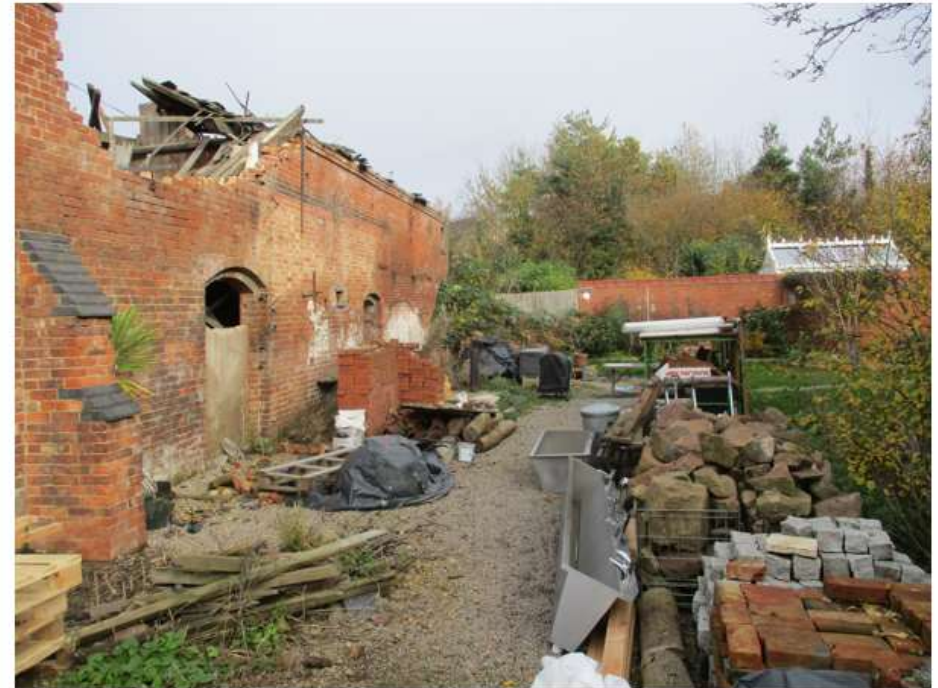
**Photo No.4: Facing north showing the rear (eastern) face of the dilapidated barn**

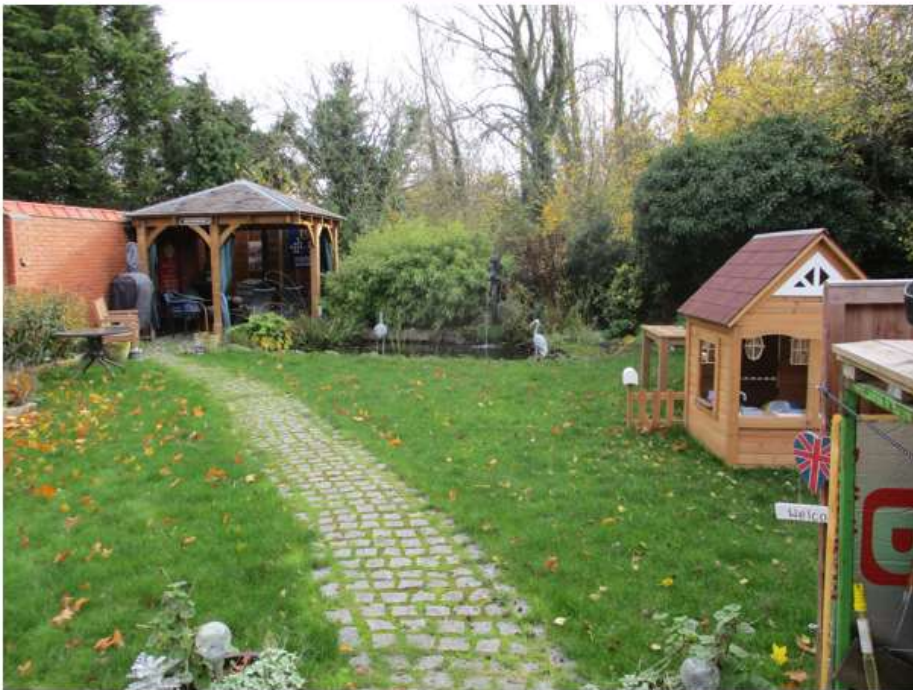
**Photo No.5: Facing SE showing garden area located in eastern extent of site**

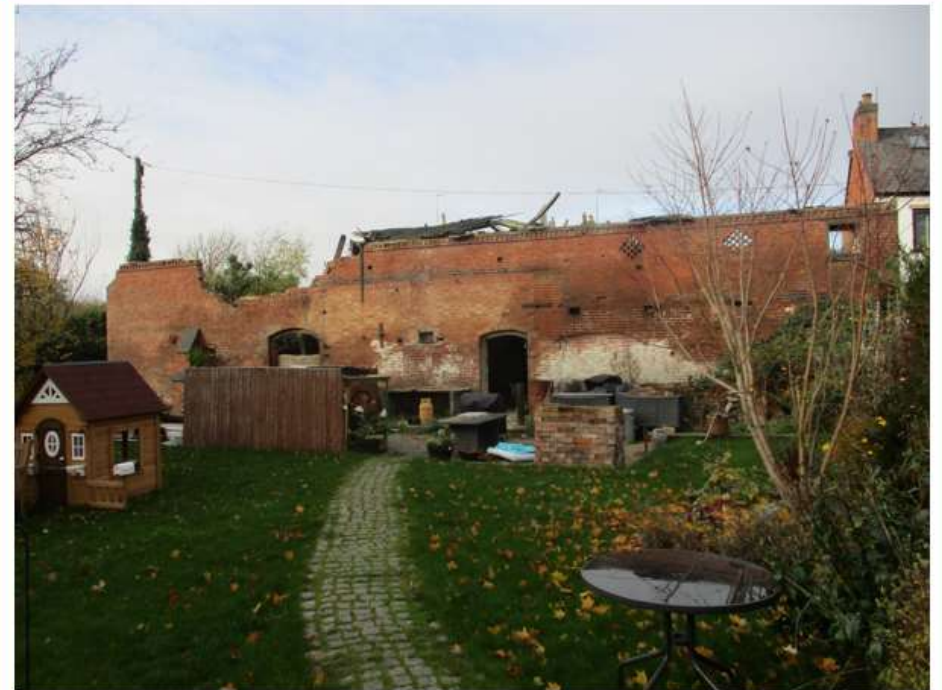
**Photo No.6: Facing NW from the easternmost boundary on site and garden area showing barn**

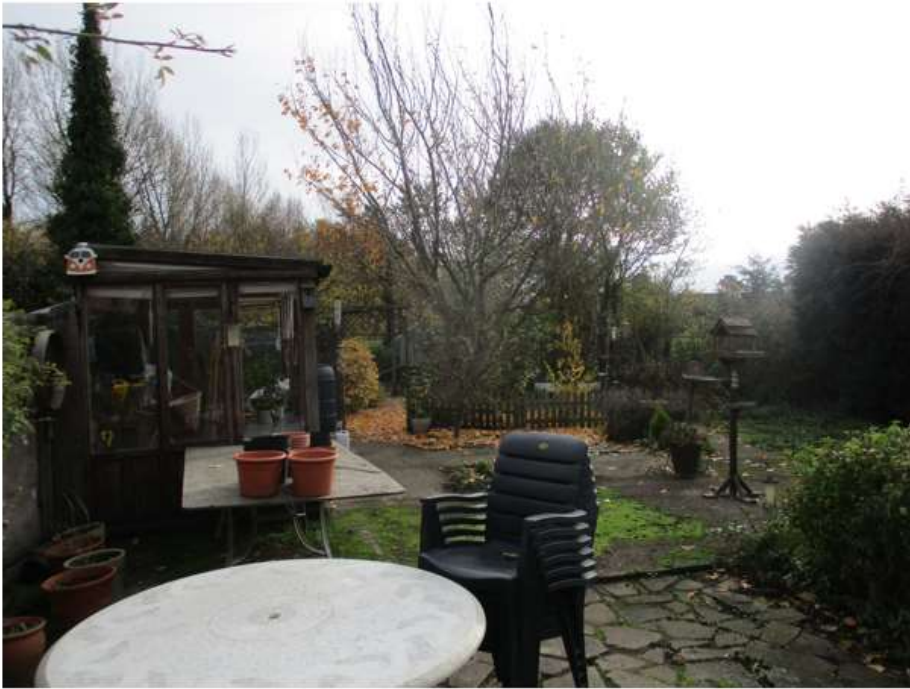
**Photo No.7: Facing SE in the southern gardened area to the southernmost corner of site**

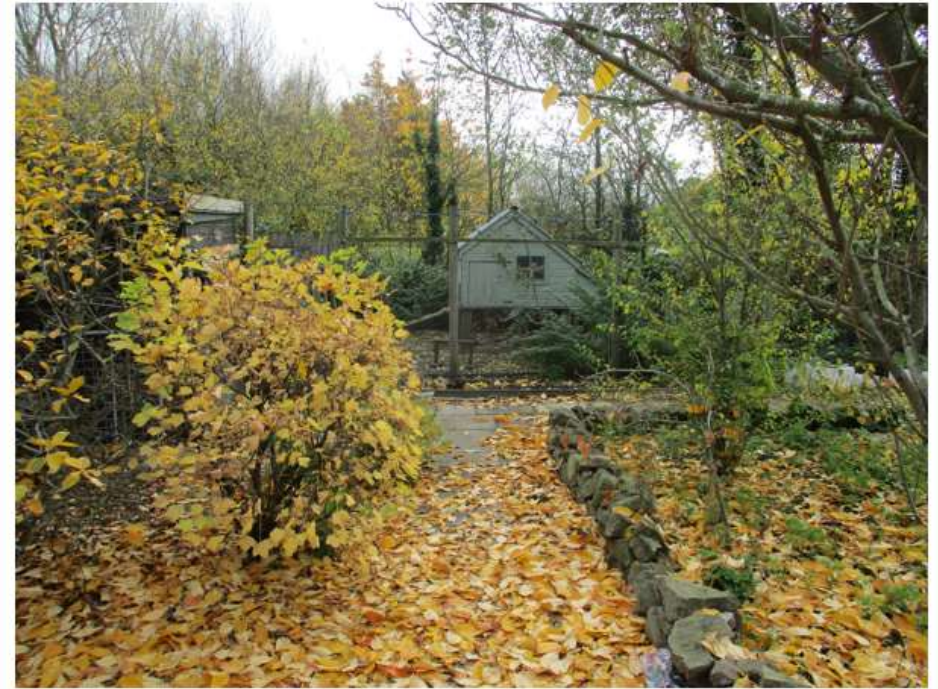
**Photo No.8: Facing SE showing SE / S extent of site and chicken coop in well maintained garden**

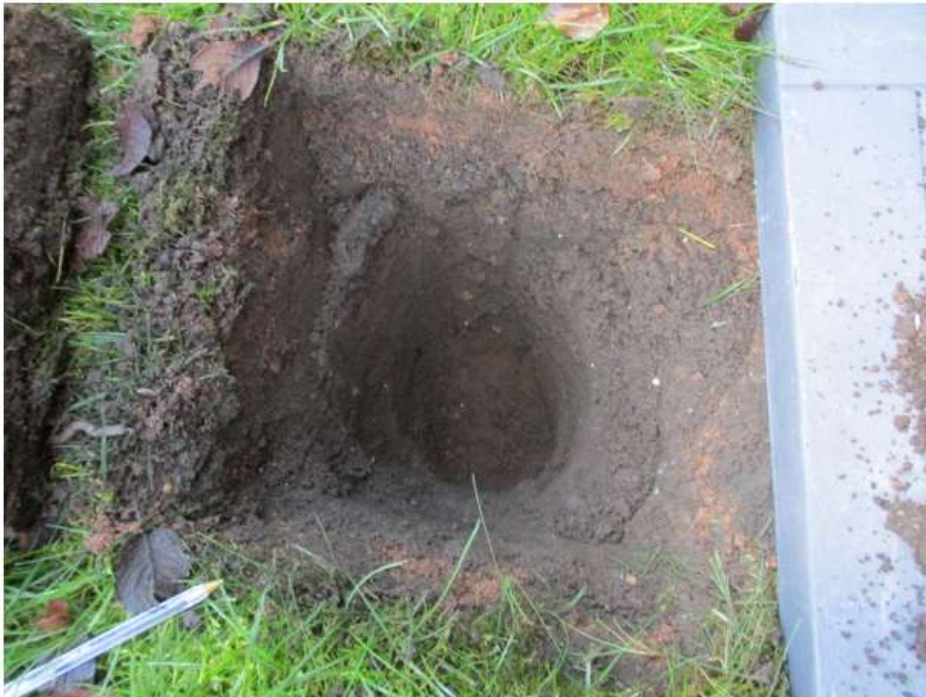
The ground conditions encountered comprised a dark brown to light brown slightly clayey, slightly gravelly Topsoil with a light brown sand lens from surface level to 0.40m depth at HP01; with a brown, very sandy, slightly gravelly Clay encountered beneath this to a confirmed depth of 0.55m. The

**Photo No.1: HP01 located in area of present soft-landscaping in the eastern extent of site**

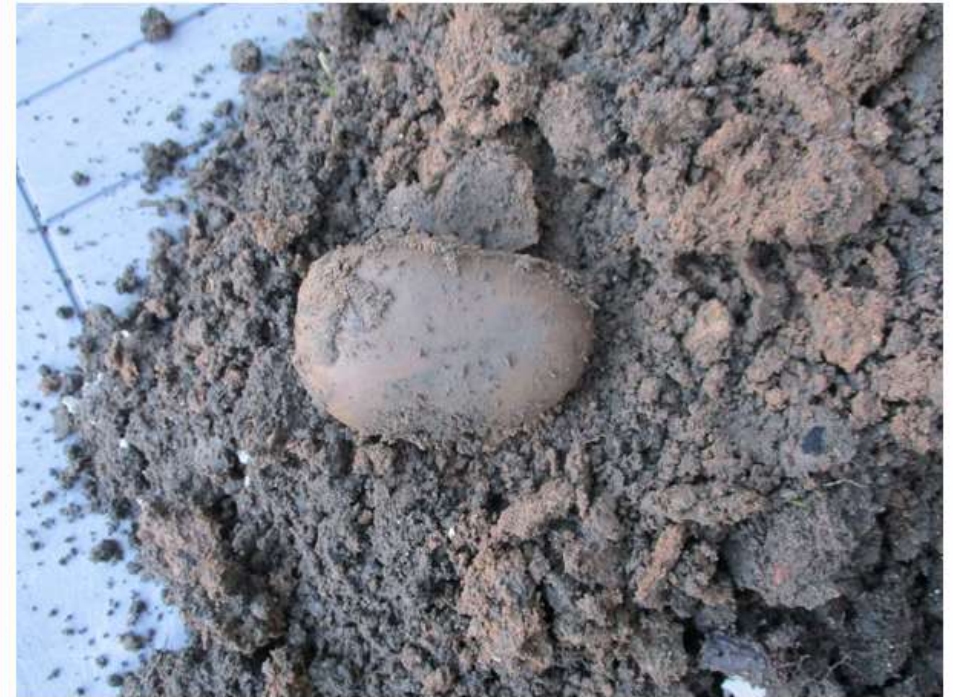
**Photo No.2: HP01 pit spoil showing sandy clay, topsoil and rounded gravel inclusions**

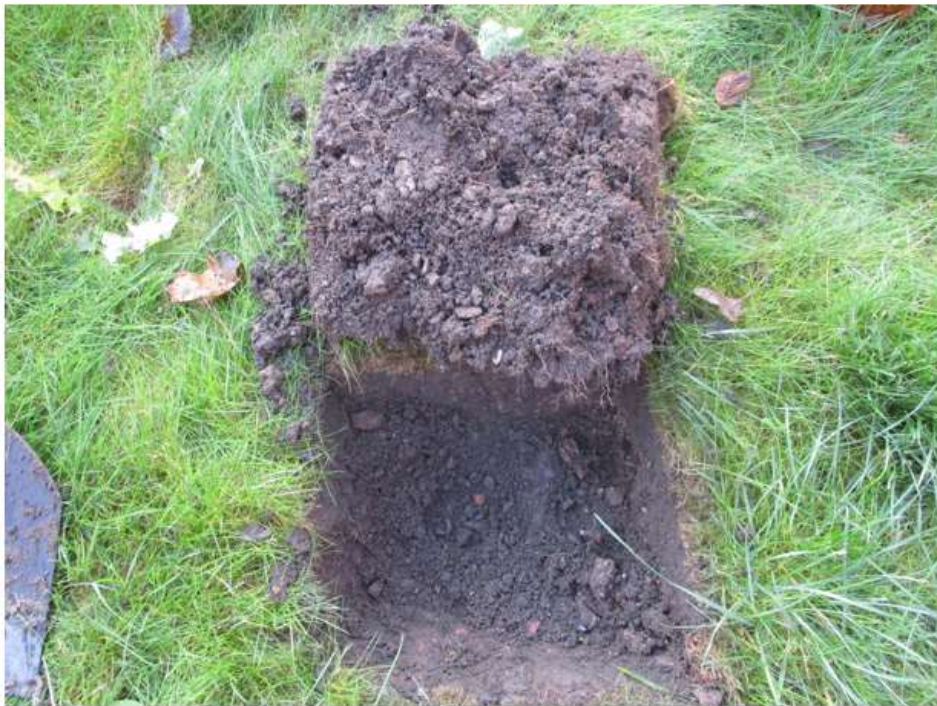
gravels were noted to be fine to medium (to coarse in the Clay), subrounded to rounded sandstones and quartzites. At HP02, a similar topsoil was encountered, which was logged as Made Ground Topsoil due to additional ceramic, brick and wood fragments noted at this location. Samples were taken from each topsoil and the underlying clay.

**Photo No.3: HP02 located in the northern extent of the far eastern area of present soft-landscaping**

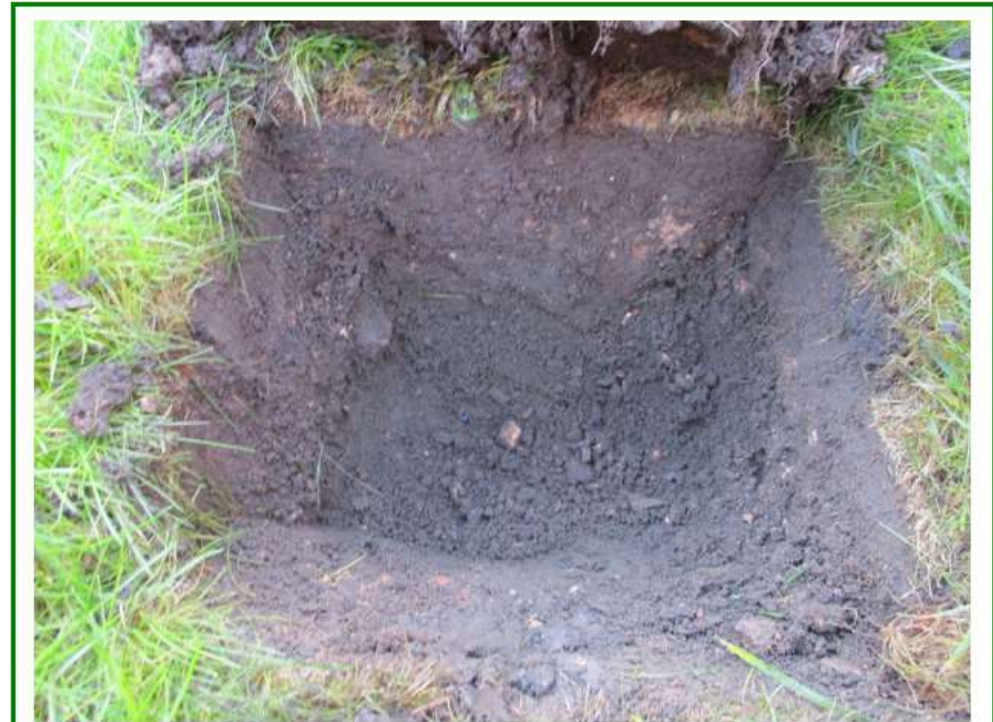
**Photo No.4: HP02 pit sides and base**
