STRUCTURAL CONDITION REPORT

Former Chambers Bus Garage site, Bures

Rose Builders

Project no: 62021

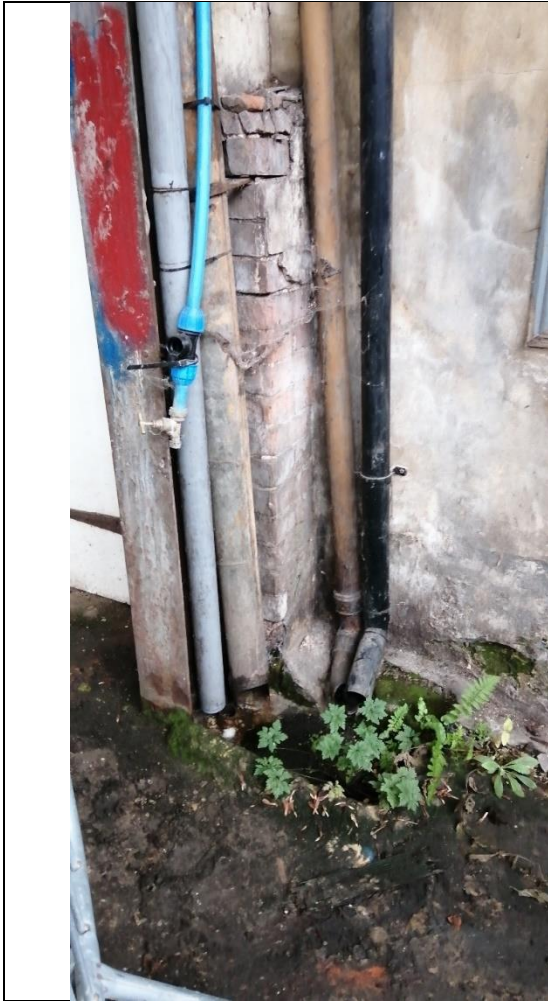
15..

- 4.13. The right-hand wall of the bus shed (viewed from front) would have originally been the outer wall of that range of buildings. From front to rear, the first panel is rendered while the remainder of the wall is brickwork. The render to cracked throughout and some of it has probably blown and is debonded from the underlying masonry. Much of the lower section is pot-marked and several pieces are missing. For any of these buildings that are remain, all the underlying structure will need checking and the render will need replacing. See photos 15 and 16.

- 4.14. The first inner truss support column aligns with a small step and return to the building elevation. This is likely to represent the junction between different phases of the construction to this range of buildings. The bottom 900mm of the corner brickwork appears in reasonable condition, while the next six courses have missing mortar to joints and some split and disturbed bricks. This may partially relate to the metal straps embedded within these joints, which appear rusty and may have expanded. See photo 15.

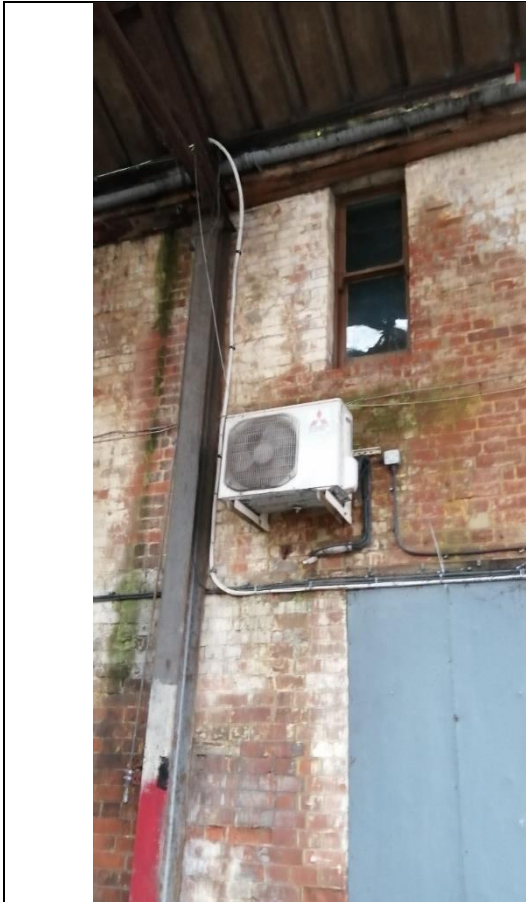
19.

- 4.15. Some of the brickwork has the remains of previous paint and the outline of previous abutting construction can be made out. The brickwork has regular surface damage and blown brick facings. The lower approximately 1/2m of the brickwork is damp, with a green surface growth. See photos 10-12 and 19-20.

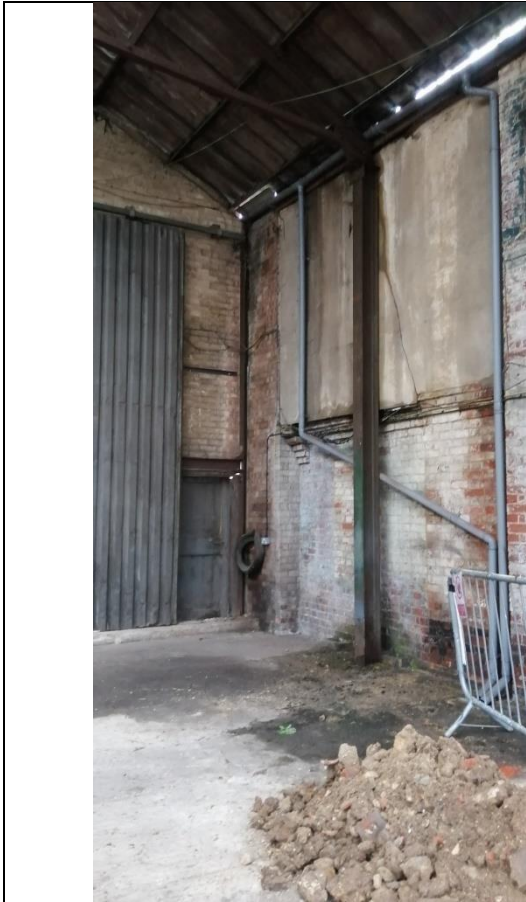
21.

- 4.18. The rear two panels have a coursed step-out of the elevation at higher-level and the upper portion is rendered. The render has a diagonal crack to the right of the column. There is a taller stepped brick coursing feature to the left of the downpipe. This abuts an one-and-half brick return wall, which has a vertical crack down the middle of the return. See photos 21-24.

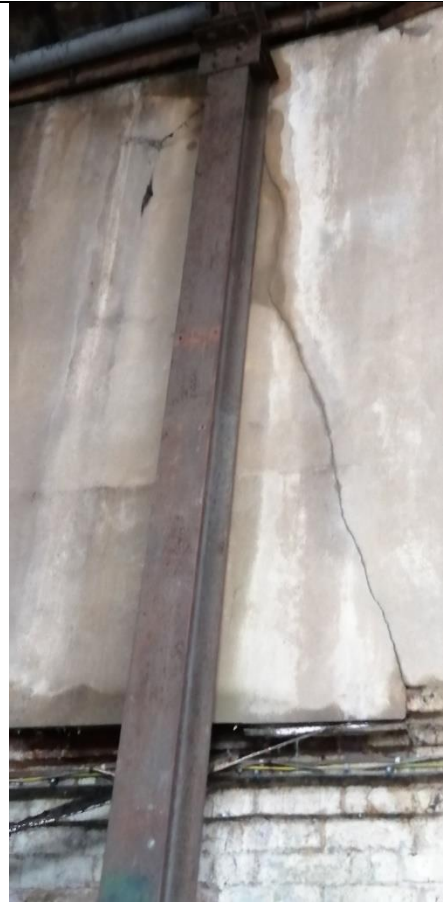
- 4.12. Steel columns to the RHS (viewed from the front) are built against the brick walls of the adjacent building. Some of the columns to the LHS are masked by other structure or finishes. Visible column faces are generally in reasonable condition, however they have peeling paint and some surface

rust. That at the rear of the shed (photo 22) has lost most of its paint and has more extensive surface rust. There is some rusting to the base of the columns. See photos 10-12, 17,18 and 22.

- 6.4. There are currently no plans to retain any structural steelwork, but should any remain, these steels will need to be wire brushed and a replacement primer applied. For steels that are to be external, this should be followed by a coating system of external category paint protection.

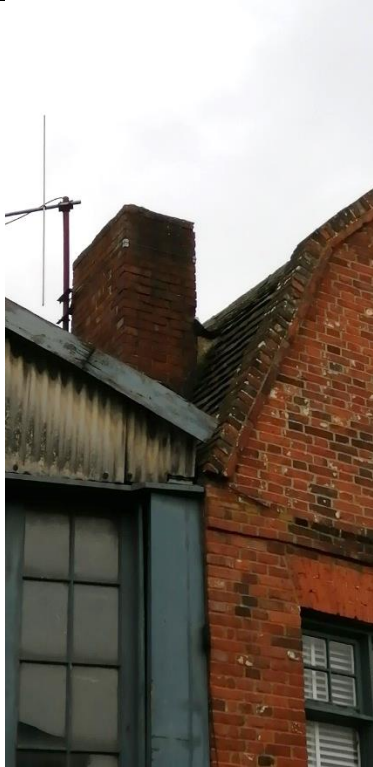
- 4.7. The tiled roof of this building shows aging of the tiles, however seen from ground level appears even and in reasonable condition for its age. The brick chimney stack to the left-hand side needs a close-up inspection, however it does need repointing. See photos 5 and 43.

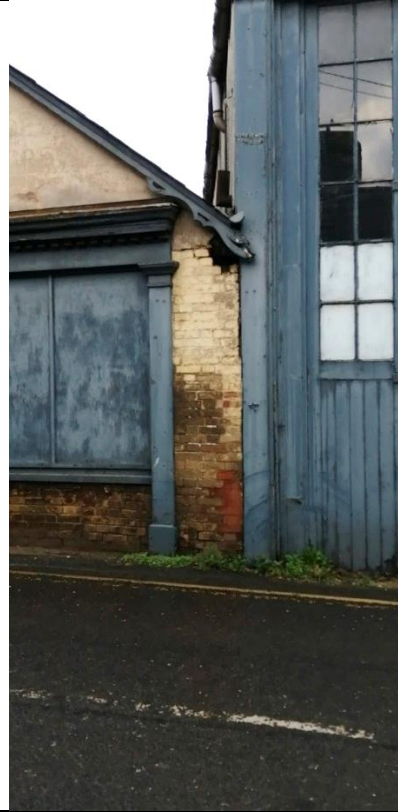
44.

- 4.8. To the left-hand side of the bus sheds is a single storey brick faced building, with boarded-in commercial scale window frames. Paintwork is aged and peeling, with some timber rot evident beneath. The brickwork to the left-hand side is in reasonable condition, other than some surface damage to bricks and mortar joints to the courses near ground level. Brickwork to the right-hand has diagonal cracks in the mortar joints at mid-height and both cracks and missing bricks to the top of the panel at the eaves. See photos 44 and 45.

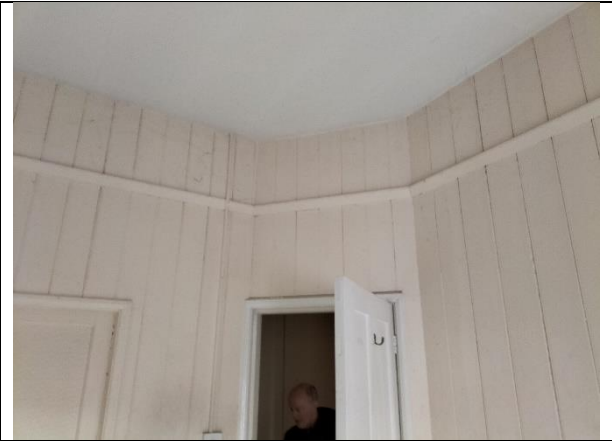
66.

- The first floor comprises a bedroom and the bathroom. The bedroom walls are timber panelled and the underlying fabric should be inspected. There are a number of small cracks across the ceiling, in particular at the sloping ceiling line over the windows. See photos 63-66.

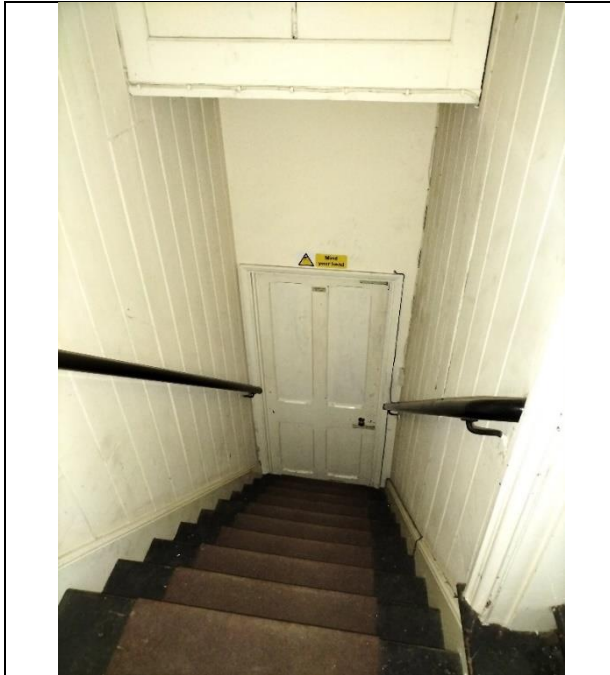
69.

- 4.26. Front building
 - The ground floor room is generally in reasonable decorative condition. There is a covered lobby with double doors from the road, within which are electricity meters. See photos 86, 87, 93
 - There is a narrow winding stair to first floor, which is timber panelled throughout. Above the stair is a double door which would only be accessible with a ladder. This area should be opened-up and inspected. See photos 69 and 70.

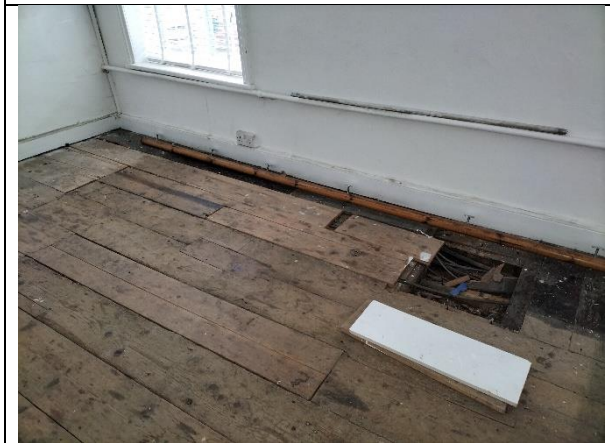
71.

- The front room at first floor has floorboards lying parallel to the front elevation, implying that the main joists span from the front to central wall. Some boards have been removed and the zone beneath appears full with shavings. Walls appear in reasonable condition. See photos 71-73.

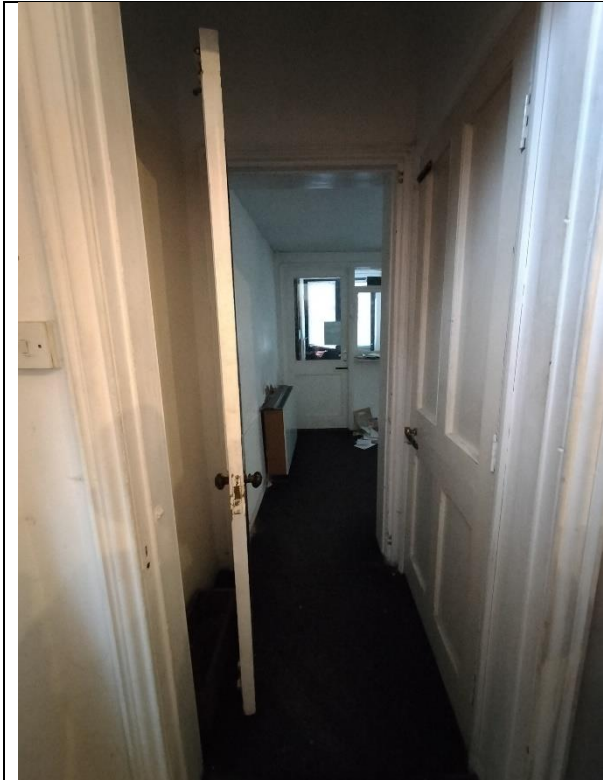
85.

- 4.28. Second building
- This is the plot behind the front house, the upper parts of which are used as a residence and it has a double side window at ground level. There is a beam front to rear at underside of the first floor. Internally the finishes are in good decorative condition, as the tenant is using this space for aspects of their business. See photos 83-85.

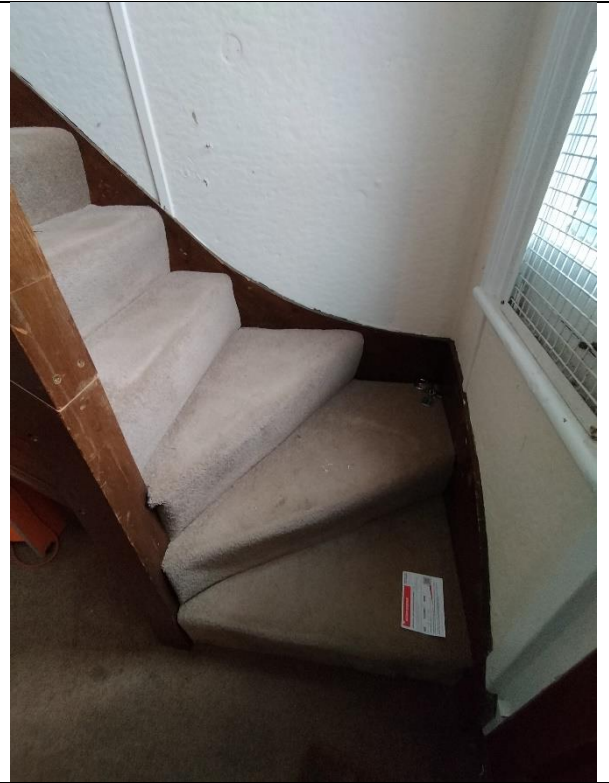
94.

- 4.29. There entrance lobby and timber stairs appear in reasonable condition. See photos 94 and 104.
- 4.30. Third building
- The large ground floor room has an archway formed in the main wall, through to the room behind. Both rooms appear generally in reasonable decorative condition. There is a boxed beam at high level across the room. See photos 107, 108 and 112.

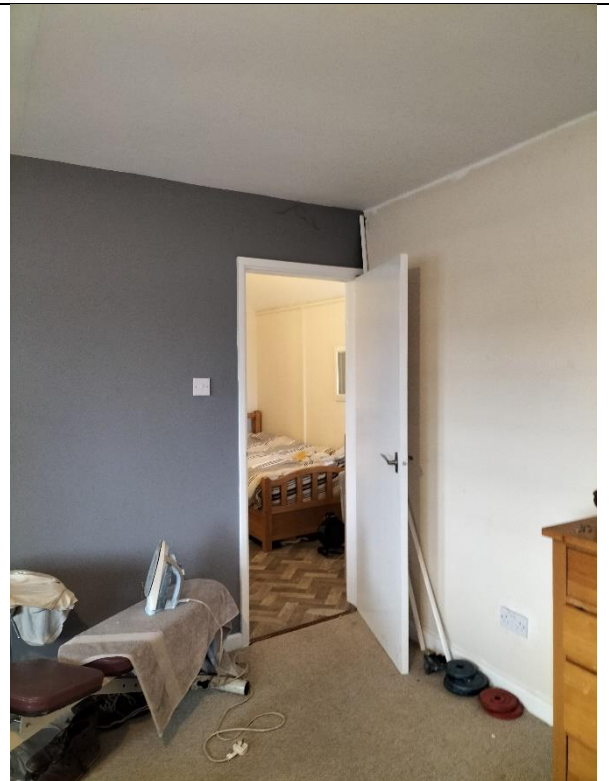
96.

- At first floor there are two rooms, both of which are in use and in reasonable decorative condition. The first is a lounge. See photos 100-102
- The rear room is the bedroom and is also in reasonable decorative condition. There is a small storage area with a hot water cylinder within the roof space beyond the back of the room. See photos 96-99.

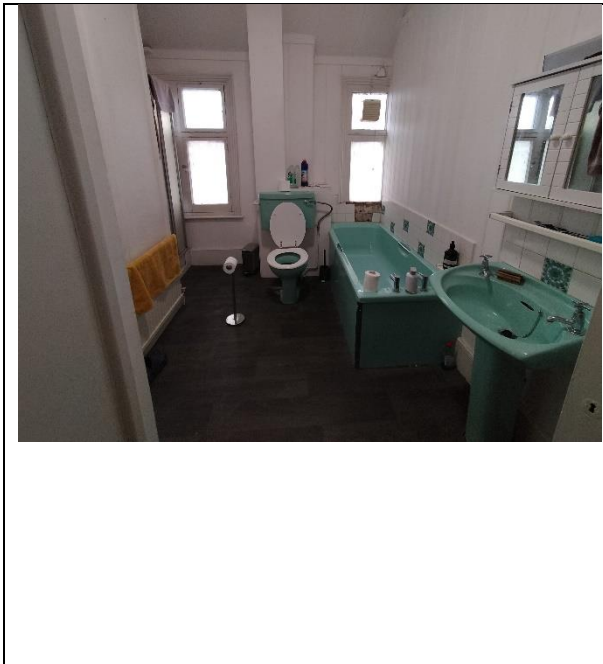
105.

- The bathroom is also timber panelled above the tiling. The room is in use, has been redecorated and is in reasonable condition. There are missing tiles between the bath and narrow window. See photos 105 and 106.

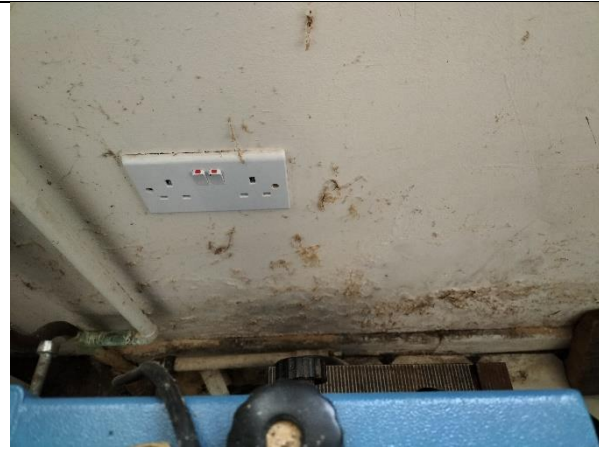
119.

- The fourth building at ground floor is accessed internally via the archway noted above. There is a pair of doors to the side wall, which access into a paved area that includes a maintenance pit from the discussed bus garage. See photos 113 to the front room.
- The rear room is a well decorated and fitted out kitchen. There is a vertical crack from the corner of the window that continues behind the radiator. There is also a fine overpainted crack in the plasterboard ceiling. See photos 114, 116 - 118 to rear kitchen.
- The single storey rear extension has two storage rooms, which are fully stocked and most walls are not visible. However there are signs of damp at low level. See photos 119 and 120.
