MASONRY DAMP INVESTIGATION OF BASEMENT AT THE OLD RECTORY

JOB NO. 157-85 **Rev A**

10 AND 11 JANUARY 2023

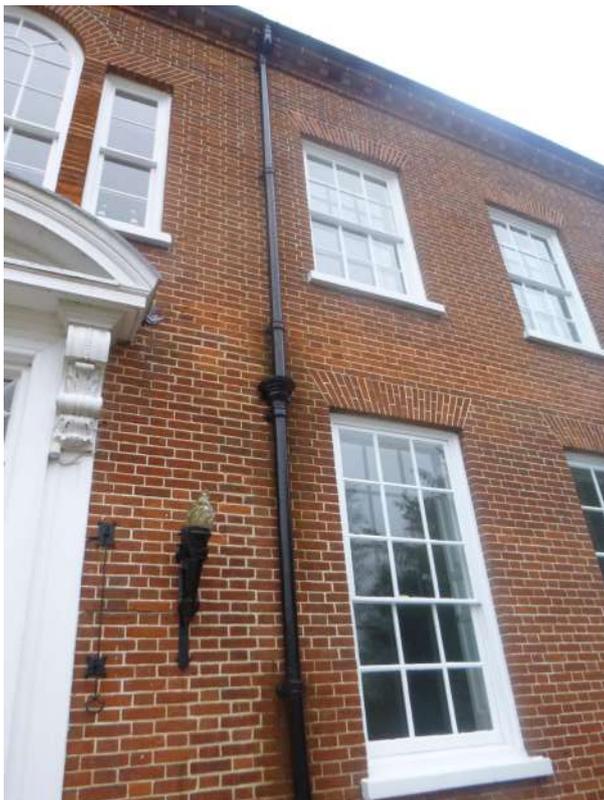
Fig 2:

Exterior, west elevation; showing a view of the singular downpipe serving this elevation. Note the cast iron downpipe was found to have been oxidised and damaged approximately 1.5m above ground level. There was also evidence that the sequential hopper has previously overcharged down the masonry below

Roof drainage should be repaired/replaced and inspected for blockages and cleared to restore function, where necessary. Consideration should be given to a general re-design of the roof drainage system to improve provision for access, cleaning and maintenance. Consideration should also be given to undertaking roof drainage calculations based on up-to-date meteorological data to ensure that adequate drainage capacity is provided to discharge surface water clear of the structure at all times

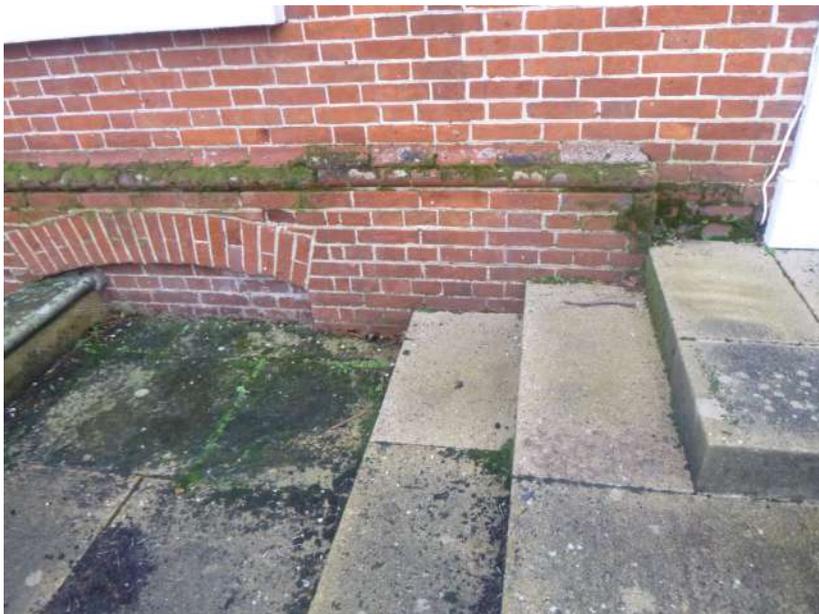
Fig 4:

Exterior, west elevation; showing a view of masonry at low level including previously bricked in window. Note the biological growth and general damp conditions of paving stones indicative of water ponding and tracking back into the masonry mass

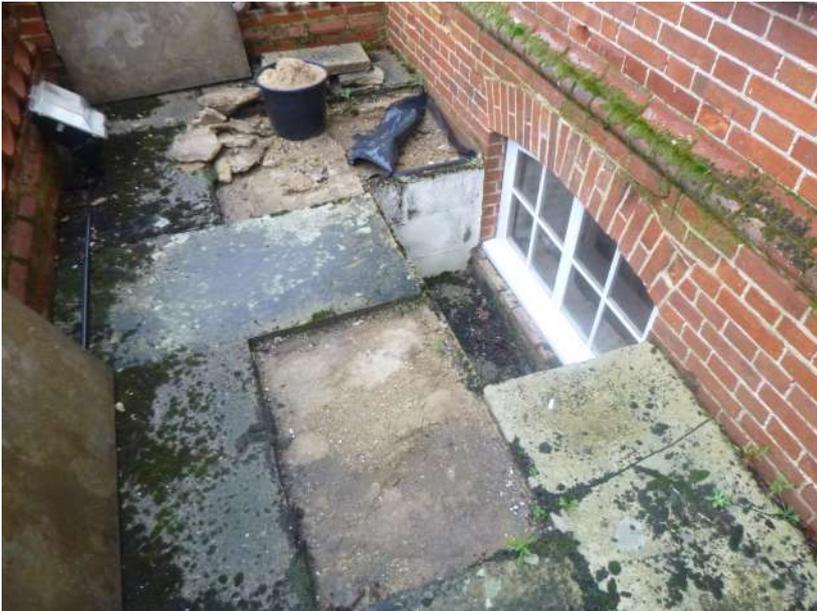
Fig 5:

Exterior, west elevation; showing partial exposure works to better understand the external landscaping relative to basement window openings. Note further modern landscaping with concrete blockwork polythene lining and sand. This will potentially create moisture reservoirs which could become compromised and saturate lower ground masonry at a rapid rate

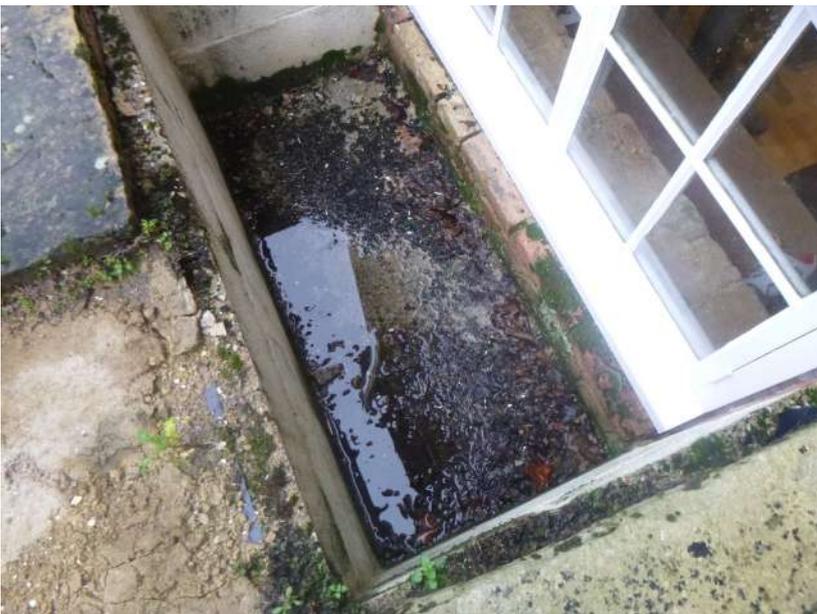
Fig 6:

Exterior, west elevation; showing water ponding below a window opening which has concrete blockwork and a cement base. Note wall masonry in this location is likely to be damp with any finishes also likely to be damp affected

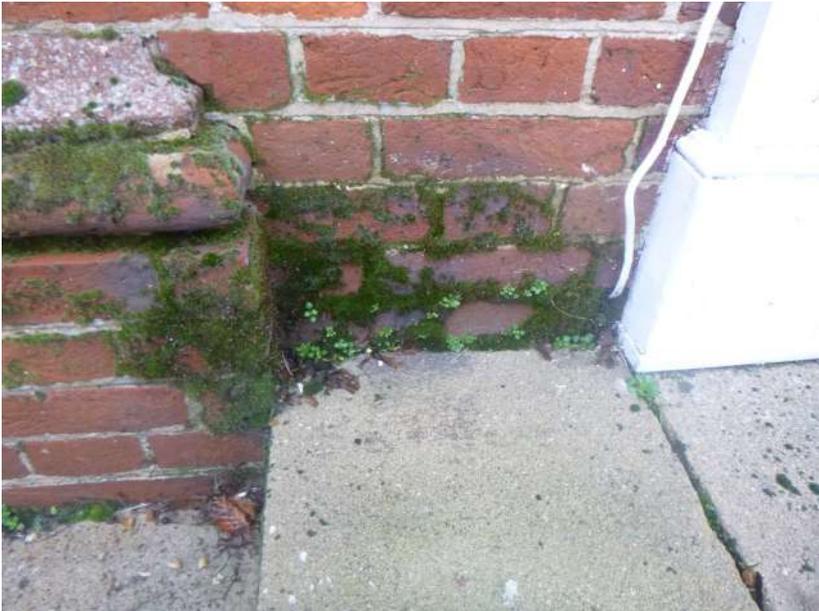
Fig 7:

Exterior, west elevation; showing a close up view of wall masonry with extensive biological growth indicative of damp conditions due to water ponding and tracking back from modern landscaping

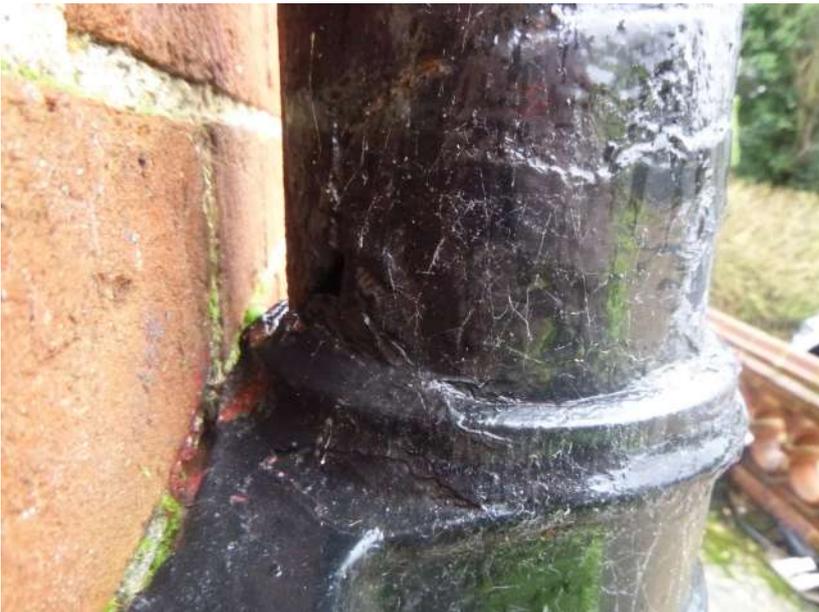
Fig 8:

Exterior, west elevation; showing a close up view of the cast iron downpipe which was found to be cracked and overcharging onto adjacent masonry

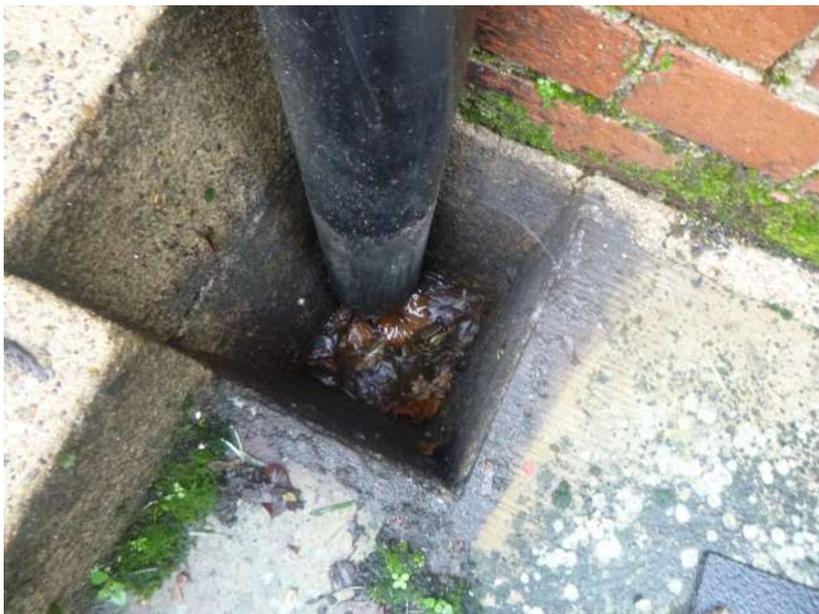
Fig 10:

Exterior, west elevation; showing a view of the surface gulley provision for the west downpipe. Note the gulley was partially blocked at the time of survey and it was not clear what the condition of below ground drainage was like nor where it drains to

All below ground pipework serving surface drains should be inspected in detail, using CCTV as required and allowance should be made for all necessary cleaning, repair and upgrading to ensure that surface water is drained clear of the masonry and foundations of the structure at all times

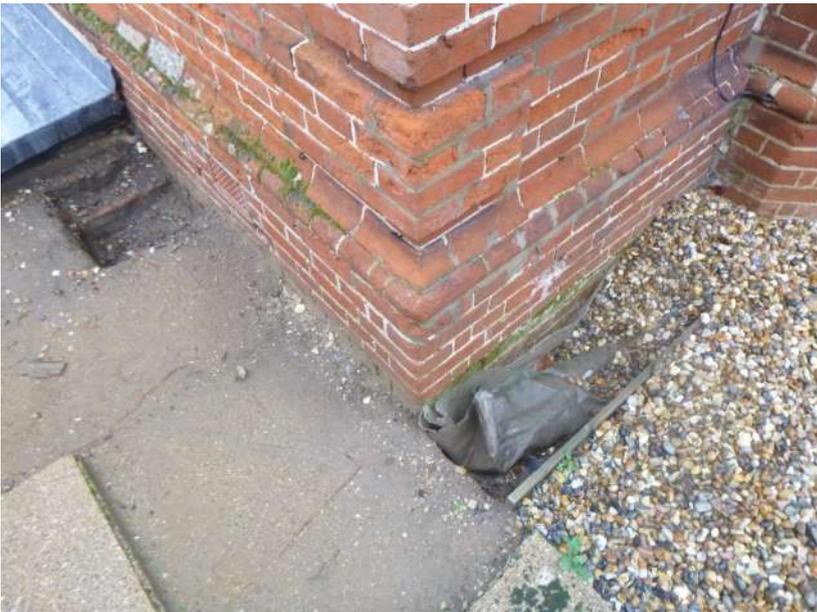
Fig 12:

Exterior, south-west corner; showing a view of what appeared to be provision for a partially constructed French drain detail. Note no perforated pipe was found so a geotextile sheet and sharp stones were used to improve drainage at the base of the elevation

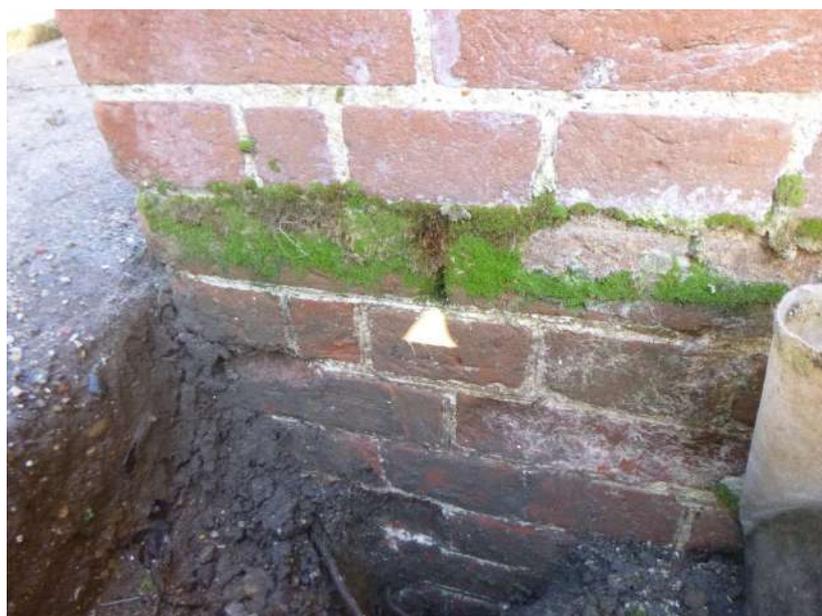
Fig 14:

Exterior, south elevation; showing a view of an excavated area used to investigate for the presence of a damp-proof course, with no evidence found

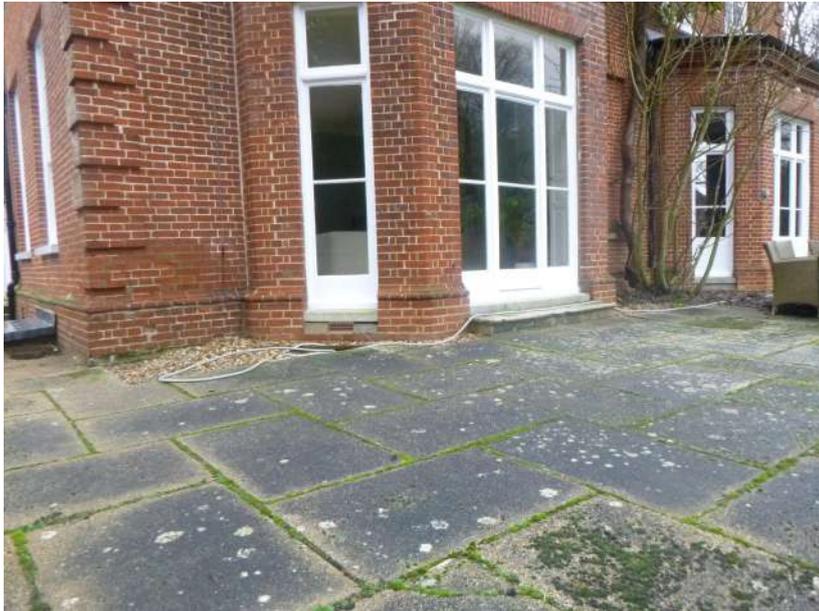
Fig 17:

Exterior, south elevation; showing a view of modern external landscaping which was found to have been laid to a slight fall away from the property

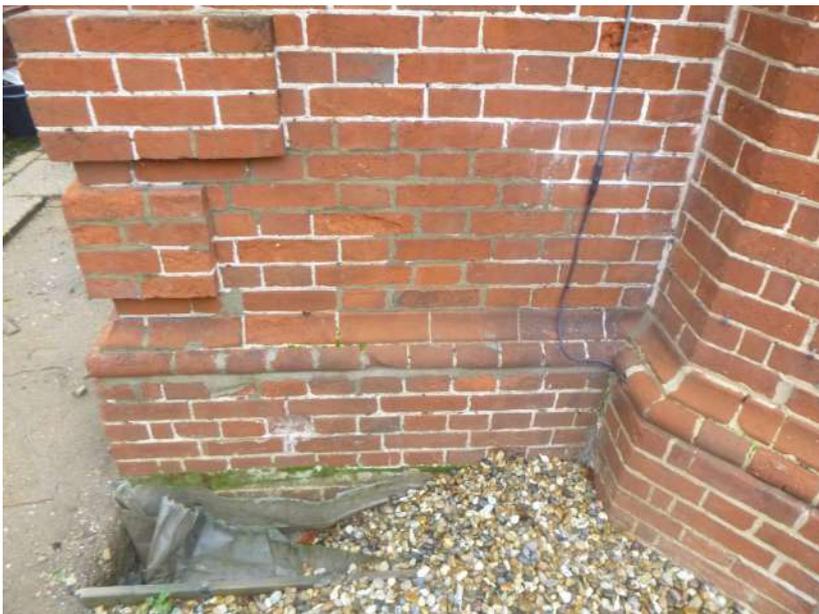
Fig 18:

Exterior, south elevation; showing a view of localised cementitious re-pointing indicative of damp affected brickwork and subsequent erosion of previous pointing

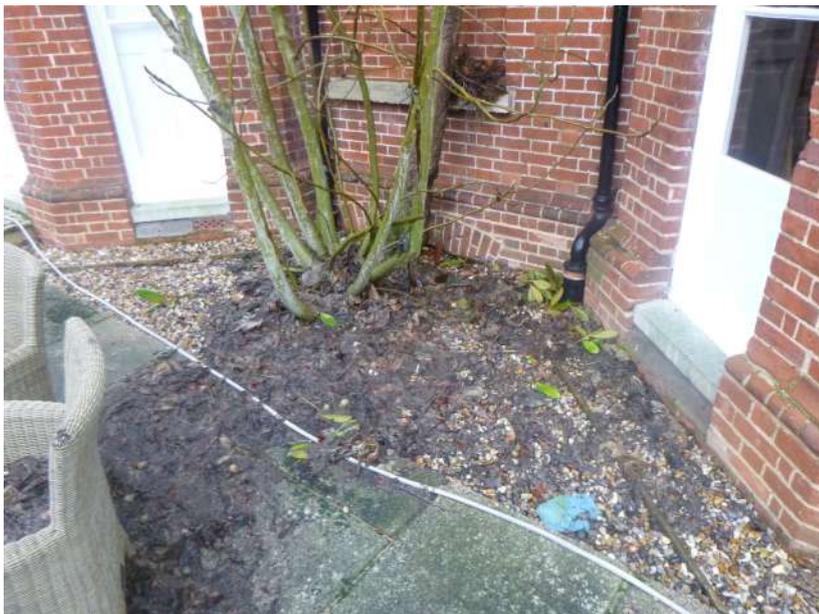
Fig 20:

Exterior, south elevation; showing a view of raised external ground level. Also showing large fig tree and neighbouring tree of another species that was established very close to the property. Note this may present issues when reinstating the basement

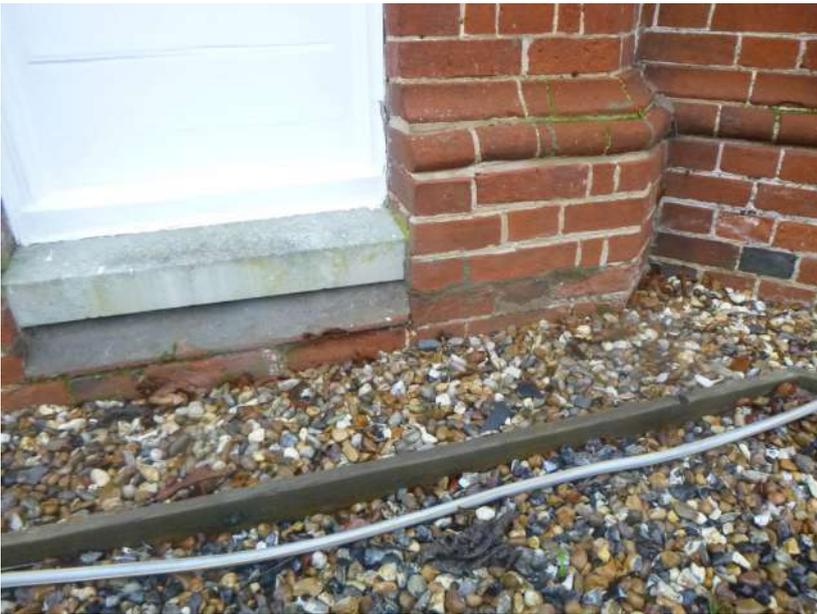
Fig 22:

Exterior, south-east corner; showing a close up view of localised masonry erosion and cementitious pointing repairs

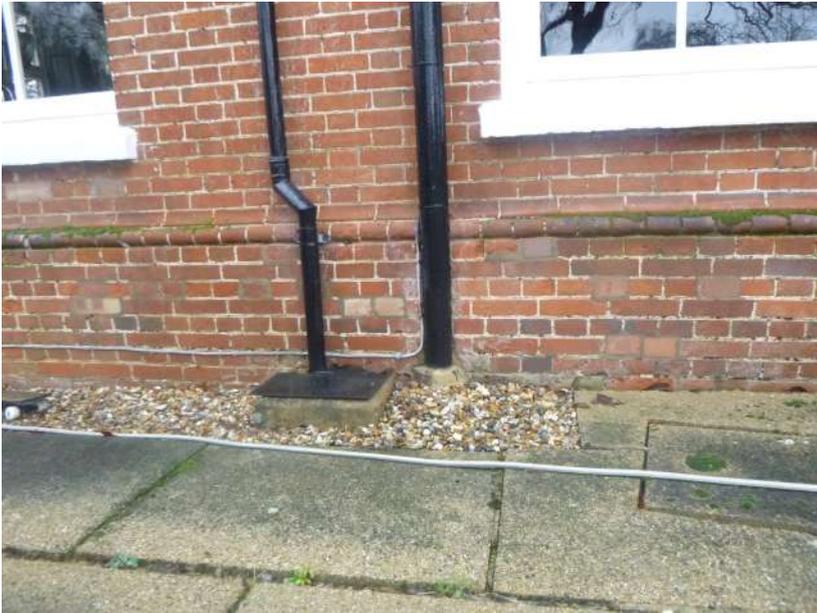
Fig 25:

Exterior, east elevation; showing a view of localised brick repair using mismatched bricks and cementitious mortar

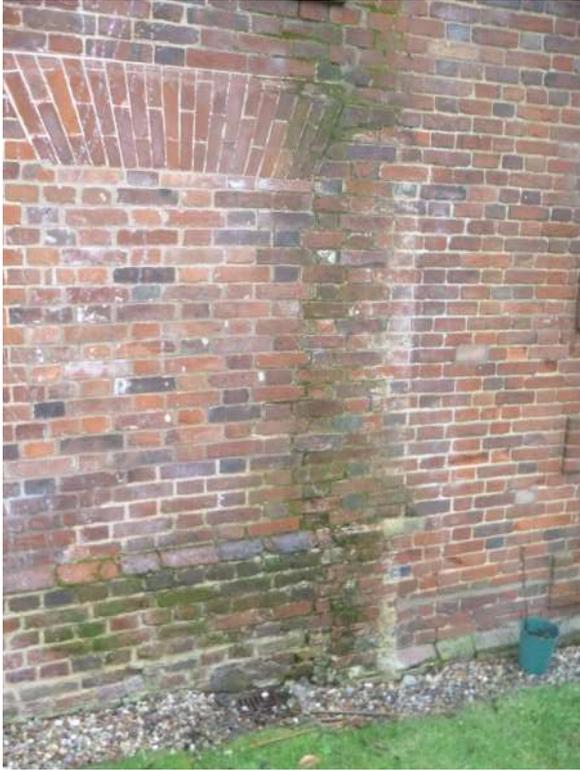
Fig 29:

Exterior, east elevation; showing localised biological staining to brickwork, below a window sill which may be discharging rainwater onto masonry. Note that guttering sections above were found to be leaking at the north-east corner

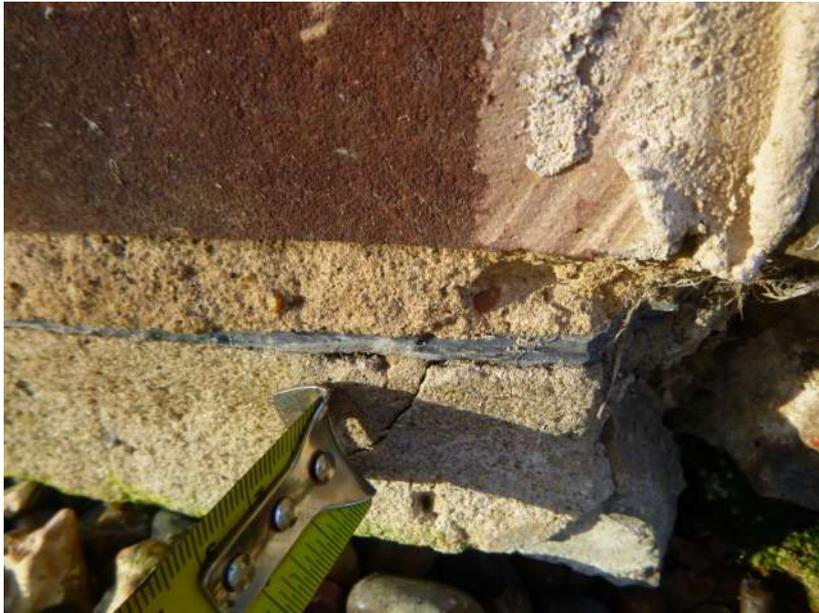
Fig 33:

Exterior, east elevation; showing the presence of a slate damp-proof course (DPC), which was found at the north-east corner, at the base of the more contemporary wing

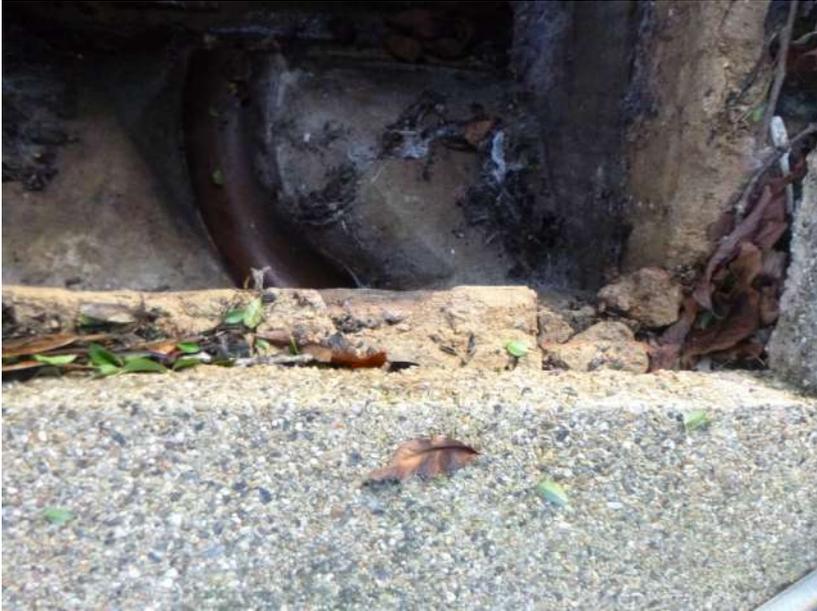
Fig 35:

Exterior, east elevation; showing a close-up view of a cement shoulder of the inspection point, which required repair to prevent the risk of the manhole cover collapsing and causing injury

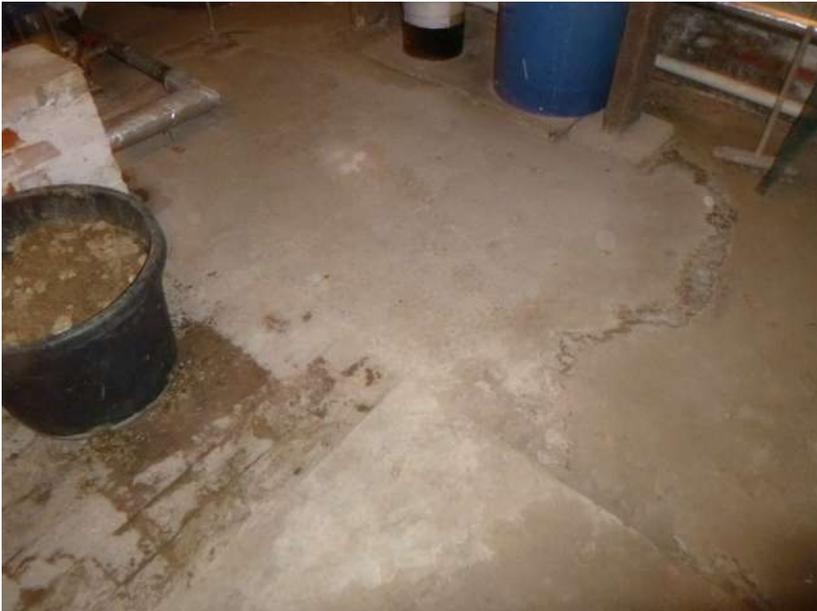
Fig 49:

Interior, basement, boiler room;
showing evidence of water staining to
the concrete slab, likely from a historic
services leak

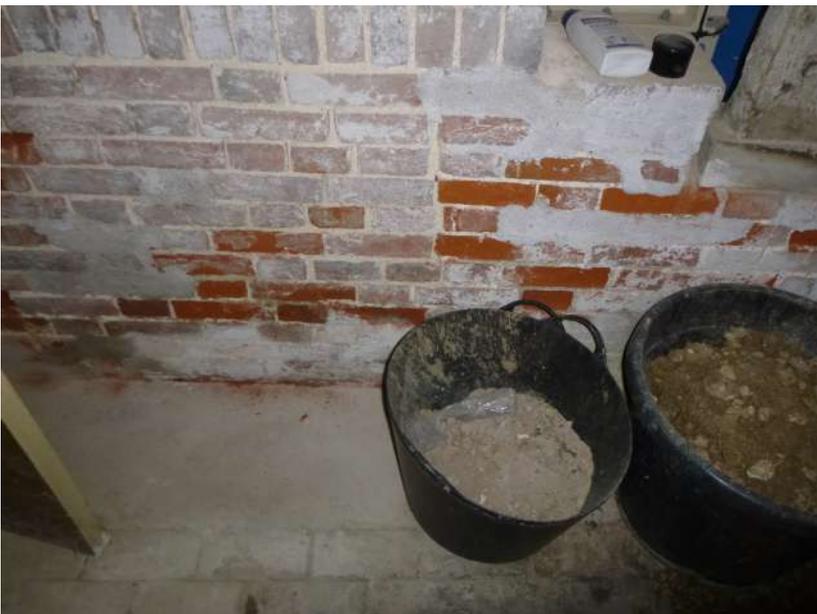
Fig 50:

Interior, basement, boiler room;
showing a view of soiling to brickwork
due to the migration of hygroscopic
salts

The source of the active water leak should be addressed urgently. Allow for brushing down of soiled brickwork and for applying a new coat of limewash or breathable paint

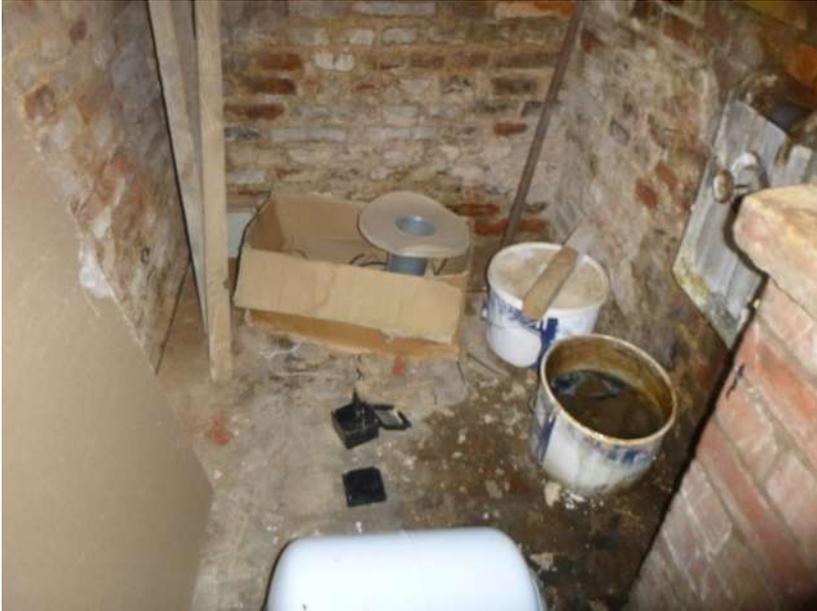
Fig 51:

Interior, basement, boiler room; showing localised water ponding and buckets used to collect water from a leaking services pipe above

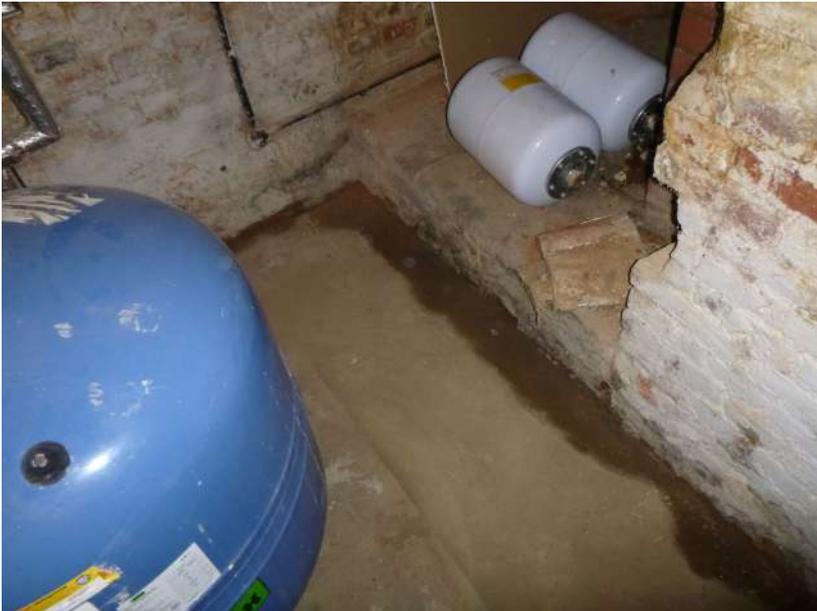
Fig 53:

Interior, basement, boiler room; showing water tracking and staining, believed to be associated with the nearby ongoing services leak

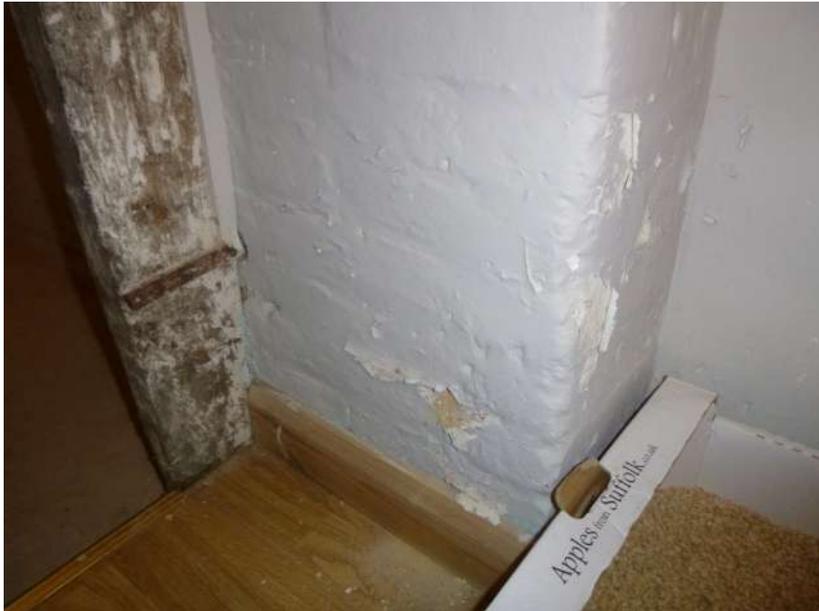
Fig 55:

Interior, basement, central corridor;
showing localised failure of film-
forming paint at low level

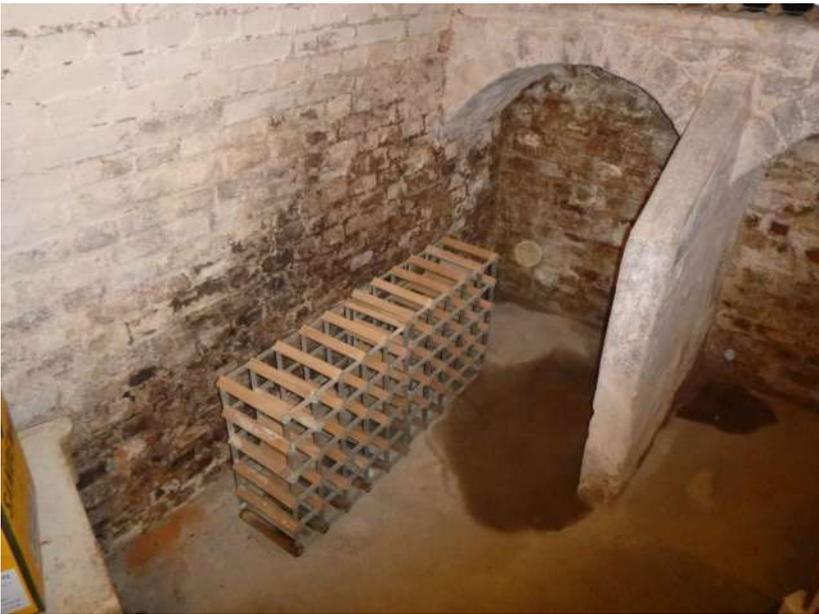
Fig 58:

Interior, basement, wine cellar;
showing a view of moisture movement
and associated staining and soiling to
brickwork

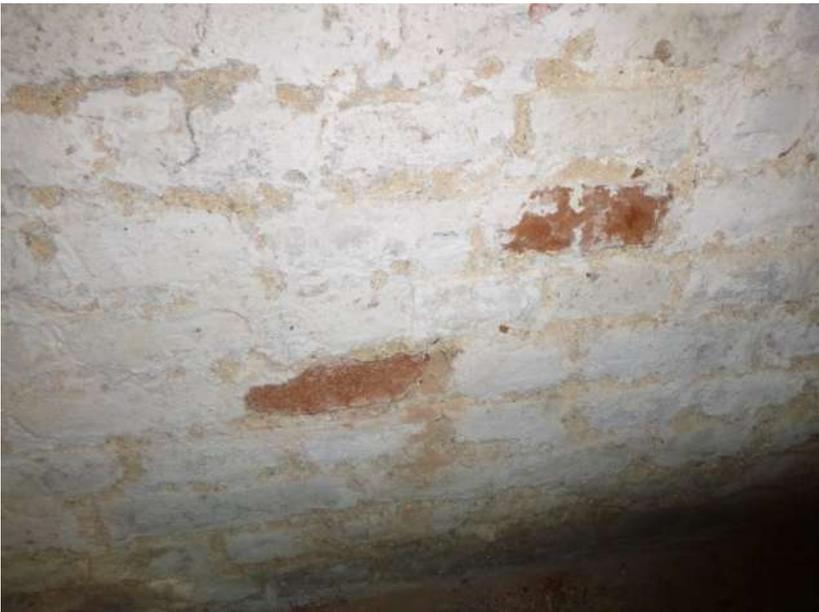
Fig 62:

Interior, basement, south room;
showing a close-up view of minor
damage to wall finishes

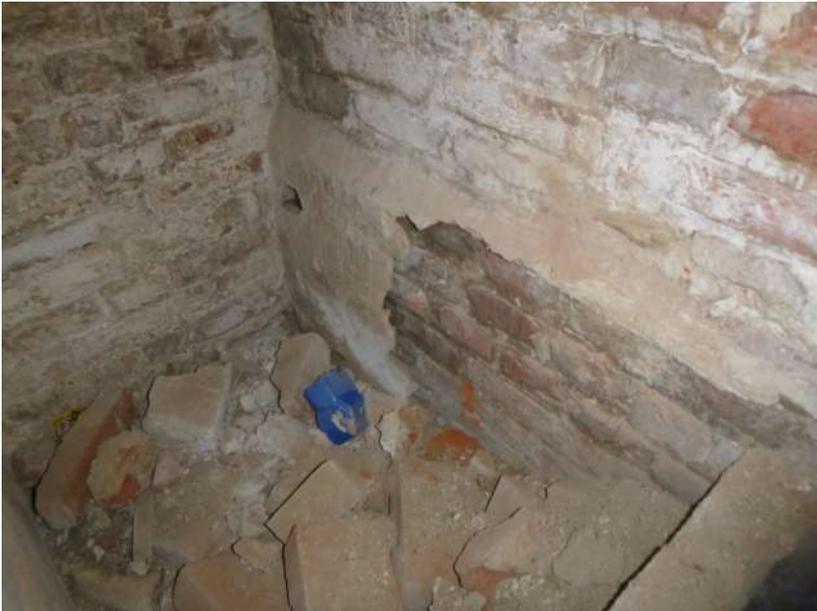
Fig 67:

Interior, basement, vaulted east room;
showing a view of a failed cementitious
render applied to brickwork at low level

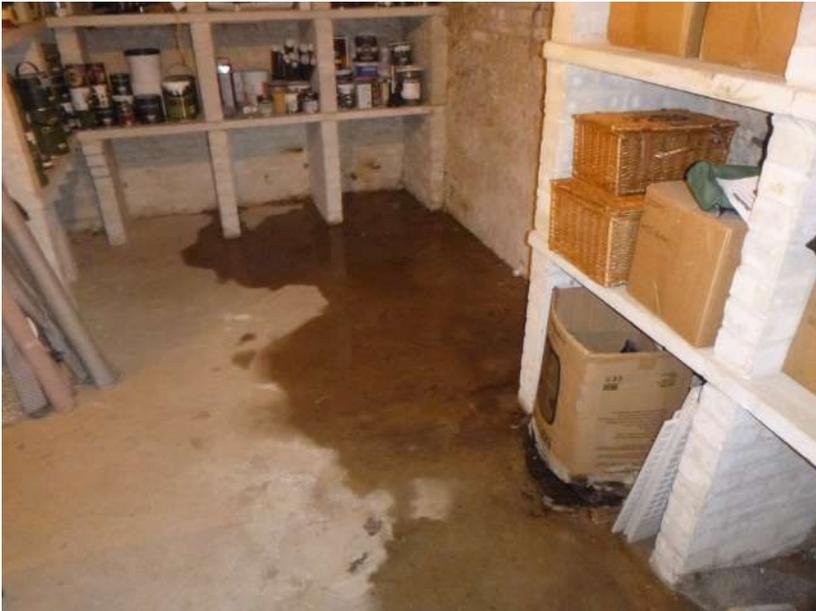
Fig 69:

Interior, basement, south-west room;
showing a view of moisture movement
across the existing concrete slab

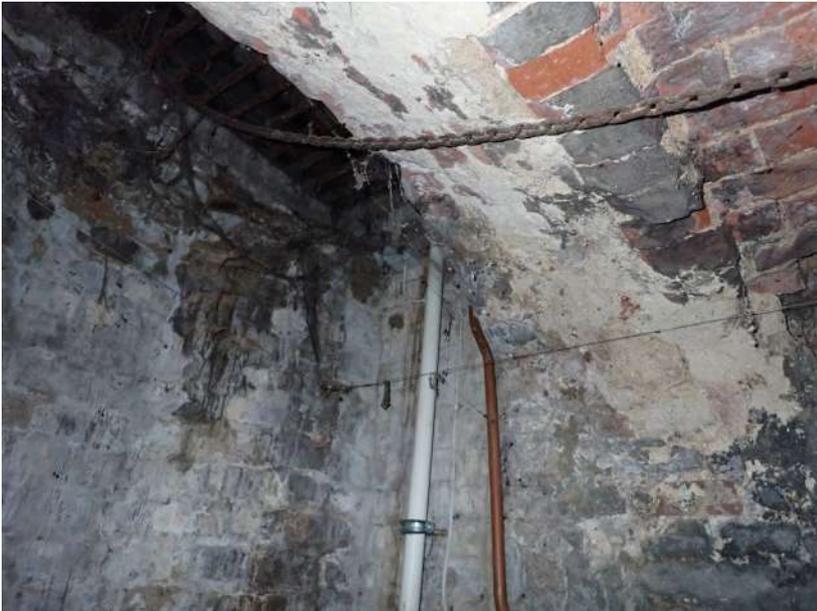
Fig 75:

Interior, basement; showing a view of the ingress point of the sump pump. It should be noted that there was no mechanical ventilation within the plant room as well as no pathway for air to circulate

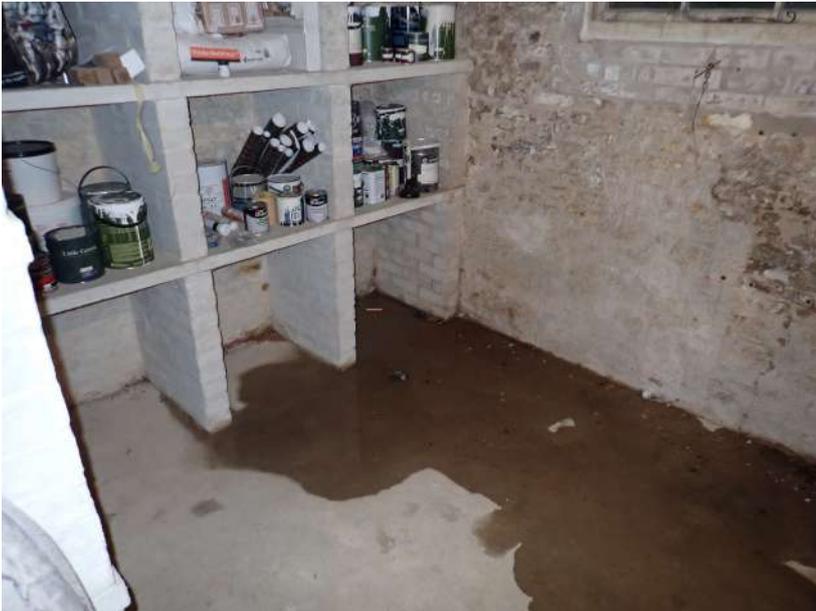
Fig 85:

Interior, basement; showing a view within a storage room at the south-west corner. Ongoing liquid water ingress was occurring which encourages the damp environment and due to the lack of ventilation in the basement area may lead to problems of damp and decay

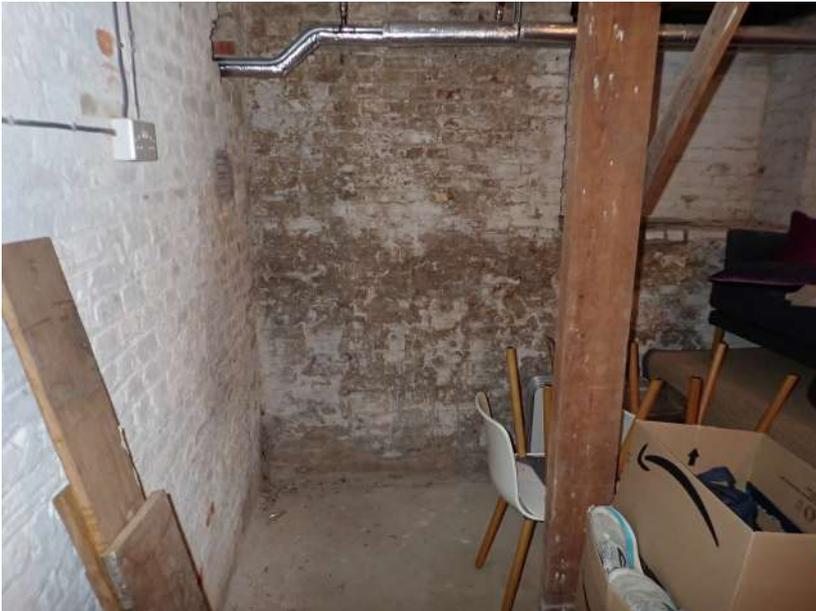
Fig 87:

Interior, basement; showing a view of failing paint finishes to a brick wall. This indicated problems of damp and salt efflorescence. Damp will be exacerbated by the lack of ventilation within the area
