**Arboricultural Assessment of a tree growing at 46,
Church Road, Wick**

On behalf of:
Mrs Myles

Prepared by:
Chris Wright M.Arbor.A
Arboricultural Consultant
March 2024

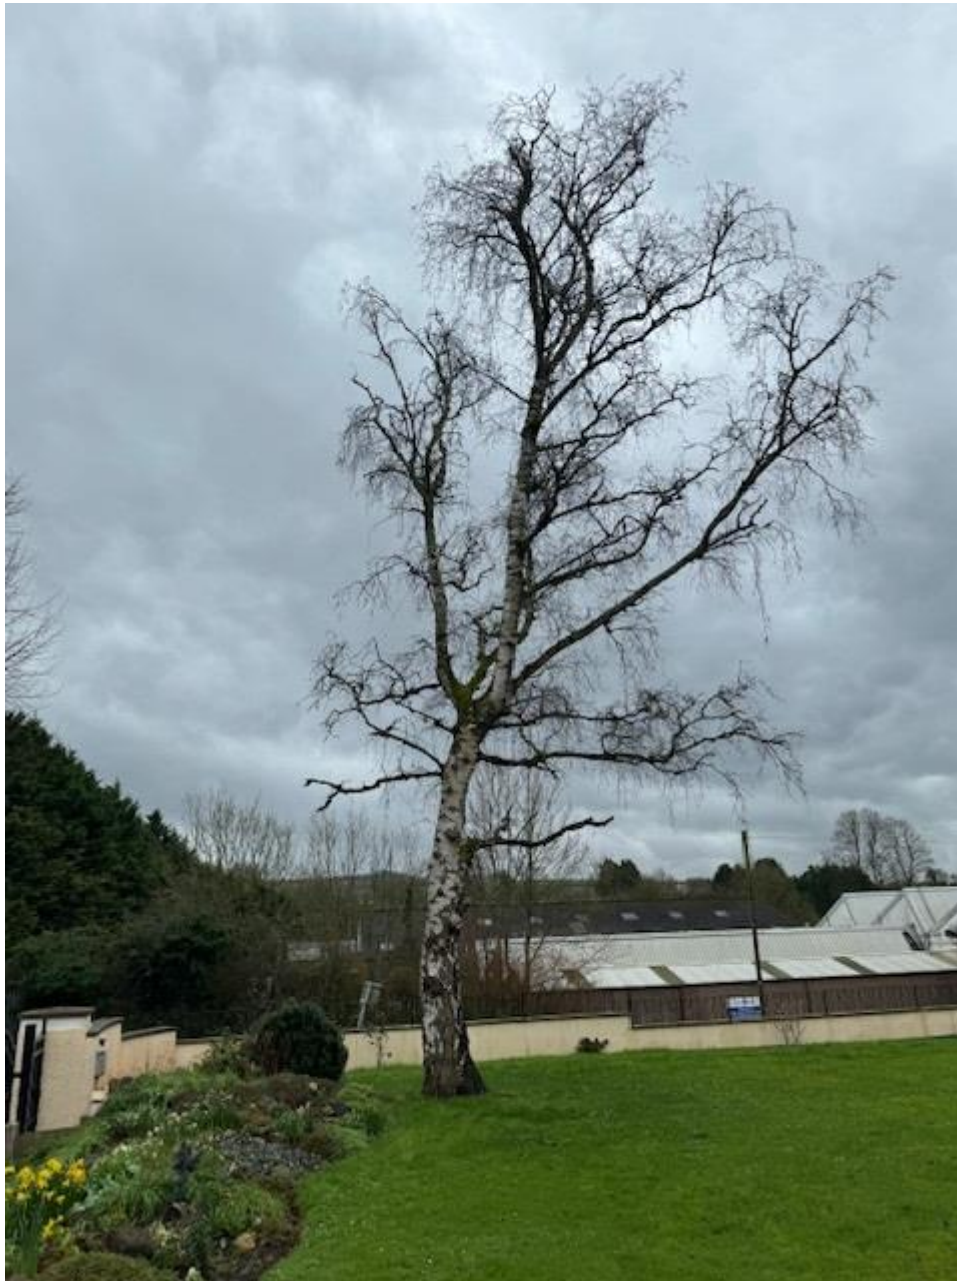
Pic 1

- 4.3 On inspection it was found the canopy of the tree contained significant amounts of dieback primarily at the end of branches with minor deadwood throughout canopy and large dead branches on the northern side. (Pic 1). We were informed by the resident that the tree has been shedding limbs for some time including a major 1m+ limb last month. It is considered that the tree is in major decline.

The tree is adjacent to a major highway with the canopy overhanging the public footpath which is regularly used by children attending the neighbouring school. There is extensive dieback within the canopy with areas of major deadwood on the northern side. Fungal bodies are growing around the base of the tree and along a major structural root extending to the south. It is considered that this is evidence of deadwood within the stem and root which could potentially make the tree unsafe and liable to failure.

5.2 In conclusion, the tree is a poor specimen with a suppressed asymmetric canopy, limited useful life expectancy and offers little visual amenity to the area. It is considered that the tree is in terminal decline and poses a health and safety threat to the adjacent public. If the tree were removed a new tree will be planted to mitigate the loss and enhance the area.

It is recommended that the Birch tree is removed.

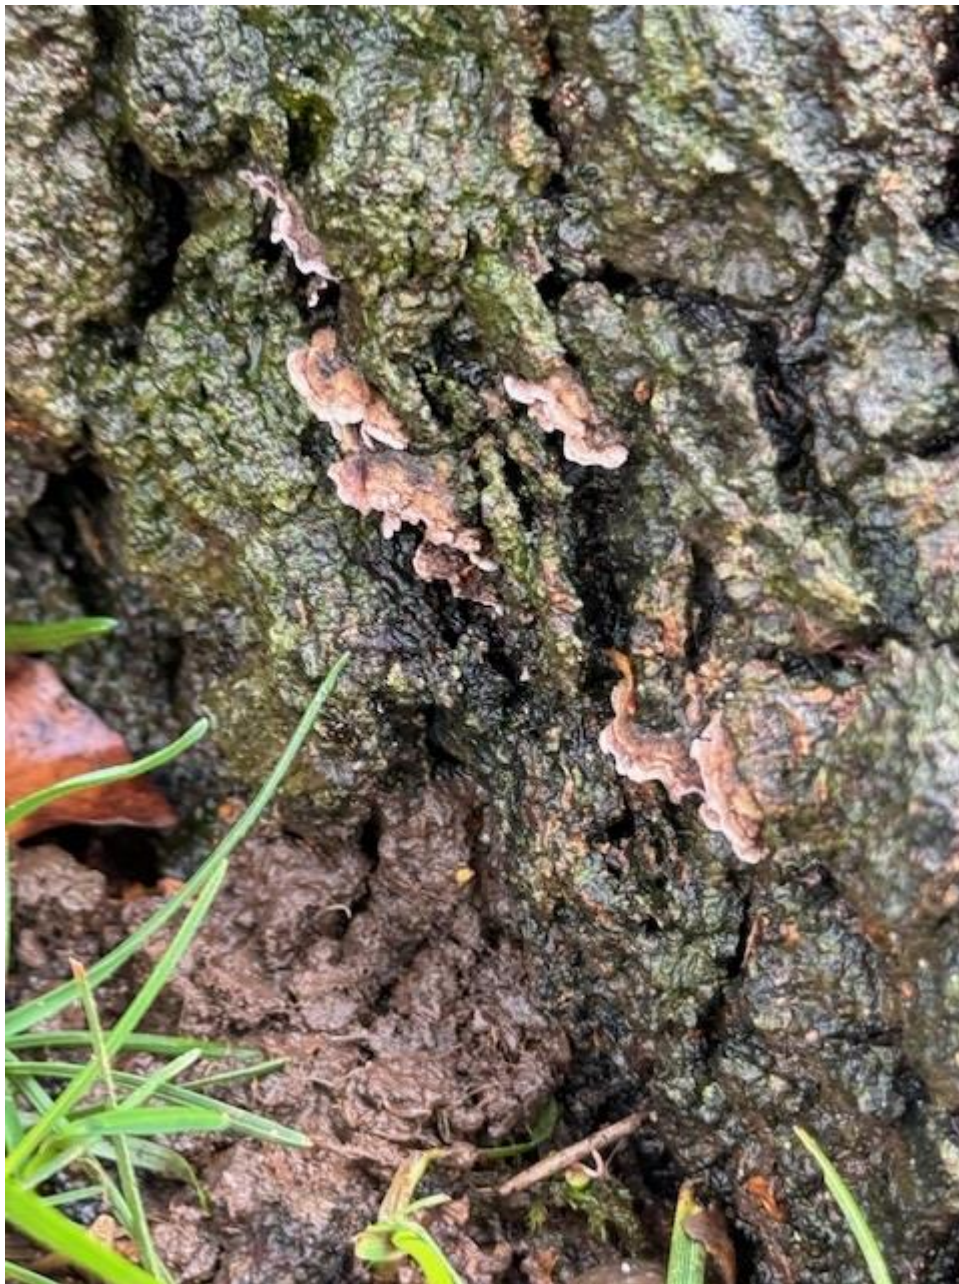
Pic 2

- 4.4 A large surface root extends to the south from the base of the tree. There are fungal fruiting bodies growing on the base of the stem and along the root which were identified as Turkey tail (*Trametes versicolor*) (Pic 2). This is a saprophytic fungi which breaks down deadwood. It is therefore fair to assume that there is deadwood present within the base of the tree and the root. There is a column of deadwood within the main stem extending downwards from the wound.
