**BANFF CASTLE, CASTLE STREET,
BANFF**

**Archaeological Watching Brief
and Recording**

Report by
J Charles Murray

September 2003

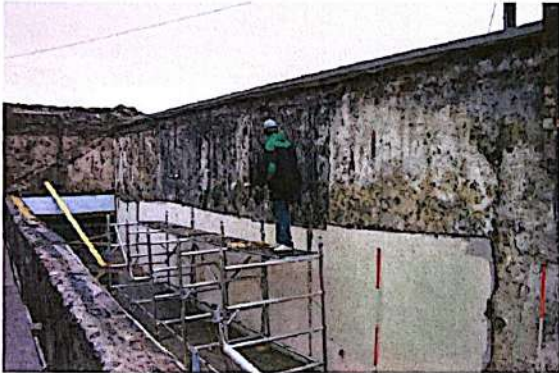
Scheduled Ancient Monument Consent was given for the reroofing of that portion of the East Pavilion buildings used as a rifle range. The E wall of the building is thought to be formed by part of the medieval curtain wall. Although recording in detail by a measured survey was not required, the internal face of the E wall was extensively photographed digitally, in colour, and in black and white print. Little detail emerged, as the plaster work and earlier pointing was not removed [see Photographs 1 and 2, below].

Photograph 1 – E wall, looking N.

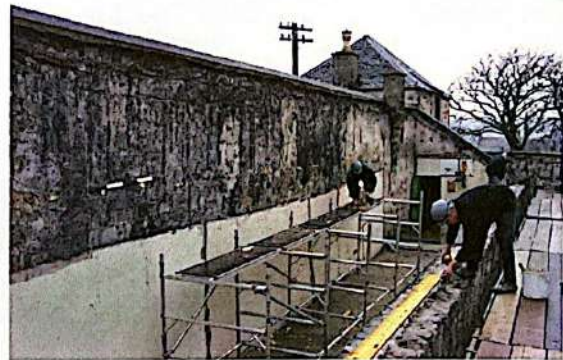
Photograph 2 – E wall, looking S.

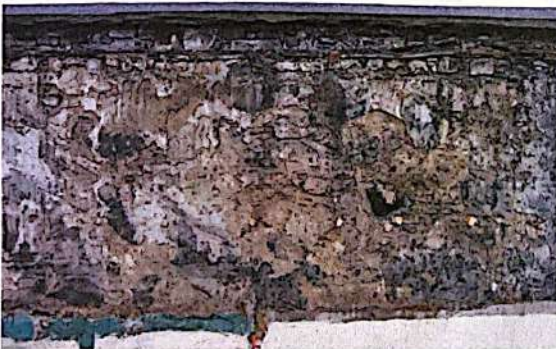
Photograph 3.

Photographs 3 and 4, (below), show in greater detail, the state of the internal face of the E wall, which was left intact.

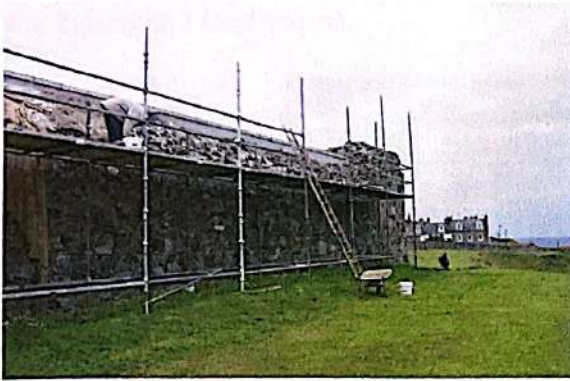
Photograph 5.

Observation showed the wall, at its surviving height, to be of small rubble construction. Loose stones were removed and, after the surface was cleaned and examined, were replaced where required. The wall cap was then remortared to prevent further erosion and deterioration. No cut stone or other stone of architectural significance was evident at this level in the wall construction.

Photographs 5, (below), shows the external face of the E medieval curtain wall, looking N, while Photograph 6 shows a detail of the rubble construction at this level.

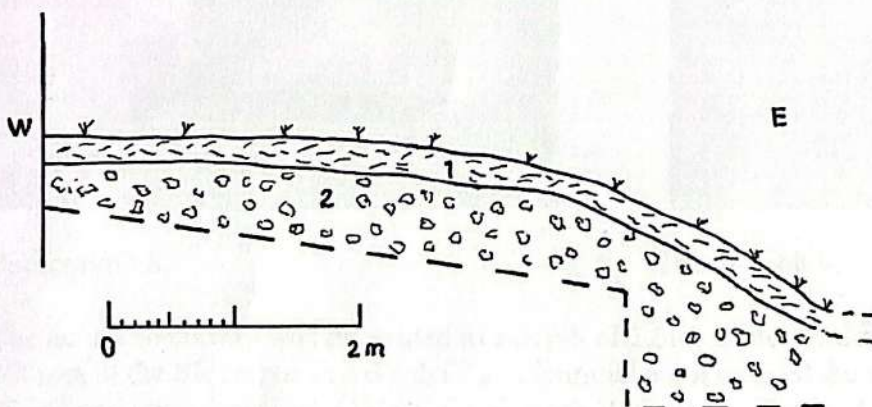
Section through 'A'

The fill was comprised of a c.250mm layer of topsoil and pea-gravel mix, Layer (1), which overlay a deep made-up deposit of brown earth mixed with stone and some animal bone, Layer (2). No cut for the moat or ditch was observed and it appears that at this point, the ground level was raised and landscaped.

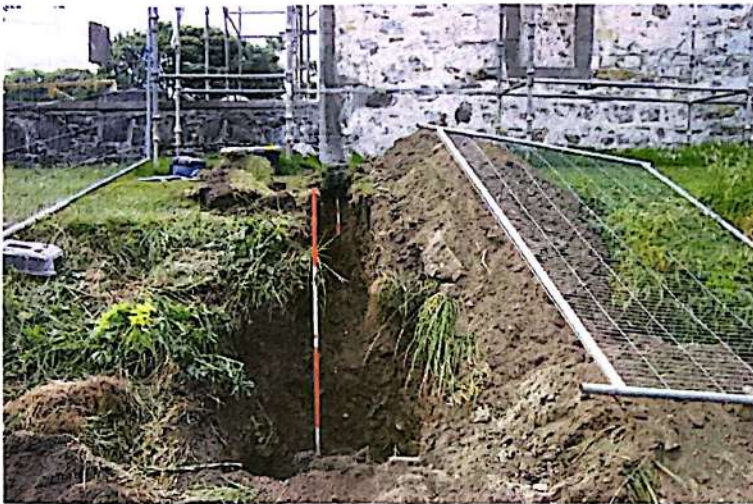
Photograph 7 – shows Soakaway ‘A’, looking W. Only a depth required for drainage was excavated and no attempt was made to ascertain the original ditch profile.

No archaeological features or artifacts were evident in this trench.

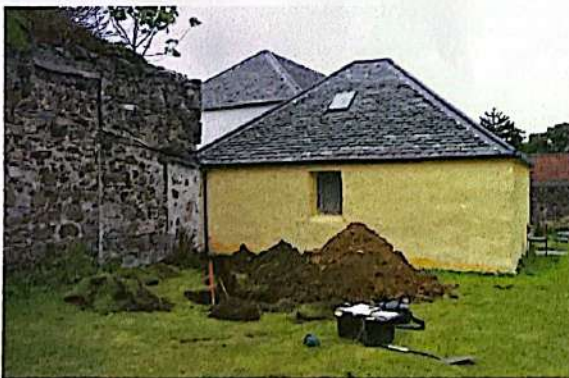
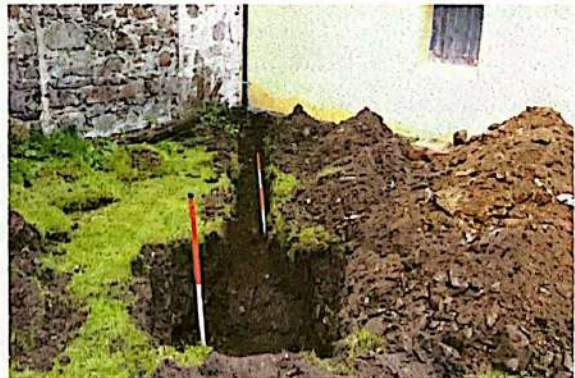
Soakaway ‘B’ was located in the garden, to the N of the garden store which forms part of the West Pavilion range of buildings. It ran from the SE corner of the store, to the NW for a distance of c.4.5m [see Site Plan, p.3 and Photographs 8 and 9, below].

The actual soakaway was excavated to a depth of 1.5m, while the drain running into it was 300mm at the SE corner to a depth of c.600mm where it entered the soakaway. A 150mm layer of sod and topsoil overlay a layer of dark earth, 450mm deep, mixed with 19th and 20th century broken flowerpot, glass and crockery. This, in turn, directly overlay the natural brown sandy soil with fractured stone.

Even though the soakaway was within the medieval enclosure, no archaeological features or finds were evident.

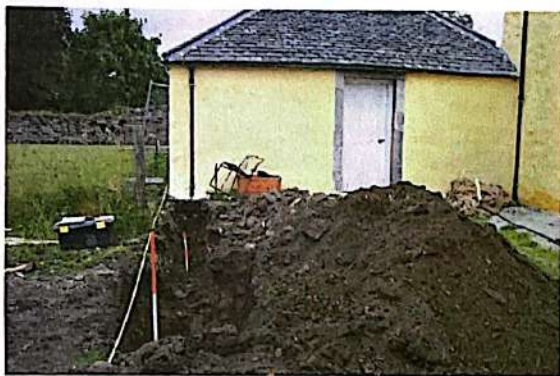
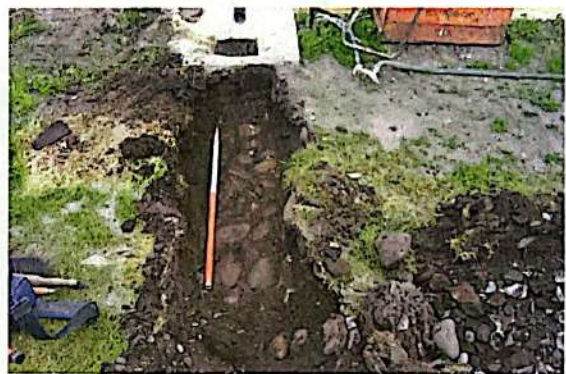
Soakaway 'C', projected S from the SW corner of the garden shed [see Site Plan, p.3]. The drainage trench was c.4.4m long, leading into a soakaway c.1.6m long x 1.2m across and 1.4m deep [see Photograph 10, below]. The drainage trench was excavated to a depth of c. 500mm and consisted of a thin top layer of earth which overlay a layer of cobbling confined to the N end of the trench [see Photograph 11, below]. Below the cobbling was a dark brown earth fill mixed with 19th and 20th century material. In the soakaway, this layer extended down for c.700mm where it overlay the yellow-brown sandy and stoney natural [see Photographs 10 and 11, below].

No archaeological features or artifacts were evident in Soakaway 'C'.

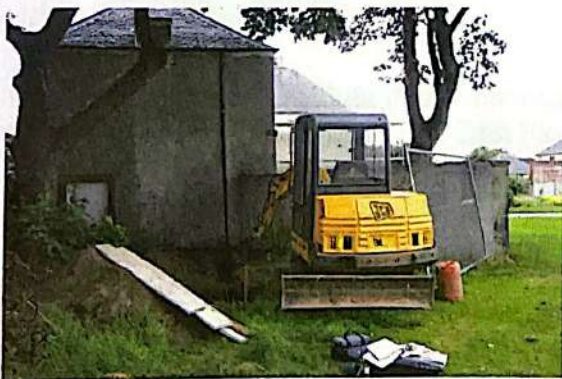
Photograph 12

Soakaway 'D' was located at the SE corner of the South Gatehouse and extended S for a distance of c.6.7m [see Site Plan, p.3 and Photograph 12, below]. The drainage trench leading to the soakaway was 5.5m long and was 250mm deep at its N end, deepening to c.750mm at its S end where it entered the soakaway. The soakaway was excavated to a depth of 1.52m.

Below a 100mm layer of grass and topsoil was a 200mm layer of pea-gravel, which extended the length of the drainage trench and overlay a brown soil with much tree root. In the soakaway itself, a 300mm layer of mixed earth and stone overlay the natural sand.

No archaeological features or artifacts were evident in Soakaway 'D'.

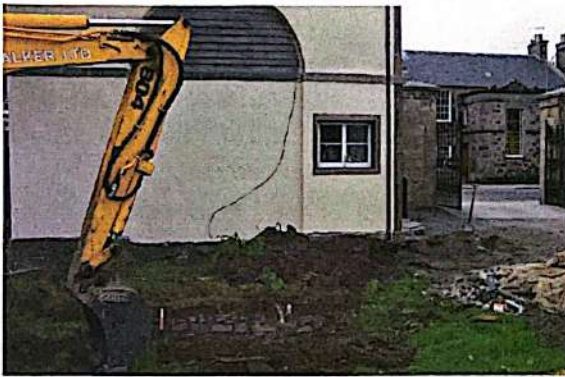
Photograph 14.

It was proposed that Soakaway 'E' would lead from the NE corner of the South Gate House and extend c.4m to the SE [see Site Plan, p.3 and Photograph 14, below]. The machine strip revealed a cobbled surface along the proposed line of the drainage trench and in the area of the proposed soakaway. It was clear from the small area exposed, that the cobbling probably covered the general area to the E of the South Gate House [see Photograph 15, below]. On account of this, the placing of the soakaway in this location was abandoned and instead was routed to run NE of the NE corner of the South Gate House to cross the driveway, through ground previously disturbed, and link up with an existing drain in front of the Caretakers House (No. 3 on Site Plan, p.3).

It was not possible to positively date the cobbling, but it is likely to date to 19th/20th century ground improvements.
