**STRUCTURAL SURVEY**

Barn at Holcombe Granary  
Holcombe Lane  
Uplyme  
Lyme Regis  
Dorset  
DT7 3SN

266/23

23 October 2023

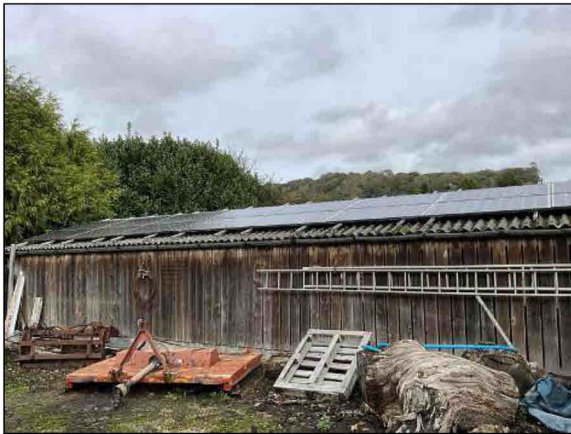
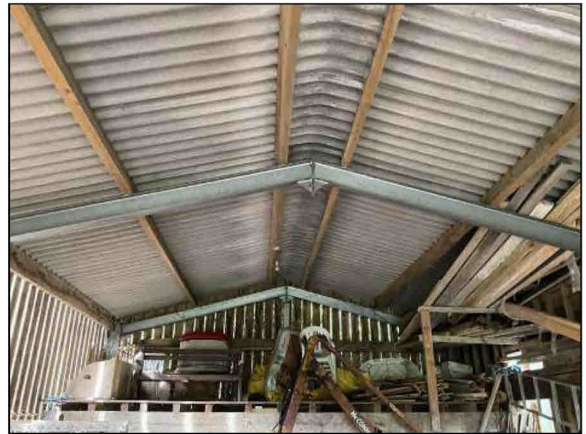
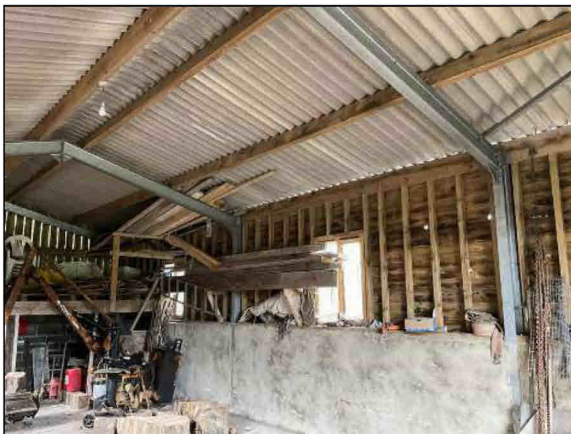
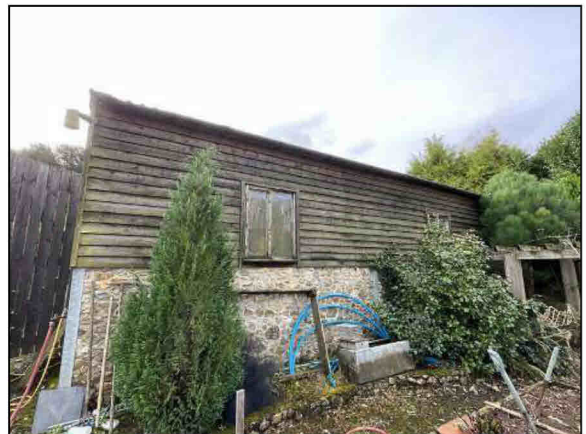
The barn is of concrete pad foundations and concrete strip foundations, steel framed, solid stone and blockwork walls, with timber boards to the walls.

The barn is provided with timber doors and windows to the building.

The roof is provided with corrugated man made sheet cladding to the roof.

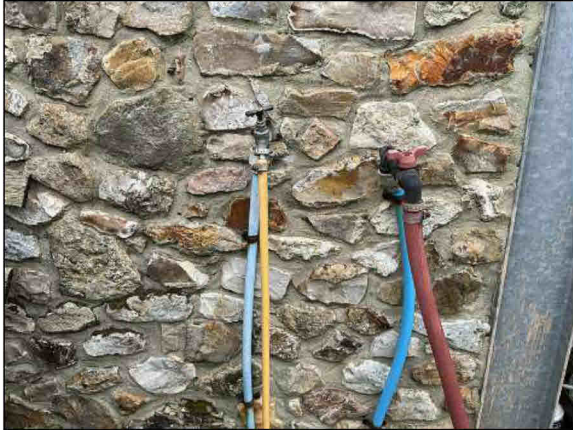
The barn is currently provided with a mains water supply and an electric supply that is situated within the curtilage of the land under the control of our client.

The building is not provided with any form of foul drainage, but would be able to connect into the existing sewage treatment plant that serves the adjacent property. The current owners confirm the existing treatment plant should have sufficient provision to serve this new property.

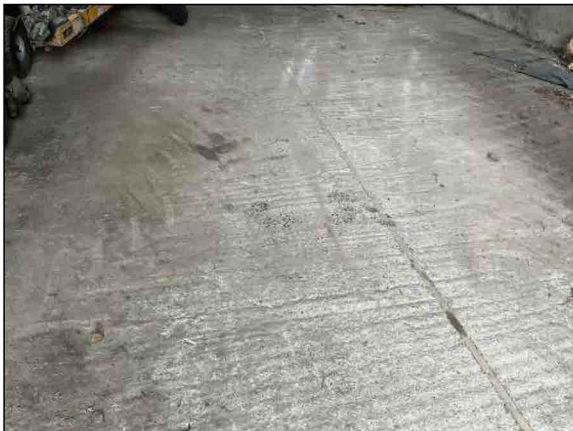
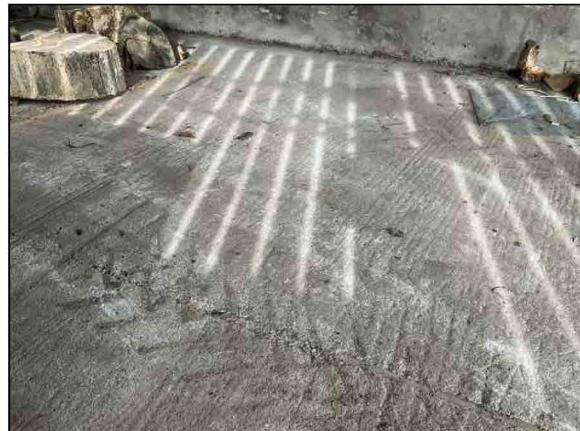
The ground floor is provided with a concrete floor with tamped floor finish, the floor runs from front to back of the building. The floor has been laid to a slight fall to allow for making it easier to clean out.

I can see no reason why the floor slab would require any significant remedial works in this situation. The slab will however require some degree of updating with the provision of insulation to comply with current building regulations but this will require the provision of a new concrete slab, which can be laid directly on top of the existing concrete floor finish.

The ground floor is relatively level and is in good order with no signs of any movement or subsidence noted at the time of the survey. The concrete floor all appears to be in a stable condition and suitable for retention.

The existing tamped concrete floor will be retained and levelled off using a slurry screed.

A new radon and damp-proof membrane will be laid over the concrete screed and sealed to the wall to provide a suitable vapour check.

Internal insulated timber floating floor to be laid over the new damp proof membrane to meet the current requirements of the Building Regulations.

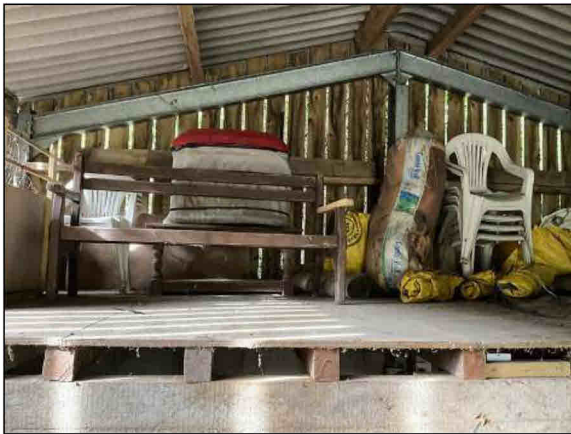
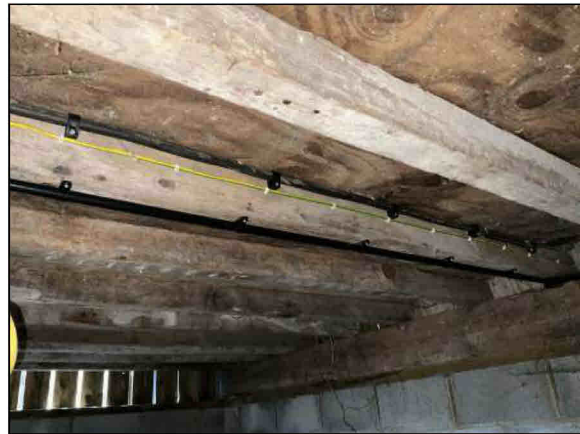
There is a timber beam, supported on the front and rear walls that is in the order of 225 x 75 mm timbers that has been provided to support a first floor structure. The beam is in reasonable order, with no evidence of deflection, and appears to be in good structural order.

The floor is provided with a series of timber floor joists which are in the order of 100 x 75 mm joists spaced at 400 mm centres. The joists are showing some signs of historic deflection but generally appear to be in good structural order. The floor is provided with a timber boarded floor finish which has evidence of general decay. The floorboards will need to be removed and replaced with new at the time of conversion and this will inevitably lead to some degree of repairs to the timber joists.

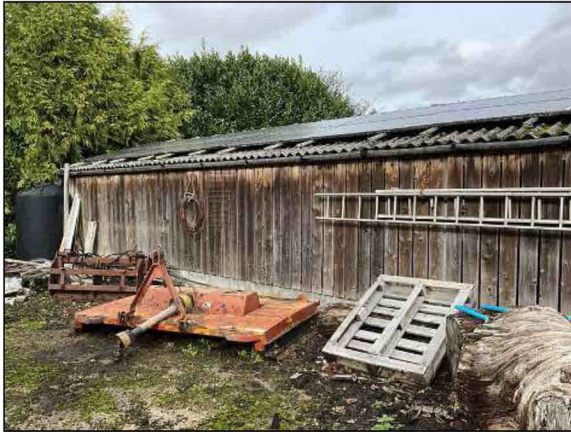
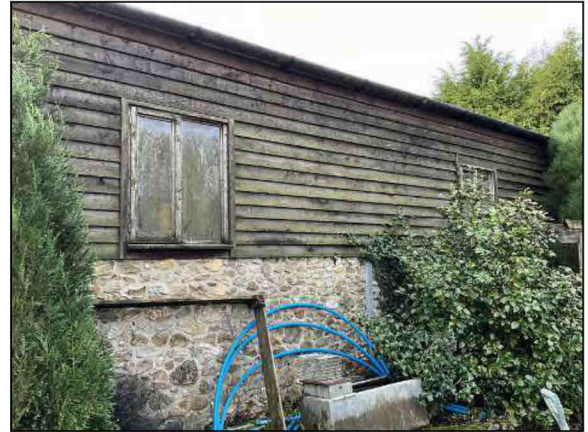
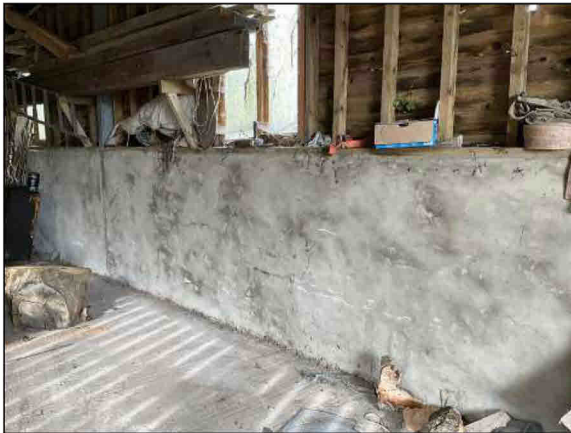
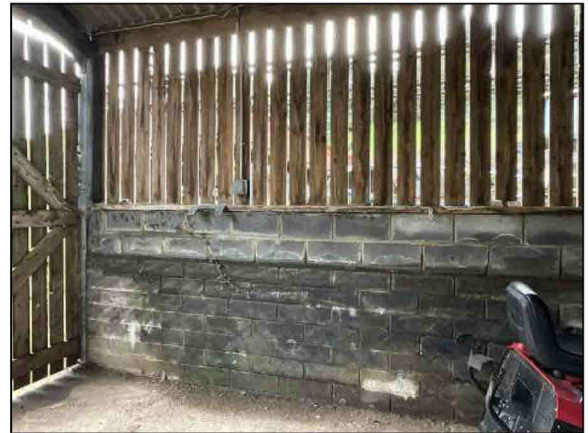
The upper section of the walls are provided with a series of timber studwork, which have been used to support the timber boarding to the walls, all of which appears to be in reasonable order. The mid rails are in the order of 75 x 50 mm timbers with the head and sole plate being in the order of 175 x 50 mm timber. The purlins are supported on the main structural posts with metal angles and bolted connections, all of which appear to be in good order. There is some evidence of minor deflection to the head plate, however generally they appear to be in good order and are suitable for retention in this location.

The north eastern side of the barn is provided with stone work with a painted finish, which is securely fixed in between the steel columns. The other external walls are provided with 140 mm concrete block work, with the blocks predominantly laid on their flat, with a pointed finish to the block work. The block work is set below the ground level and is retaining the adjacent earth bank. The block work is set in between the steel columns and is in good structural order.

The south western ground floor walls are set below ground level and are retaining the earth bank. The walls appear to be in good order with no signs of movement or cracking. There is evidence of moisture ingress through the walls, but this is to be expected with the makeup and design of a traditional block wall.

The masonry walls, timber framing and cladding to the barn all appears to be in good condition with no signs of structural movement or failure.

The external walls to the buildings are generally in good structural order with no signs of any current structural movement. I do not believe that the walls will require any substantial work and can largely be left in their current condition and are structurally sound.

Existing masonry walls, timber framing and timber cladding to have the existing external face of the walls repaired to leave them in a weather tight condition.

The internal walls are to be lined with elements of new timber framework to receive new insulated linings to meet current Building Regulations with a new vapour check and plasterboard with plaster finish internally.

The external cladding whilst not aesthetically in the best condition is suitable for its continued primary use as a rainscreen to the external walls. The external cladding has and will continue to operate in a way that prevents moisture ingress into the internal fabric of the walls, which is its primary function. There is no distinct need to remove the external cladding in this situation, minor repairs can be undertaken to leave the cladding in full functional order.

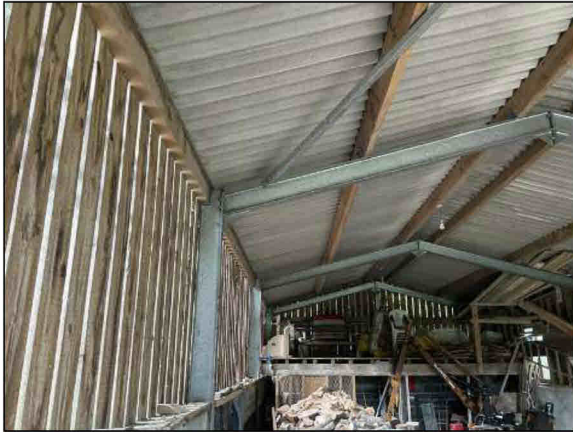
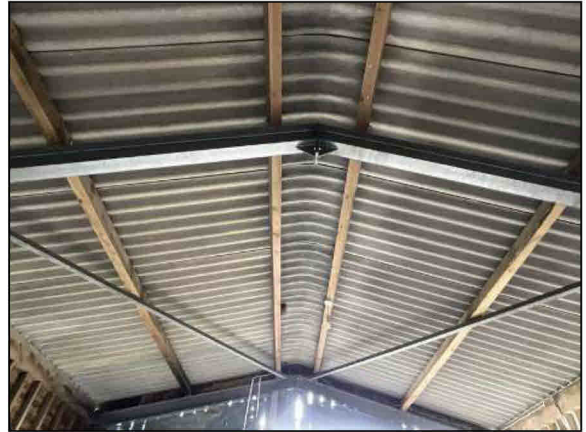
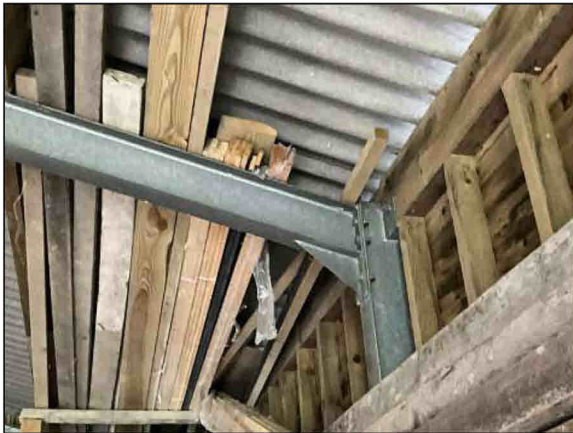
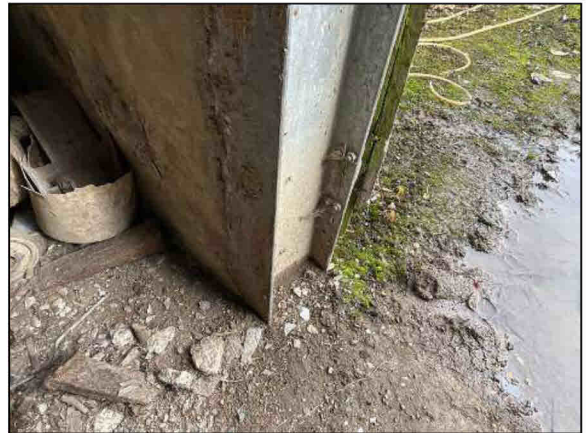
The building is primarily a three bay steel and timber framed building, with a central ridge running front to back on the building. The building is provided with four main frames, one to the front, one to the rear and two to the middle bays. The bays are provided with 185 x 102 mm steel columns with 185 x 102 mm steels to the main roof structure all of which appears to be in good order, with no evidence of deflection or decay noted at the time of the survey. The bays to the front and back of the barn are also provided with steel wind posts which are in good vertical order. The roof structure is also provided with square metal tube wind bracing, to ridge and adjacent to the purlins, which are in good order. There is no evidence of corrosion or significant cracking to the steel columns, with no signs of any actual decay to either the main steel columns or timber roof members and their ongoing stability. The junction between the steel columns and roof members is provided with steel weltd connections with bolted connections, all of which appear to be in good order.

There were no signs of any movement or distortion or damage to any of the fixings on the junction between the roof and the wall members. It is clear that the timber and steel frame to the walls and roof is in good structural order.

The steel and timber framing and cladding all appear to be in good condition with no signs of structural movement or failure. The structural condition of the building is therefore in good order to the main roof and wall elements with no structural repairs required at the time of the survey.

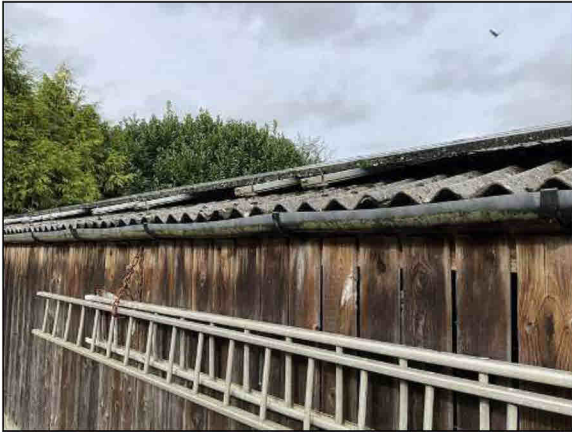
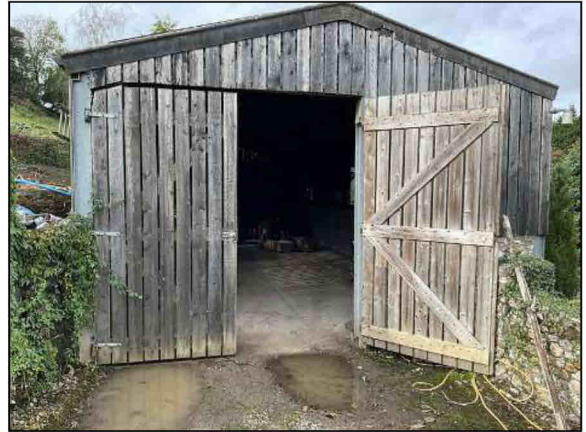
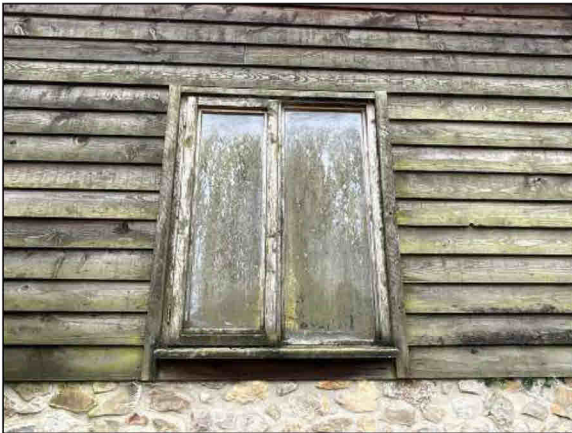
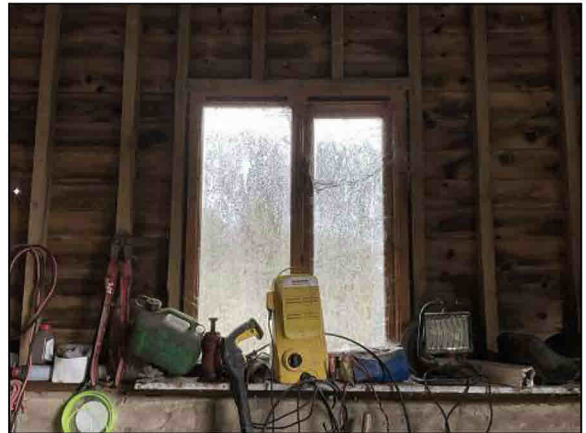
The external joinery is of timber doors and single glazed windows to the main structure with timber fascias to the individual elevations.

The existing roof is provided with a limited amount of UPVC rainwater goods all of which were in working order at the time of the survey. The existing external joinery would be replaced as part of any conversion works but generally appears to be in working order at the present moment in time.

The new windows and door frames will be fixed to the existing timber walls and steel frame using new DeWalt, or similar, anchor bolts. The anchor bolts will be pre-drilled through any new window or door frames and the wall structure, in accordance with the manufacturer's recommendations. The new window and door frames can then be fixed to the walls using new DeWalt, or similar, M10 150mm long anchor bolts which are designed for this particular application. This will not require the provision of any new structural elements of support or bracing to these frames.

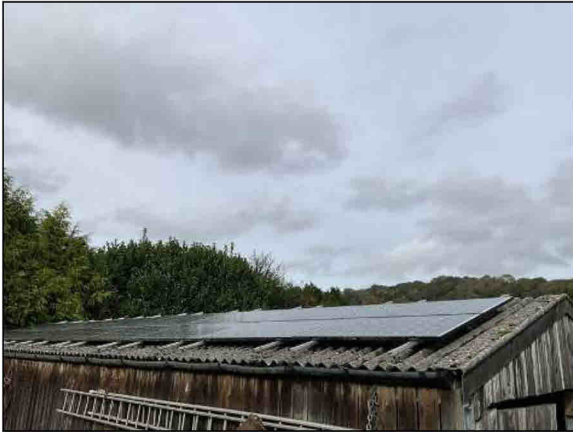
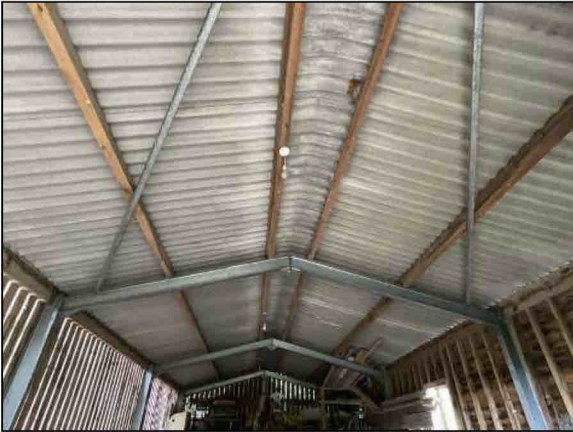
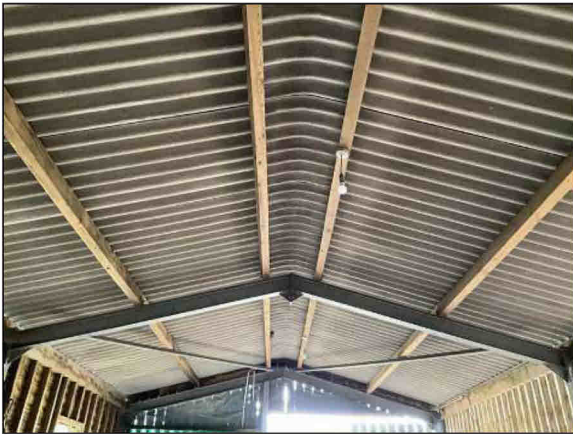
The roof is provided with a series of timber purlins on each side of the roof that are supported on the main steel members. The purlins are supporting the main corrugated manmade cement sheet roof covering. The purlins are provided with 175 x 75 mm treated timbers, spaced at approximately 1500 to 1800 mm centres, with no signs of any significant deflection, with a 225 x 75 mm timber eaves plate.

The roof is then provided with a man made profiled sheet covering. The man made profiled sheet covering is provided to the roof externally and appears to be in good condition. There is evidence of some minor damage to the cladding to the roof but again this is not to be unexpected, given the age and previous use of the building. The cladding however generally appears to be in reasonable condition with no signs of significant damage or repairs required.

The steel trusses and roof timbers all appear to be in good order with no signs of any significant damage or decay.

Existing corrugated man made sheet roofing could be removed and replaced with modern metal roof sheets and timber structure to be retained.

However, if required, the existing roof coverings could be retained to receive internal insulated lining with ventilation gap over to meet the requirements of the current Building Regulations with vapour check layer and internal plasterboard and skim finish.
