## TREE SURVEY REPORT – Rev A

The Galley, Market Hill, Woodbridge

December 2018

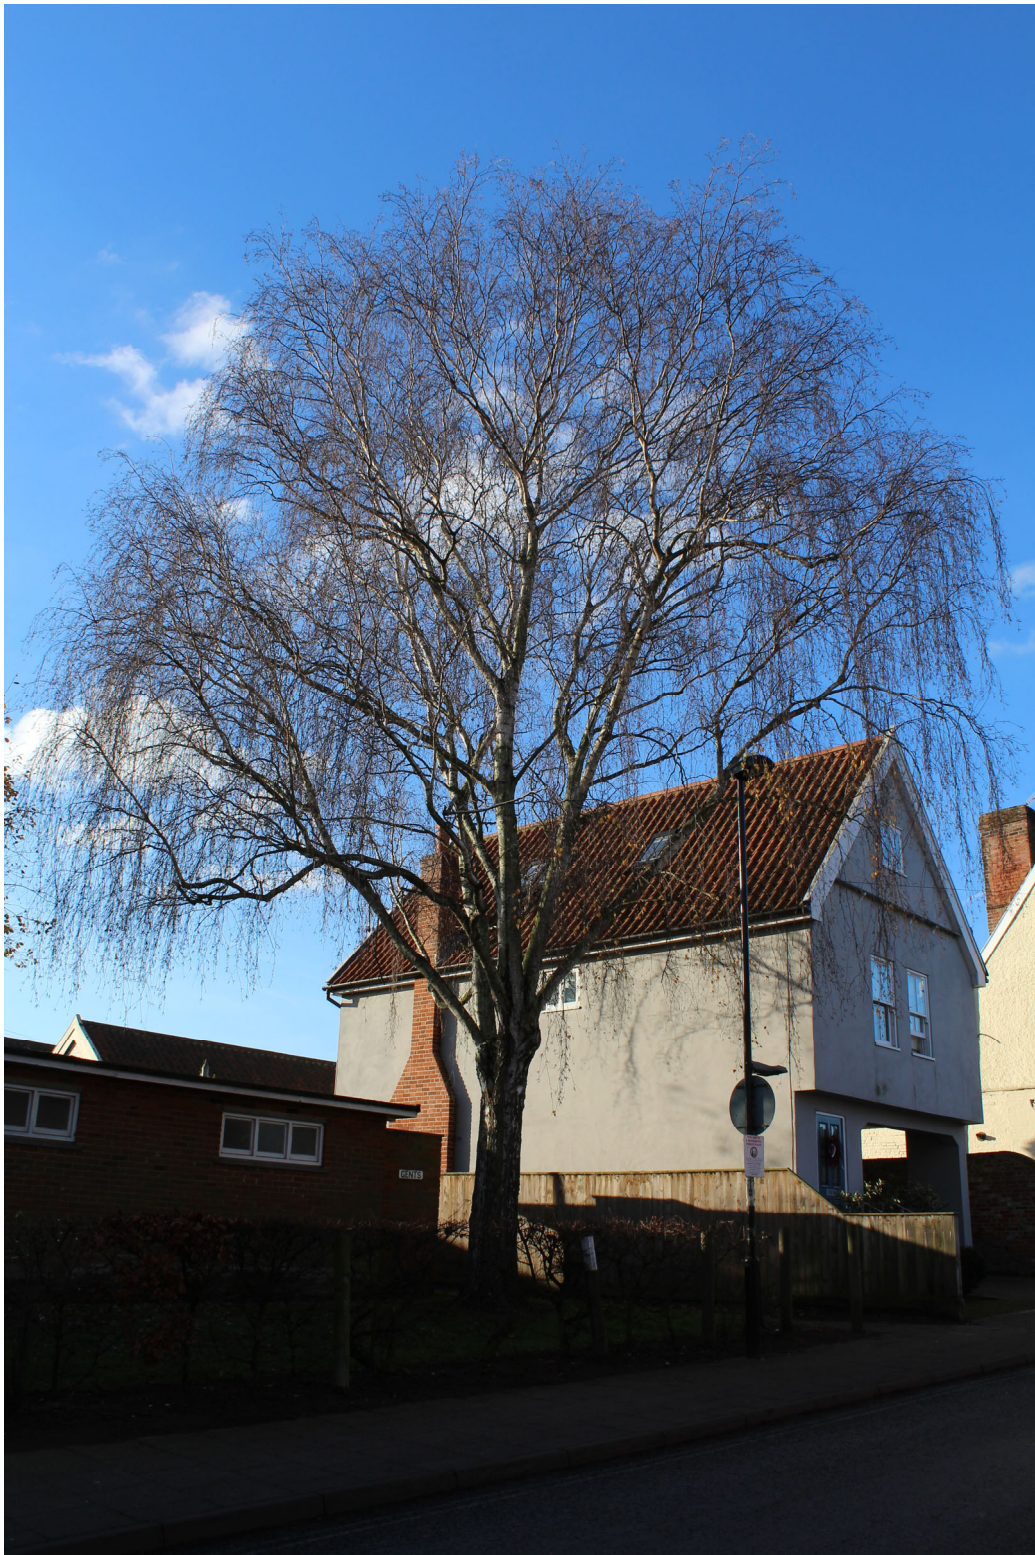
This tree is considered to be category A due to its high quality and value in contributing to the visual amenity of the surrounding area. It is in good condition and capable of making a substantial contribution for 20 years or more.

The image attached of T1 illustrates the close proximity of the tree to the existing buildings nearby. Its height and stature means that it contributes to the character of the Site and since it is in good health it is proposed that it is retained.

The tree was not surveyed when in full leaf, so although it appears to be in good health currently, it should be monitored when in full leaf to check for any signs of dieback or stress in the crown. If there are any concerns then the tree should be further inspected by a qualified Arboriculturalist.

**Photo 1.** T1 as viewed from Theatre Street looking south-west. The tree is growing in a grassed area between the public toilets and the road. A beech hedge to the front of the Site helps soften the appearance of the existing setting.

The birch tree (T1) does not require any work as it is in good health and recent wounds from branch removals are occluding well. Apart from a check to ensure there is no deadwood, no work is required.

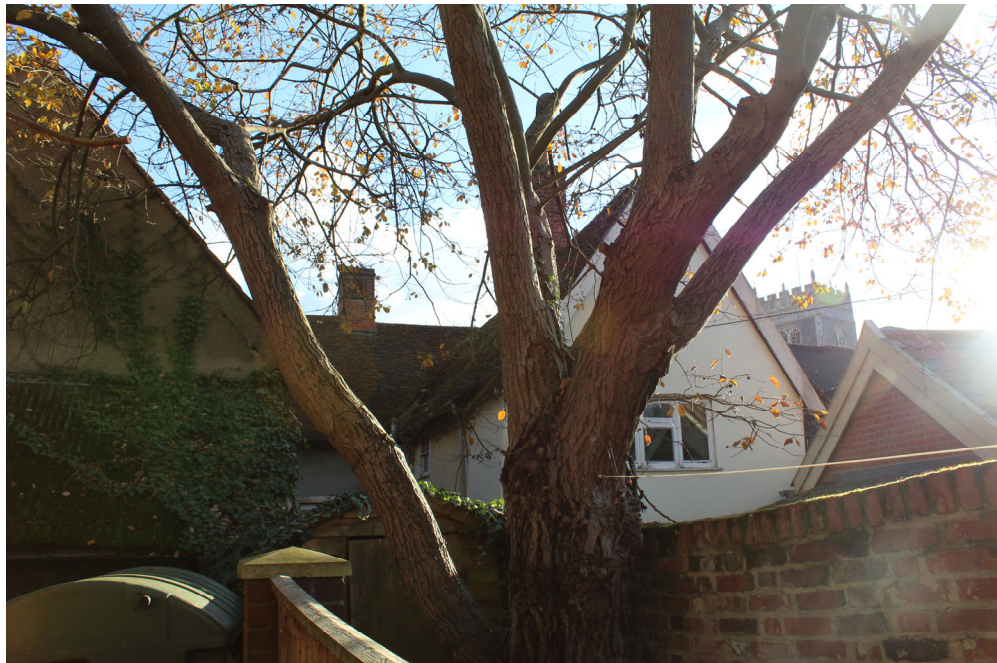
The image below of T2 illustrates the close proximity of the tree to the existing buildings nearby. The branches overhang the Site and some of these are rubbing against one another. The low branch growing towards the existing toilet building is a concern. The branch connects with the main stem at a height of approximately 1m and there is little clearance between the branch and the roof of the public toilets. Other branches growing in an easterly direction towards the Market Hill are in physical contact with the backs of the listed buildings.

**Photo 2.** Looking east towards the back of the buildings on the Market Hill. Branches from T2 are in contact with the buildings, both of which are Grade II listed.

T2 is in fairly good health, but it does have a low branch overhanging the Site and in order to facilitate the proposals it is recommended that this is removed and cut back to the main stem. The crown of the tree is also in contact with the rear of the buildings on Market Hill and it would therefore be advisable to trim these branches back on a regular basis (every 2-3 years) to ensure that they do not damage the buildings.

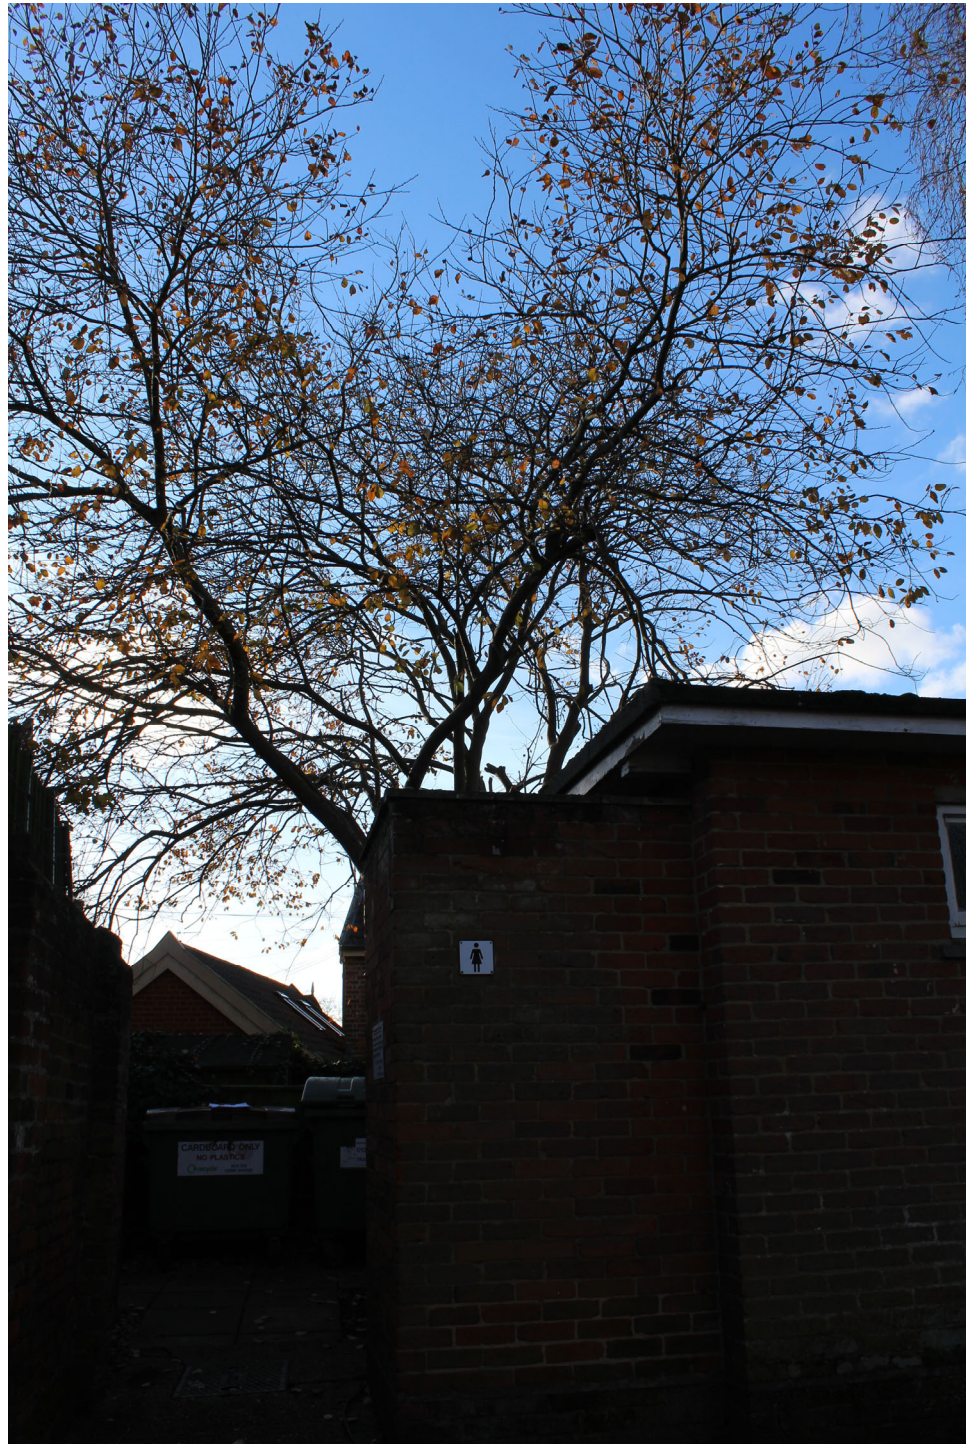
T2 is not within the Site, but to the back of No.1 Theatre Street and within the rear garden of No.3 Theatre Street. This tree is considered to be category B due to its only moderately good form and its value in contributing to the visual amenity of the local area. It is in generally fair condition, with some scars on the main stem and nodular growths, but it appears to be in reasonable health and is capable of making a contribution to the setting for 20 years or more.

**Photo 3:** T2 is outside the Site and is not readily accessible. It is also constrained by the adjoining boundaries of neighbouring properties.
