2/1 2 Great Western Terrace Glasgow G12 0UP

We propose replacing the existing sash and case window with newly manufactured hardwood timber sash and case windows that will be manufactured in a like for like formation. Horn detail would be lifted from the existing windows to preserve the established style.

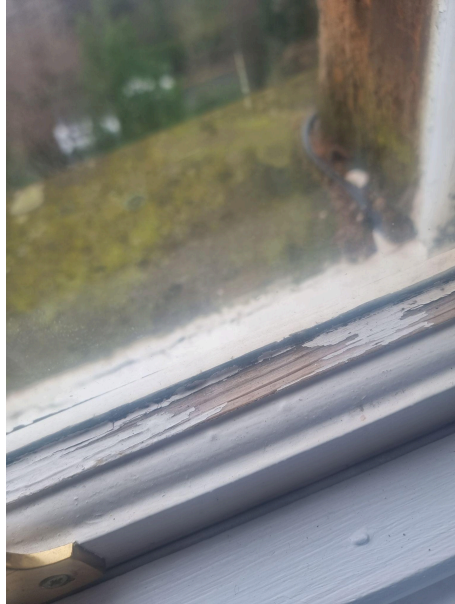
Internal bare wood of the previously replaced window is soft pine wood and is already showing signs of deterioration.

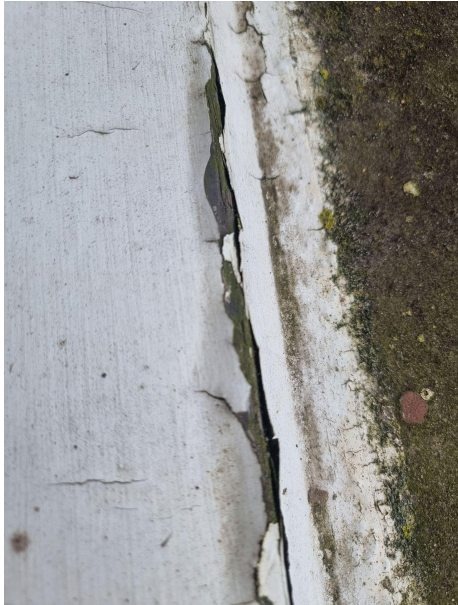
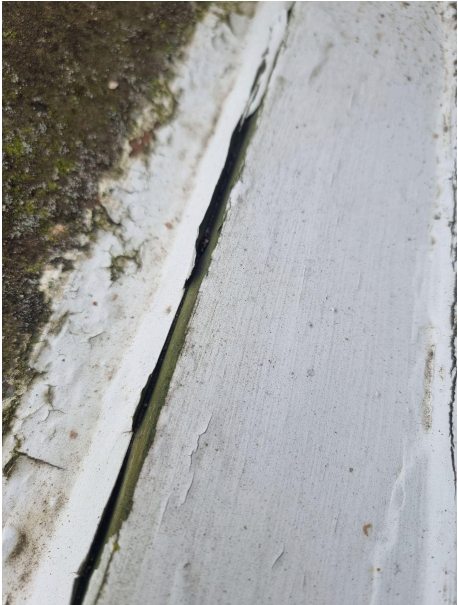
Rotting sills

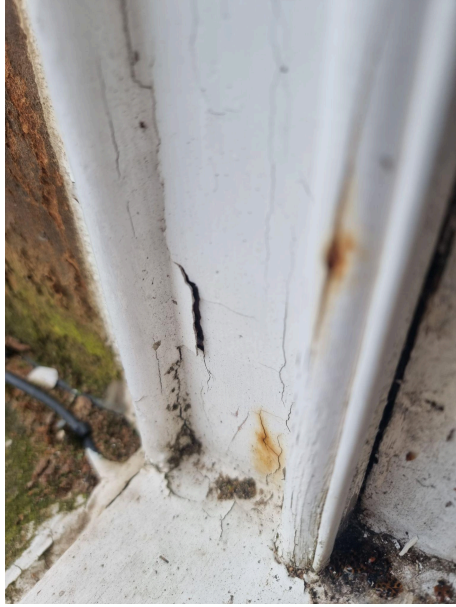
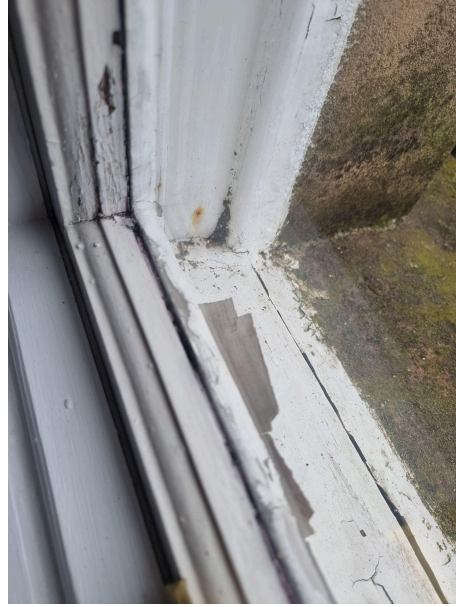
Casement and external woodwork of bottom sash has bubbling and peeling paint to the woodwork which is allowing water to penetrate the soft pine woodwork and escalating the deterioration. Woodwork is damp and showing signs of rot underneath.

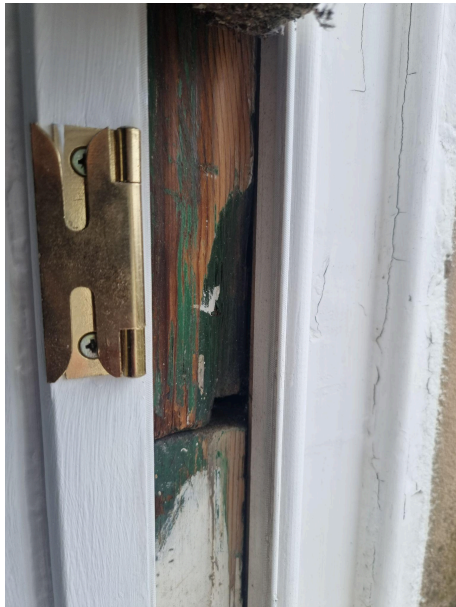
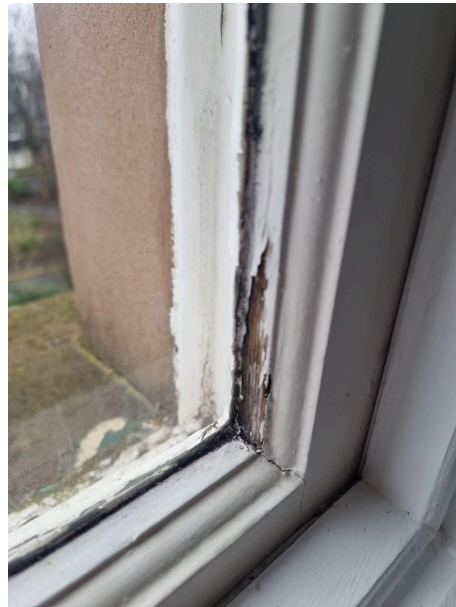
Rotting pulley stile and internal woodwork.

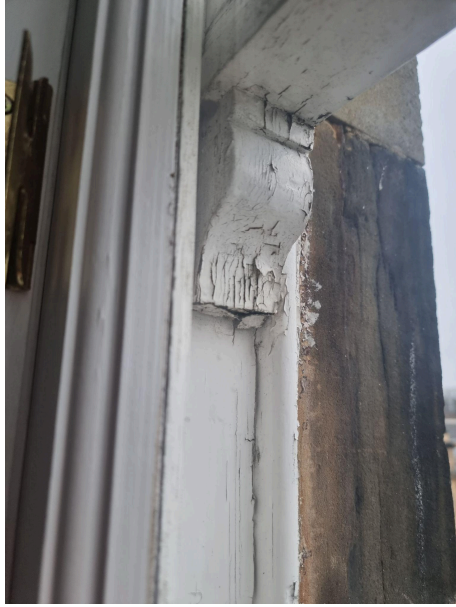
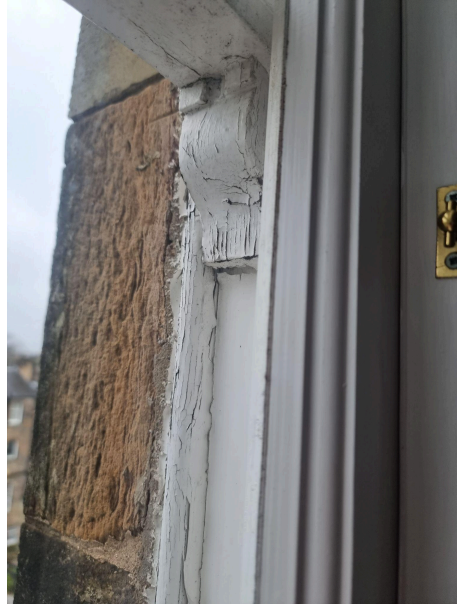
Older style horn details which are deteriorating and rotting.

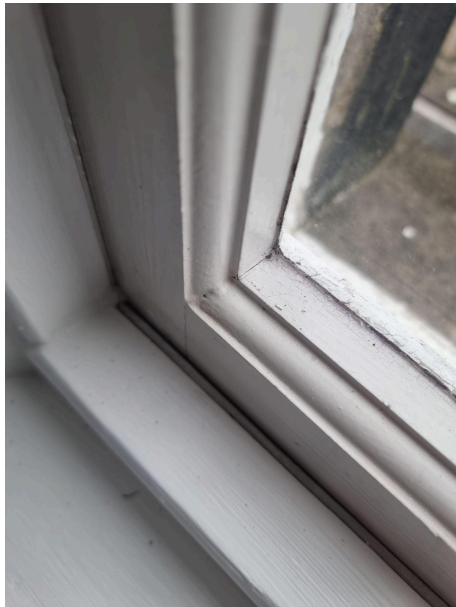
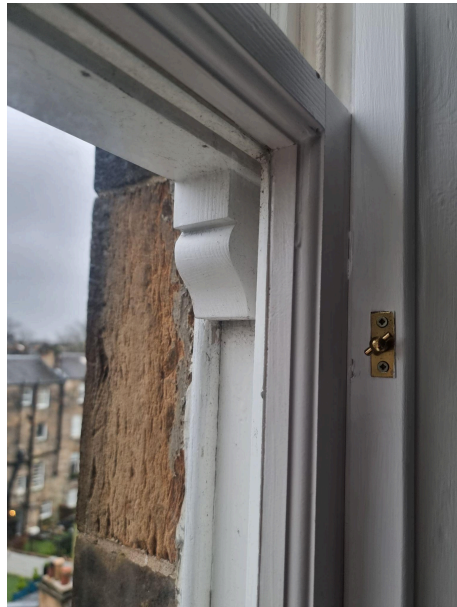
Modern horn details and internal molds showing that the windows have been replaced.

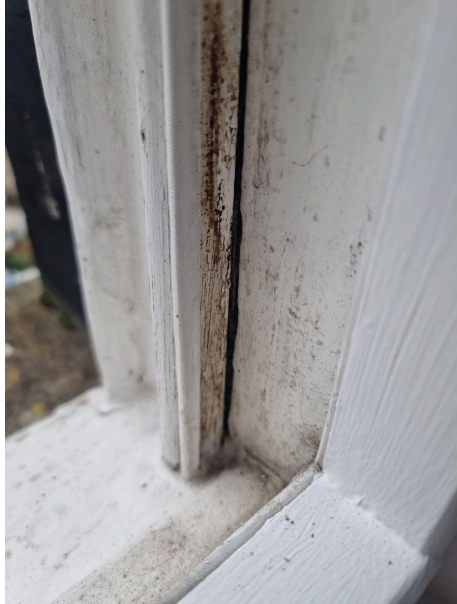
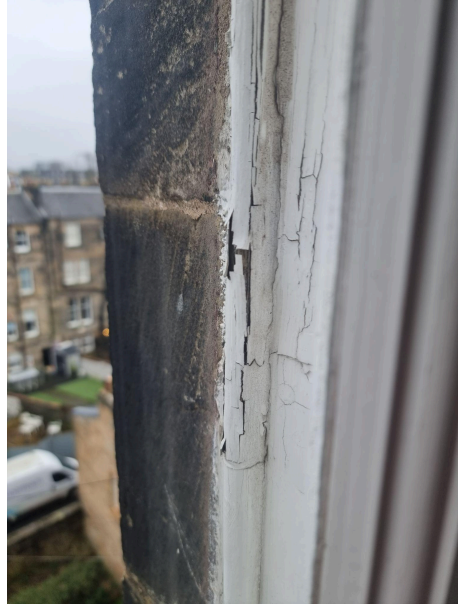
Rotting parting beads and baton rods

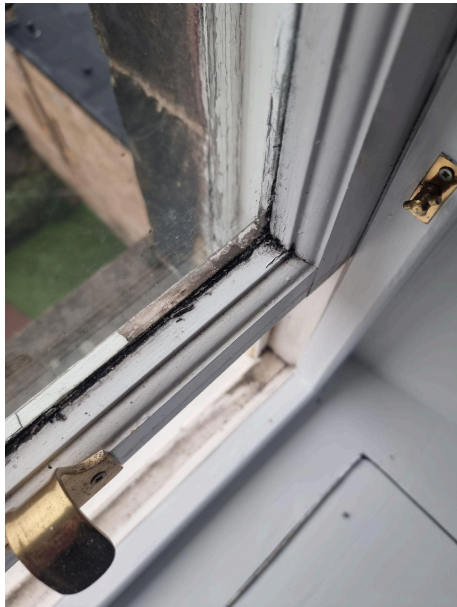
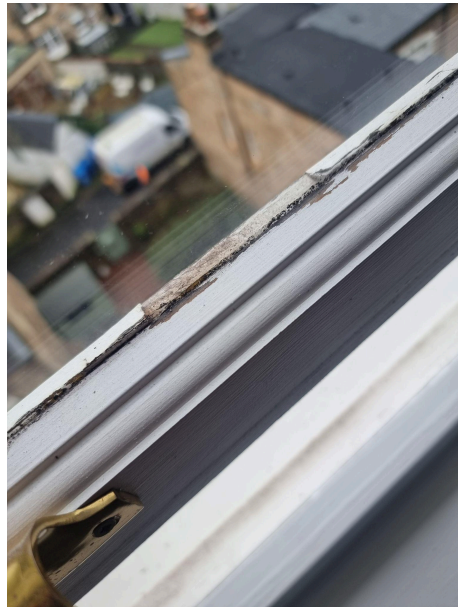
Broken putty and rotting woodwork to new windows.

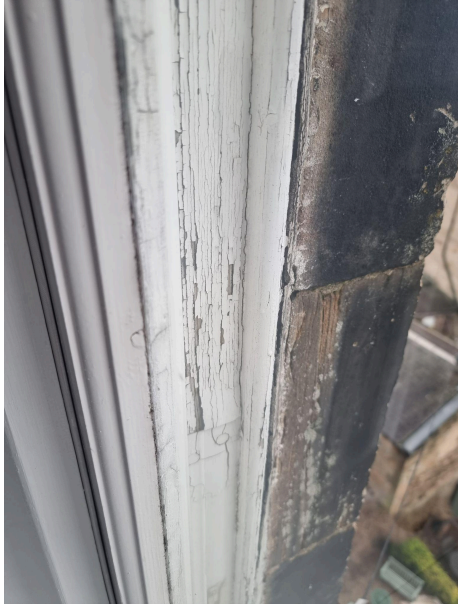
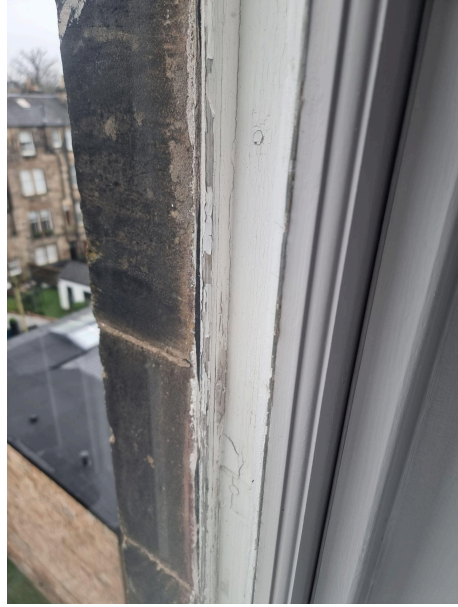
Deteriorating and rotting woodwork to external casement.

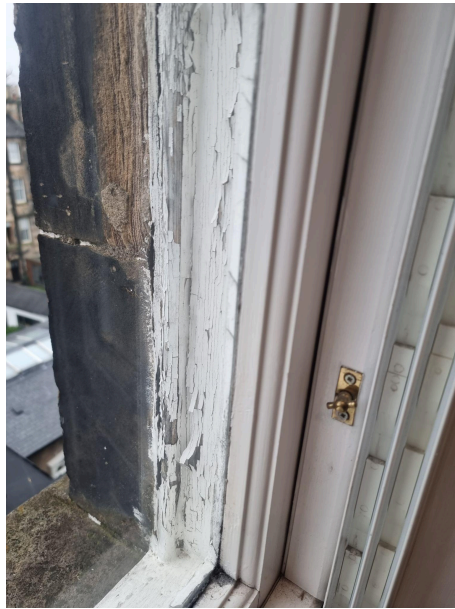
Deteriorating and rotting woodwork to external casement.

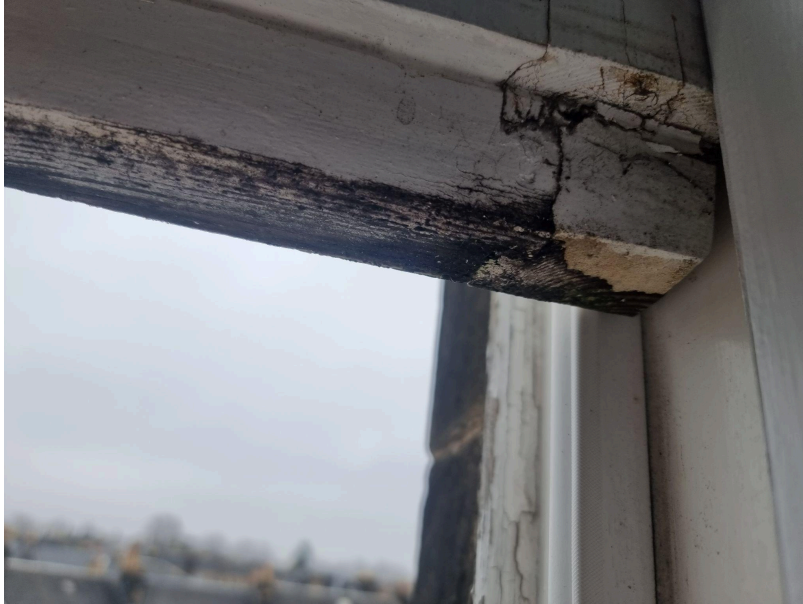
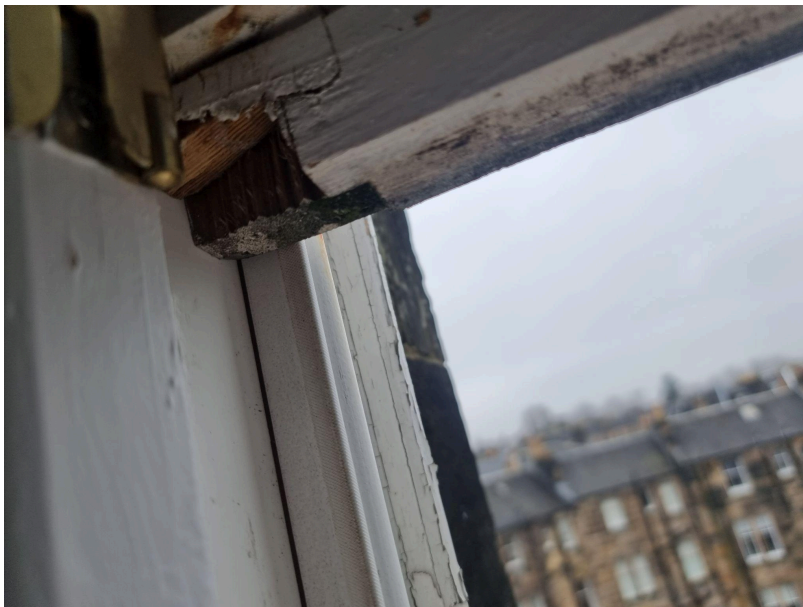
Deteriorating tenon joints.

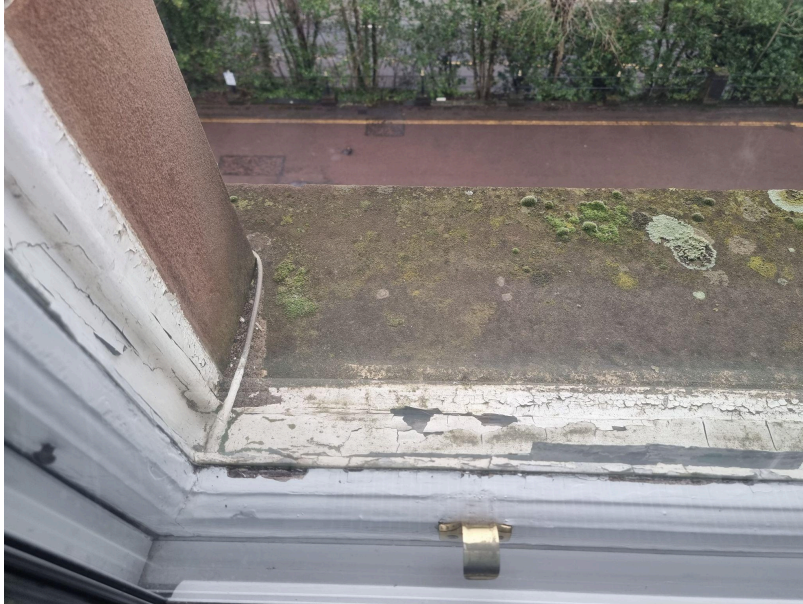
Rotting sill

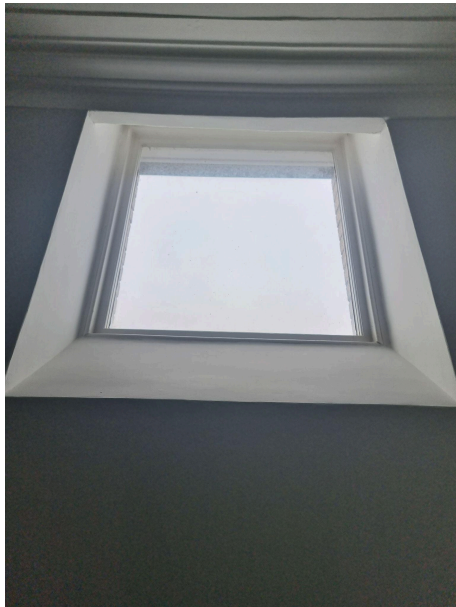
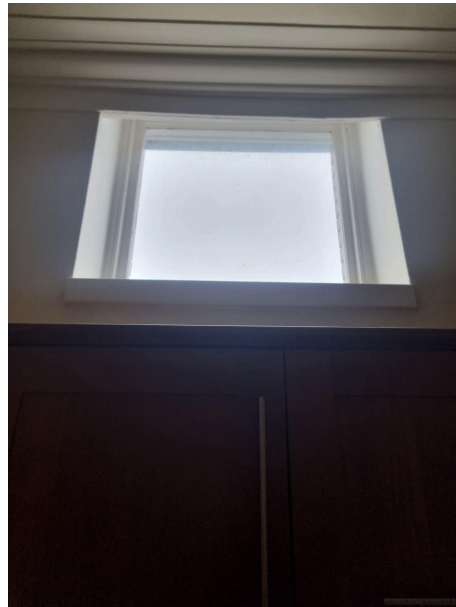
The above fixed panes are currently causing issues and leaking into the neighbouring building/property. Access is only available from the neighbouring buildings roof space.

We propose to remove the windows and replace them with hardwood timber fixed sash windows, introducing the double glazing. Any further issues will need to be investigated when the windows are removed.
