Barn
Laurel Farm
Pilning Street
Pilning
Bristol
BS35 4HN

Mr Adam Williams

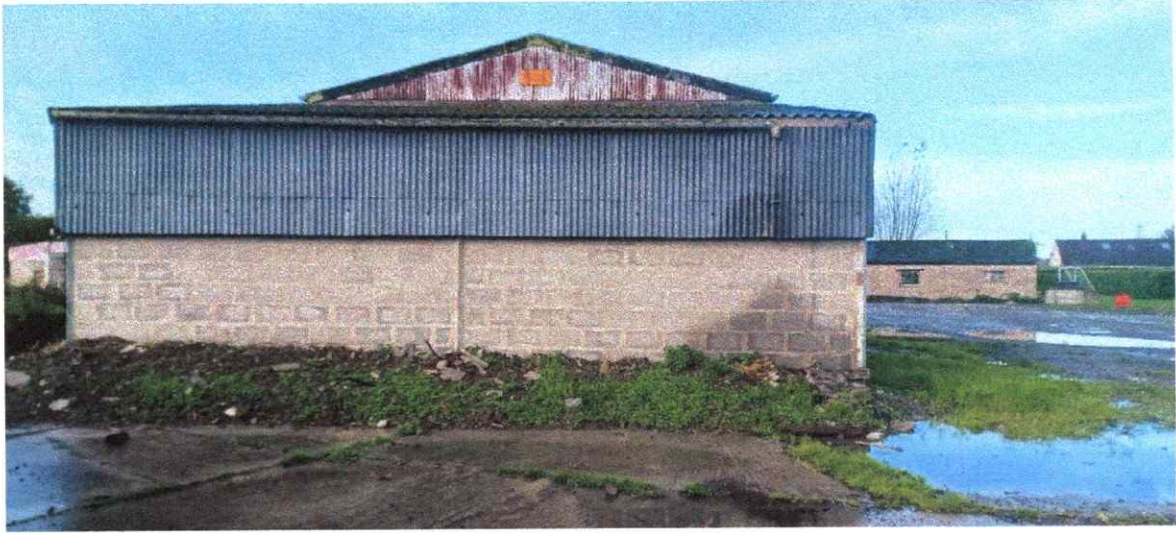
Photograph of east elevation.

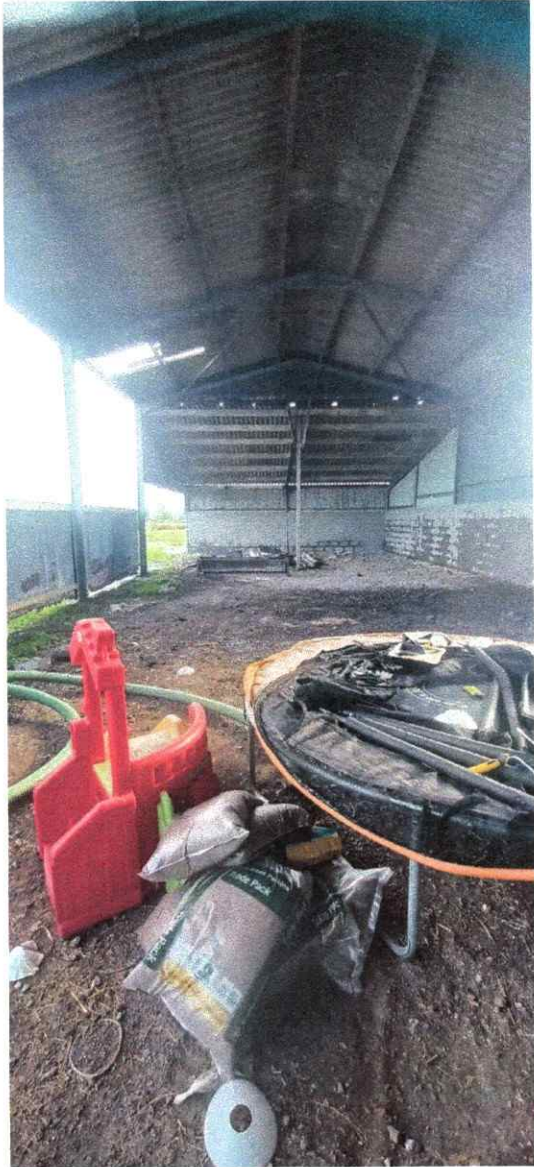
Looking towards the east elevation internally, showing the principal rafters and timber purlins which are in good condition.

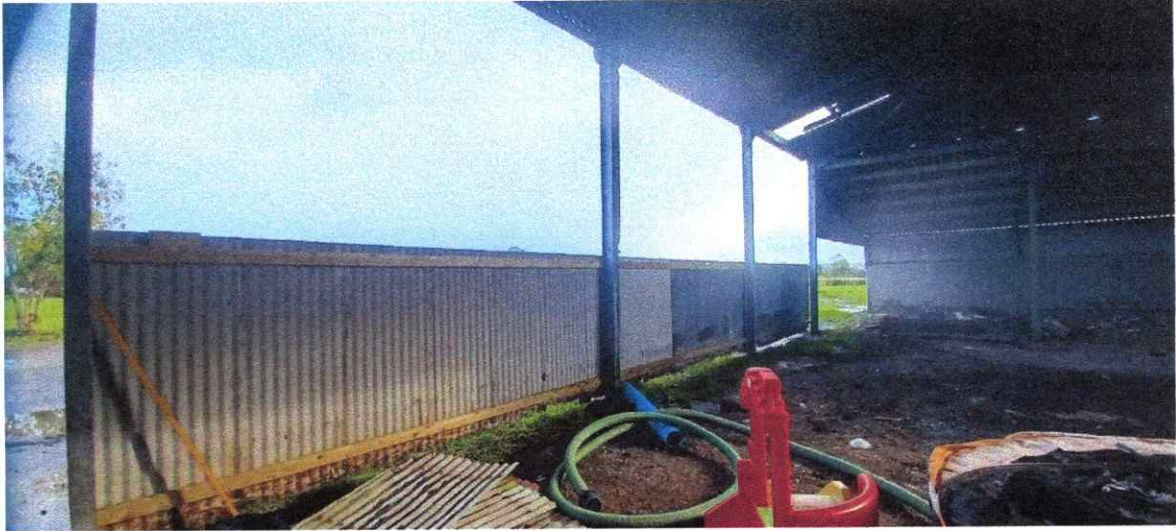
Internal view towards the north elevation which is partly open at the front.

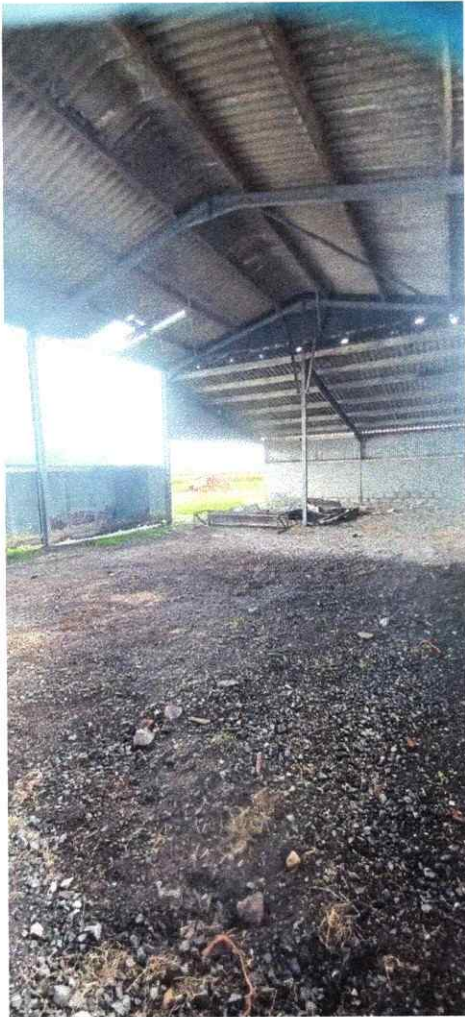
Internal photograph showing the lean-to structure to the east elevation. Also note the principal rafters which are in good condition.

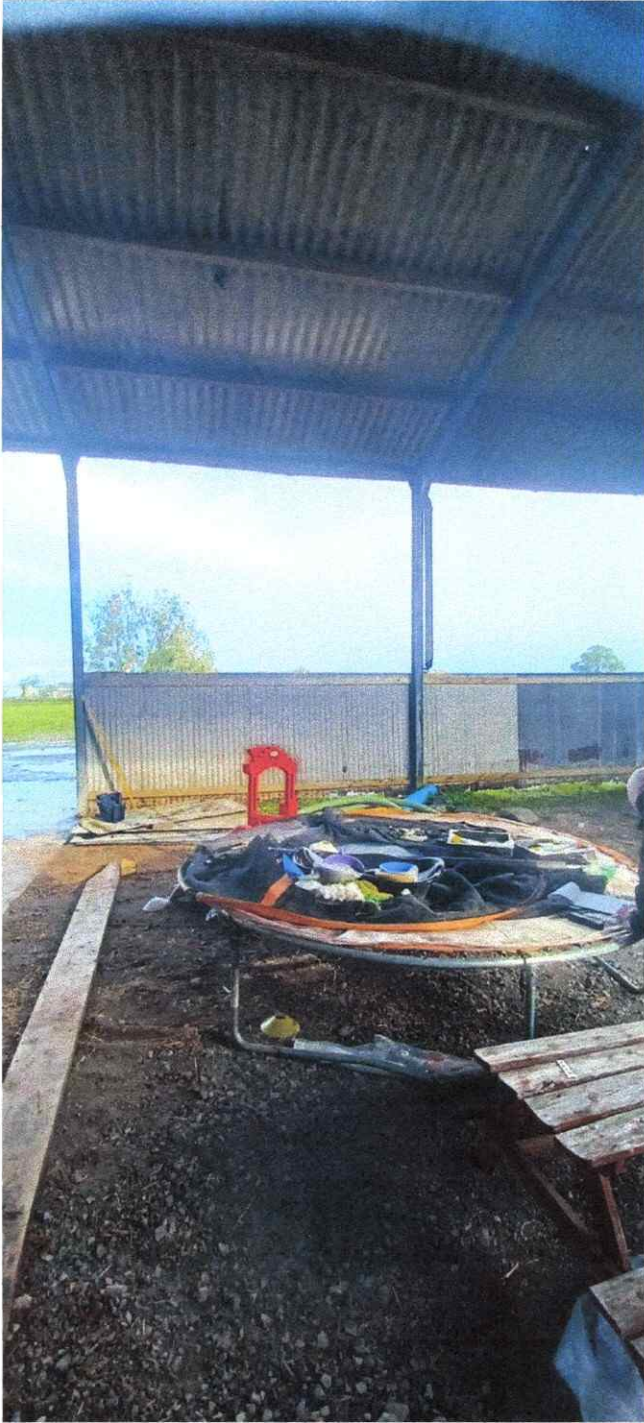
Rafters and column in steel which are in good condition.

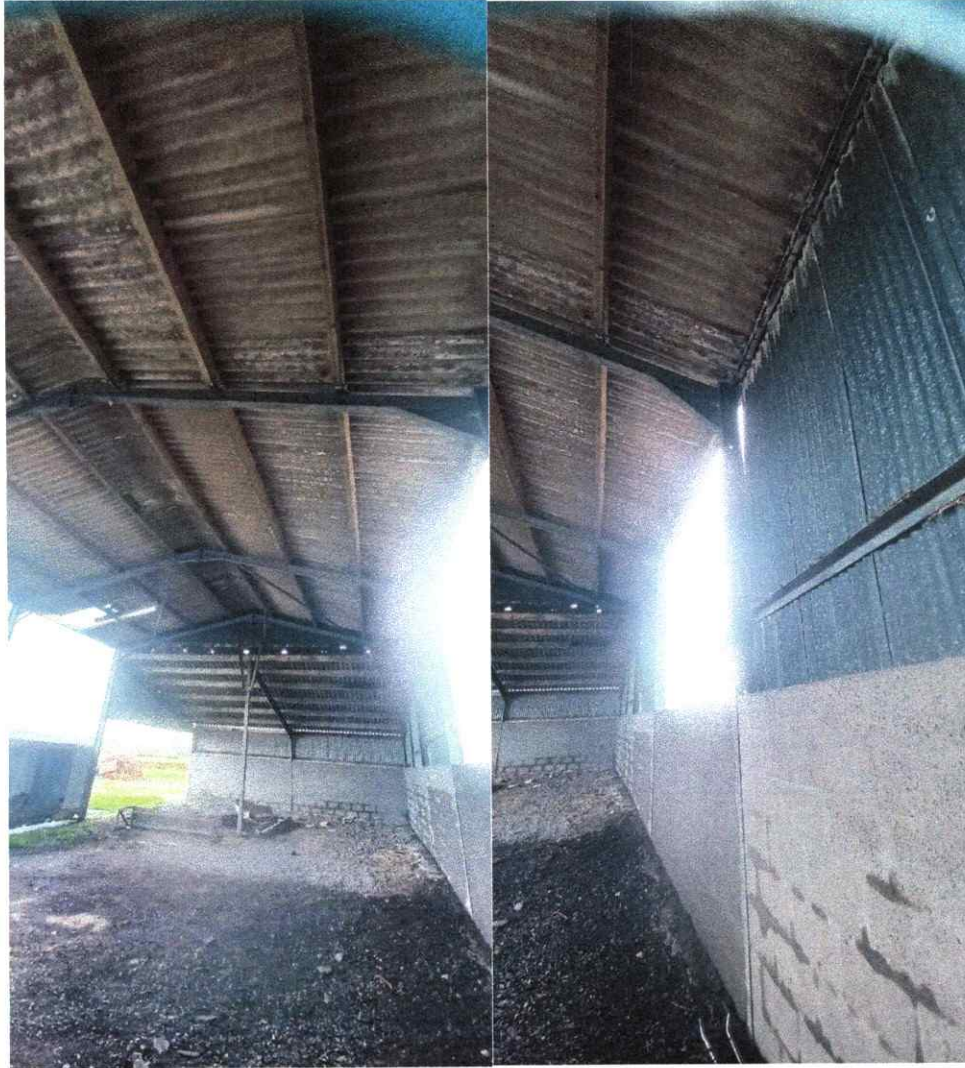
Photographs showing the internal structure and the rear south and east walls partly blocked adding lateral stability to the wall.

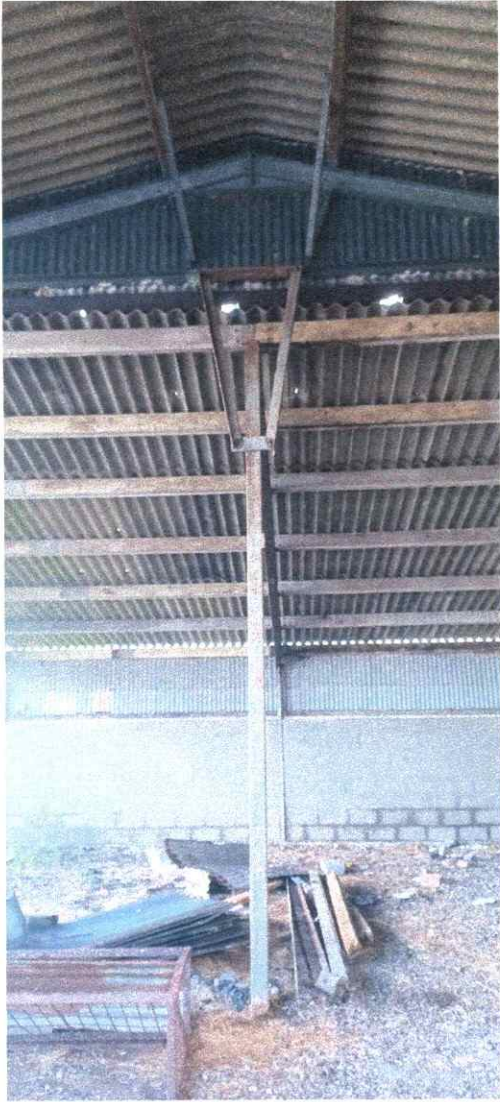
Lean to structure to east elevation. Roof structure in timber and steel shown to be in good condition.

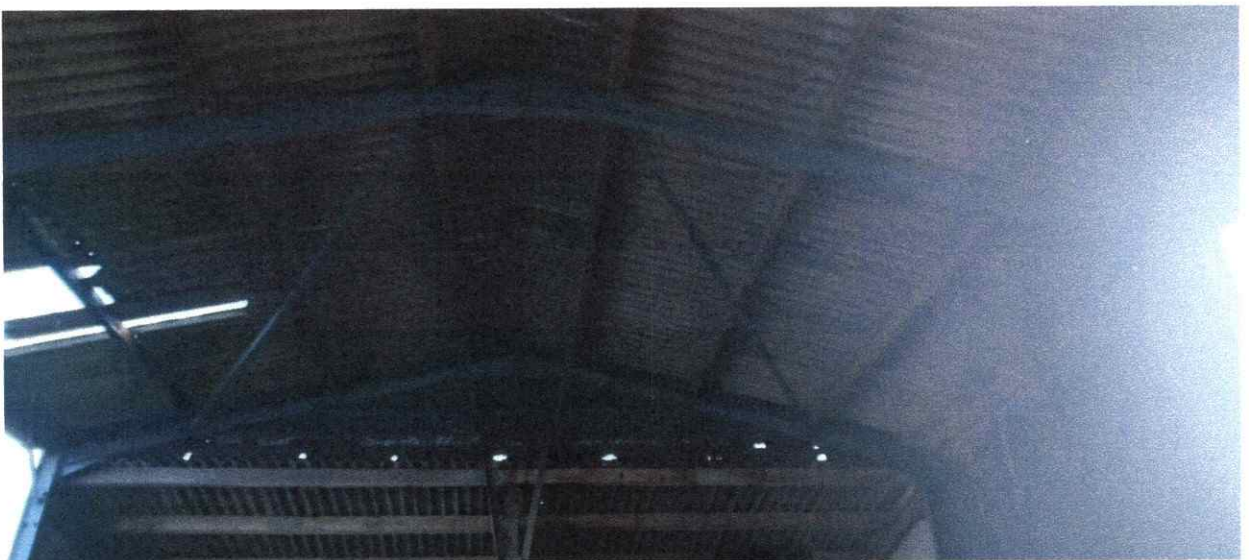
Roof structure with steel members in good condition.

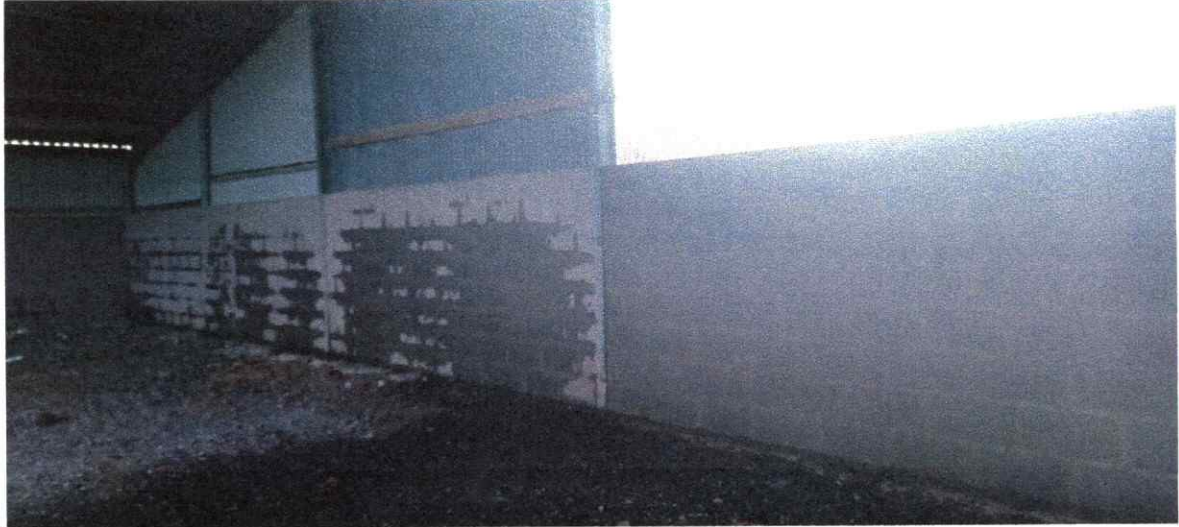
Rear wall to lean to and main barn.

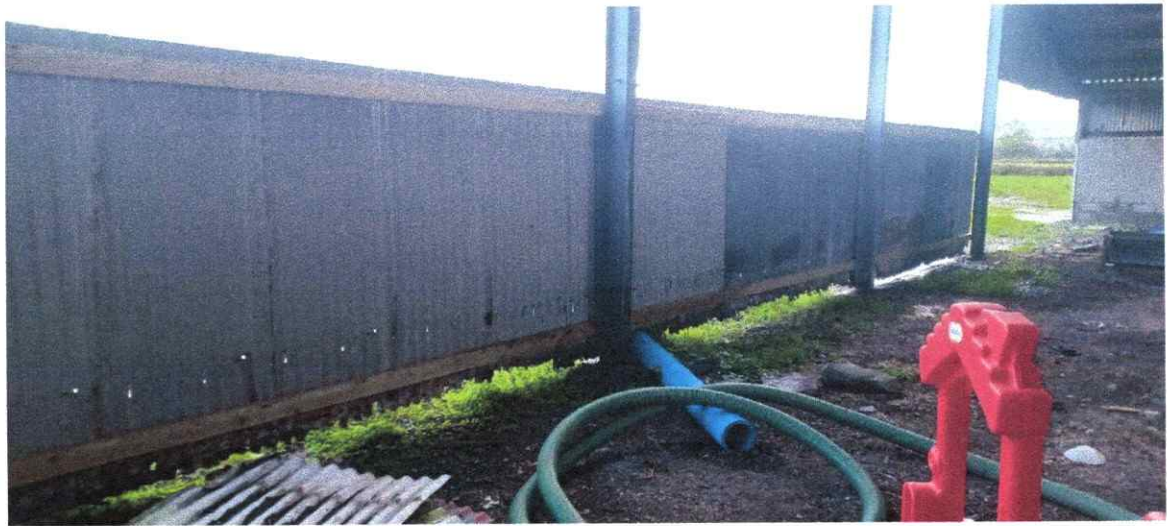
Front elevation facing north where the steel columns are exposed but nevertheless in good condition.

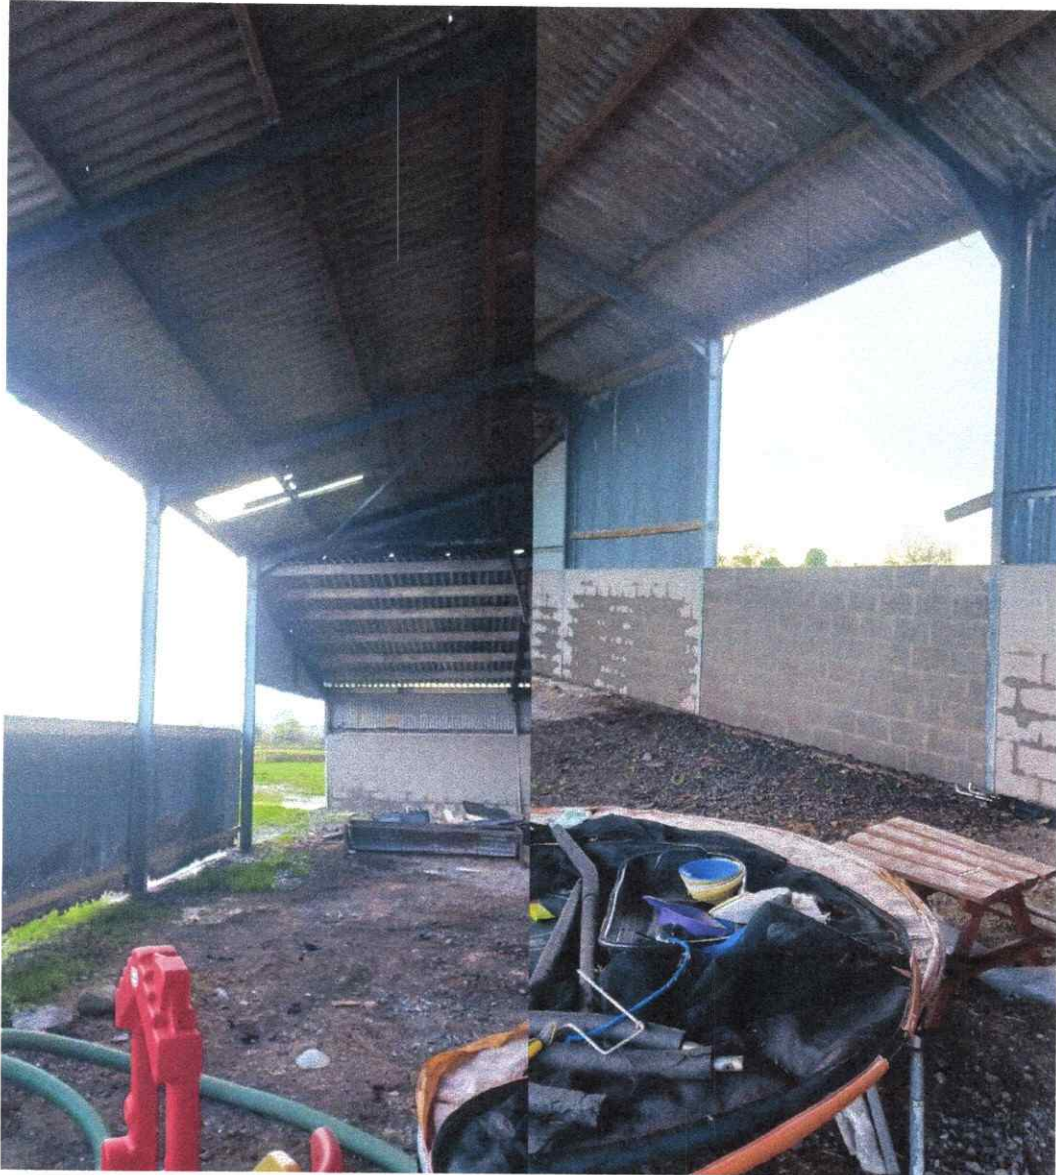
Internal photographs of the barn .

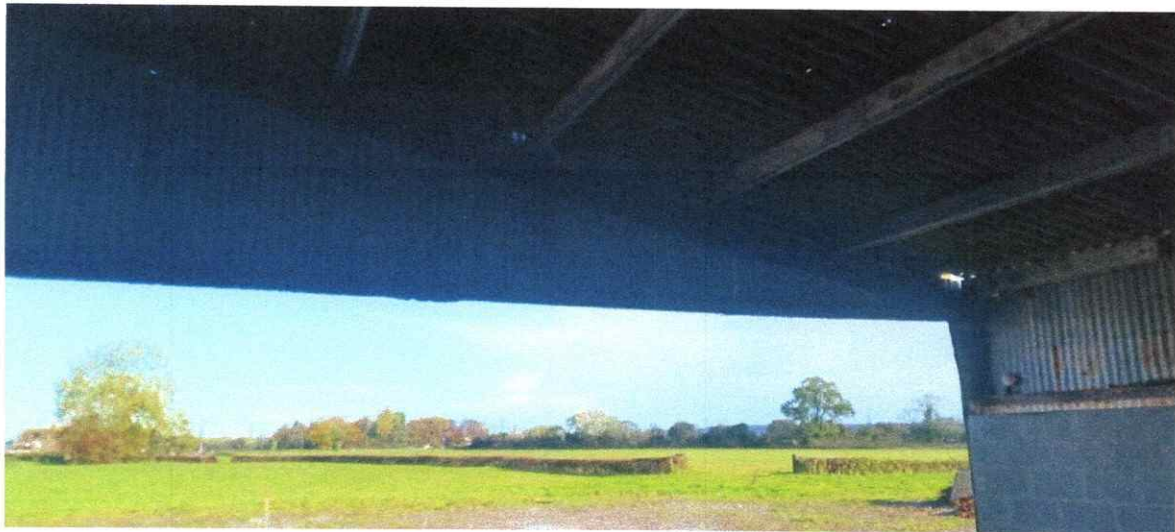
Photograph of timber purlins supporting lean to roof on east elevation which appear to be in reasonably good condition.

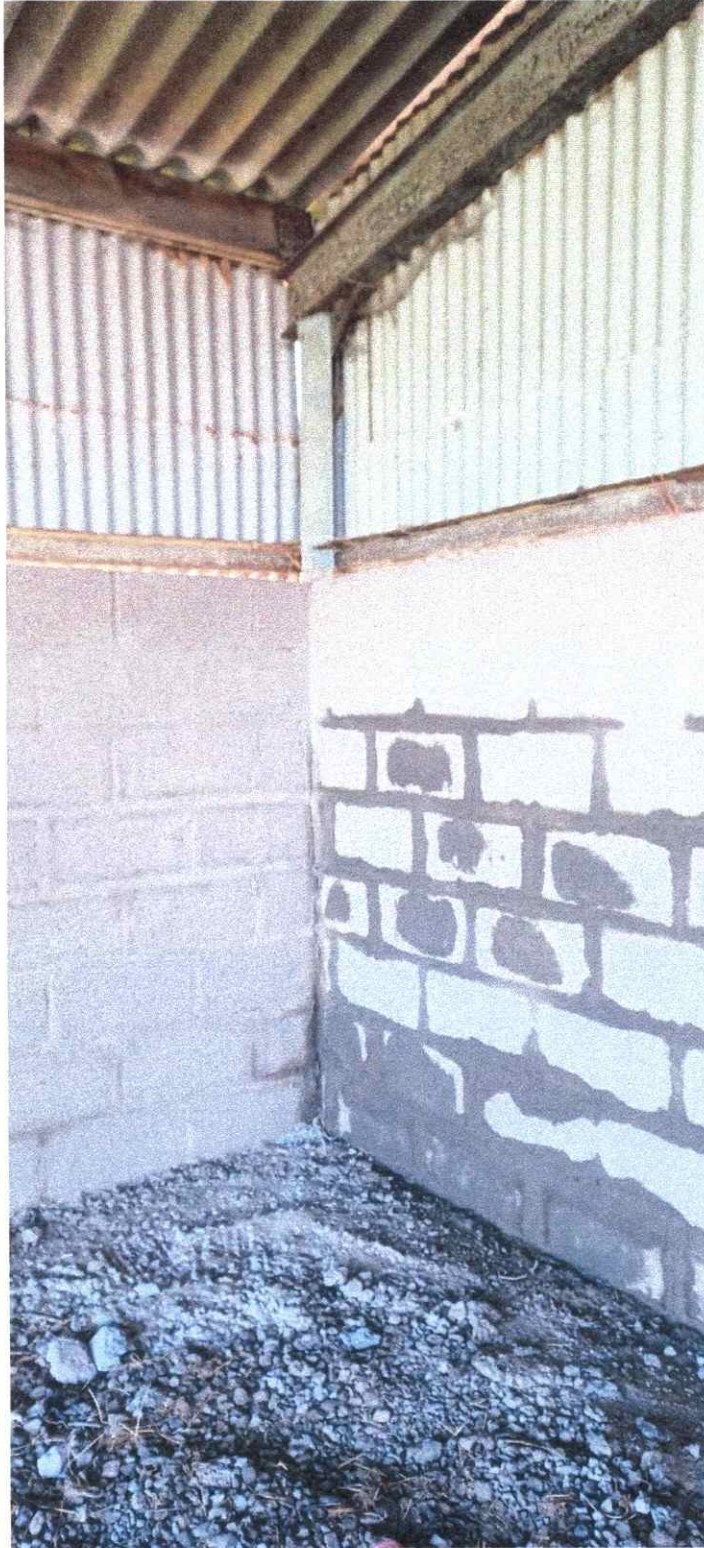
Photograph of southeast corner of lean to showing diagonal column, principal rafter and foundation which is evident at the surface.

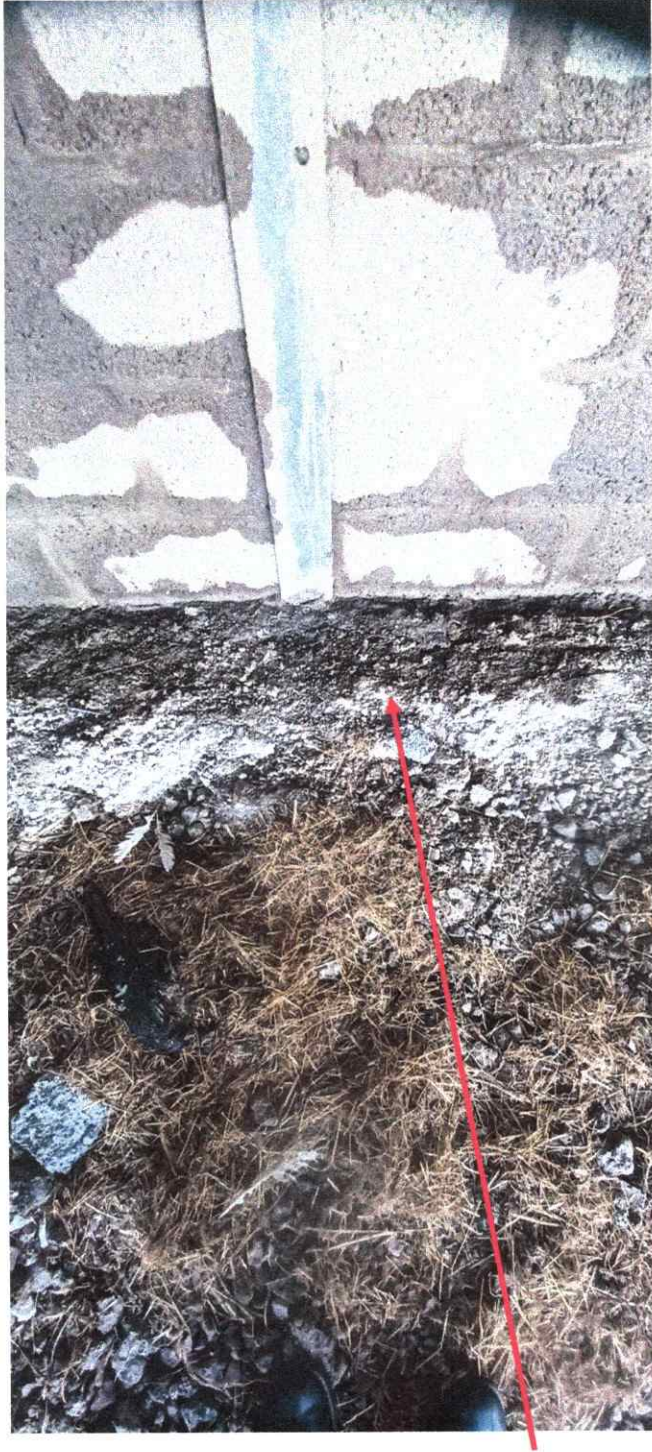
Foundation seen on rear south wall exposed at the surface which is found to be adequately sized to support a wall full height of the elevation.

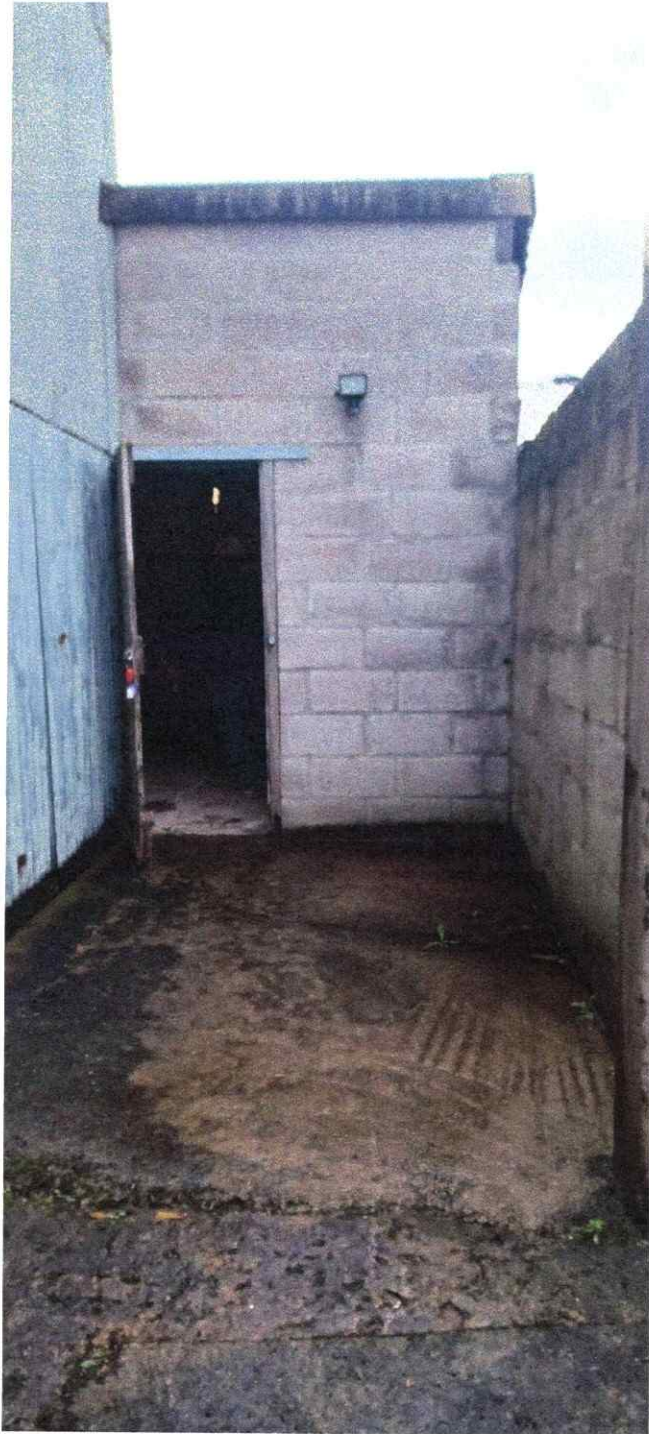
Photograph of lean to barn to south west corner and rear of main barn.

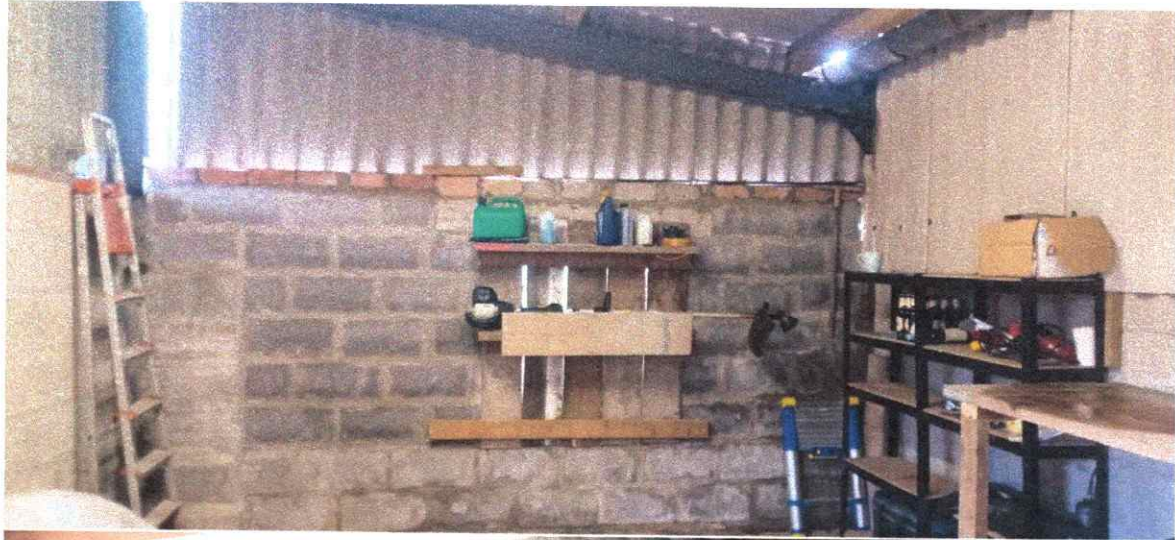
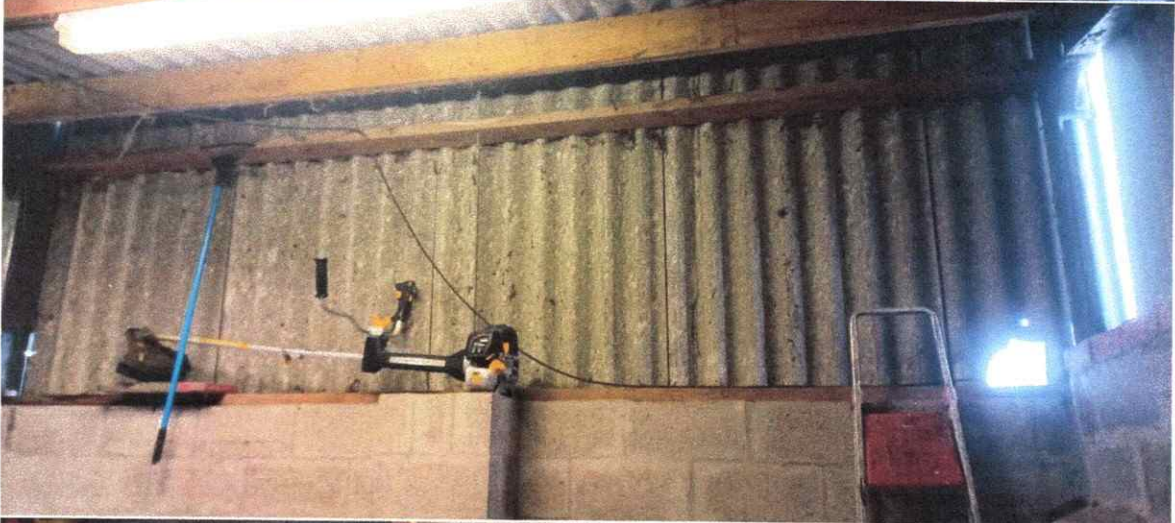
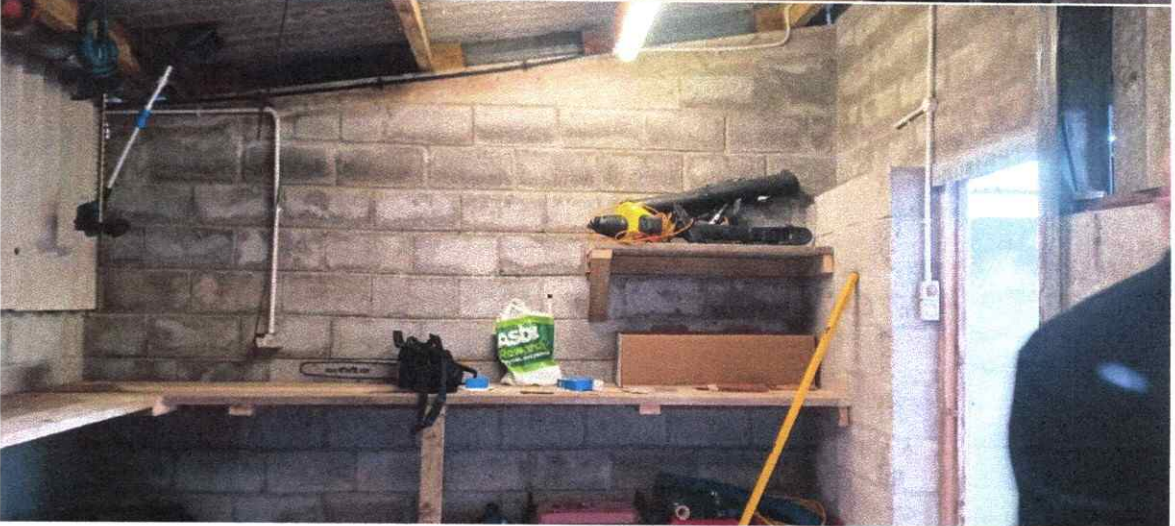
Internal photographs showing the internal area of the lean to barn to the rear and southwest corner. The photograph shows the steel members and block walls which exhibit no cracking or structural distress.
