**CCTV REPORT FOR: 4 MILL DRIVE
FORTON HEATH
MONTFORD BRIDGE
SY4 1HP**

Insured: Mr K and Mrs L Selman
Reference: 084474139

Site Visit: 22-Dec-22
Report Date: 27-Mar-23

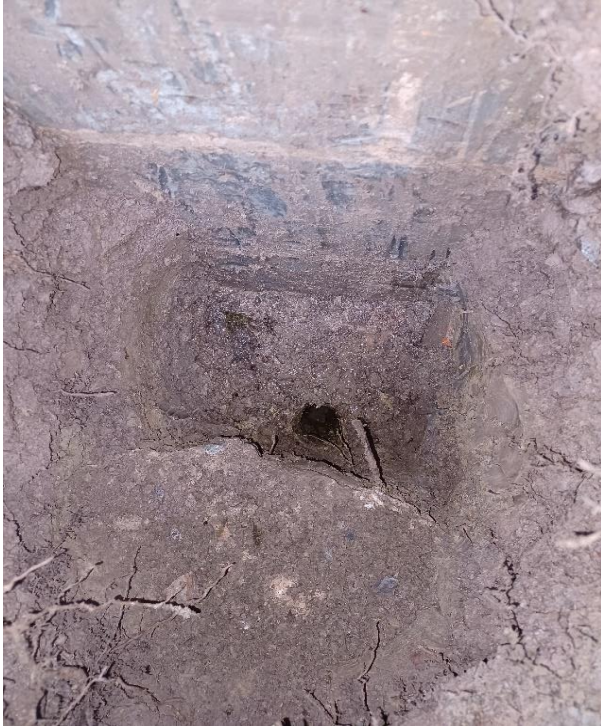
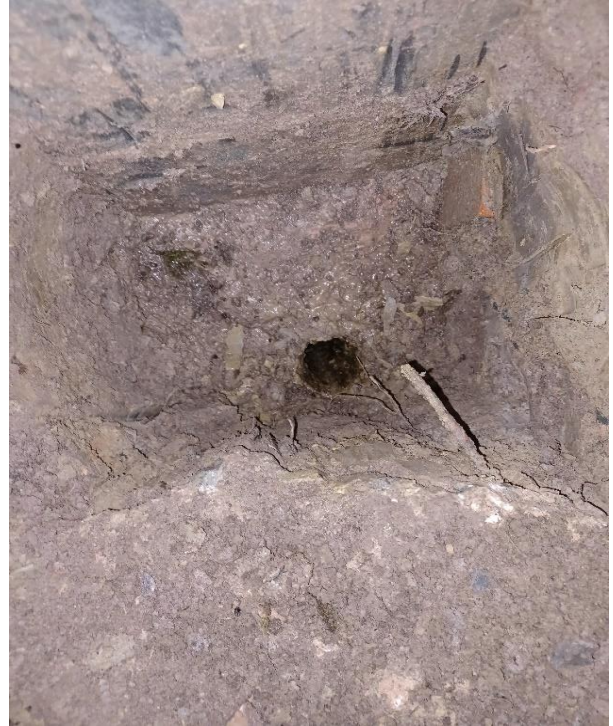
T/H1

Roots Depth & Diameter:
 From 1.5m
 Down to 2.5m
 up to 2mm diameter

Water Depth Hit & Rise:
 Hit at 1.5m

Reason for Termination :
 Hole at instructed depth

Depth (m)	Soil Descriptions <i>(NB: Field crew description only)</i>	Test Type	Depth (m)	
			From	To
G.L.				
1.50	Soft/firm dark brown/brown CLAY with rare medium gravel & roots	V(n) 70	1.500	
2.00	Soft firm brown CLAY with rare medium gravel & roots	V(n) 80	2.000	
2.50	Soft/firm light grey/brown CLAY with rare medium gravel & roots	V(n) 91	2.500	
3.50	Soft/firm light grey/brown CLAY with rare medium gravel	V(n) 97	3.000	
4.00	End of Borehole	V(n) 105	3.500

TP1, 1.5-2.0m		
3 no.	Examined root: QUERCUS (Oak).	Alive, recently* .
TP1, 2.0-2.5m		
4 no.	Examined root: QUERCUS (Oak).	Alive, recently* .
3 no.	Unfortunately all with insufficient cells for identification.

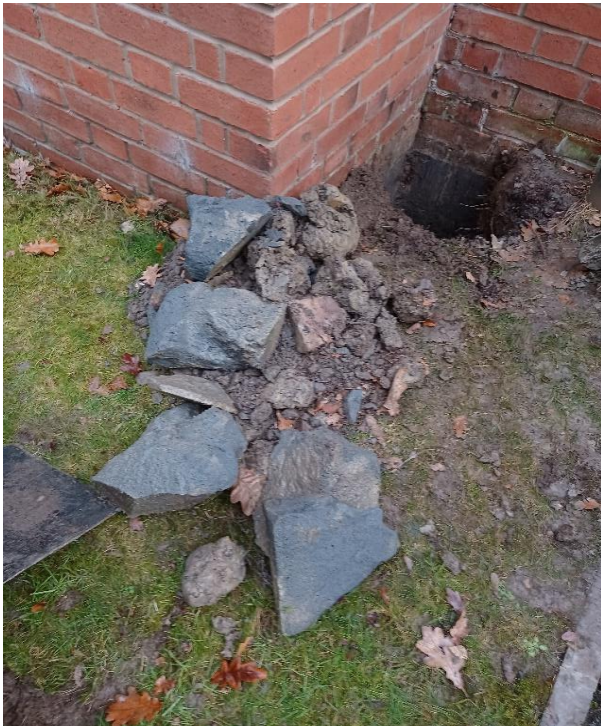
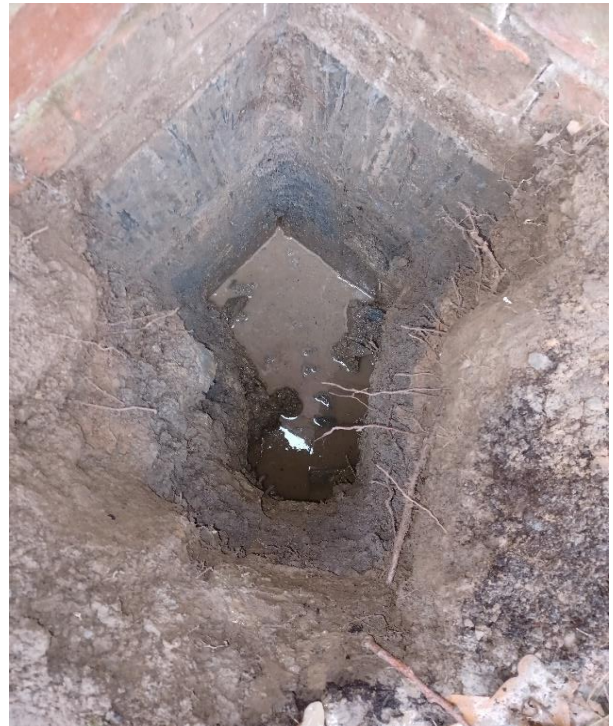
On excavating T/H2 we encountered large breeze block fragments as well as ground water and the hole had to be abandoned. We stepped back and attempted a borehole in the front lawn area, however the ground conditions were the same and this also had to be abandoned.

Should a trial pit still be desired in this area then this will require a full day on site due to the ground conditions encountered as well as the possible depth of the footings as indicated in T/H1.
