Tree Condition Report

Our Reference	AC.2023.226
Client	Mr Matthew Pearce of Marymount School
Site	Marymount School, George Road, Kingston, Surrey, KT2 7PF
Survey & Report by	Mr I S Thompson (known as Tom) BSc. (Hons.) Arb. MSc. (eFor) MArborA
Date	4th July 2023
Date of Inspection	24th March and 20th April 2023

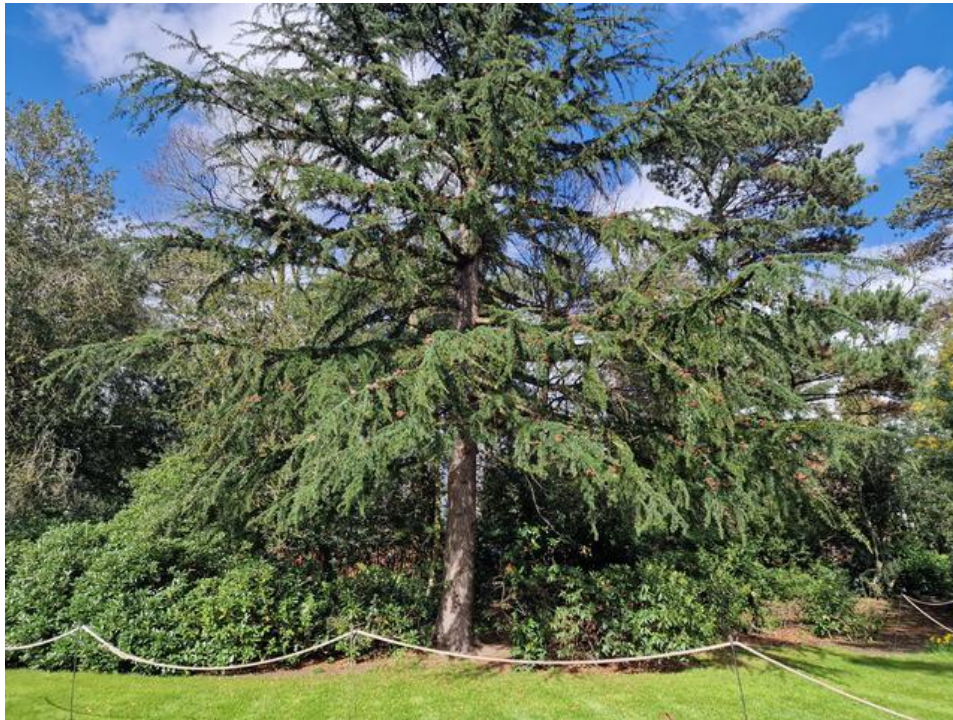
Image 1 T520 a deodar cedar in the front lawn.

- 5.5** T560 the Deodar cedar is recommended to be crown lifted with the removal of three rings of branches, two branches on either side, to raise the crown and reduce future conflict. This is recommended to be completed within the next six months. This will have a very limited short-term impact and no long-term impact to the amenity value of the school.

7.1.2 T560 the Deodar cedar is recommended to be crown lifted with the removal of the three lowest rings of branches, two branches on either side, to raise the crown, within the next six months.

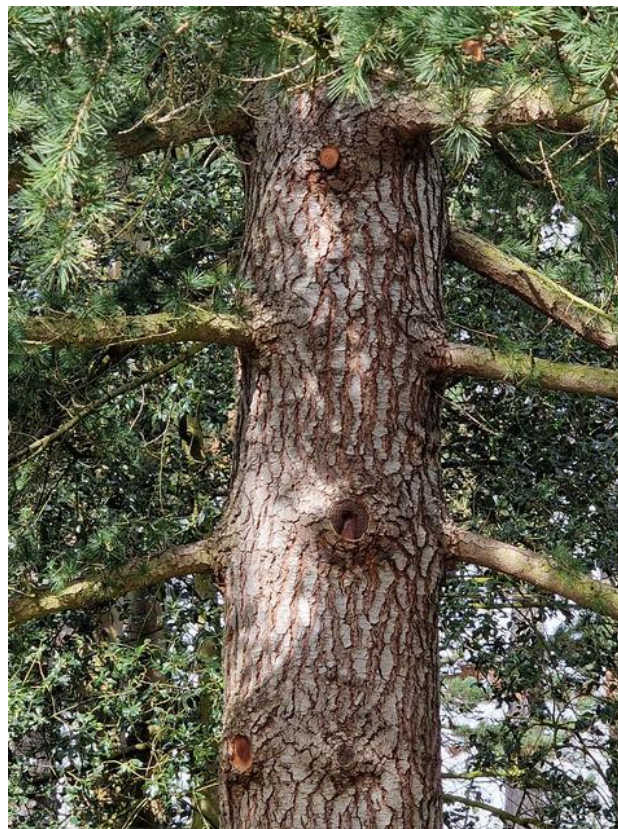
Image 2 Remove the three lowest pairs of opposite branches to lift the crown.

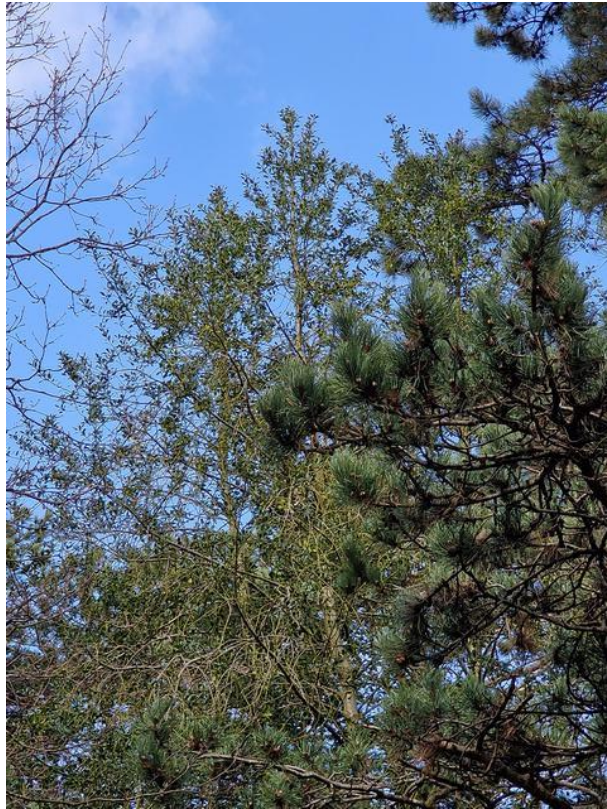
Image 3 T562 a holly with dieback characteristic of drought stress.

- 5.6** T562 a holly tree is recommended to be reduced to just above the laterals at around 6-7 m to help create hedge effect. This is recommended to be completed within the next six months.

7.1.3 T562 a holly tree is recommended to be reduced to just above the laterals at around 6-7 m within the next six months.

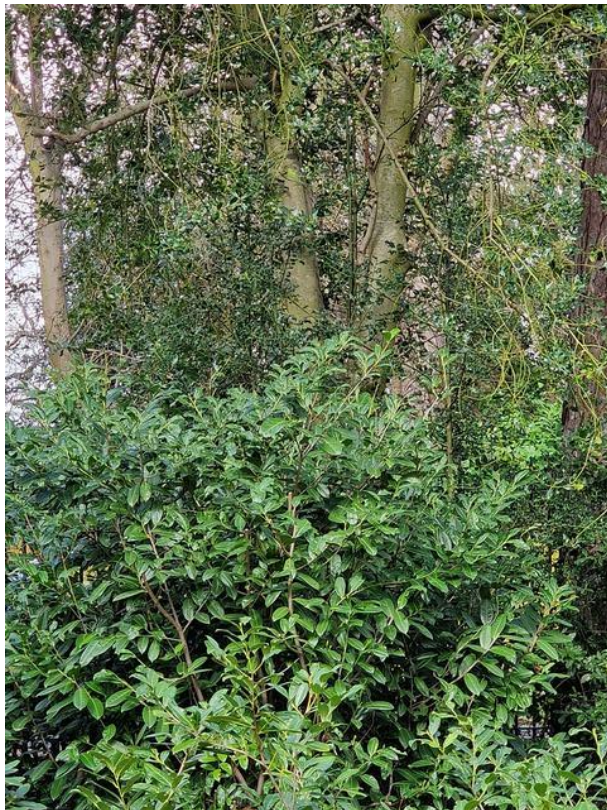
Image 4 T562 a holly with extensive basal growth.

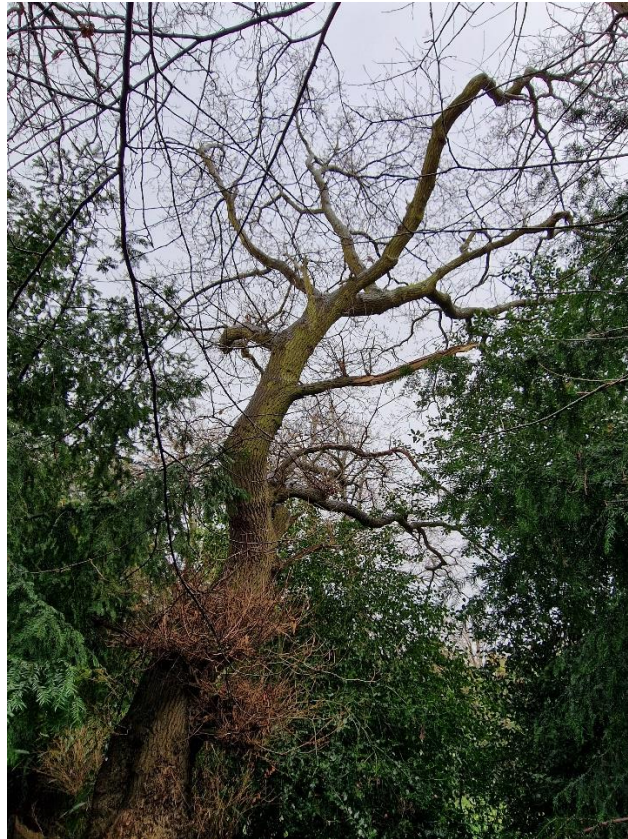
Image 5 T708 an oak tree with a crown bias over the lockers.

- 5.7** T708 has no work recommendations at this time.
- 5.8** T718 a sweet chestnut tree is recommended for the removal of deadwood greater than 50 mm in diameter within the next six months.

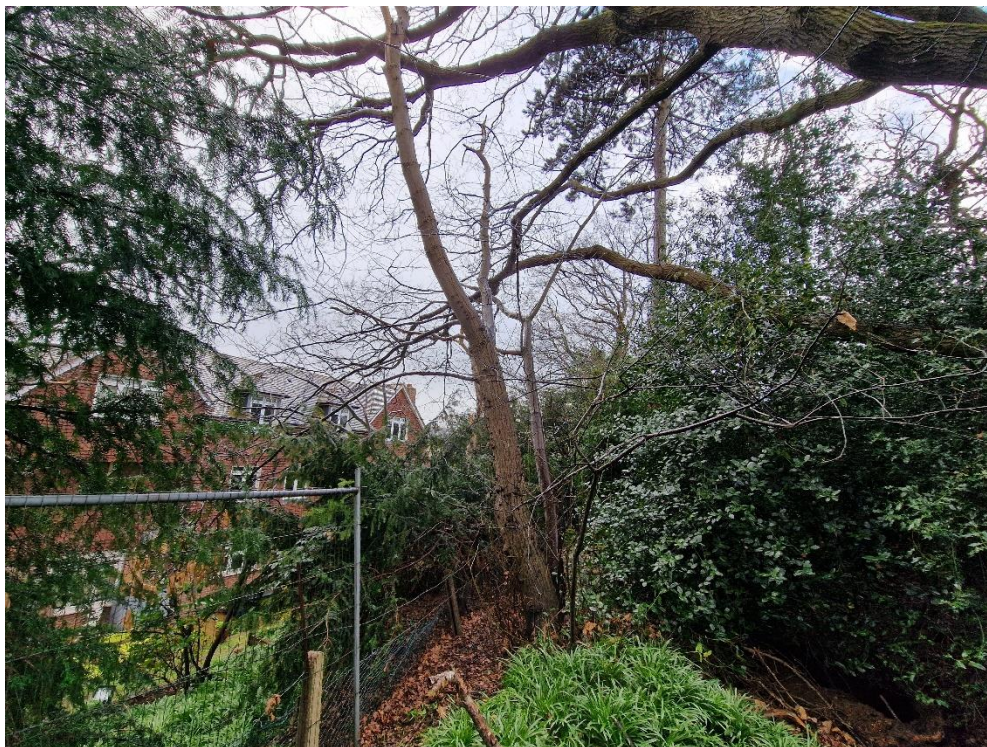
- 3.3.4** T718 is a sweet chestnut tree that has epicormic growth and mutual crown suppression, see Image 6. It has a crown bias over adjacent garden and some deadwood in its crown. It is recommended for the removal of deadwood greater than 50 mm in diameter within the next six months.

Image 6 T718 a sweet chestnut tree with a crown bias over the adjacent garden.

7.1.4 T718 a sweet chestnut tree is recommended for the removal of deadwood greater than 50 mm in diameter within the next six months.

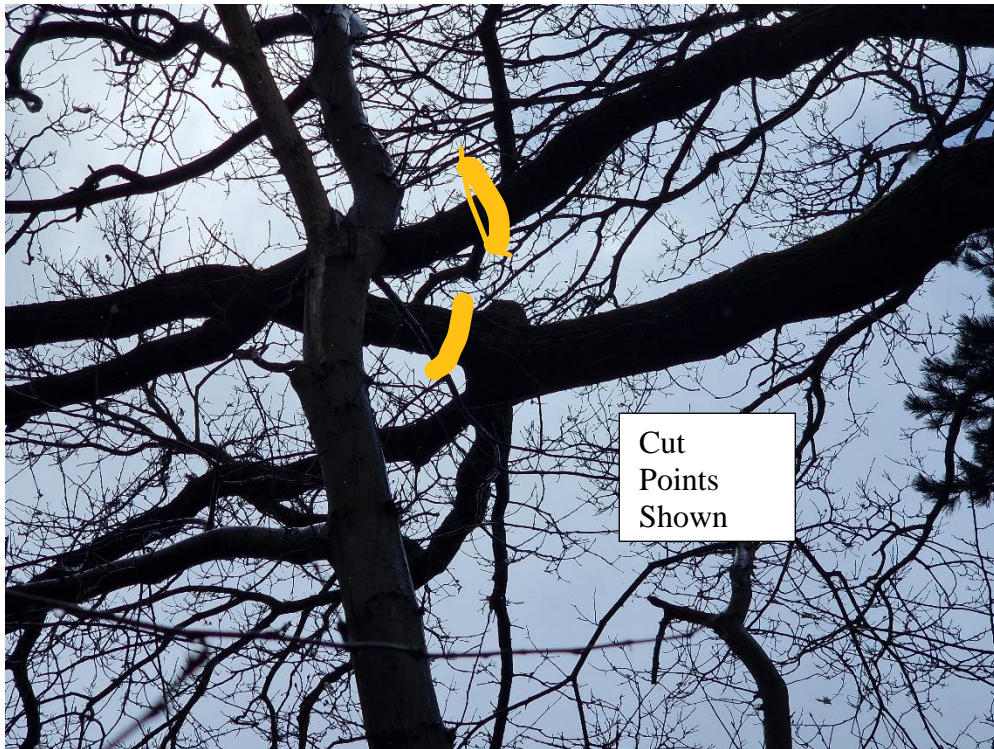
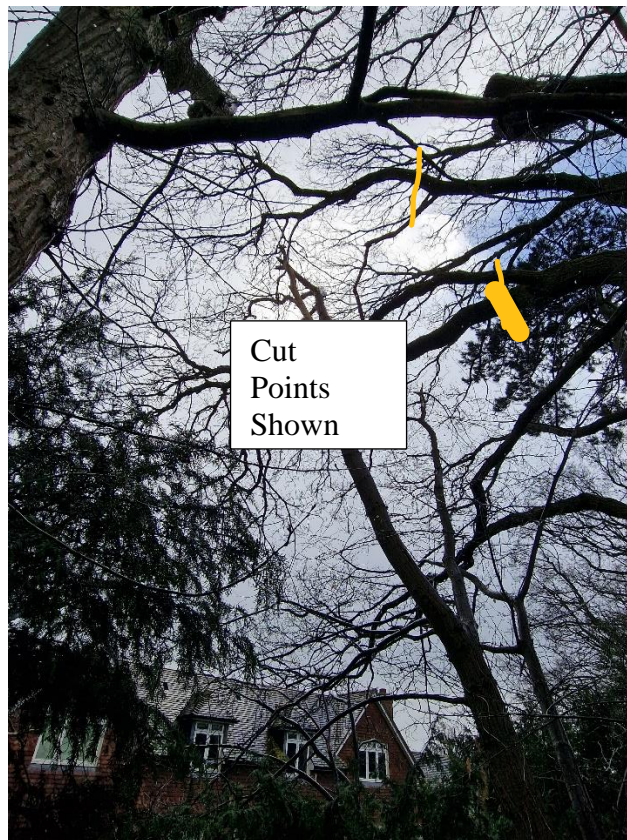
Image 7 Overhanging branches of oak tree T719.

Image 8 Overhanging branches of oak tree T719.

- 5.9** T719 an oak tree is recommended to have its overhanging branches cut back, as shown on the Images in Appendix III. This is to reduce the overhang, shading, nuisance issues and fear to adjacent nearby properties with small gardens. This will result in the removal of around 8 m of branch length to leave around 8 m. This will entail taking one branch back to the union with three emerging stems. Also taking the adjacent stem to the east back to a similar point, roughly where it runs against dead chestnut stem, see Images 7 and 8. This should be completed within the next six months.

7.1.5 T719 an oak tree is recommended to have its overhanging branches cut back. This will result in the removal of around 8 m of branch length to leave around 8 m. This will entail taking one branch back to the union with three emerging stems. Also taking the adjacent stem to the east back to a similar point, roughly where it runs against the dead chestnut stem, see Images 7 and 8. This should be completed within the next six months.

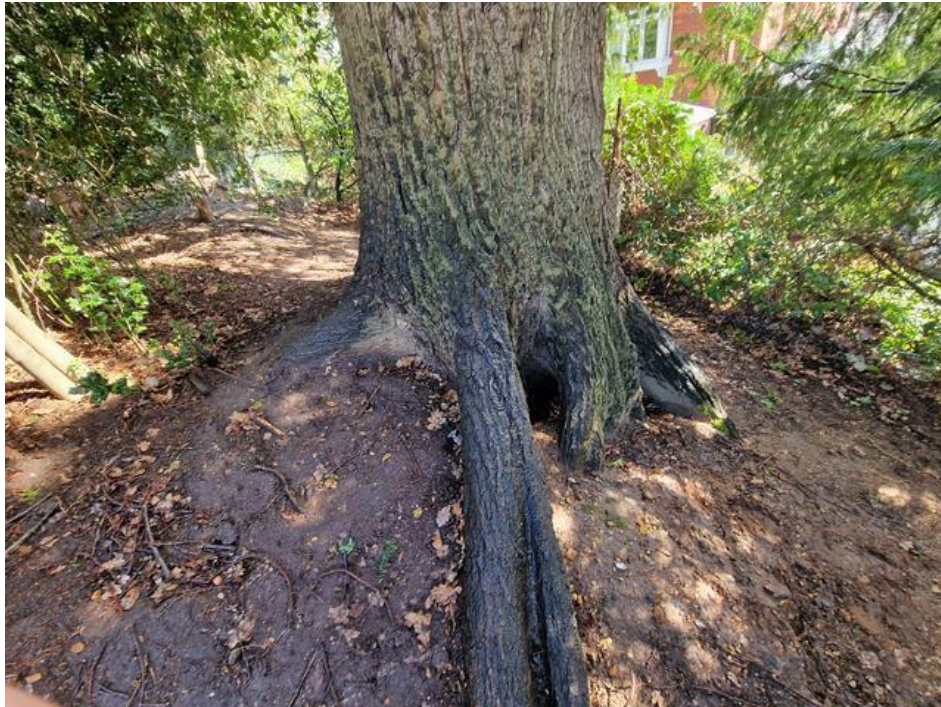
Image 9 Undermined root plate of oak tree T719.

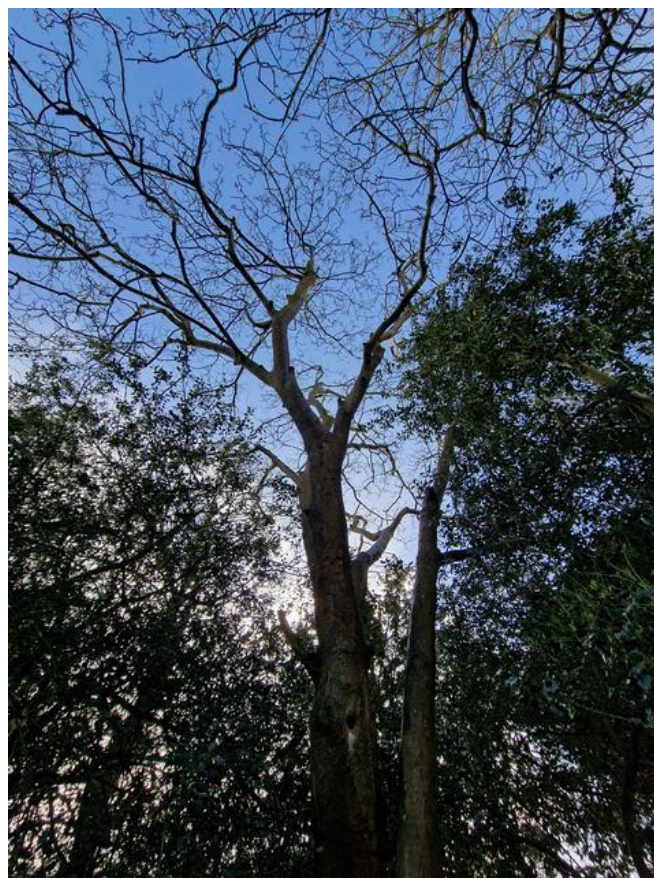
Image 10 Degrading main stem with 2nd stem establishing on sweet chestnut T720.

- 5.10** For T720 a sweet chestnut tree it is recommended to coppice the main trunk and favour the basal growth stem to become the next main trunk. This is recommended to be undertaken within the next six months.

7.1.6 For T720 a sweet chestnut tree it is recommended to coppice the main trunk within the next six months.

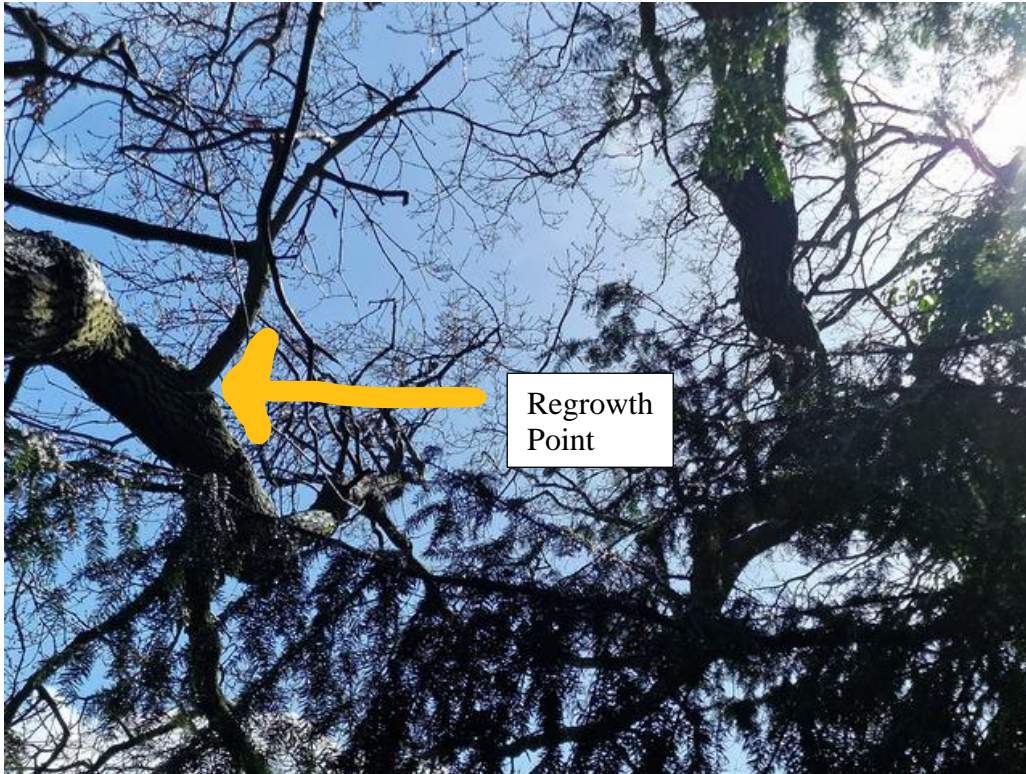
Image 11 Large limb of T725 extending over adjacent garden, with regrowth branch.

- 5.13** It is also recommended that the southern branch is reduced at around 4 m in height, reducing it to around 5 m in length, just beyond existing regrowth as shown on Image 11, removing around 8 m of the limb. This is recommended for action within the next six months.

- 7.1.8** It is also recommended that the southern branch is reduced at around 4 m in height, reducing it to around 5 m in length, just beyond existing regrowth as shown on Image 11, removing around 8 m of the limb. This is recommended for action within the next six months.

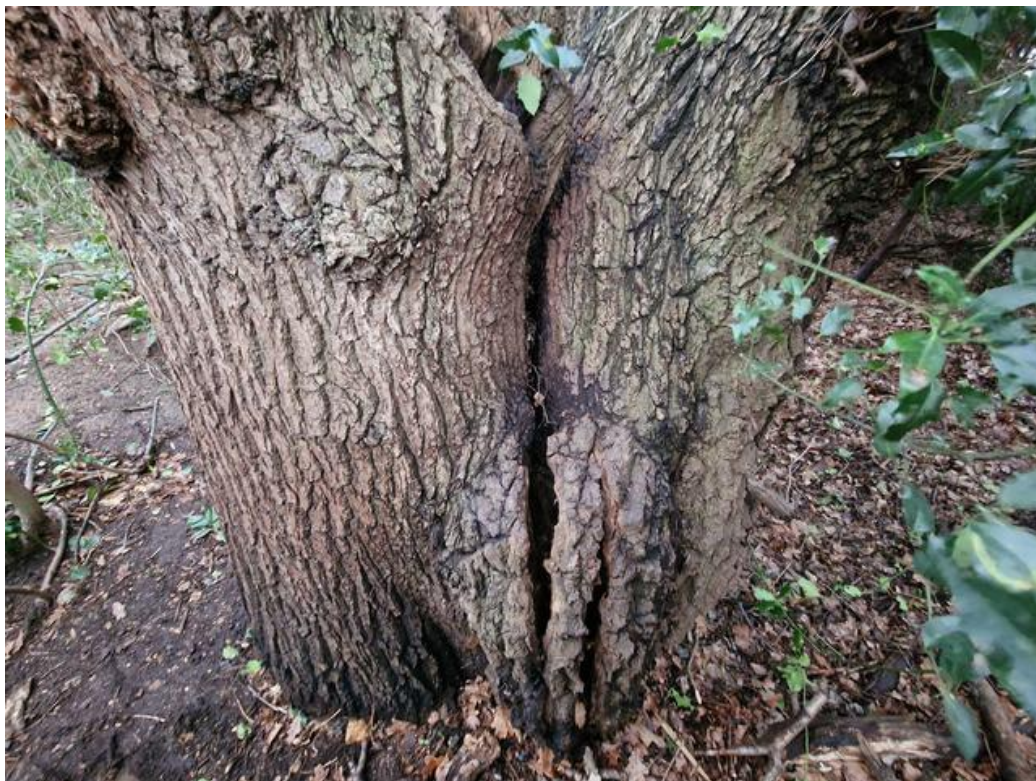
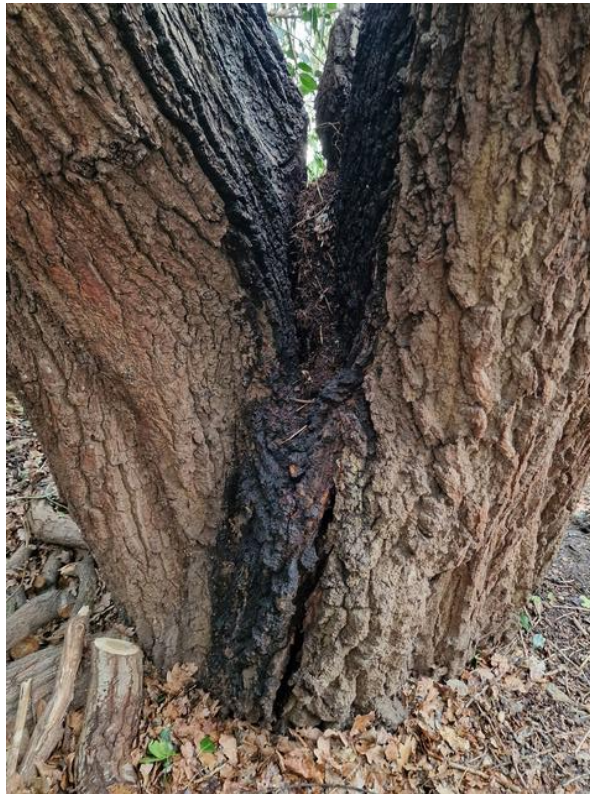
- 3.3.10** Following the inspection in 2023 it appears that the twin stems have moved apart with a separating shear crack, see Images 12 and 13. Historically a large limb has snapped on the east side at around 6 m and left a large cavity with limited occlusion, see Image 14. It also has a more recent branch failure on the woodland side, possibly from last year's storms. It has been previously cut back on boundary side.

Image 12 T226 an oak tree with a separation shear crack.

Image 13 T226 an oak tree with a separation sheer crack.

- 5.15** T726 a pedunculate oak tree is recommended to be reduce by around 8 m to leave around 10 m within the next three months. It is recommended that the client considers fitting a threaded bar through the two trunks east to west at around 1 m to hold the tree together, as a means of preventing the tree splitting as it regrows. This is recommended for action within the next six months.

- 5.10** T726 a pedunculate oak tree is recommended to be reduce by around 8 m to leave around 10 m within the next three months. It is recommended that the client considers fitting a threaded bar through the two trunks east to west at around 1 m to hold the tree together. This should be completed within the next six months.

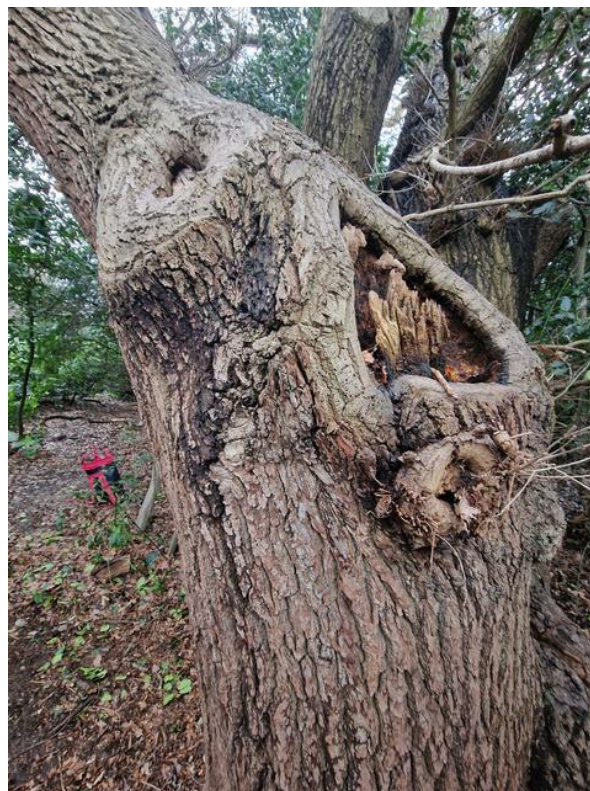
Image 14 T226 an oak tree with a large cavity from a previous major limb failure.

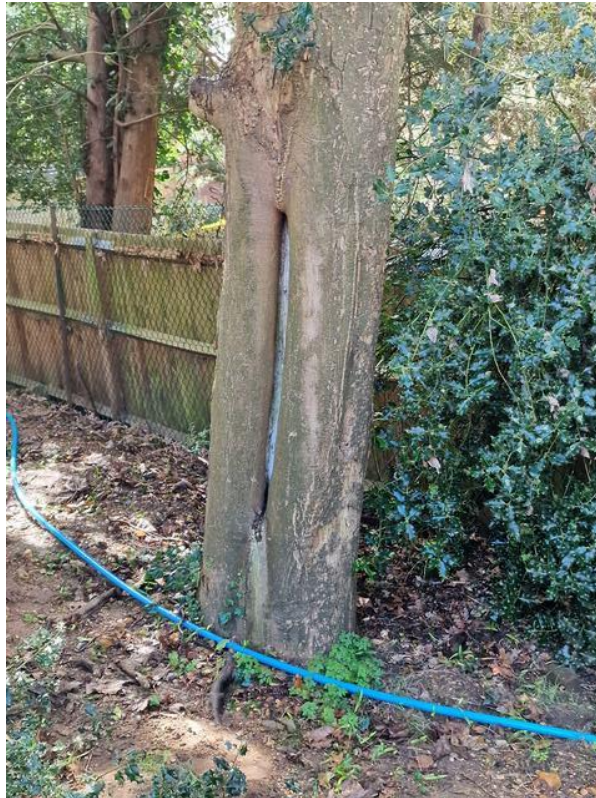
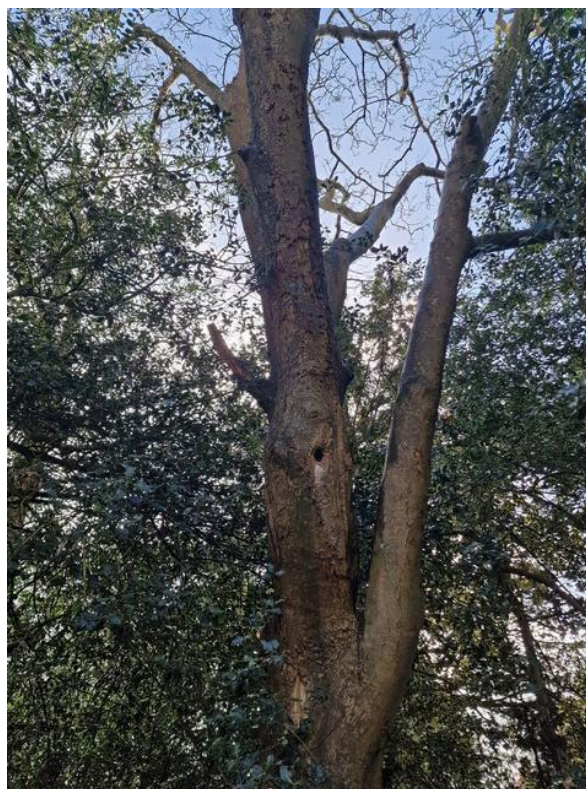
Image 15 T748 a sycamore with an occluding trunk wound with good wound wood.

Image 16 T748 a sycamore with degradation and a woodpecker hole in main trunk.

- 5.16** T748 a sycamore tree with a trunk wound 0.5 to 1.5 m on northeast side is recommended to reduce the northern stem with a woodpecker hole and necrotic bark, tsking it down to around 1m above woodpecker hole. This is to reduce the risk and maintain the habitat whilst allowing natural degradation of the stub. This is recommended for action within the next six months.

- 5.11** For T748 a sycamore tree it is recommended to reduce the northern stem, taking it down to around 1m above the woodpecker hole within the next six months.

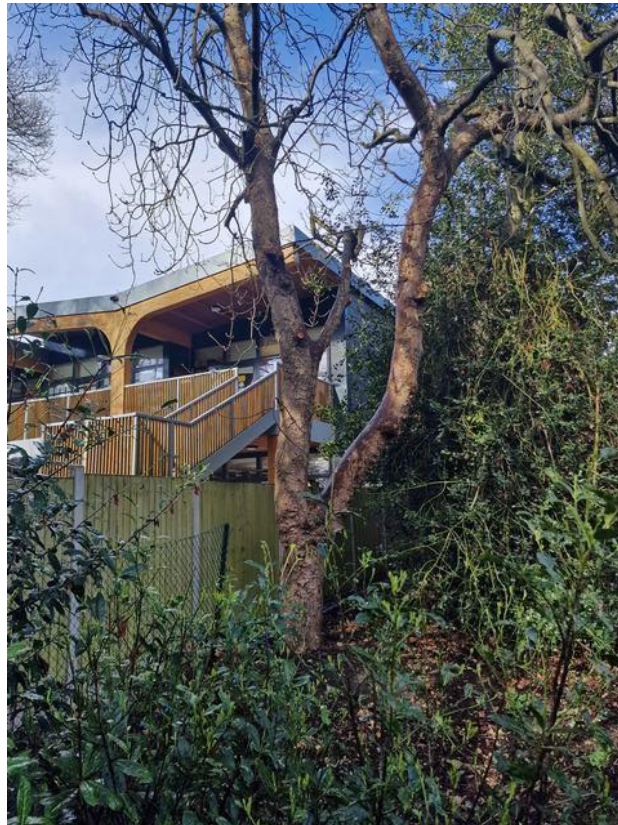
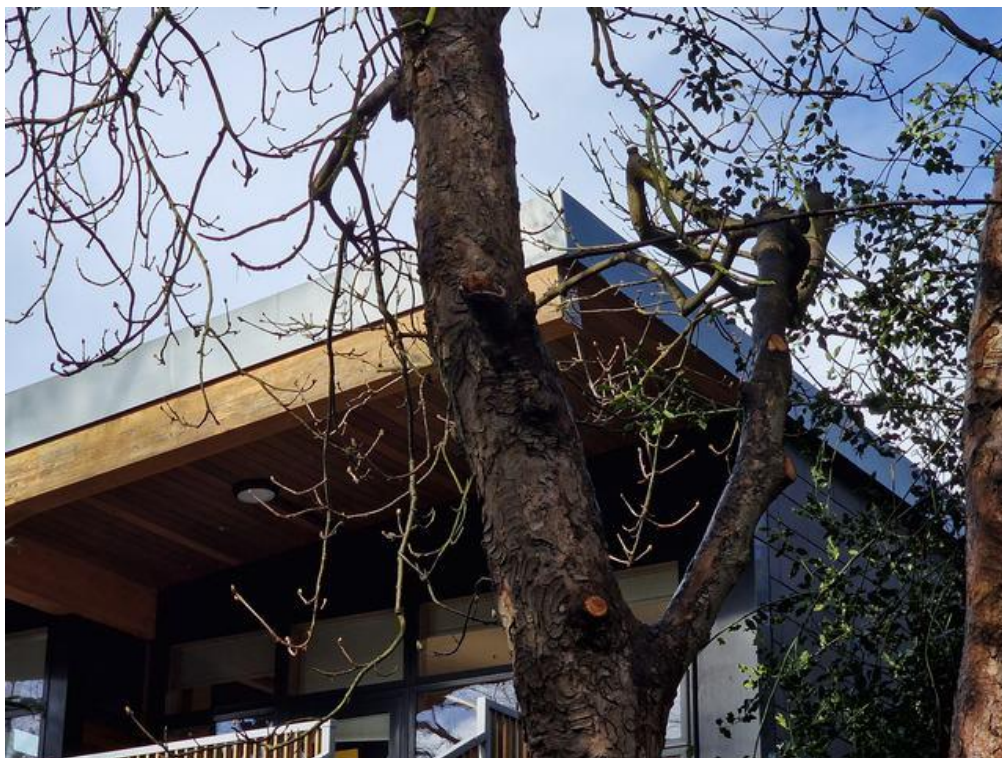
Image 17 T749 a horse chestnut growing near to adjacent school building.

Image 18 T749 a horse chestnut growing near to adjacent school building.

- 5.17** T749 a horse chestnut tree is recommended to have the branch in conflict with adjacent school building cut back, taking it back to around 1 m from the trunk. This is to allow for natural degradation of the stub. This is recommended for completion within six months.

- 5.12** T749 a horse chestnut tree is recommended to have the branch in conflict with the adjacent school building cut back to around 1 m from the trunk, within six months.
