SOIL INSPECTION & TESTING REPORT

Phase 2

Capel Manor College

Date: 23rd October 2023

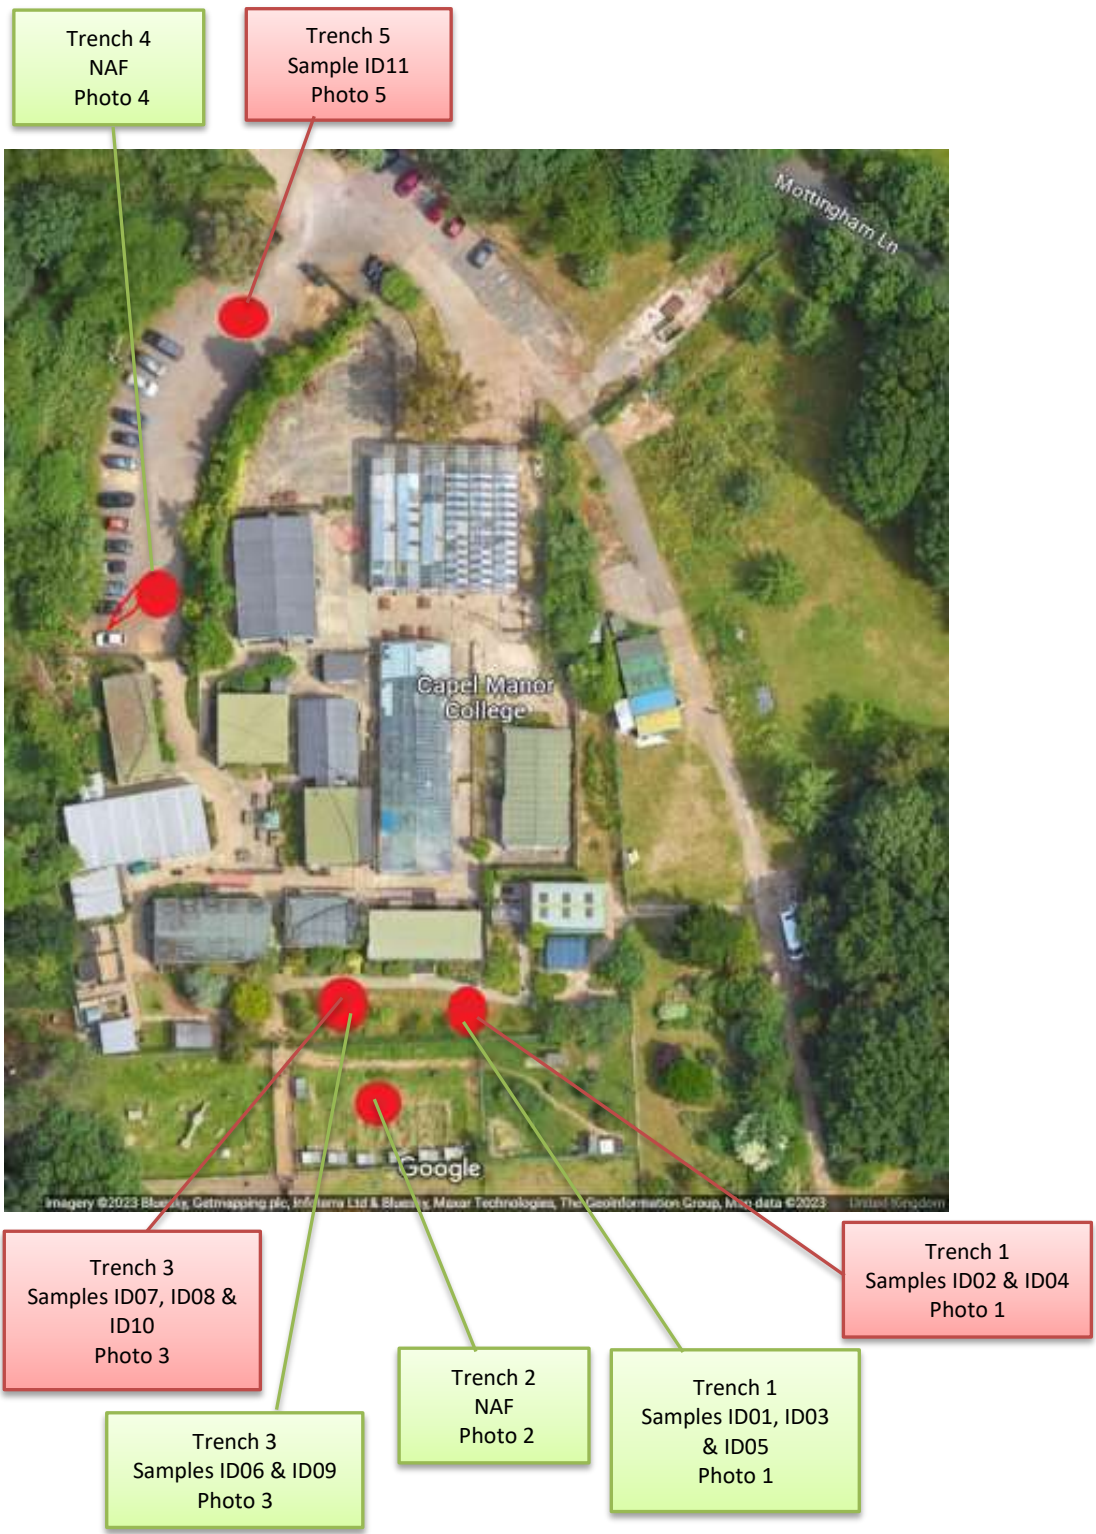
DRAWING 1 – PHASE 2

Pieces of asbestos board and board debris containing amosite were found buried in Trench 3.

Asbestos cement debris was found buried in Trenches 1 and 5.

No asbestos was found in Trenches 2 and 4.

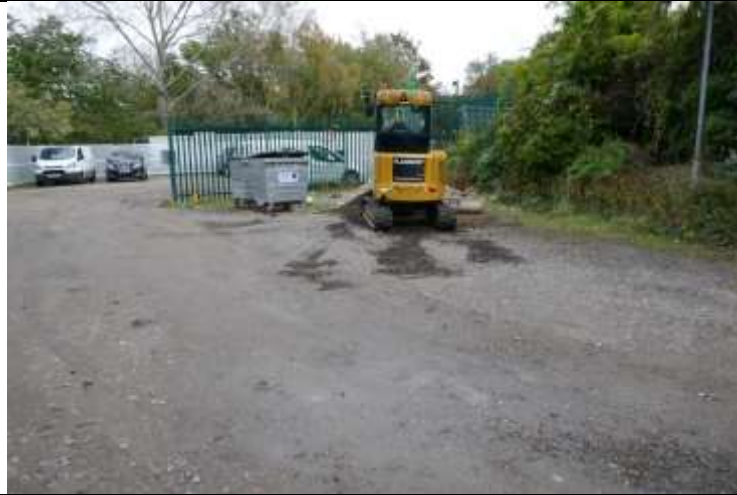
PHOTO NO: 5

AREA	Car park	LOCATION	Trench 5
LEVEL OF IDENTIFICATION	Sample taken for analysis	SAMPLE NUMBER or PRESUMPTION NO.	ID11
DESCRIPTION OF SAMPLE TAKEN OR PRESUMPTION MADE		Asbestos cement debris in the soil near the front entrance of car park.

ASBESTOS? YES - CHRYSOTILE
