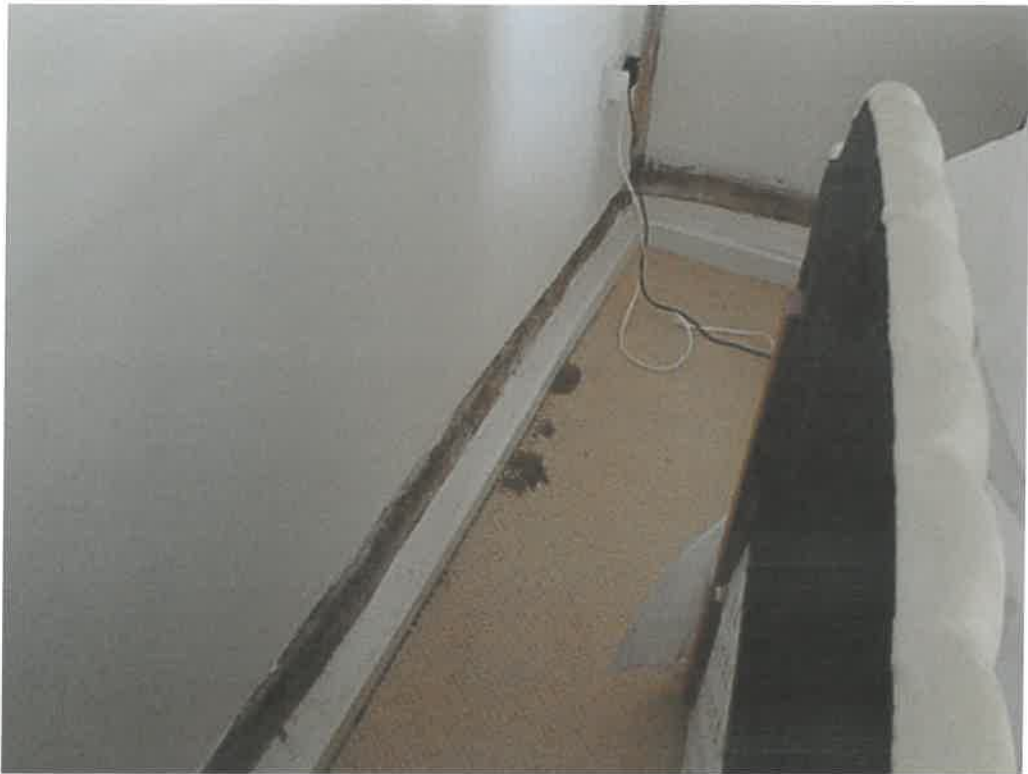
Soleplate to Outbuilding showing bore dust (East wall)

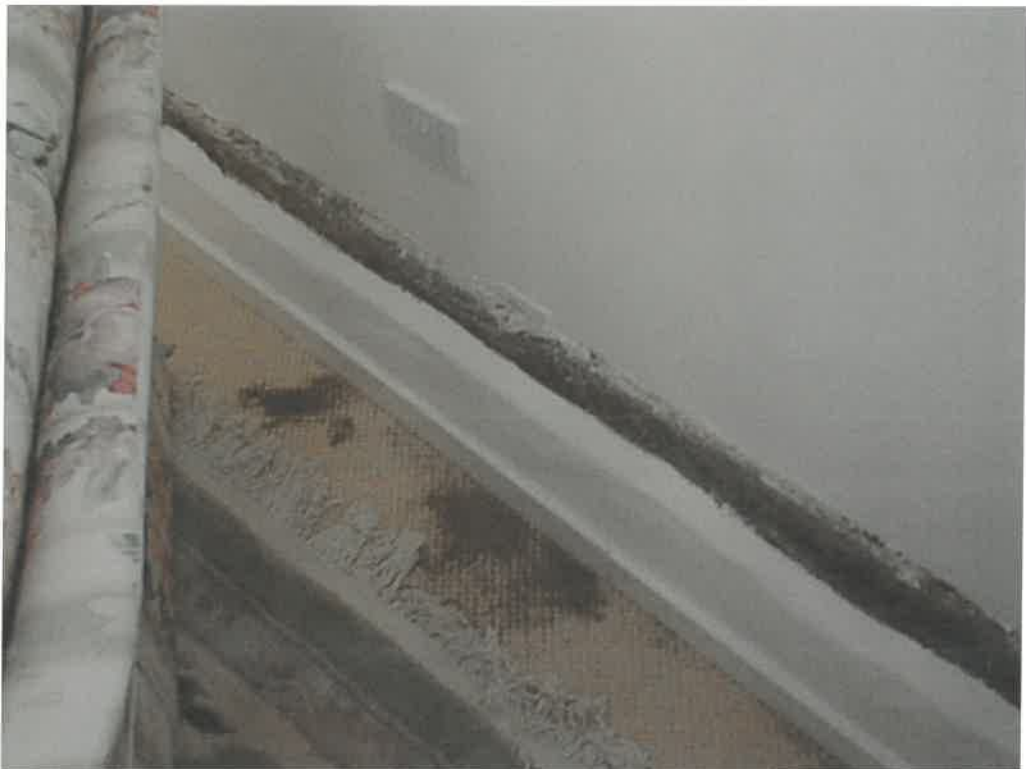
Soleplate to Outbuilding showing bore dust (South wall)
