**CCTV REPORT FOR: RUSSELL COTTAGE
BRIDGNORTH ROAD
HIGHLEY
BRIDGNORTH
WV16 6JG**

Insured: Mr Alan Matthews
Reference: LIV-SN-22-005195 Ins Ref: 100-50-194734

1st Site Visit: 04-Jan-23
1st Report Date: 09-May-23

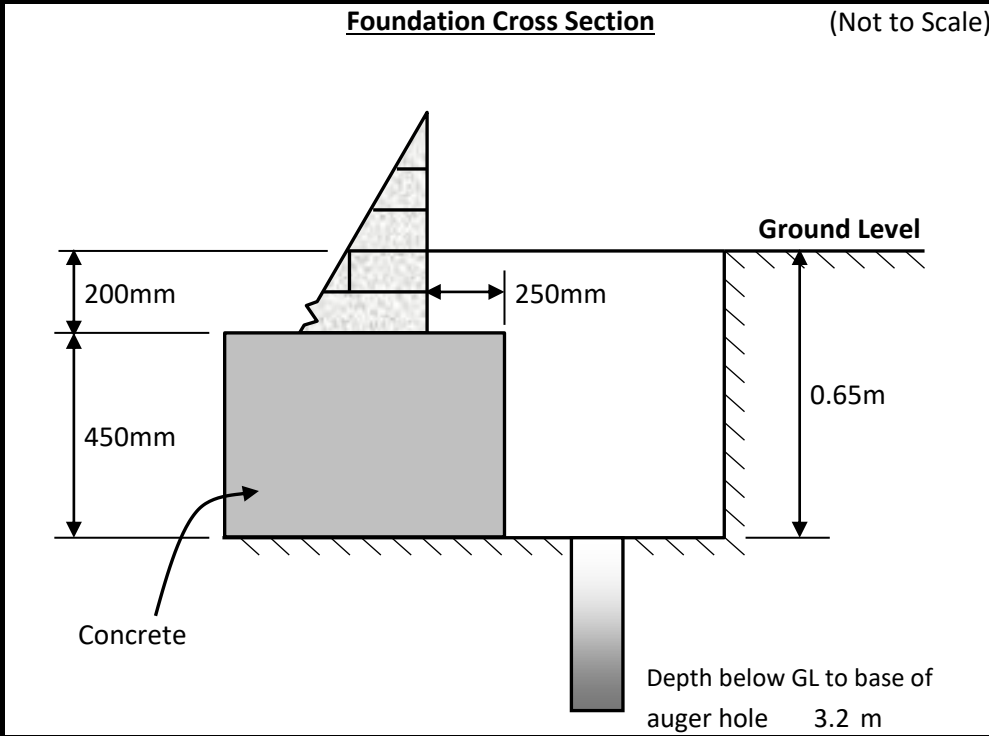
Location: Left hand side rear extension	T/H No. 1
Ground Surface: Damp	Weather: Dry
	Date: 04-Jan-23

Roots Depth & Diameter:
None observed on site
Water Depth Hit & Rise:
Hit at 0.5m
Reason for Termination :
Suction

Depth (m)	Soil Descriptions <i>(NB: Field crew description only)</i>	Test Type	Depth (m)	
			From	To
G.L.				
0.65	Very soft brown CLAY with some medium gravel	V(n) 16	0.650	
1.00	Soft/firm brown CLAY with rare medium gravel	V(n) 44	1.000	
2.50	Soft brown CLAY with occasional medium gravel	V(n) 54	1.500	
3.20	End of Borehole	V(n) 40	2.000	
		V(n) 82	2.500	
		V(n) 68	3.000

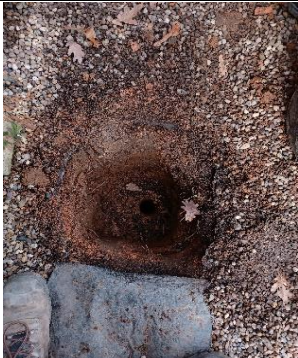
Location: **Front of House** B/H No. **2**
 Ground Surface: **Damp** Weather: **Dry** Date: **04-Jan-23**

Roots Depth & Diameter:
 From 0.6m
 Down to 2.6m
 up to 2mm diameter

Water Depth Hit & Rise:
 Hit at 0.6m

Depth (m)	Soil Descriptions <i>(NB: Field crew description only)</i>	Test Type	Depth (m)	
			From	To
G.L.				
0.65	Soft/firm brown CLAY with rare medium gravel	V(n) 80	0.600	
1.00	Firm brown slightly silty CLAY with rare medium gravel	V(n) 87	1.600	
5.00	End of Borehole	V(n) 92	2.600	
		V(n) 106	3.600	
		V(n) 112	4.600	
Photograph

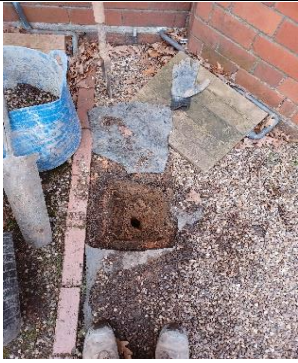
Location: **Front Left of House** B/H No. **3**
 Ground Surface: **Damp** Weather: **Dry** Date: **04-Jan-23**

Roots Depth & Diameter:
 From 0.6m
 Down to 2.6m
 up to 2mm diameter

Water Depth Hit & Rise:
 Hit at 0.6m

Depth (m)	Soil Descriptions <i>(NB: Field crew description only)</i>	Test Type	Depth (m)	
			From	To
G.L.				
0.60	Soft/firm brown CLAY with rare medium gravel	V(n) 82	0.600	
2.60	Firm brown slightly silty CLAY with rare medium gravel	V(n) 90	1.600	
5.00	End of Borehole	V(n) 95	2.600	
		V(n) 109	3.600	
		V(n) 115	4.600	
Photograph

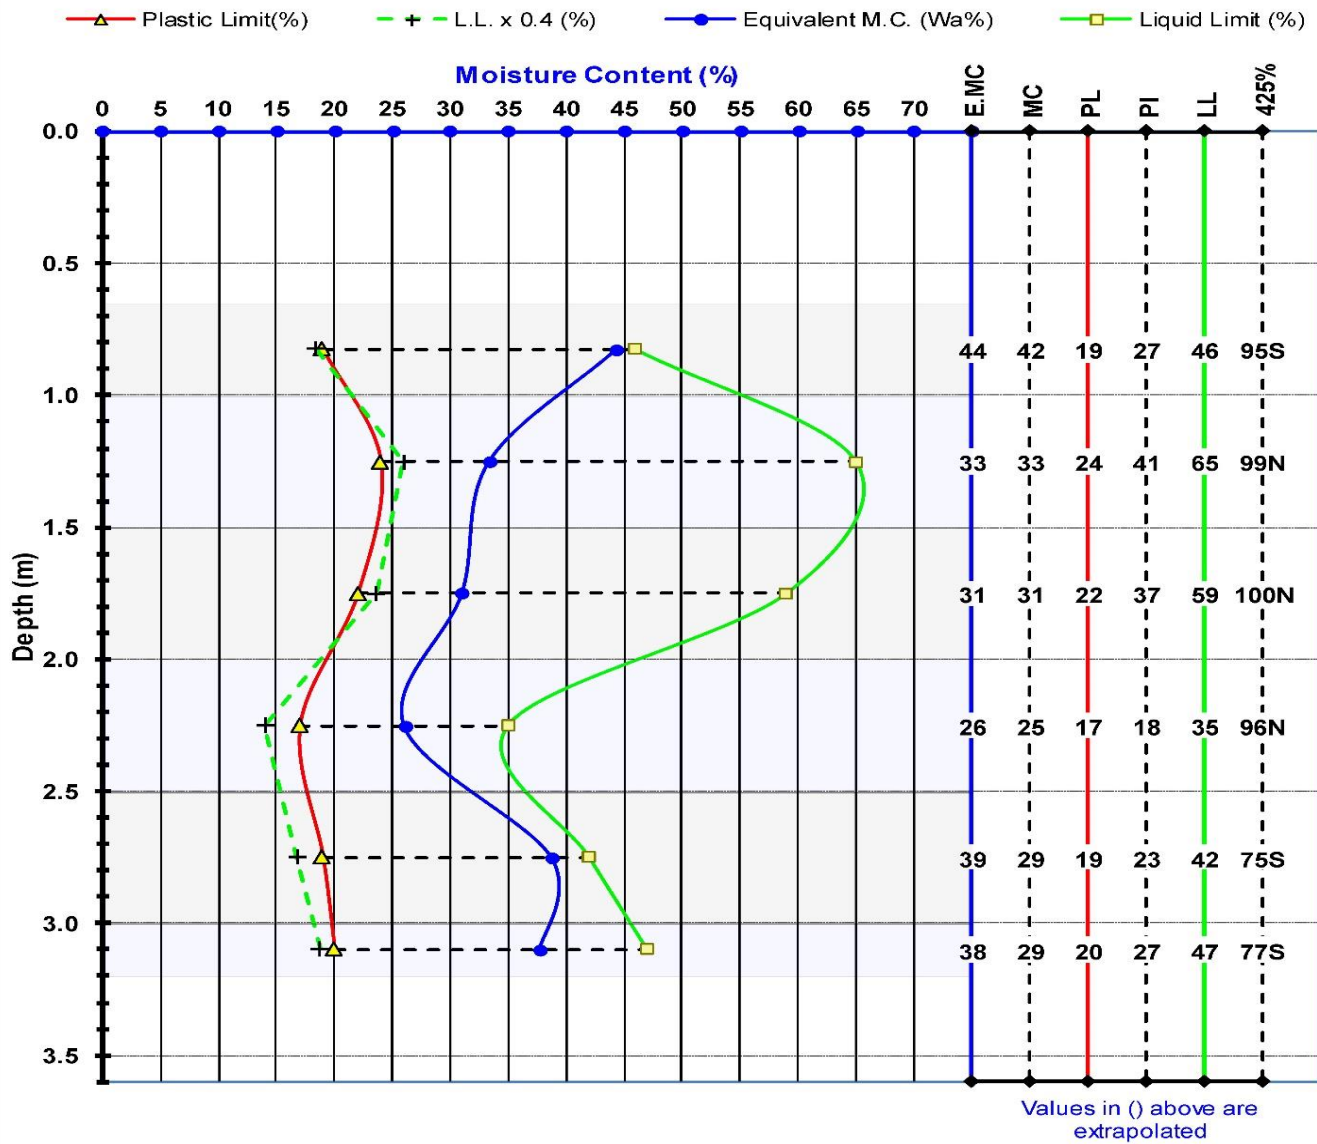
Depth T (m)	Depth B (m)	1 - LHS of rear extension Brief Soil Description	Plasticity (BS 5930)	Volume Change (BRE 240)
0.65	1	Very soft brown CLAY with some medium gravel	Intmd. CI	26% Medium
1	1.5	Soft/firm brown CLAY with rare medium gravel	High CH	41% High
1.5	2	Soft/firm brown CLAY with rare medium gravel	High CH	37% Medium
2	2.5	Soft/firm brown CLAY with rare medium gravel	Intmd. CI	17% Low
2.5	3	Soft brown CLAY with occasional medium gravel	Intmd. CI	17% Low
3	3.2	Soft brown CLAY with occasional medium gravel	Intmd. CI	21% Medium

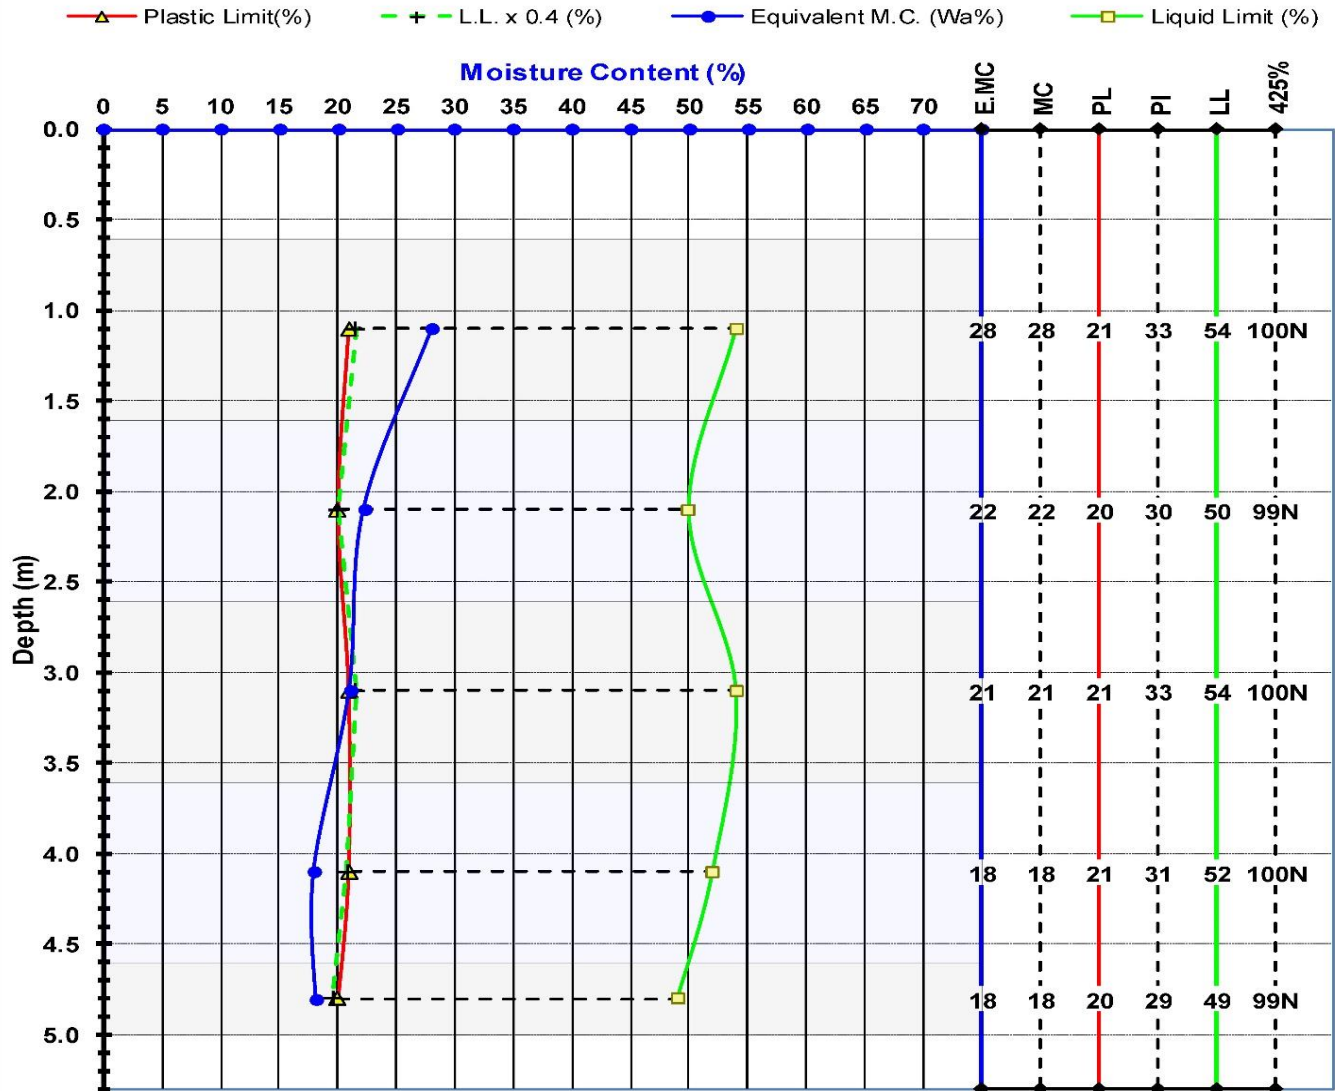
Depth T (m)	Depth B (m)	2 - Front of property		Plasticity (BS 5930)	Volume Change (BRE 240)
		Brief Soil Description			
0.6	1.6	Soft/firm brown CLAY with rare medium gravel		High CH	33% Medium
1.6	2.6	Firm brown slightly silty CLAY with rare medium gravel		Intmd. CI	30% Medium
2.6	3.6	Firm brown slightly silty CLAY with rare medium gravel		High CH	33% Medium
3.6	4.6	Firm brown slightly silty CLAY with rare medium gravel		High CH	31% Medium
4.6	5	Firm brown slightly silty CLAY with rare medium gravel		Intmd. CI	29% Medium

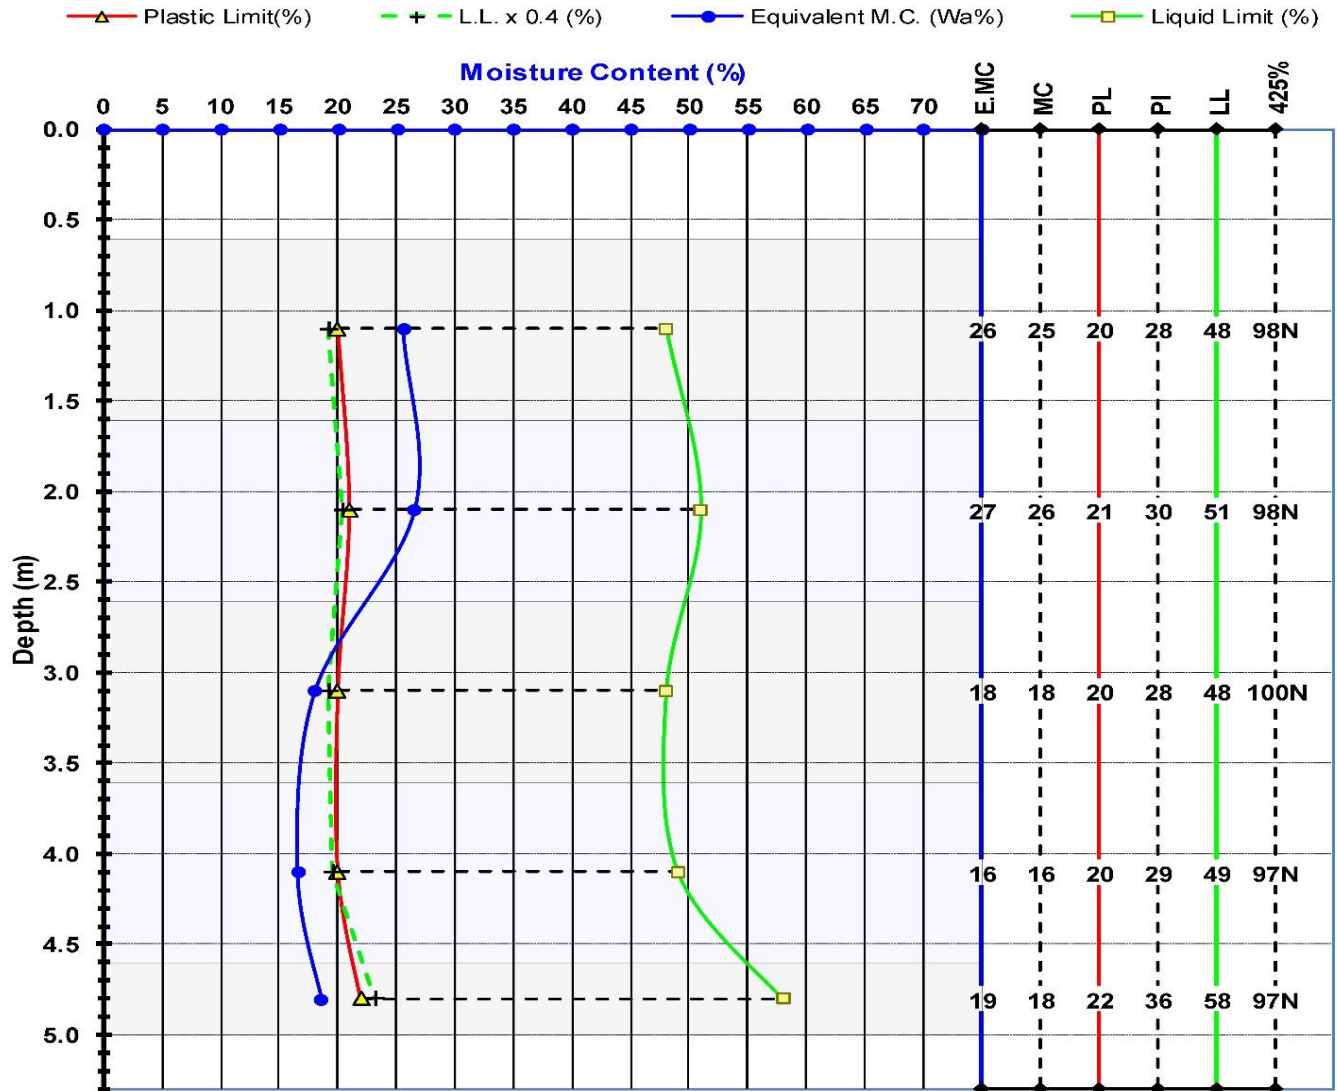
Depth T (m)	Depth B (m)	3 - Front LHS of property		Plasticity (BS 5930)	Volume Change (BRE 240)
		Brief Soil Description			
0.6	1.6	Soft/firm brown CLAY with rare medium gravel		Intmd. CI	27%
1.6	2.6	Soft/firm brown CLAY with rare medium gravel		High CH	29%
2.6	3.6	Firm brown slightly silty CLAY with rare medium gravel		Intmd. CI	28%
3.6	4.6	Firm brown slightly silty CLAY with rare medium gravel		Intmd. CI	28%
4.6	5	Firm brown slightly silty CLAY with rare medium gravel		High CH	35%
