**Subsidence
Monitoring
Services**

Monitoring visit **5** of **7**

Monitoring Plus Report

Owners name	Mr. Alan Matthews	Suspected cause	to be advised	Monitoring type	levels & cracks
Address	Russell Cottage Bridgnorth Road Highley Bridgnorth WV16 6JG	Principal area of damage	to be advised	Installed	27/03/2023

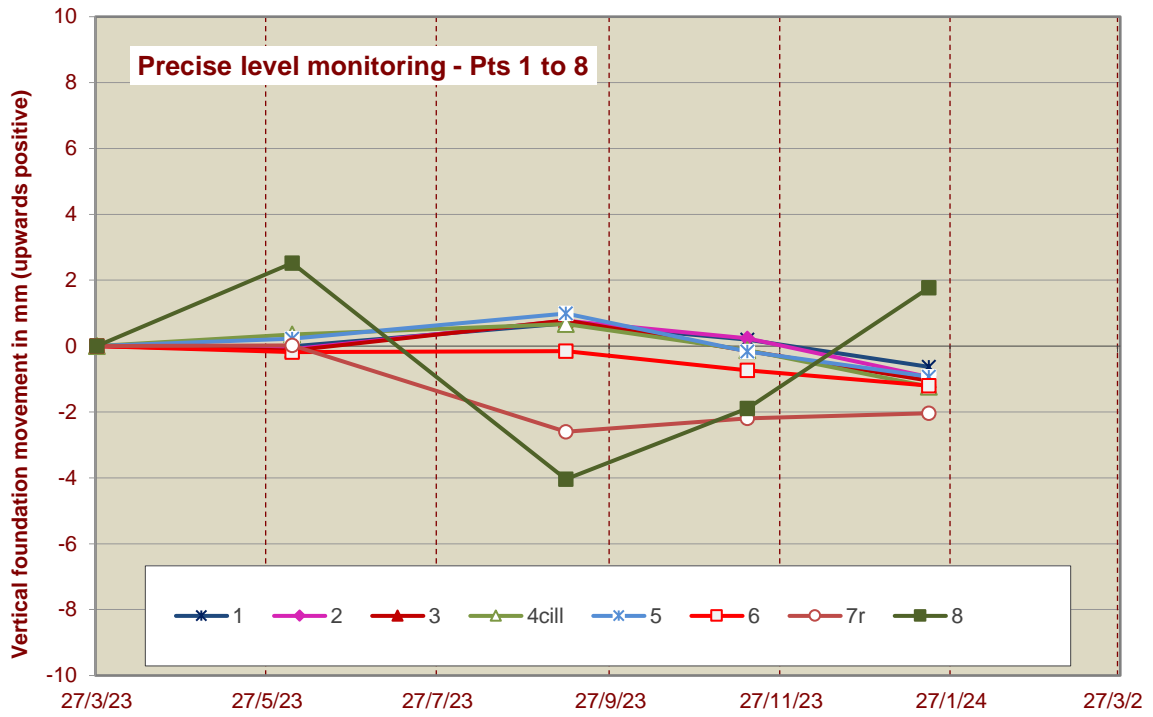
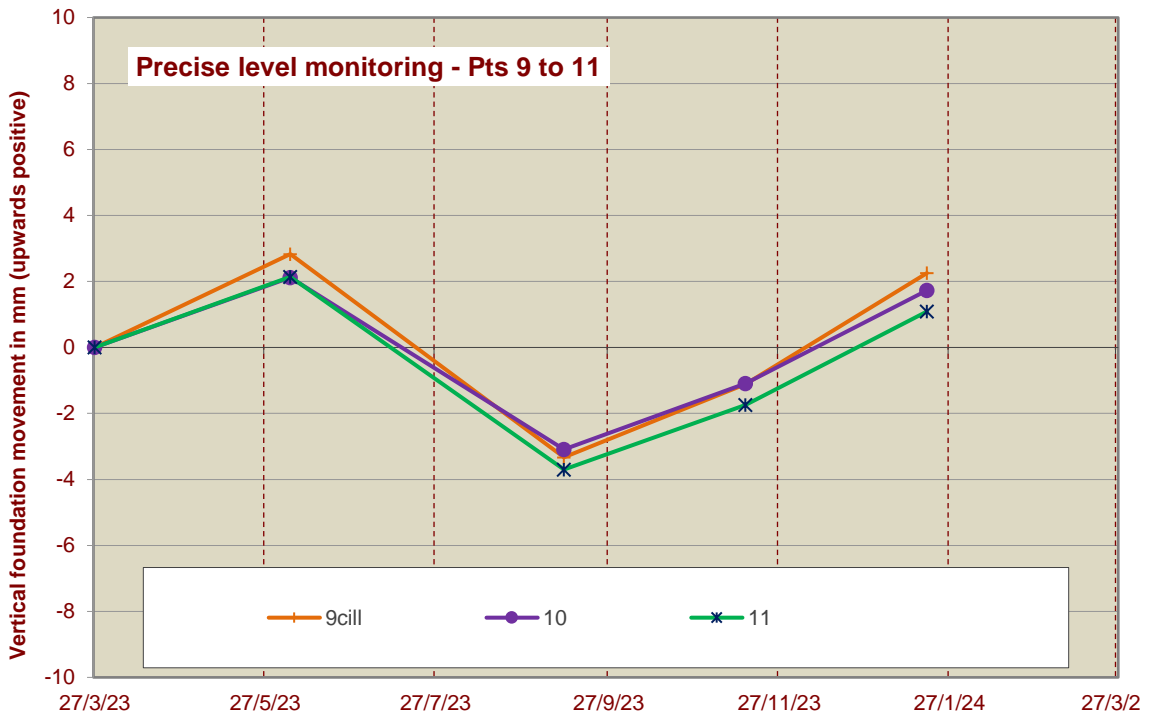
Precise level monitoring related to drain

10	1193.07	0.0	1195.19	2.1	1189.98	-3.1	1191.98	-1.1	1194.80	1.7
11	1274.00	0.0	1276.14	2.1	1270.30	-3.7	1272.26	-1.7	1275.09	1.1

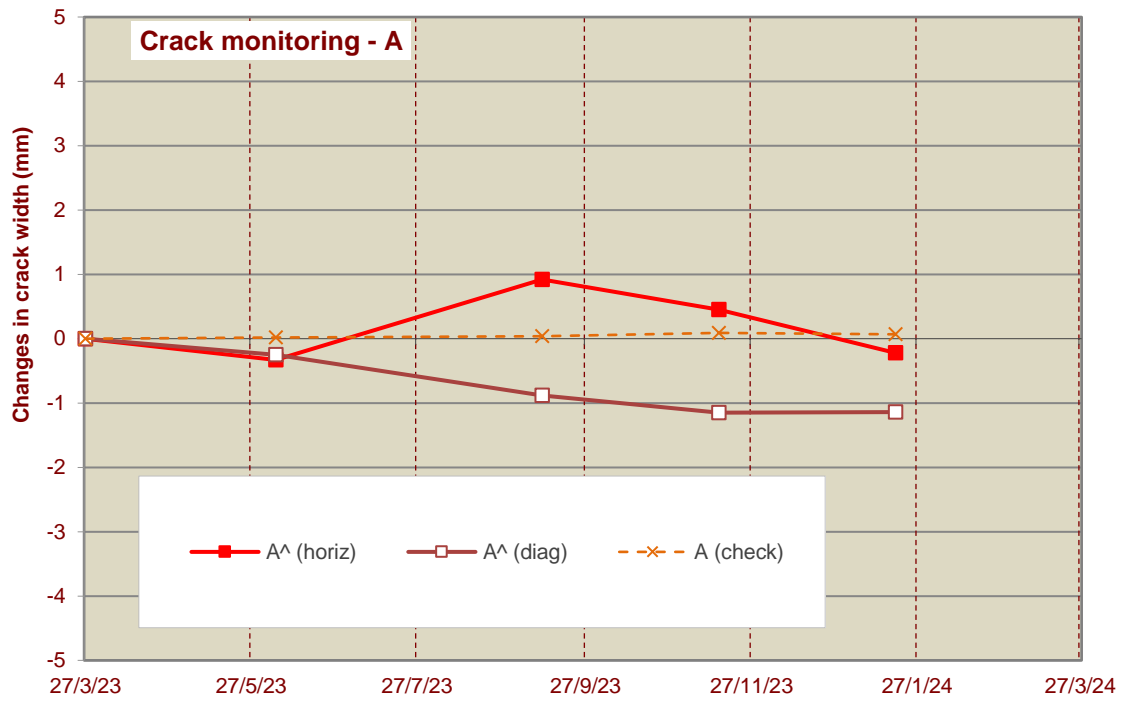
Crack monitoring

A^ (horiz) ext rear elev, junction between main house and rear ext lhs
