**CCTV REPORT FOR: RUSSELL COTTAGE
BRIDGNORTH ROAD
HIGHLEY
BRIDGNORTH
WV16 6JG**

Address: **RUSSELL COTTAGE, BRIDGNORTH ROAD, HIGHLEY, BRIDGNORTH, WV16 6JG**

Brief:	The Drainage Repair Company Ltd were commissioned to undertake a CCTV survey / inspection of the drainage at the property.
Specific Area of Interest:	Drainage as instructed by attending engineer.
System Access:	Inspection chamber in rear garden.
Visual Survey:	N/A
Water Pressure Test:	No

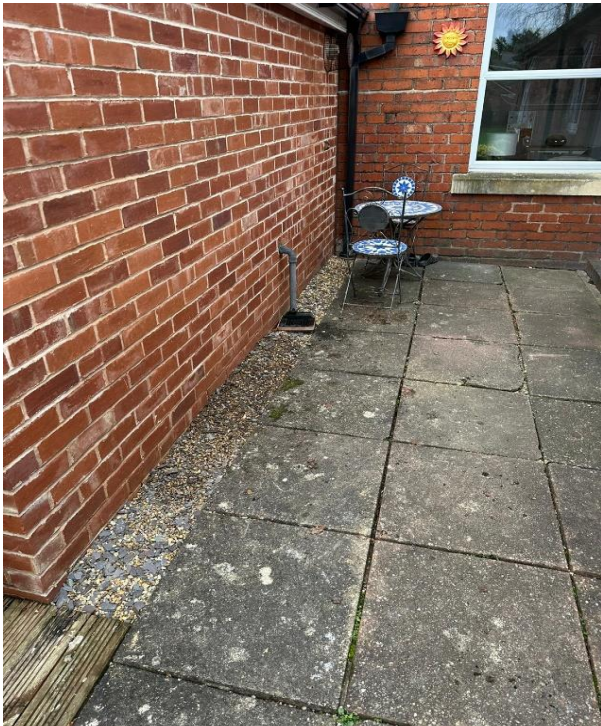
FWG1 and RWP1

Metres	Faults / Defects	Remarks
0.00		At MH1
0.10		Pipe bends right
0.80		Pipe bends left
4.50	No Visible Defects	At FWG1
		RWP1 connects to gully on back inlet
		End of survey

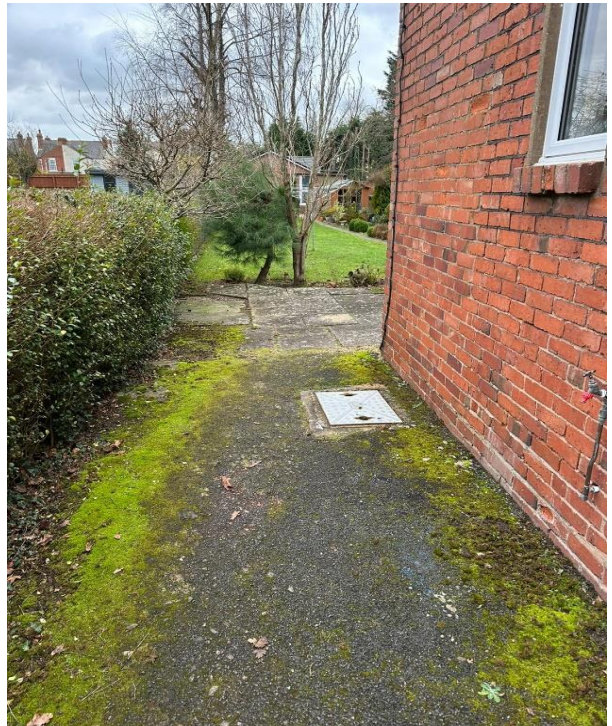
Metres	Faults / Defects	Remarks
0.00		At MH1
0.10		At boundary
0.34	Medium Displaced Joint	
1.86	Medium Displaced Joint	
2.43		Inlet at 9 o'clock
3.27		Inlet at 9 o'clock
4.80		At MH2
		End of survey

Medium displaced joints beyond property boundary.

The only defects observed are in Run 3 and are beyond the property boundary.

One the pipework leaves the boundary responsibility transfers to the local water authority.

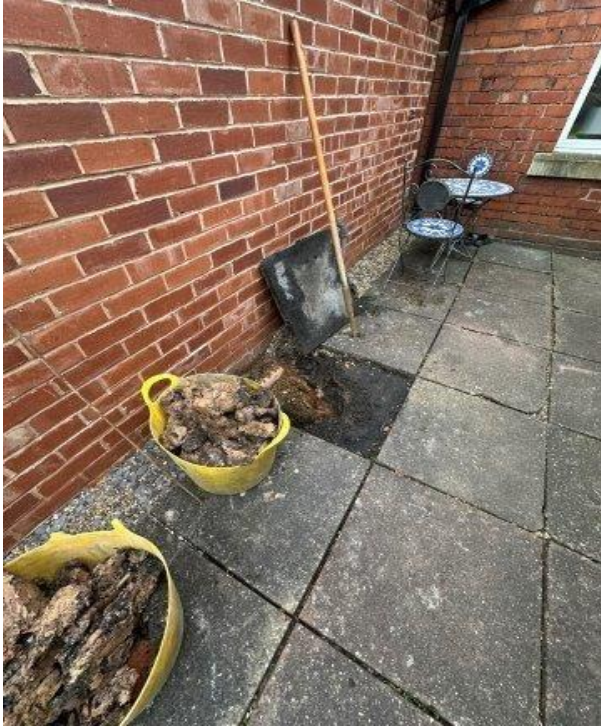
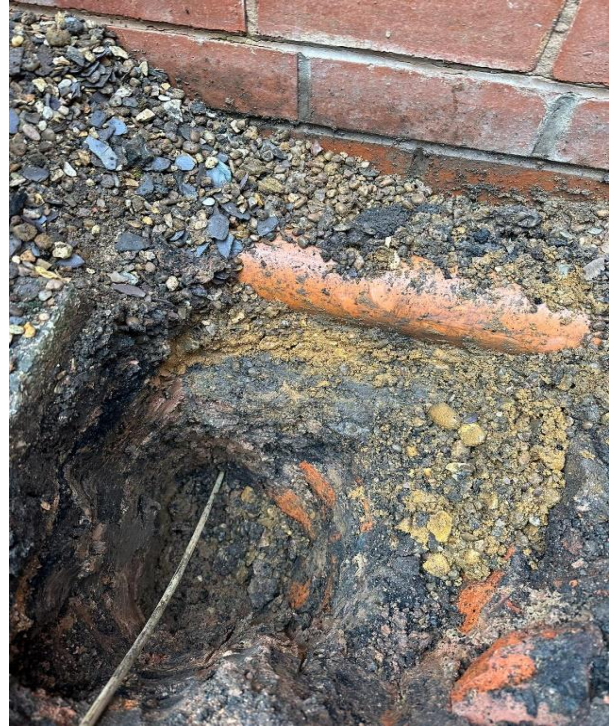
We re-opened T/H1 to check the water previously observed was still present. When we performed the pit in January 2023 we noted water lying at 0.5m below ground level. We noted that water was still present, lying at 0.7m below ground level.

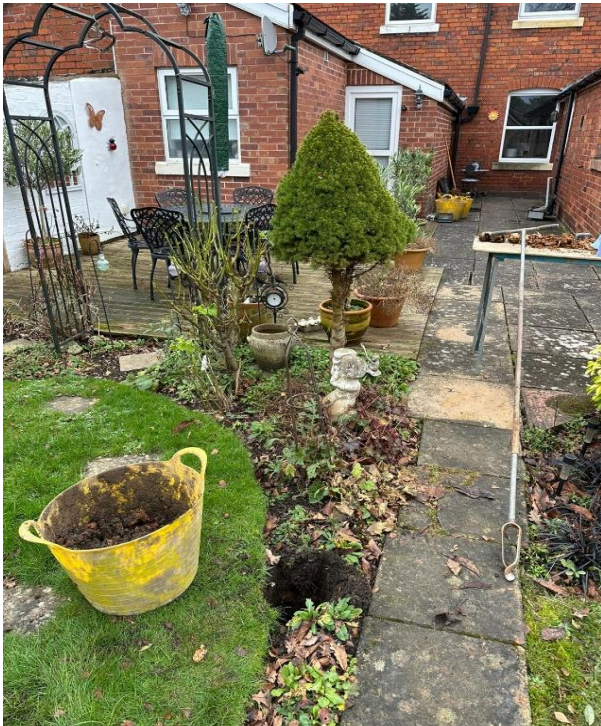
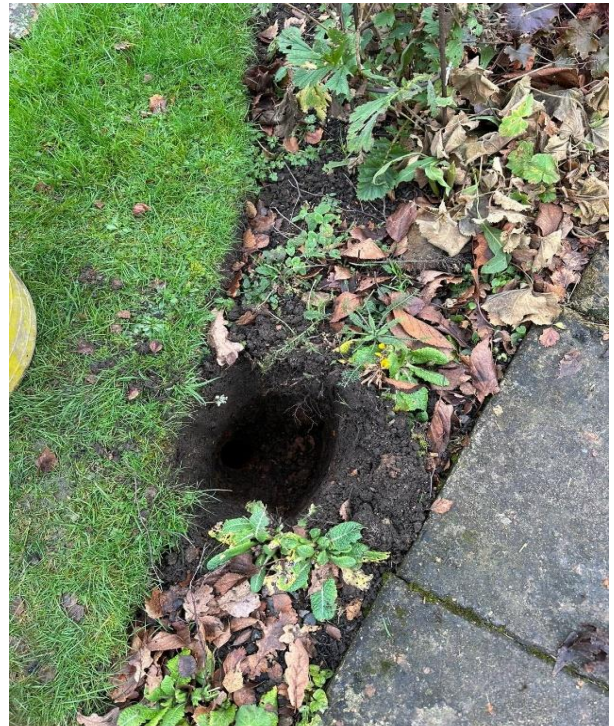
B/H4

Depth (m)	Soil Descriptions <i>(NB: Field crew description only)</i>	Test Type	Depth (m)	
			From	To
G.L.				
0.50	Firm light brown slightly silty CLAY with occasional medium gravel	P.P. 3.5	0.500	
1.00	Firm light brown slightly sandy/silty CLAY with occasional medium gravel	P.P. 4.0	1.000	
1.50	Firm light grey/brown slightly sandy/silty CLAY with occasional medium gravel	P.P. 4.5	1.500	
1.70	End of Borehole	P.P. 4.5	1.700

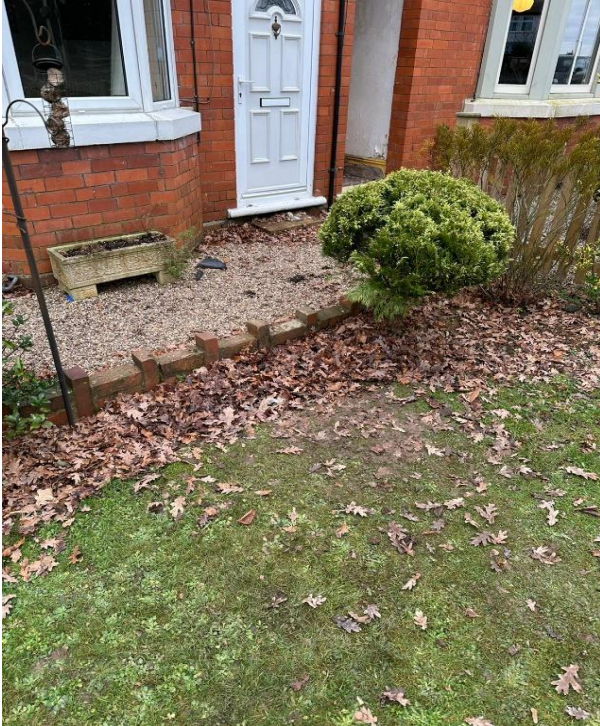
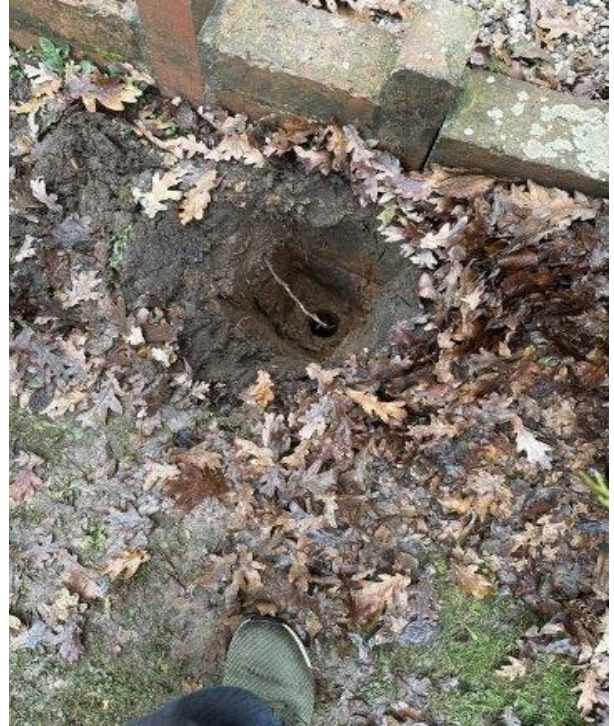
B/H5

TP/BH5, 0.50-0.60m		
1 no.	Examined root: QUERCUS (Oak).	Alive, recently*.

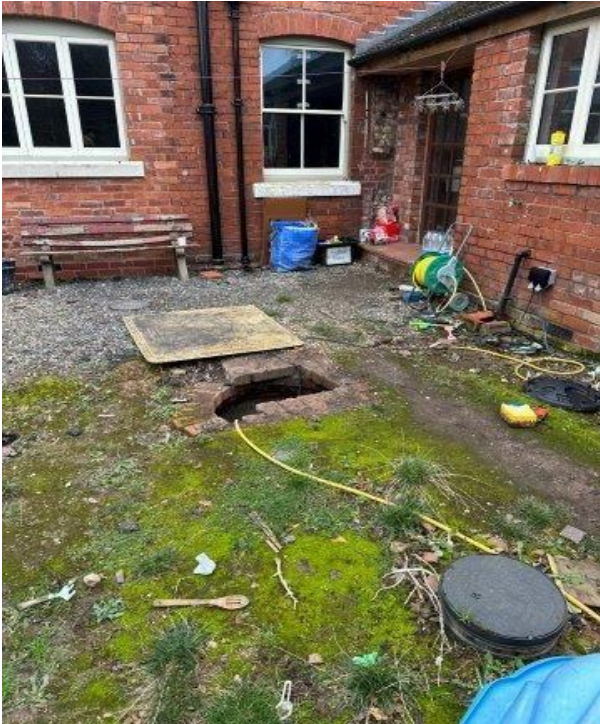
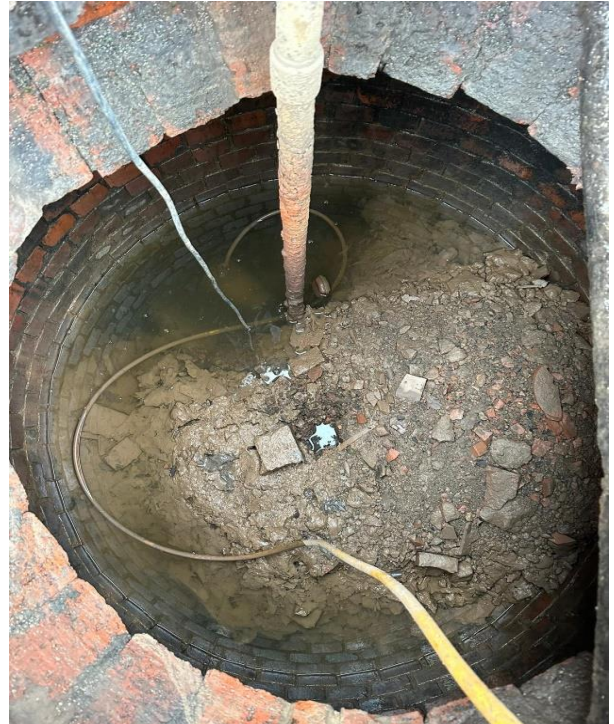
Well

While on site we investigated a well at Parkfield. This is approximately 2m in diameter and appears to have been partially backfilled with debris. Probing with rods shows that the debris lies at approximately 2m below ground level. The only drainage that looks to discharge to the well is a yard gully approximately 1m away.
