# Engineers Report

**Risk Address** Russell Cottage  
Bridgnorth Road  
Highley  
BRIDGNORTH  
WV16 6JG

**360 Reference** LIV-SN-22-005195  
**Insurer Reference** 100-50-194734  
**Policy Holder** Mr Alan Matthews

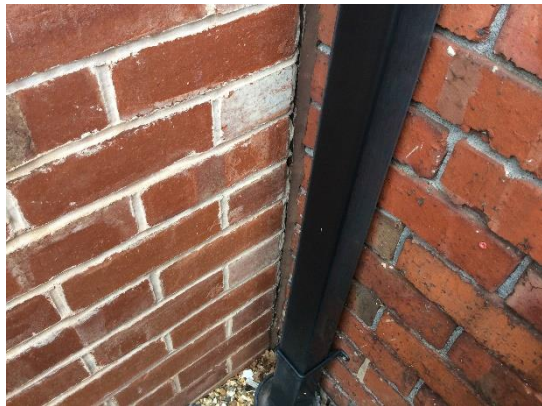
There is tapered vertical cracking at the junction of the rear extension and main house, varying in width up to approximately 5mm wide.

Picture 1: Rear extension/ house cracking

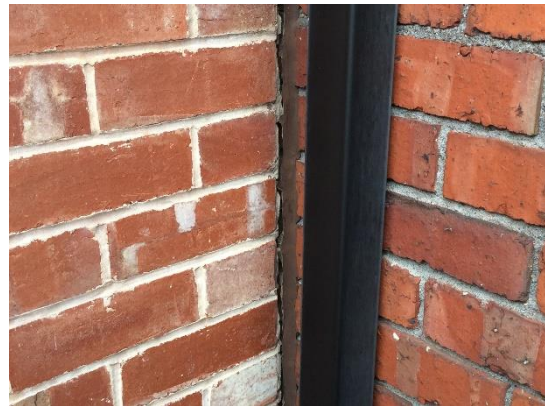
Picture 2: Rear extension/ house cracking
