Revised Arboricultural Report

Subsidence Damage Investigation at:

Hill Court
Hanger Lane
London
W5 3DF

CLIENT:	Crawford & Company
CLIENT REF:	SU1805461
MWA REF:	SUB181129-3016Rev02
MWA CONSULTANT:	George Peters BSc. (Hons)
REPORT DATE:	30/03/2020

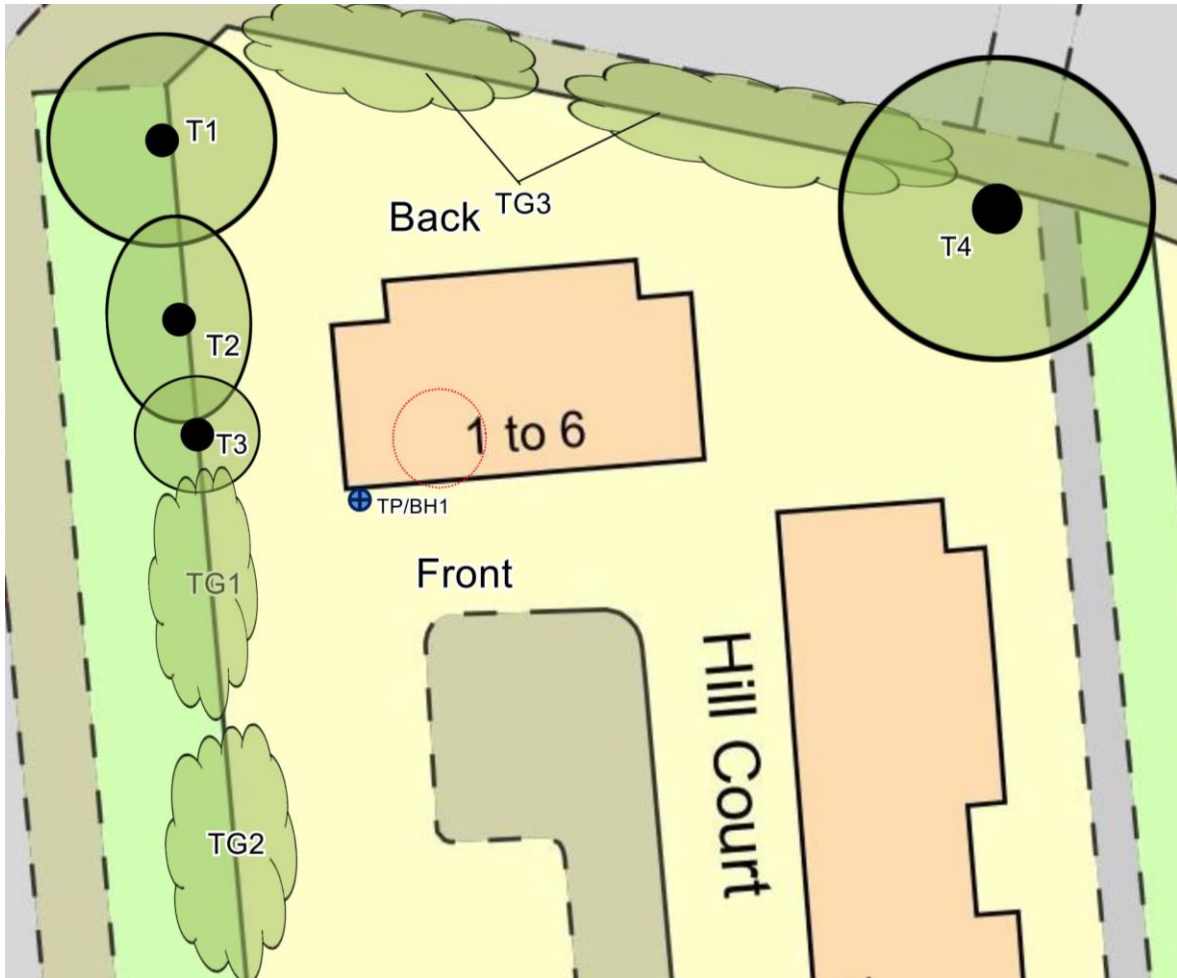
Site Plan

Approximate areas of damage

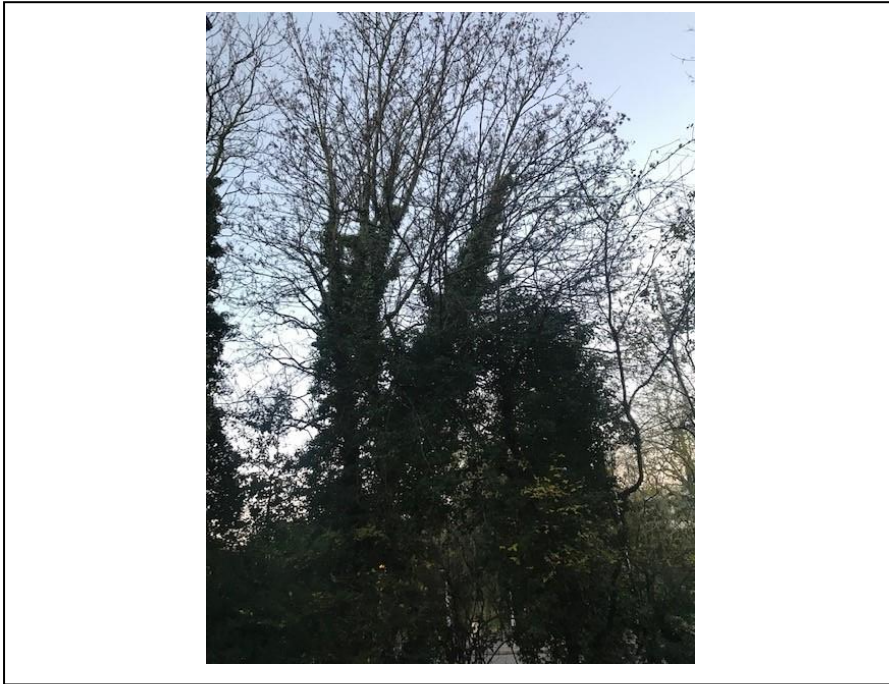
Roots were observed to a depth of 2800mm bgl in TP/BH1 and recovered samples have been positively identified (using anatomical analysis) as *Fraxinus* spp., and *Acer* spp., the origin of which will be T2 – T3 (ash) and TG1 (ash and sycamore) confirming their influence on the soils below the foundations.

Based on the technical reports currently available, engineering opinion and our own site assessment we conclude the damage is consistent with shrinkage of the clay subsoil related to moisture abstraction by vegetation. Having considered the information currently available, it is our opinion that T2, T3 and TG1 are the principal cause of or are materially contributing to the current subsidence damage.

View of T2 Ash, current claim.

If an arboricultural solution is to be implemented to mitigate the influence of the implicated trees/vegetation we recommend that T2, T3 and TG1 are removed. Other vegetation recorded presents a potential future risk to building stability and management is therefore recommended.

Tree No.	Species	Ht (m)	Dia (mm)	Crown Spread (m)	Dist. to building (m)	Age Classification	Ownership
T2	Ash	13	400	9	5	Younger than Property	Policy Holder
Management history		No recent management noted.					
Recommendation		Remove (fell) to near ground level. Owner to physically remove any regrowth (no chemical treatment due to translocation risk).					
T3	Ash	14	320	7	5	Younger than Property	Policy Holder
Management history		No recent management noted.					
Recommendation		Remove (fell) to near ground level. Owner to physically remove any regrowth (no chemical treatment due to translocation risk).					
TG1	Ash and sycamore	10	150	6	4.8	Younger than Property	Policy Holder
Management history		No recent management noted.					
Recommendation		Remove (fell) to near ground level. Owner to physically remove any regrowth (no chemical treatment due to translocation risk).

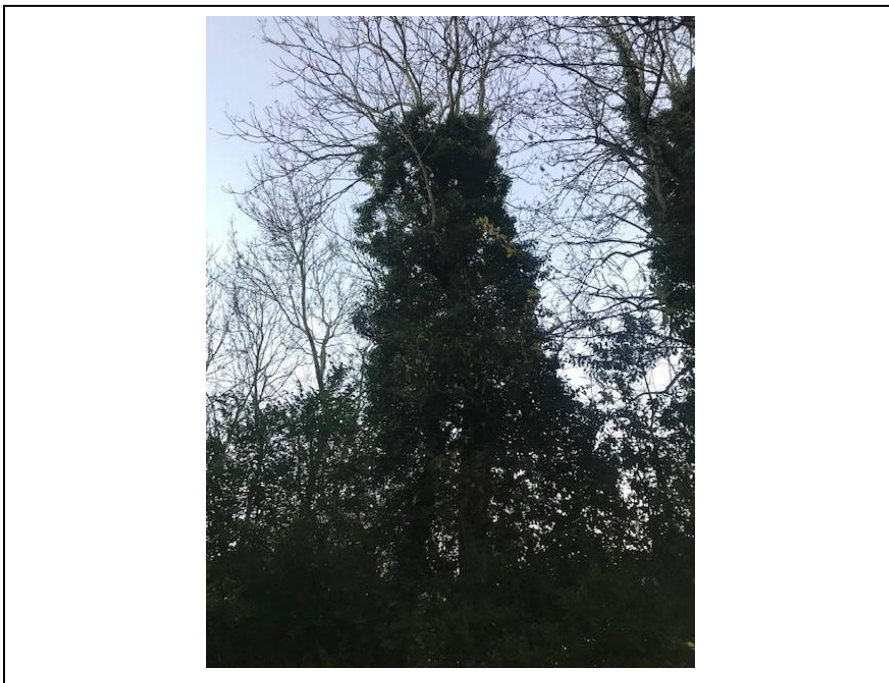
View of T3 Ash, current claim.

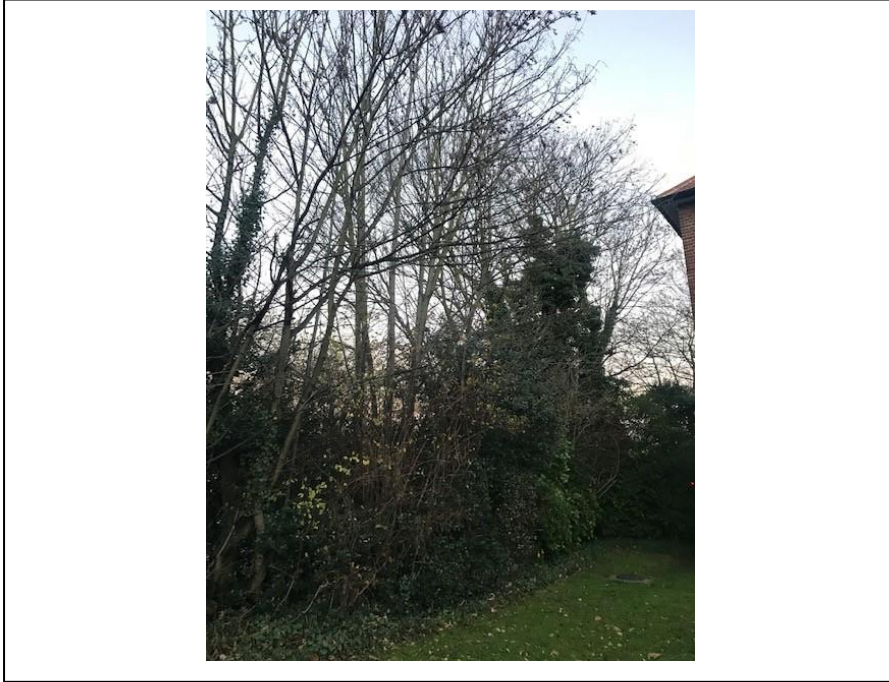
View of TG1 Ash and sycamore, current claim.

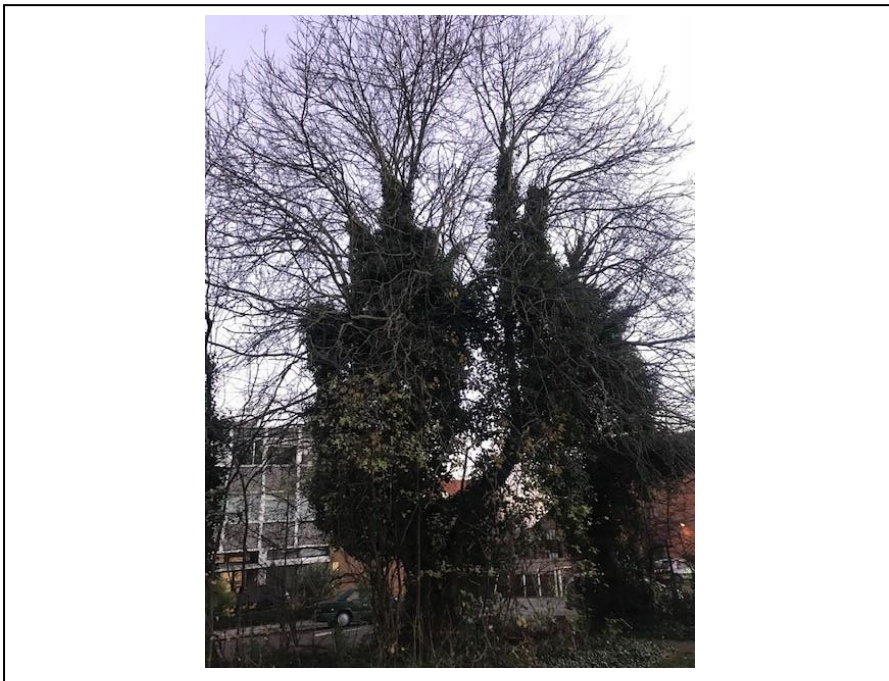
View of T4 Ash, future risk.

Tree No.	Species	Ht (m)	Dia (mm)	Crown Spread (m)	Dist. to building (m)	Age Classification	Ownership
T1	Ash	14	320	8	11	Younger than Property	Policy Holder
Management history		No recent management noted.					
Recommendation		Do not allow to exceed current dimensions.					
T4	Ash	14	400	12	12	Younger than Property	Policy Holder
Management history		No recent management noted.					
Recommendation		Do not allow to exceed current dimensions.					
TG2	Mixed species group	13	300	9	13.4	Younger than Property	Policy Holder
Management history		Species include Ash and Robinia. Subject to past management.					
Recommendation		Do not allow to exceed current dimensions.					
TG3	Ash	13	150	6	4.5	Younger than Property	Policy Holder
Management history		No recent management noted.					
Recommendation		Remove (fell) to near ground level. Owner to physically remove any regrowth (no chemical treatment due to translocation risk).
