Arboricultural Appraisal Report

Subsidence Damage Investigation at:

1 Crumpfields Lane
Redditch
Worcestershire
B97 5PN

CLIENT:	Crawford & Company
CLIENT REF:	SU1807109
MWA REF:	SUB220519-10175
MWA CONSULTANT:	David Mahon (B.Sc Hons MICFor MArborA)
REPORT DATE:	26-05-2022

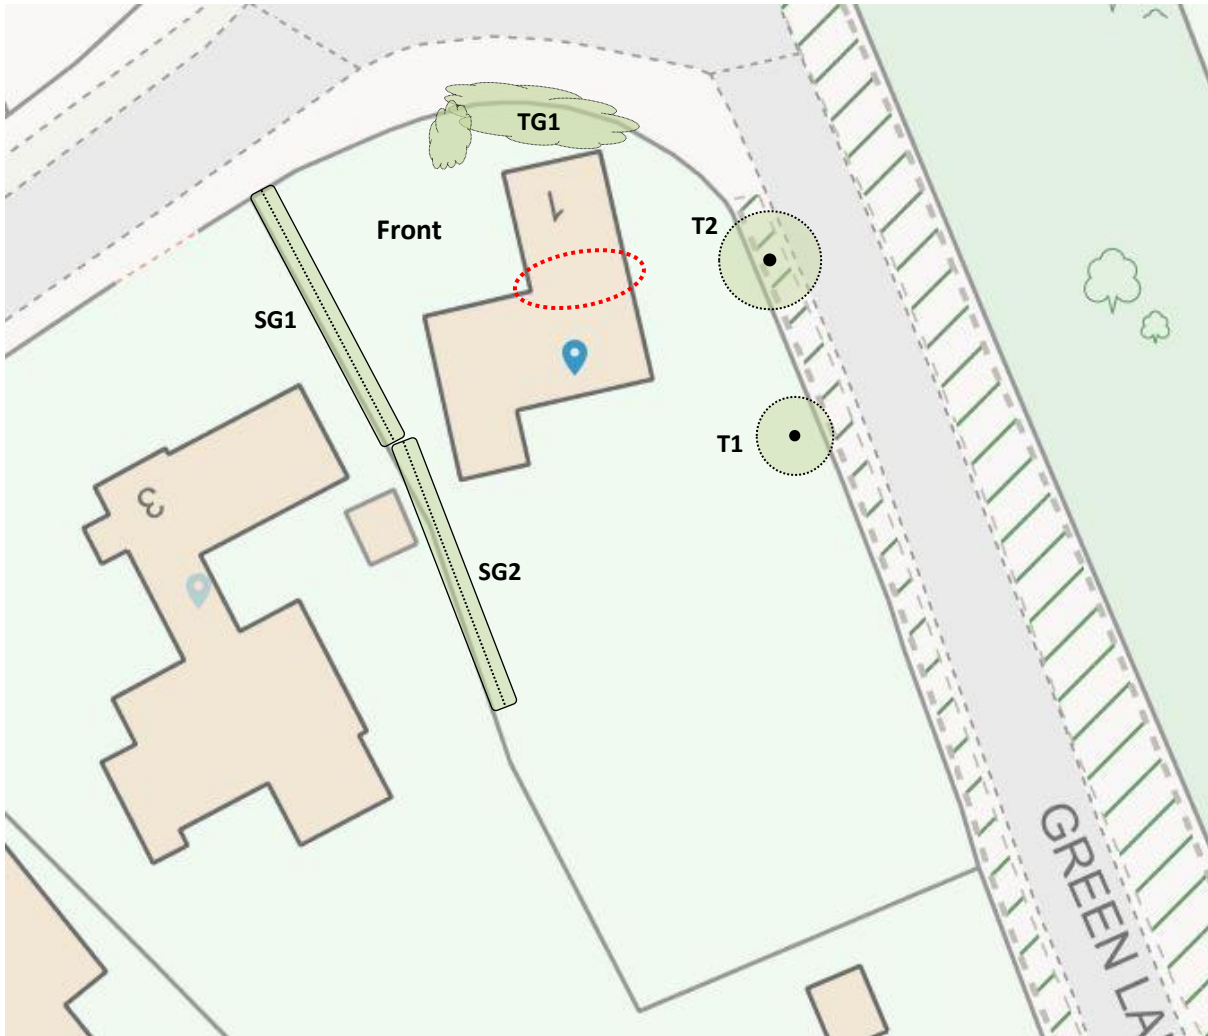
Site Plan

Approximate areas of damage

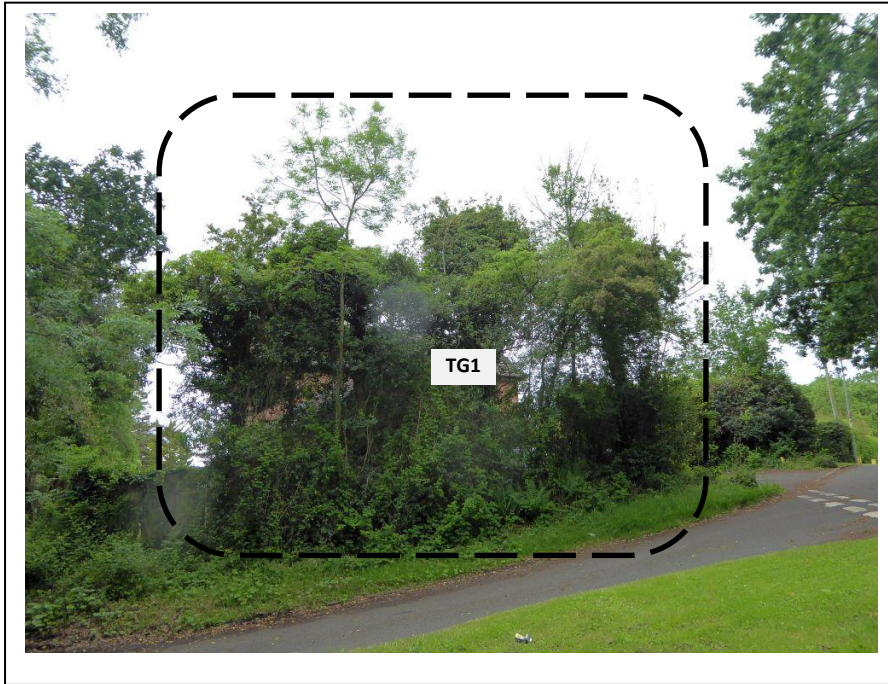
Level monitoring from 23/02/2019 to 24/08/2021 has recorded movement consistent with root induced clay shrinkage subsidence with significant amplitudes of movement along the left hand (northern) side of the garage. The cracking is consistent with the area of movement in the garage and the influence of TG1 which is within influencing distance of the garage.

Based on the technical reports currently available, engineering opinion and our own site assessment we conclude the damage is consistent with shrinkage of the clay subsoil related to moisture abstraction by vegetation. Having considered the information currently available, it is our opinion that TG1 is the principal cause of or is materially contributing to the movement and damage.

View of TG1 from road to front.

If an arboricultural solution is to be implemented to mitigate the influence of the implicated trees/vegetation we recommend that TG1 is removed.

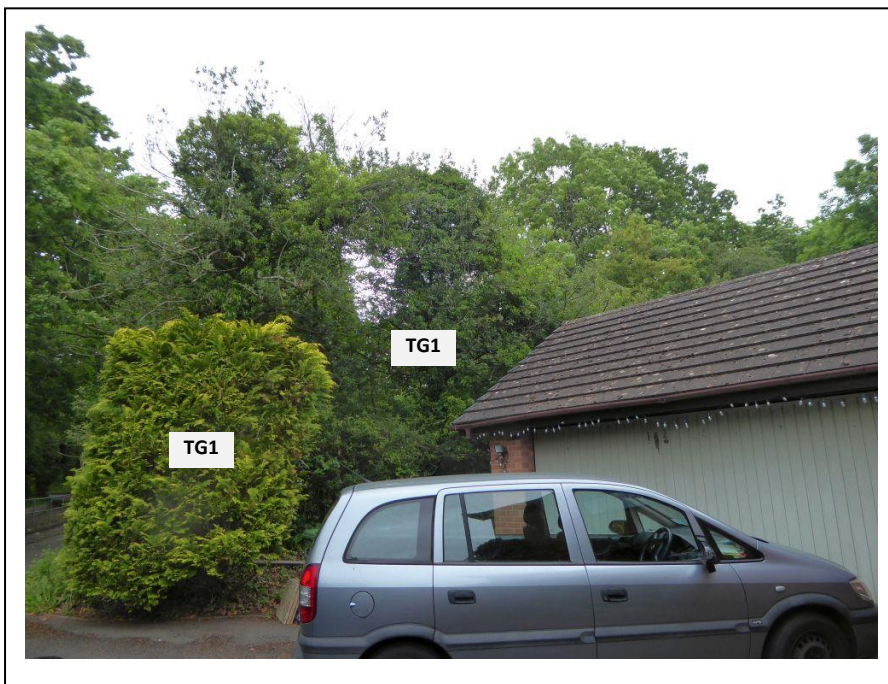
View of TG1

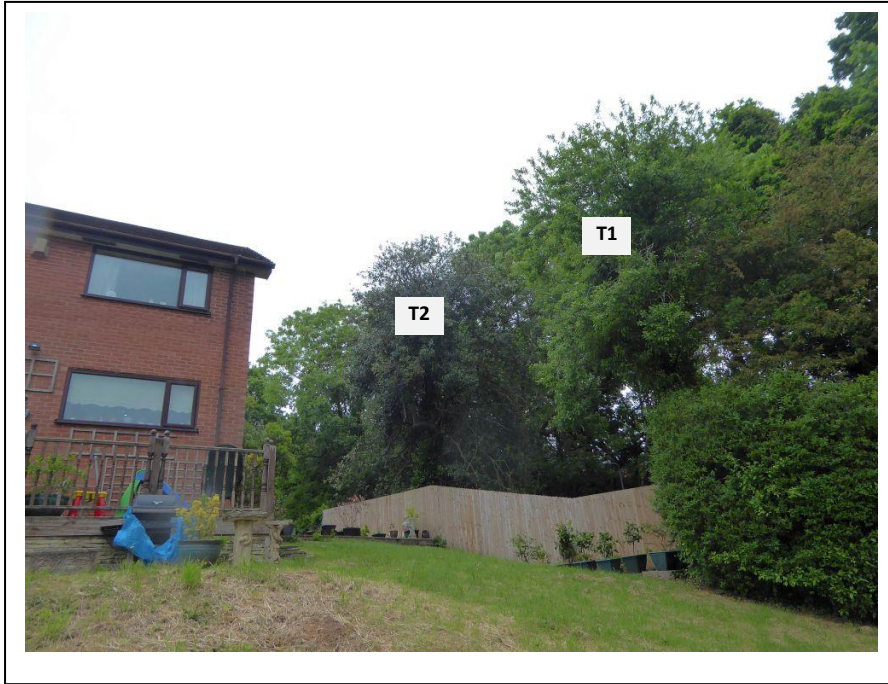
Other vegetation recorded presents a potential future risk to building stability.

View of T1 & T2 from rear garden

Recommendation		Maintain broadly at no more than current dimensions by periodic pruning.
