Current Structural Condition Report

Out - Building at Bec
House, Monxton,
Hampshire.

Project no.	877
Project title	Out - Building at Bec House, Monxton, Hampshire
Client	Mr and Mrs Brown
Document title	Current Structural Condition Report

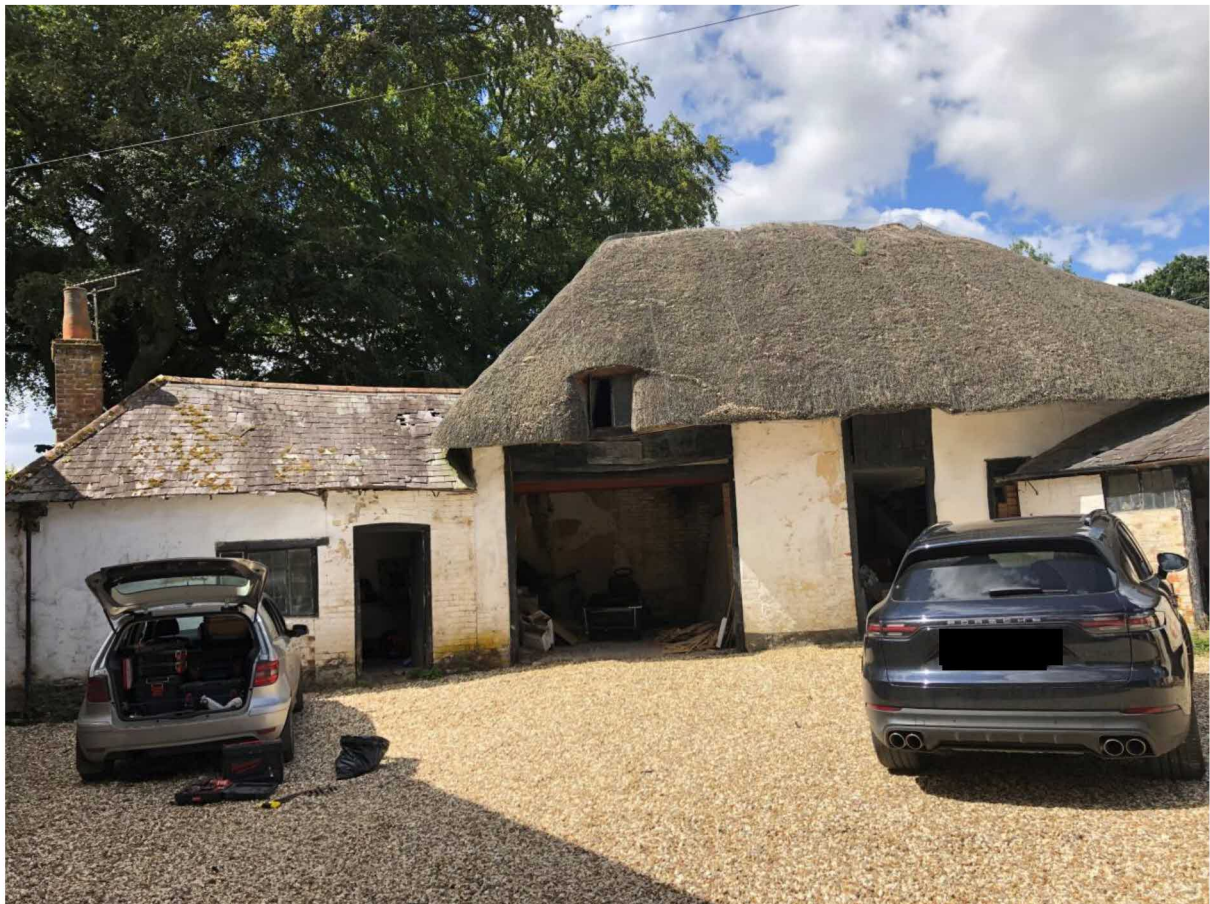
General View of Building Range - Front Elevation

Bothy to left, Former Coach House and Stable to the right

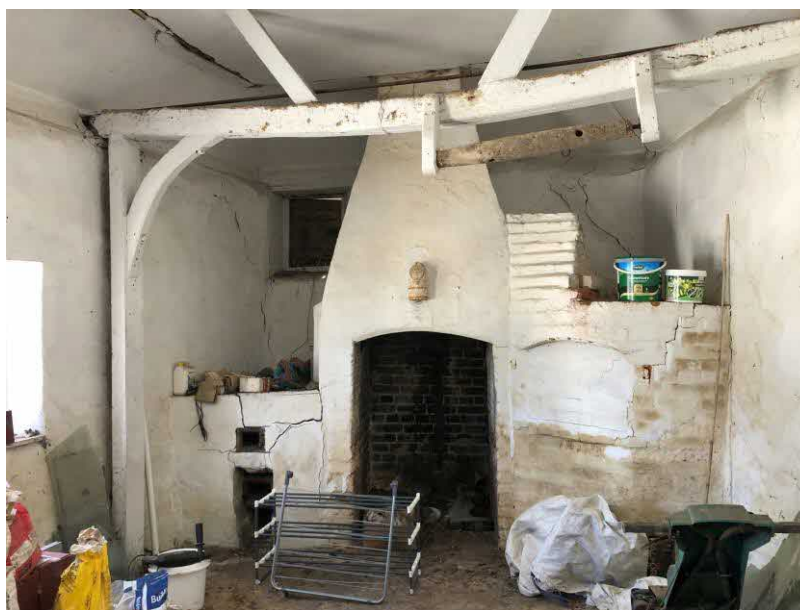
The cross frame within the room shows signs of sagging, probably due to gradual timber decay, and hence dropping of the roof purlins.

The drop of the purlins and gradual removal of support has introduced roof spread and outward thrusts on the cob walls.

It appears that a tie rod has been installed at some time in the past, above the cross frame to attempt to resist the roof spread.

The roof is in very poor condition, showing signs of slate slippage, roof spread and sagging and severe cracking in the lathe and plaster ceiling internally.

The cracking in the ceiling was noted in my recent visit as being worse than in my visit in August 2023 and a further patch of plaster on the drive-way side wall had fallen.

View of Bothy End Wall, Ovens and Cross Frame

The roof and supporting cross frame, will need stabilisation, repair, re-slating and hip tile re-instatement and new guttering.

The roof above the Bothy will require localised strengthening to the timber cross frame, such that the existing rafters and purlins are properly supported, and no further roof spread takes place.

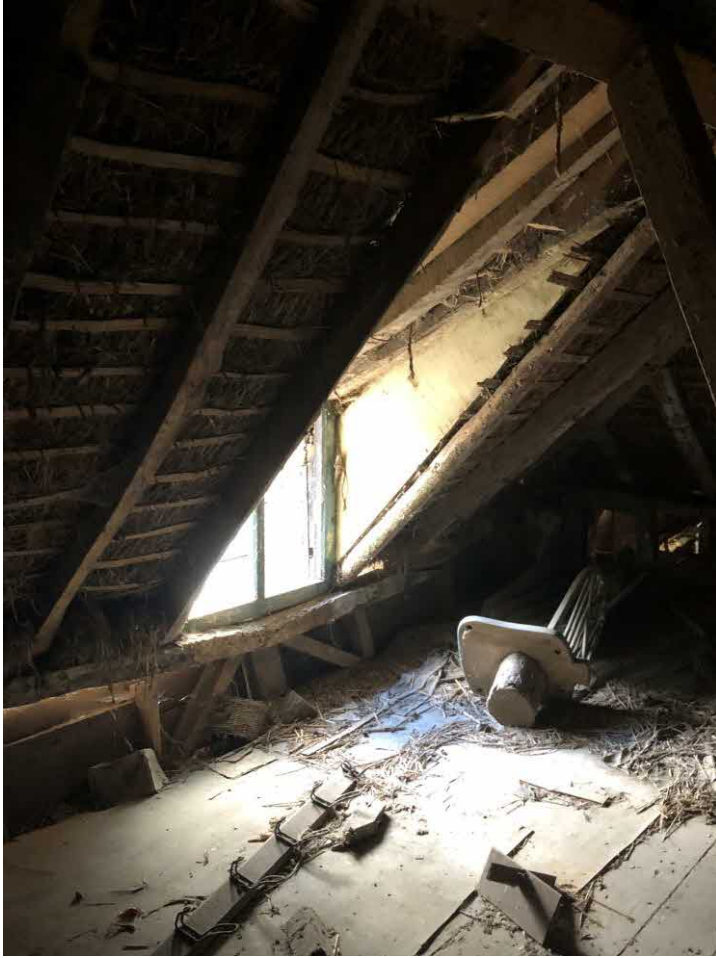
View of Internal Roof Structure Looking at Dormer Window

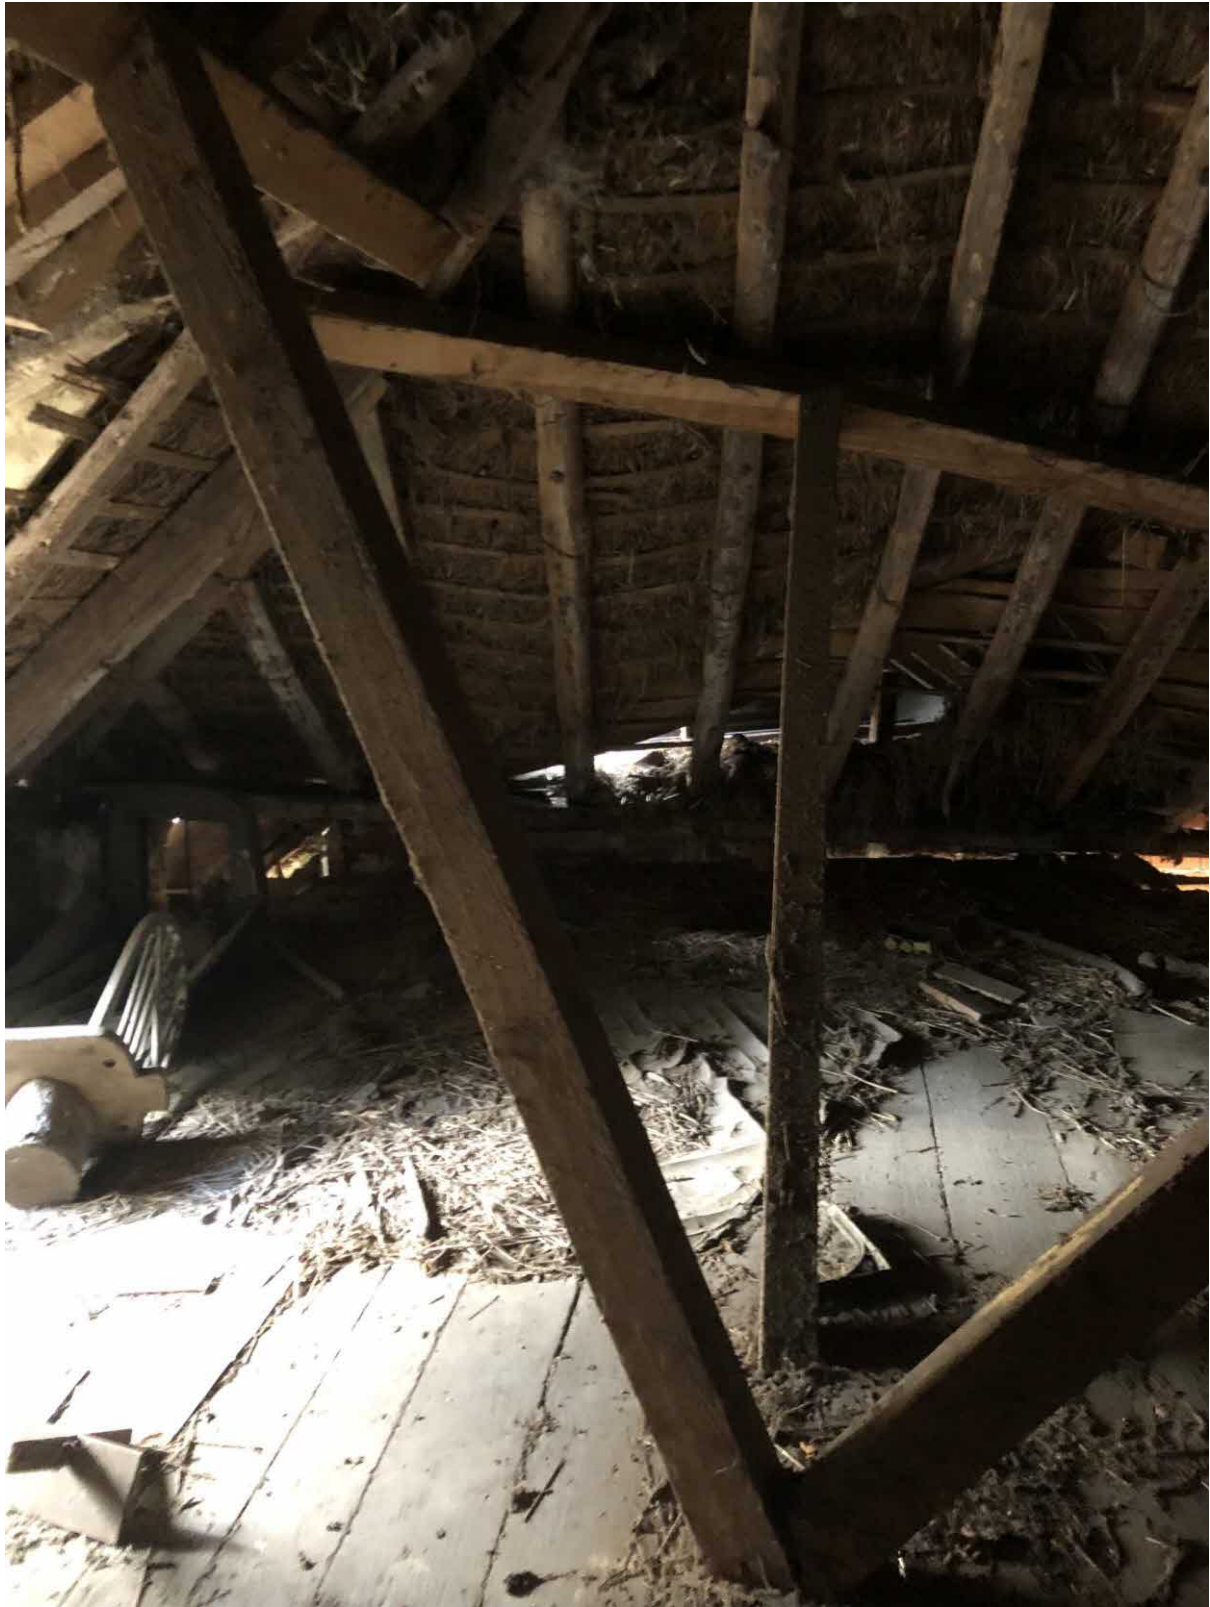
It appears that the roof to this building was originally built without the purlins and struts, which are later additions to the structure, and were probably inserted to try and arrest the evident sagging roof.

The later purlins and strutting have been introduced, as an attempt to strengthen the roof, these are supported on the ceiling structure of beams at the front entrance door, middle and rear.

These have also failed due to the increased load being applied and gradual timber decay and are sagging quite significantly.

View of Coach House Roof Structure Looking Towards Bothy – note later purlins and strutting

This will necessitate a strengthened roof structure of rafters, purlins and frames to span between the walls and laterally restrain them. This will also involve support to a new first floor.

The existing original roof structure rafters can be retained and augmented with additional structure to tie the roof structure in and stabilise it.

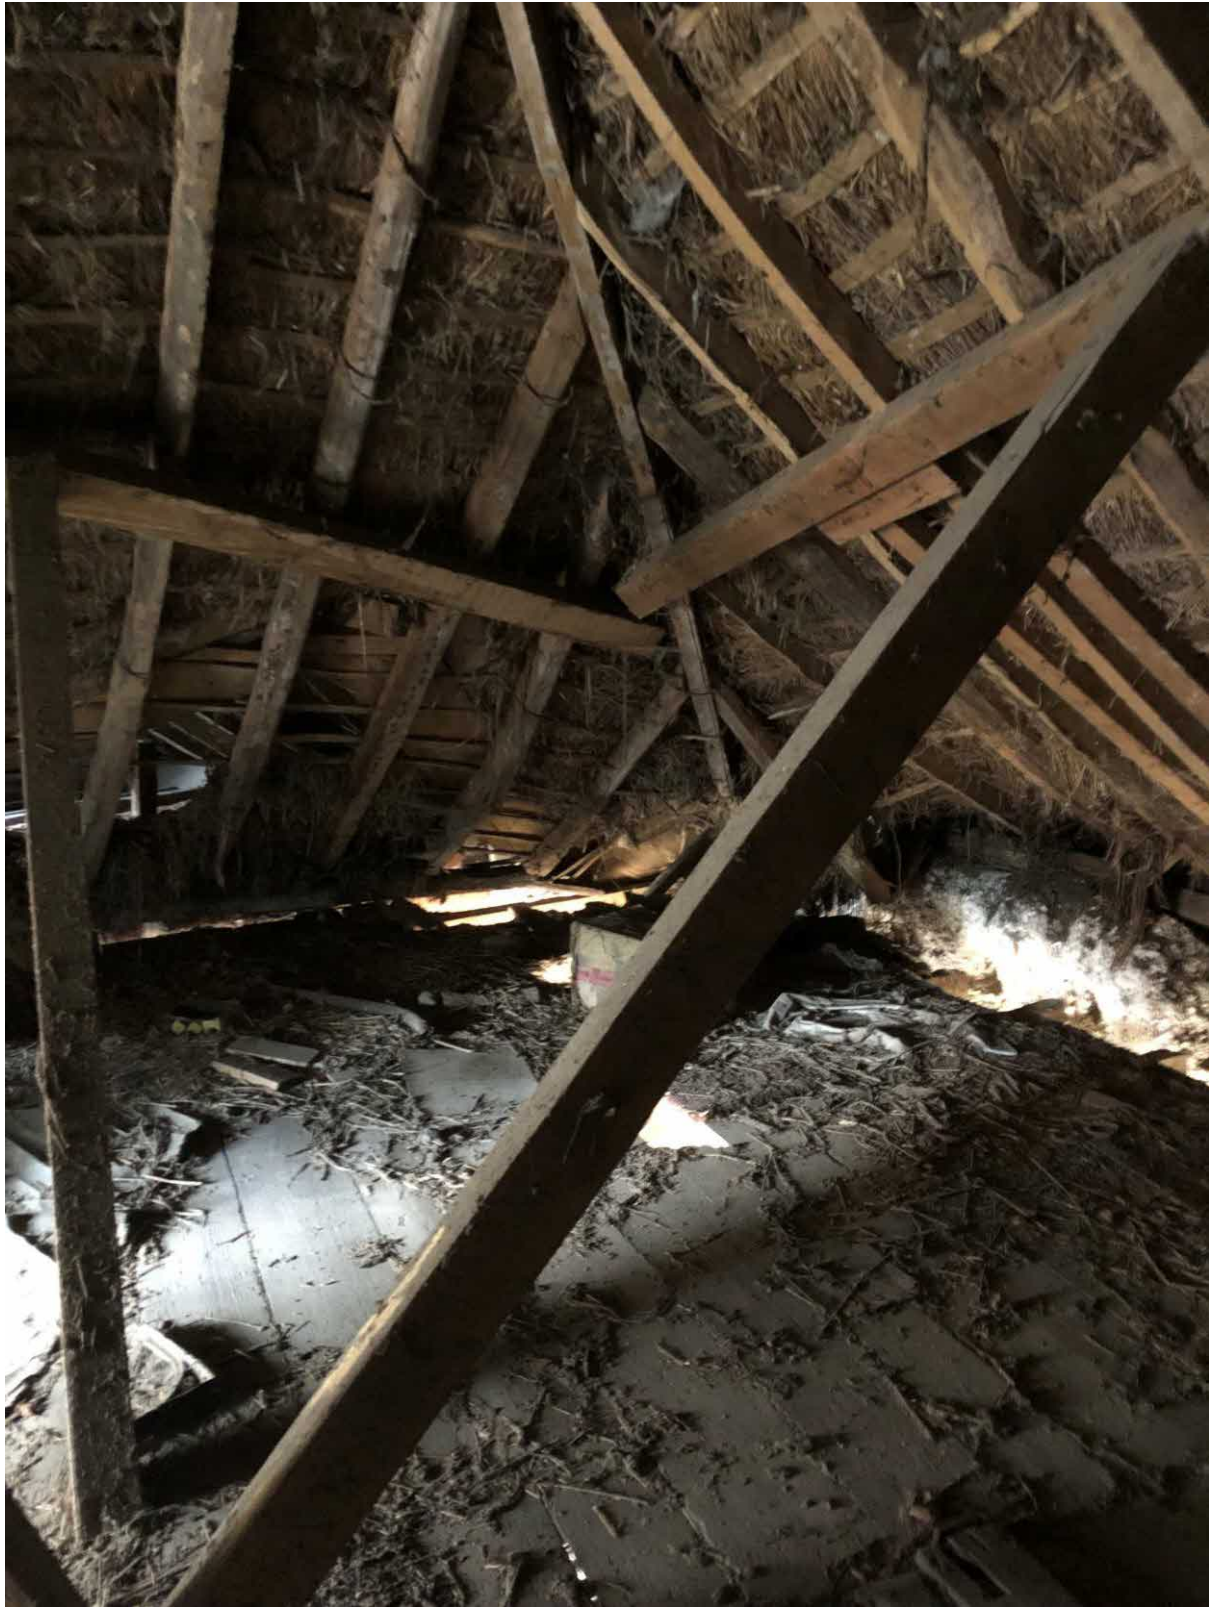
However, this roof, not being well structured (because of the lack of a horizontal ceiling tie) has resulted in roof spread of quite significant degree – estimated at 150mm in places.

Accordingly the roof is pushing the cob walls outwards at eaves level, causing an outward lean on all walls and cracking.

View of Coach House Roof Structure Looking Towards Bothy and Rear Elevation – note roof spread at eaves

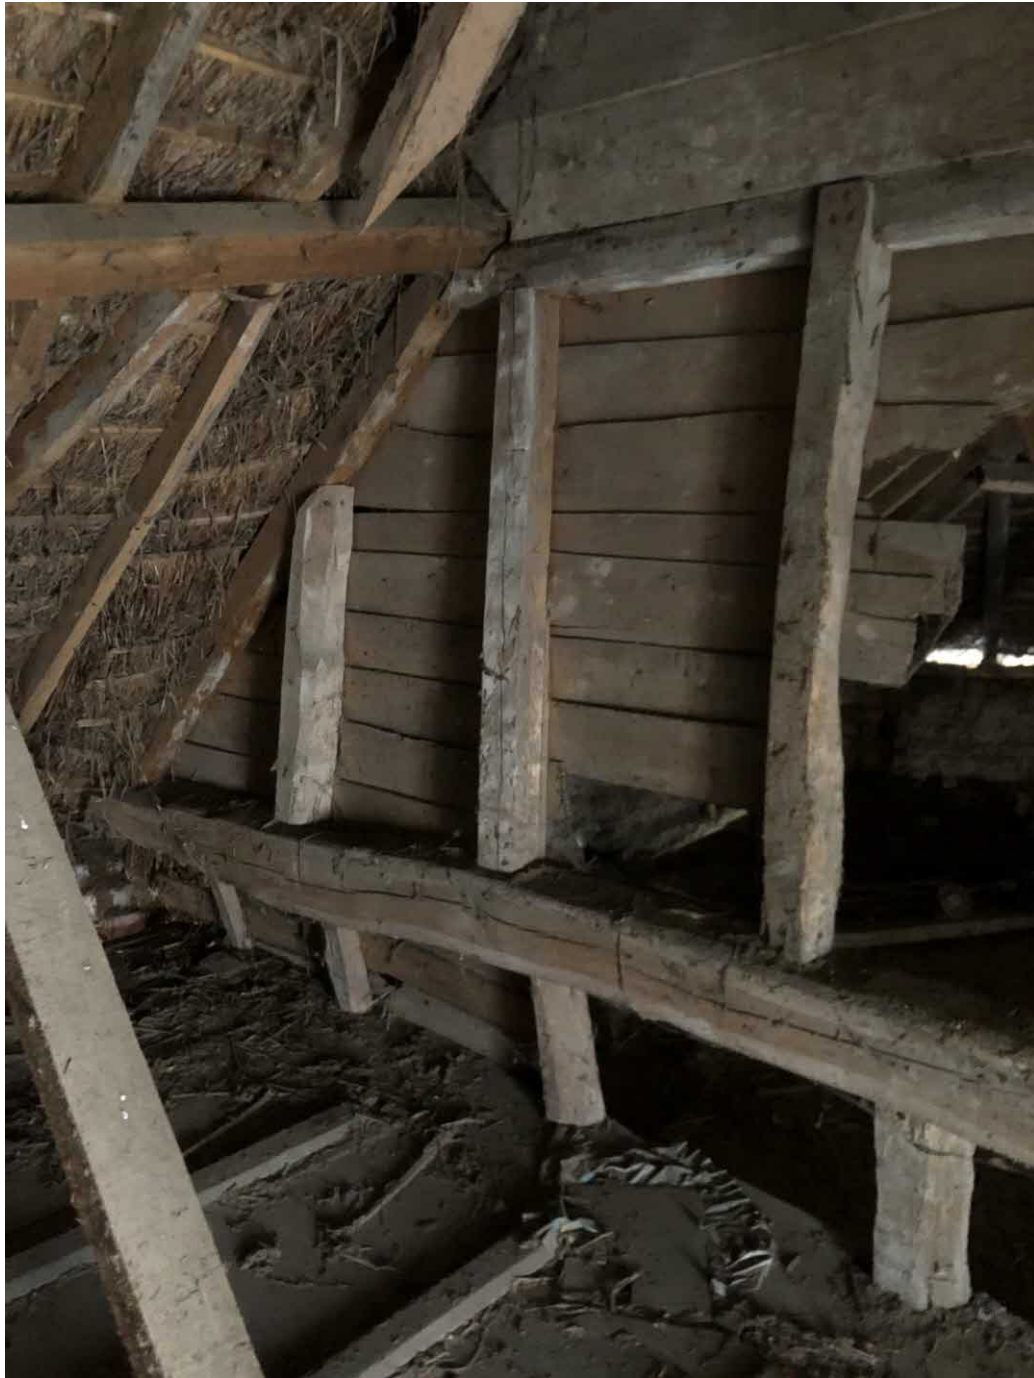
It would appear that the timber framed wall between the stables and the coach house was once external, being lapped boarded and extending up into the roof space above to the ridge.

Note Boarding on Former Gable Wall Between Coach House and Stable

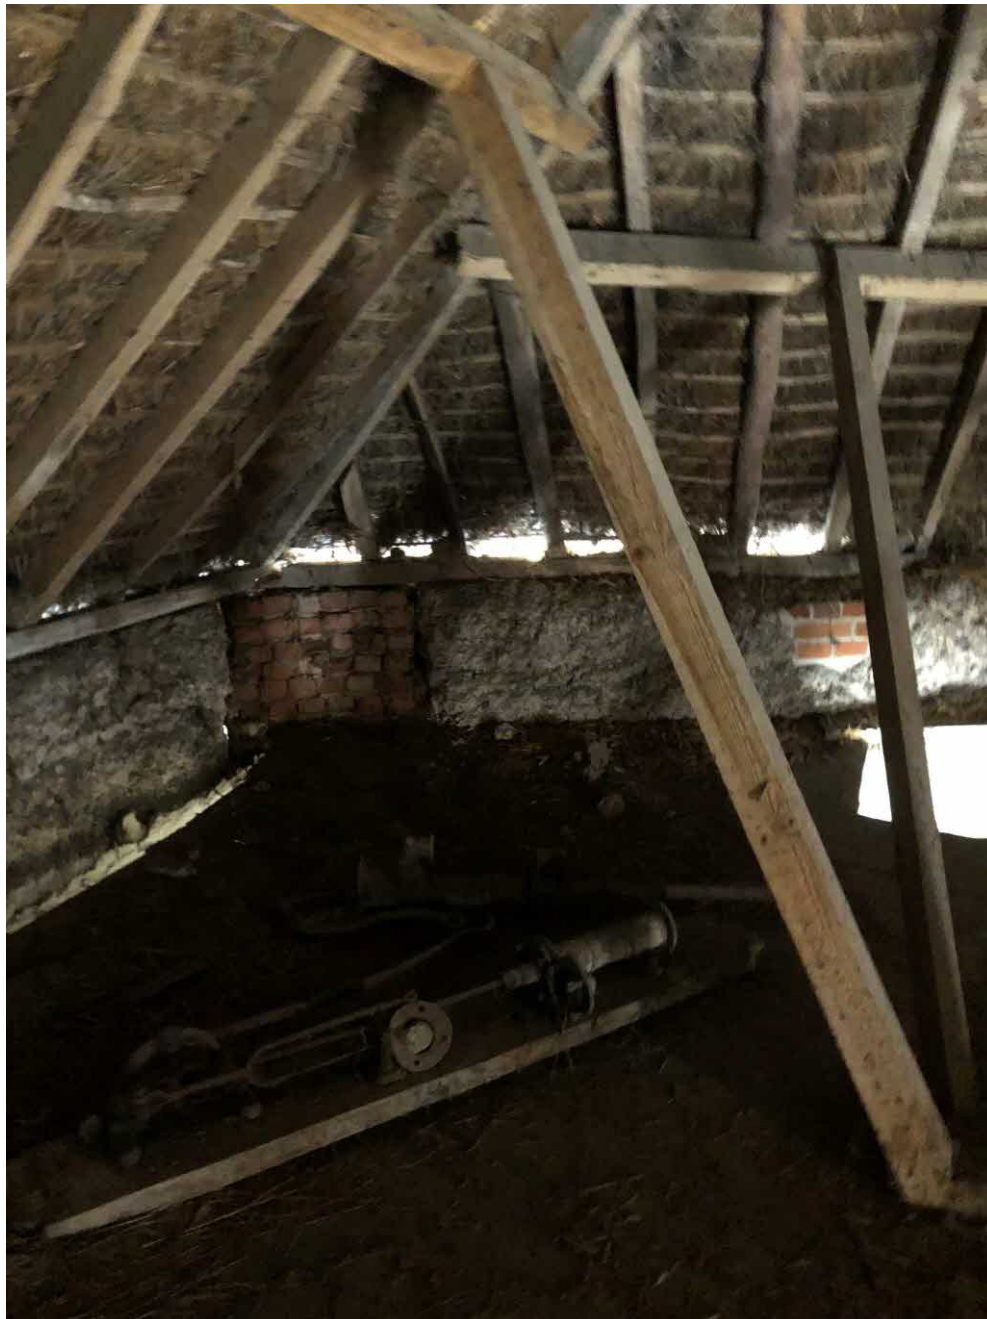
Similarly to the rest of the coach house roof, the ceiling, of timber joists fails to connect or tie the roof in, and considerable roof spread has occurred.

A later ad-hoc system of purlins and struts has again been introduced, all loaded on the central post in the stables below,

Later Strutting and Purlins in the Stable Area of The Coach House Roof – note Outward Leaning Walls

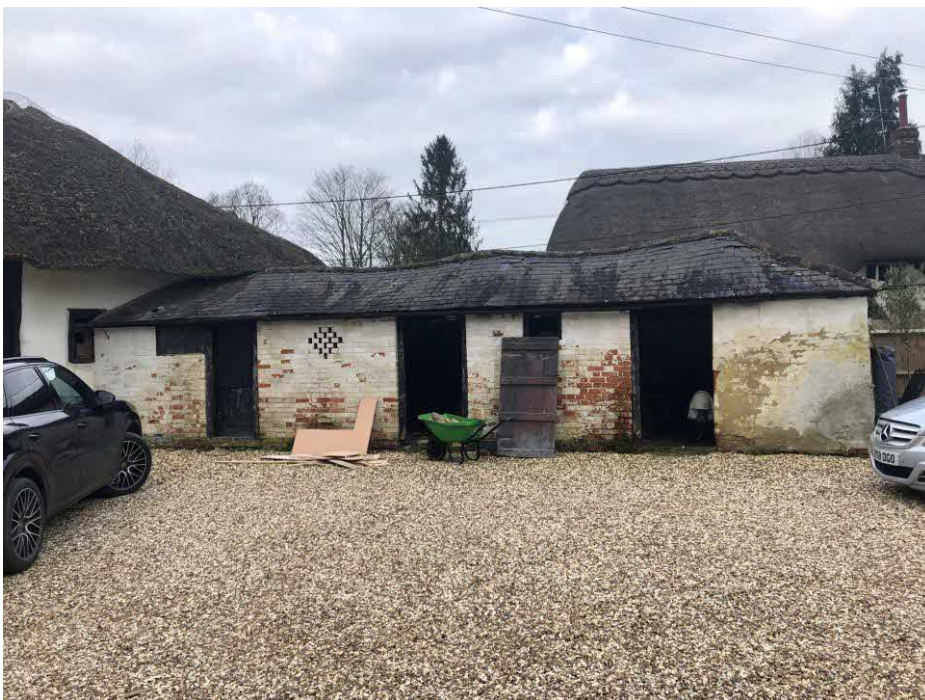
Examination of the structure reveals that the roof structure has spread and has significantly dropped, the ridge board and rafters have detached from each other in places demonstrating roof structure failure and forcing the slate covering to open up permitting rainwater to penetrate the building.

The slate roof covering is so badly undulating that it is now beyond patch repair, as slate needs a relatively flat surface on which to be successfully laid and new battens could not take up the form of the curved roof.

View of Stables Yard Side Elevation – Note Failed Roof.

The adjacent Stable block roof will require repair to ensure that the structure is stable and the roadside wall made safe.

The roof requires new rafters to be paired alongside the existing re-aligned rafters and new timber ties to be introduced. This would allow the roof slate covering to be repaired and a gutter introduced to take rainwater away from foundations.

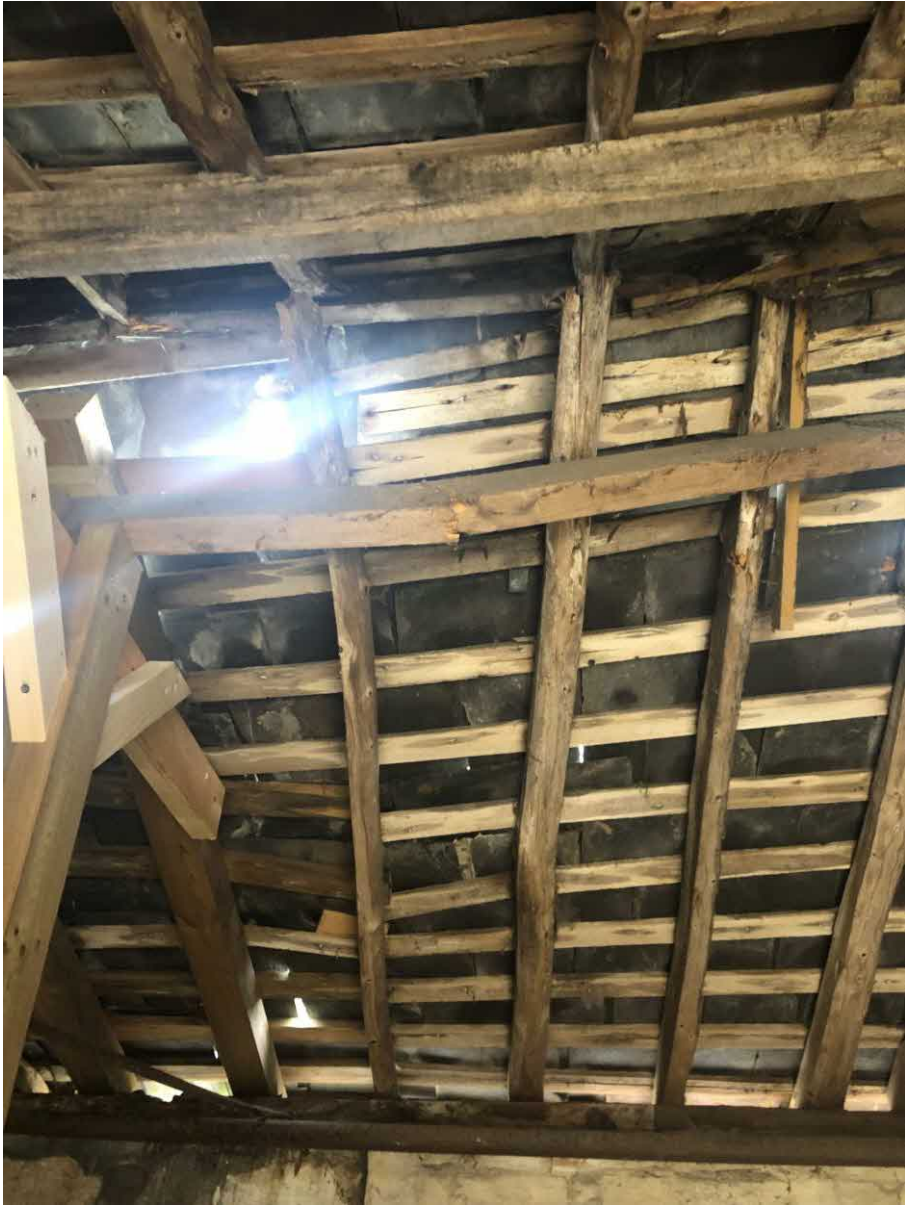
The roof structure is of small quarter timber and half round pole rafters, which have been badly attacked by worm, with a ridge board and later inserted sawn timber purlins near the ridge.

The purlins have badly deflected and are in indeed broken in one location.

Stables Roof – Note Broken Purlin and Detached Rafter From Ridge

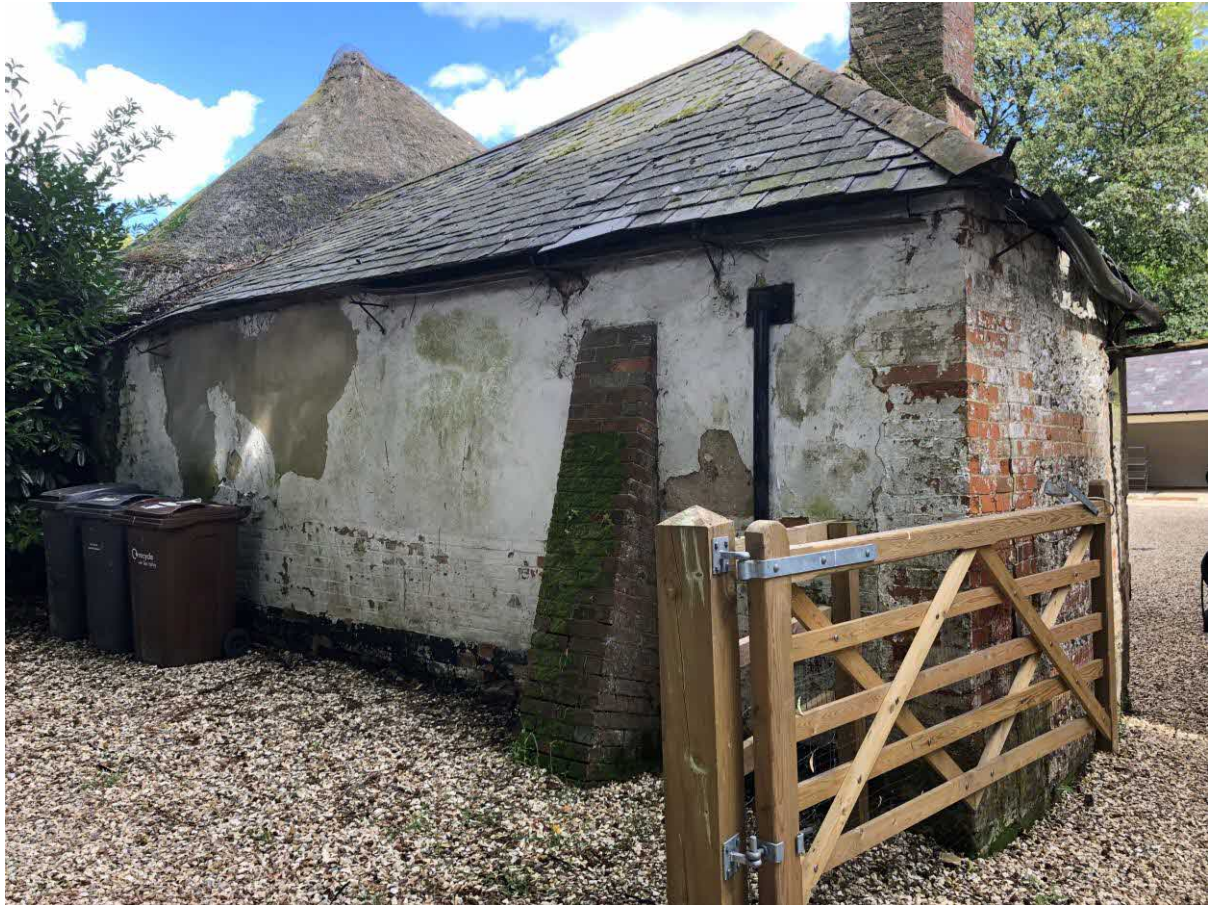
There is significant cracking throughout in the walls, predominantly around the solid, heavy brick hearth, where outwards movement in the weaker walls, which have been pushed out by the roof, has resulting in cracking.

The rear wall has been buttressed in the past at the location of the timber cross frame in an attempt to resist the apparent roof thrusts.

This has not been effective and further movement has occurred.

External General View of Bothy Rear Wall – Note Historic Buttress and dark rendered Brick Patch

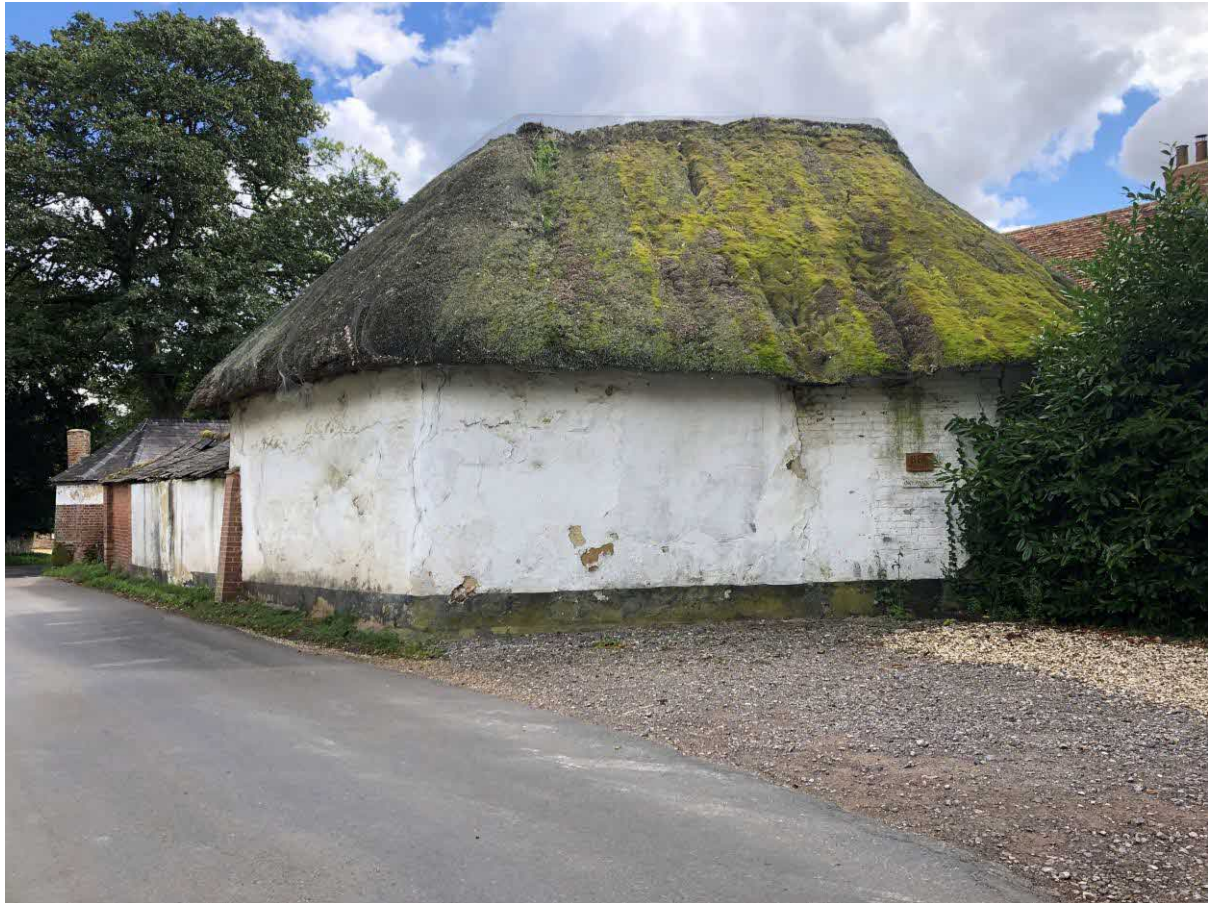
The rear driveway side wall is of cob, and due to historic outward thrusts and cracking, the wall has a significant patch of brick.

This has continued to move since this patch repair.

External General View of Coach House Stable Rear Wall – Note Small Roadside Buttress and Coach House Brick Patch to the right

The walls to this building need a comprehensive structural eaves beam/plate to tie them in and a new roof structure which has no resulting outwards thrusting.

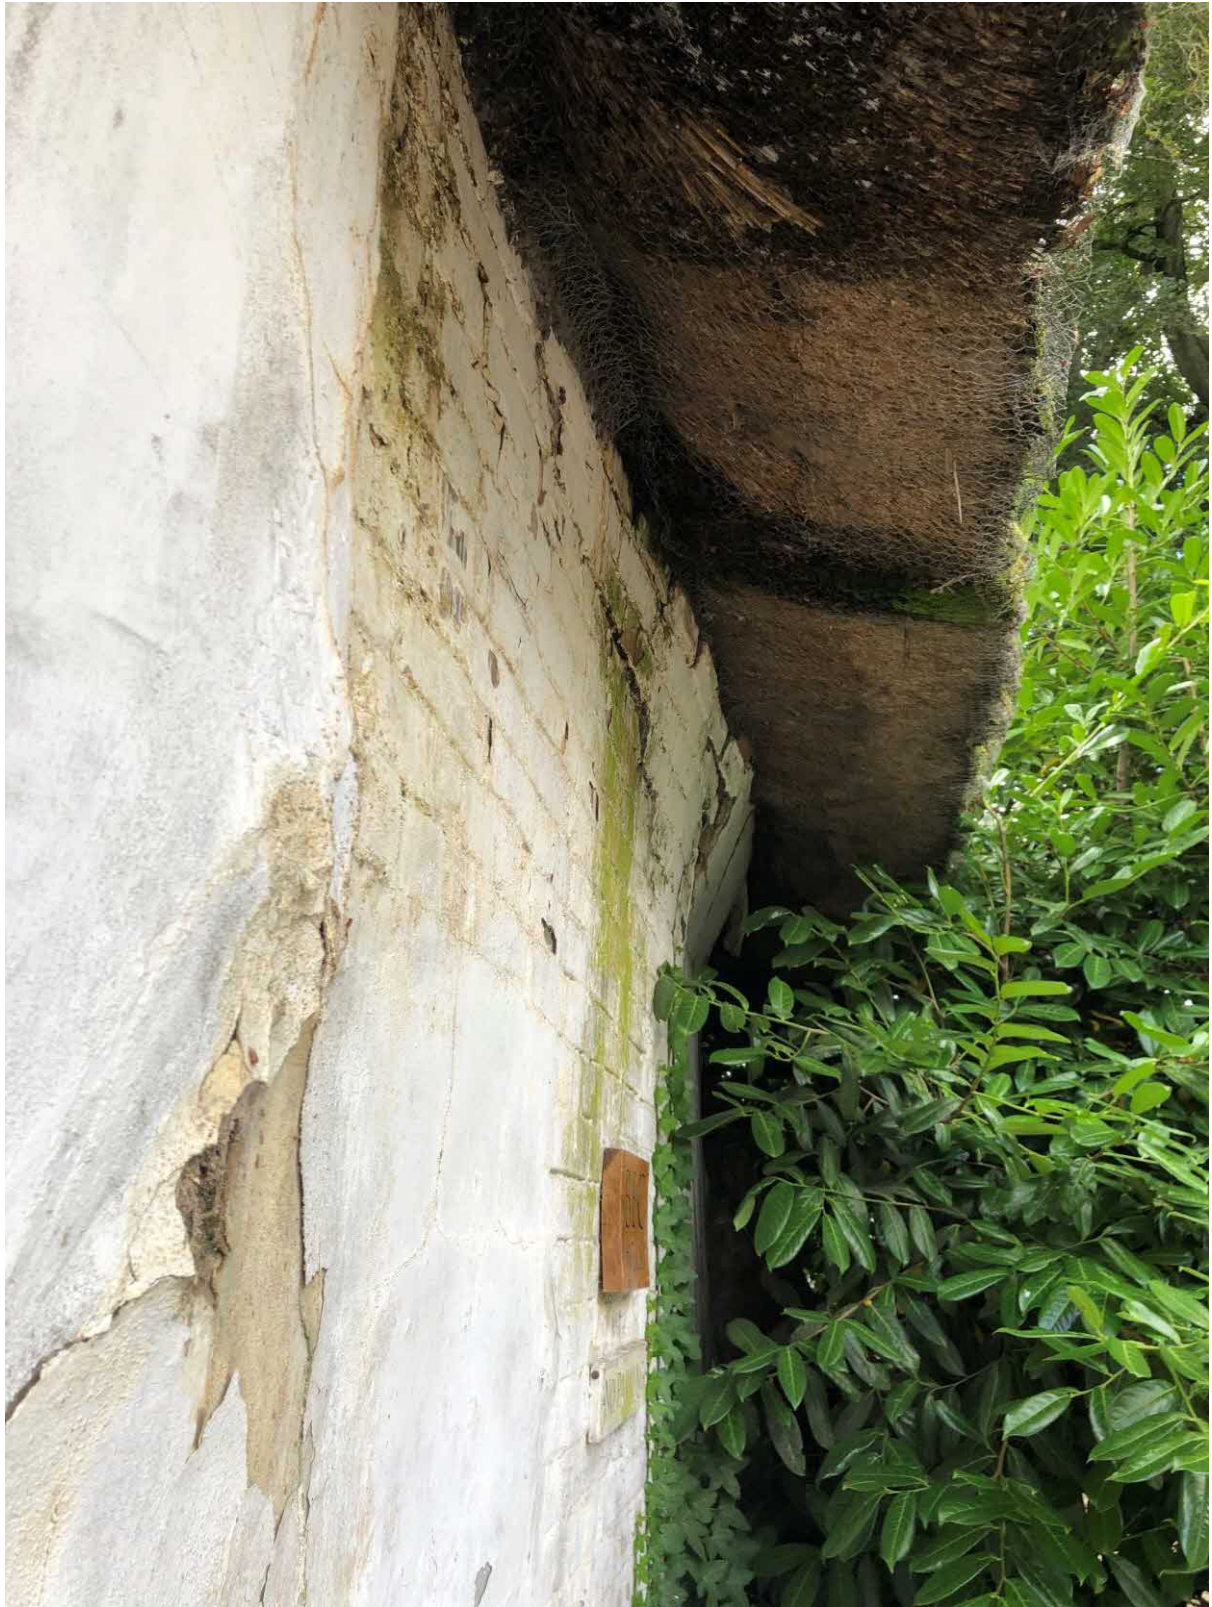
All of the walls are significantly leaning outwards to various degrees or another, where historic roof movements have taken place.

Outward thrusts from the roof have been the cause of the leaning, where none of the ceiling is tied in.

Note Outward Lean of Coach House Rear Wall Brick Patch – Very Unstable

Only when this is introduced will the walls stand any chance of achieving proper stability.

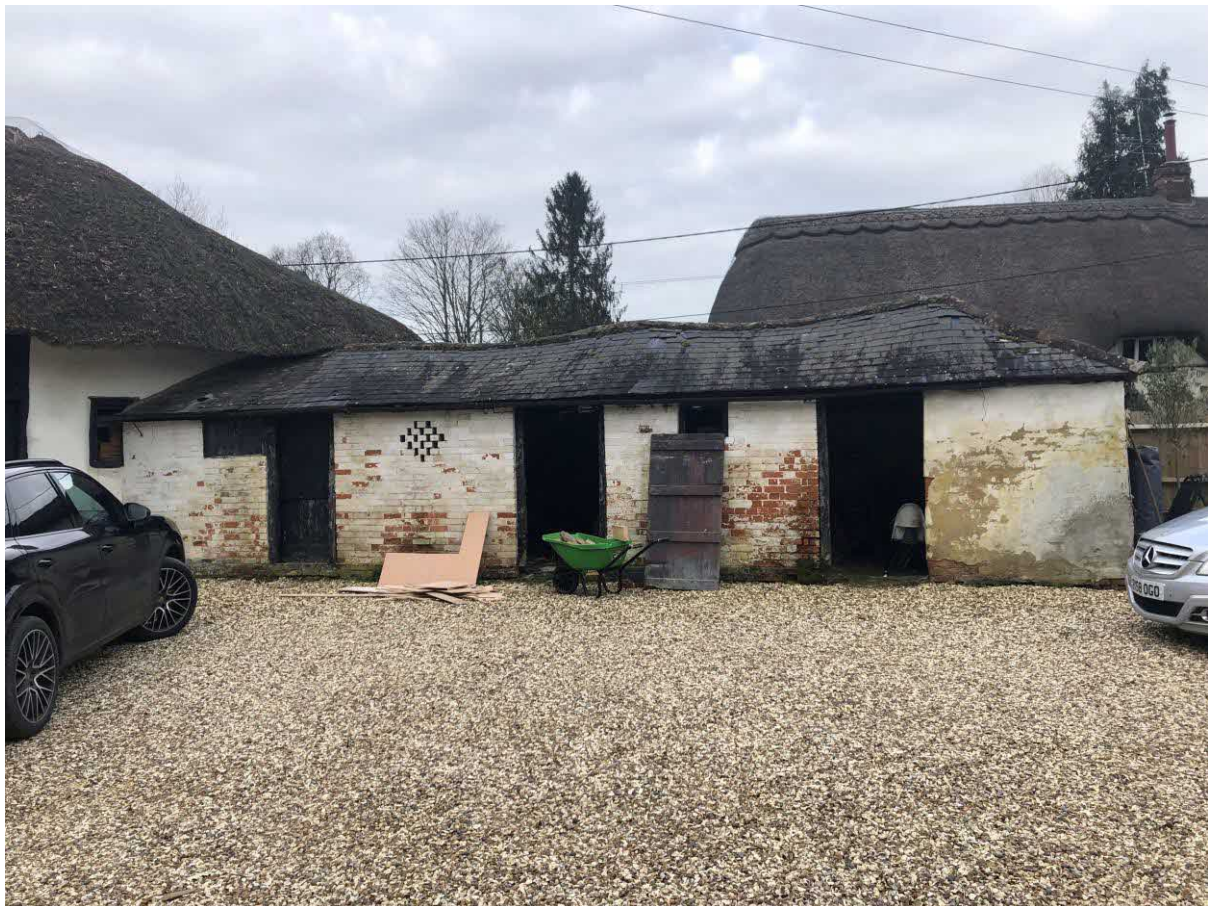
This failure to restrain the roadside walls by tying in has resulted in outward movement of the wall, caused initially by forces from the spread of the roof outwards and exacerbated by excessive water flow off the roof falling at the foot of the walls softening the ground.

I would go as far to say that given its proximity to the adjacent road, this section of the building is becoming of concern to me with regard to road safety.

General View of Road Side Stable Building – Note Collapsing Roof Structure

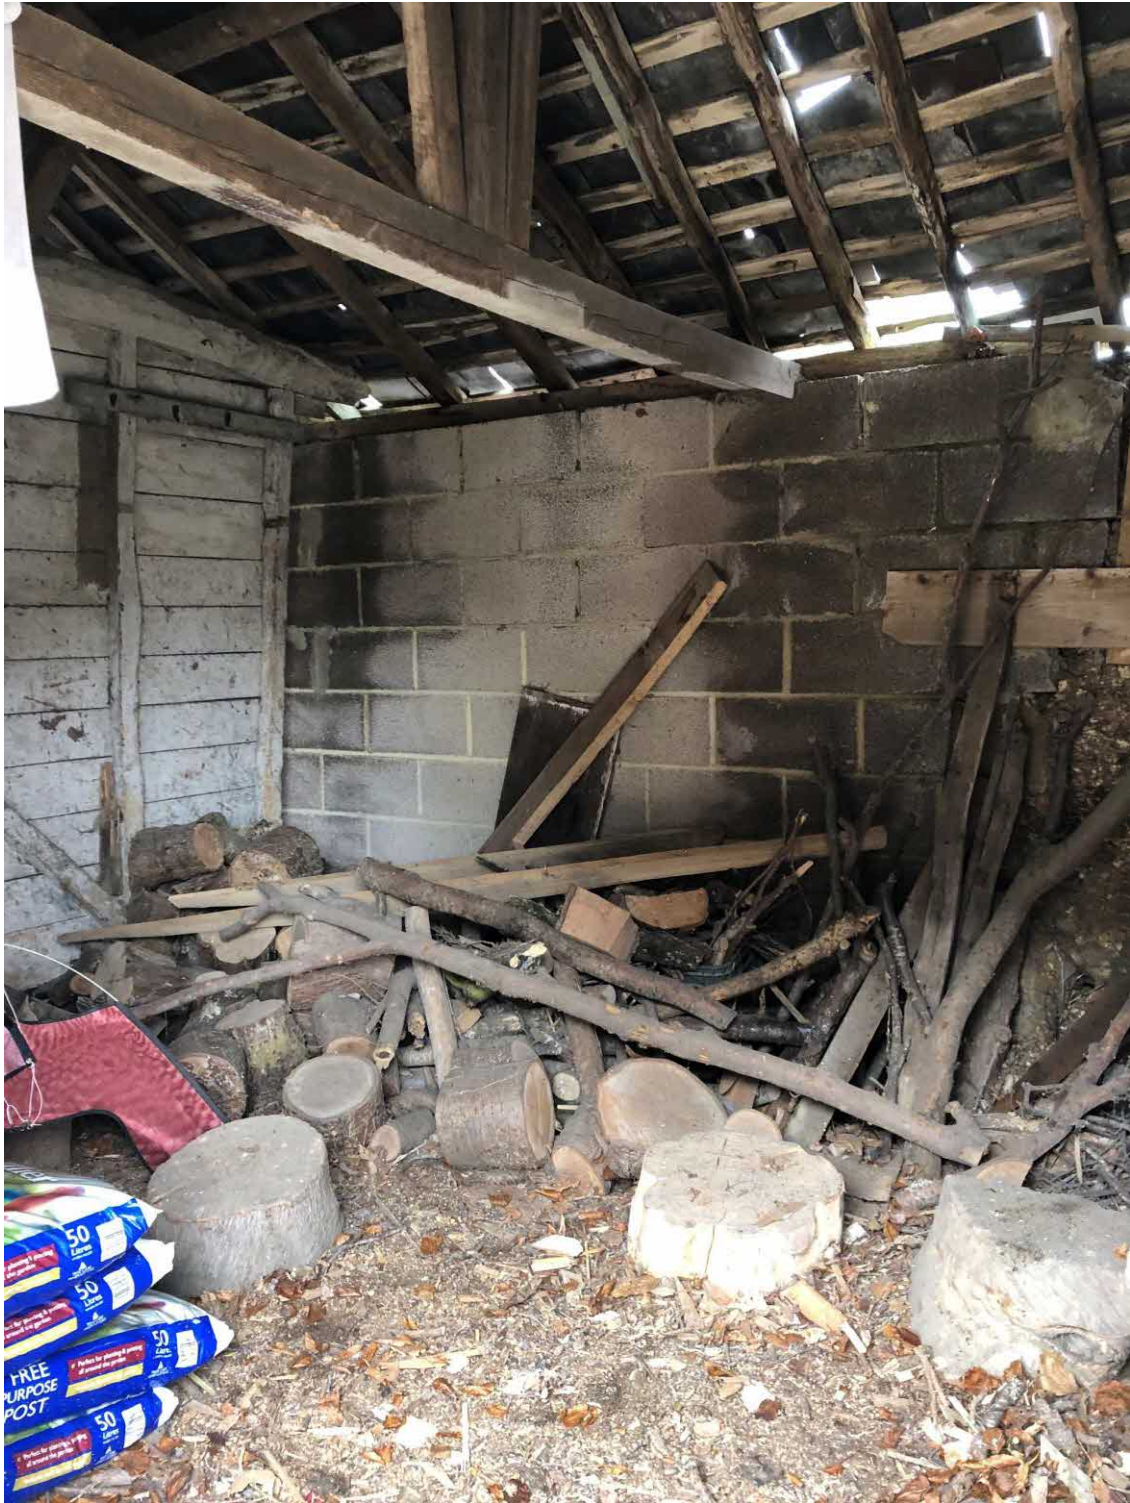
The rear wall adjacent to the road is currently a mixture of modern concrete block, original cob and brick where the original cob has been patched over the years and rendered externally.

Stables Road Side Wall – Note Modern Concrete Block Replaced Section (Where Original Cob Has Collapsed)

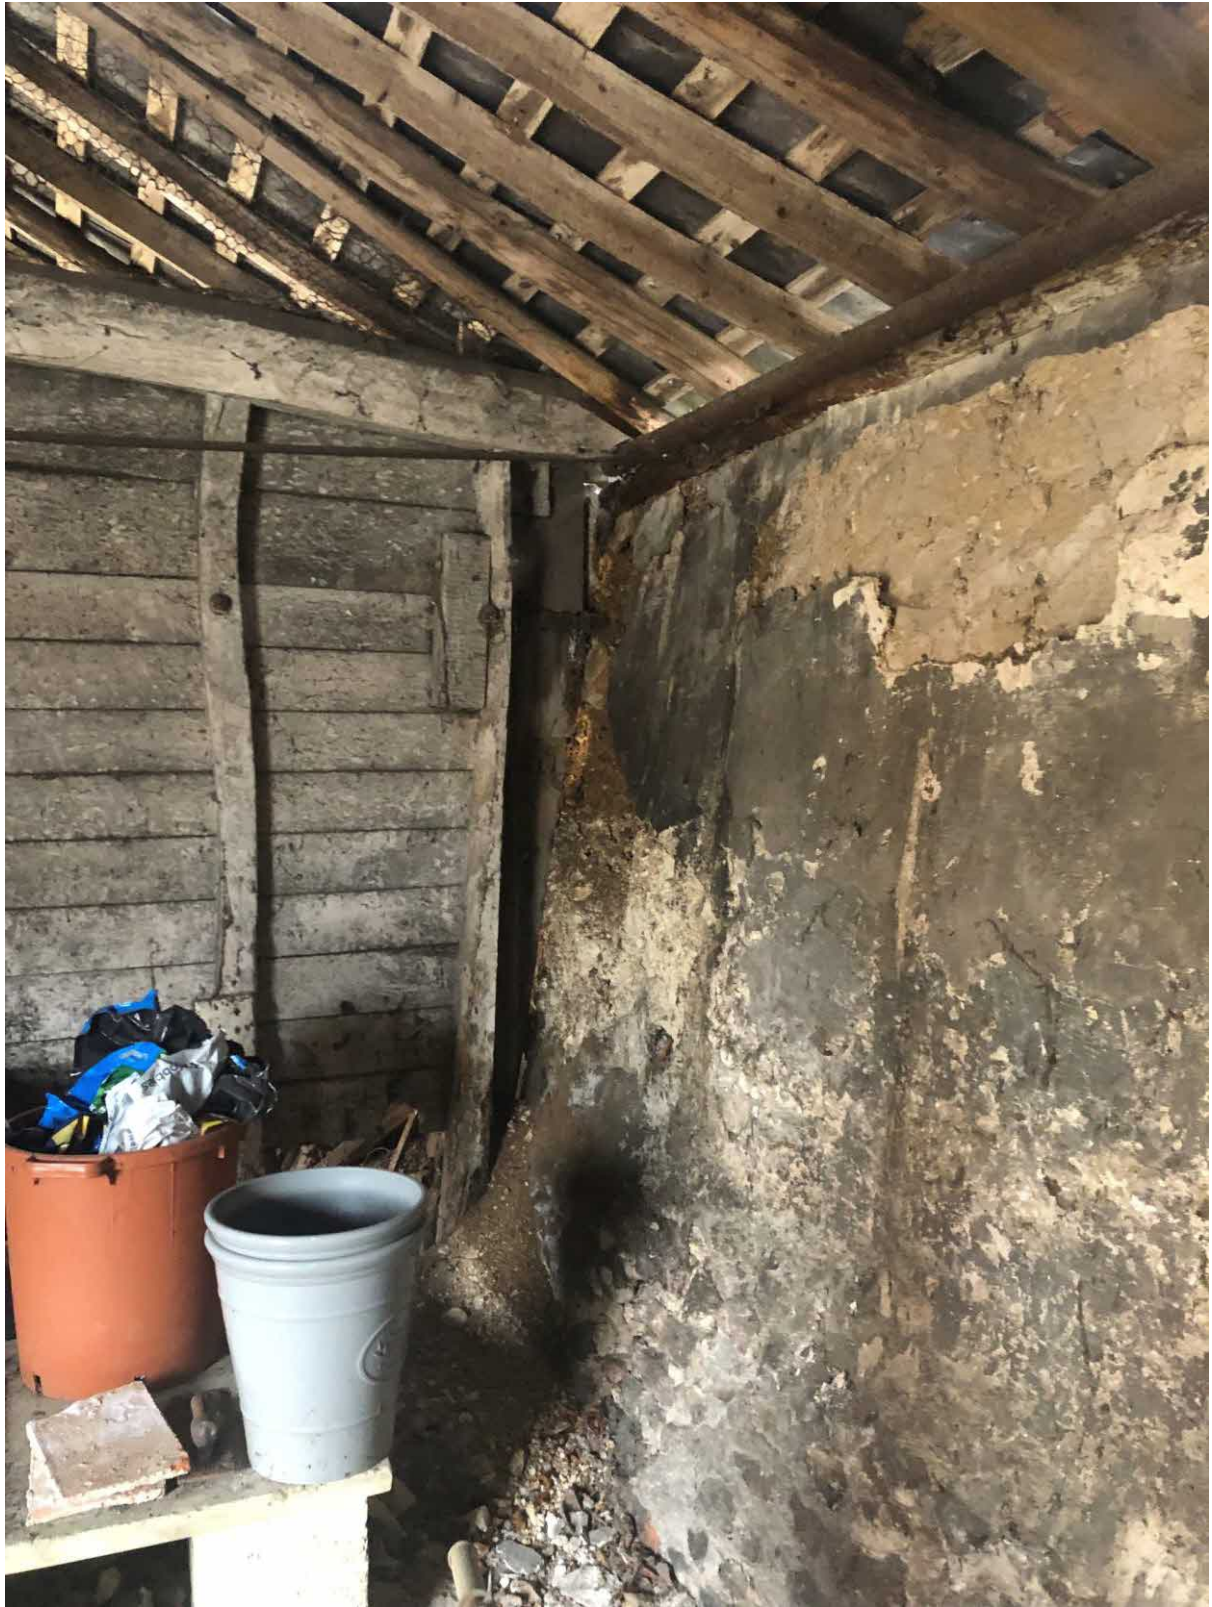
Stables Road Side Wall - Note Leaning Outwards Cob Wall

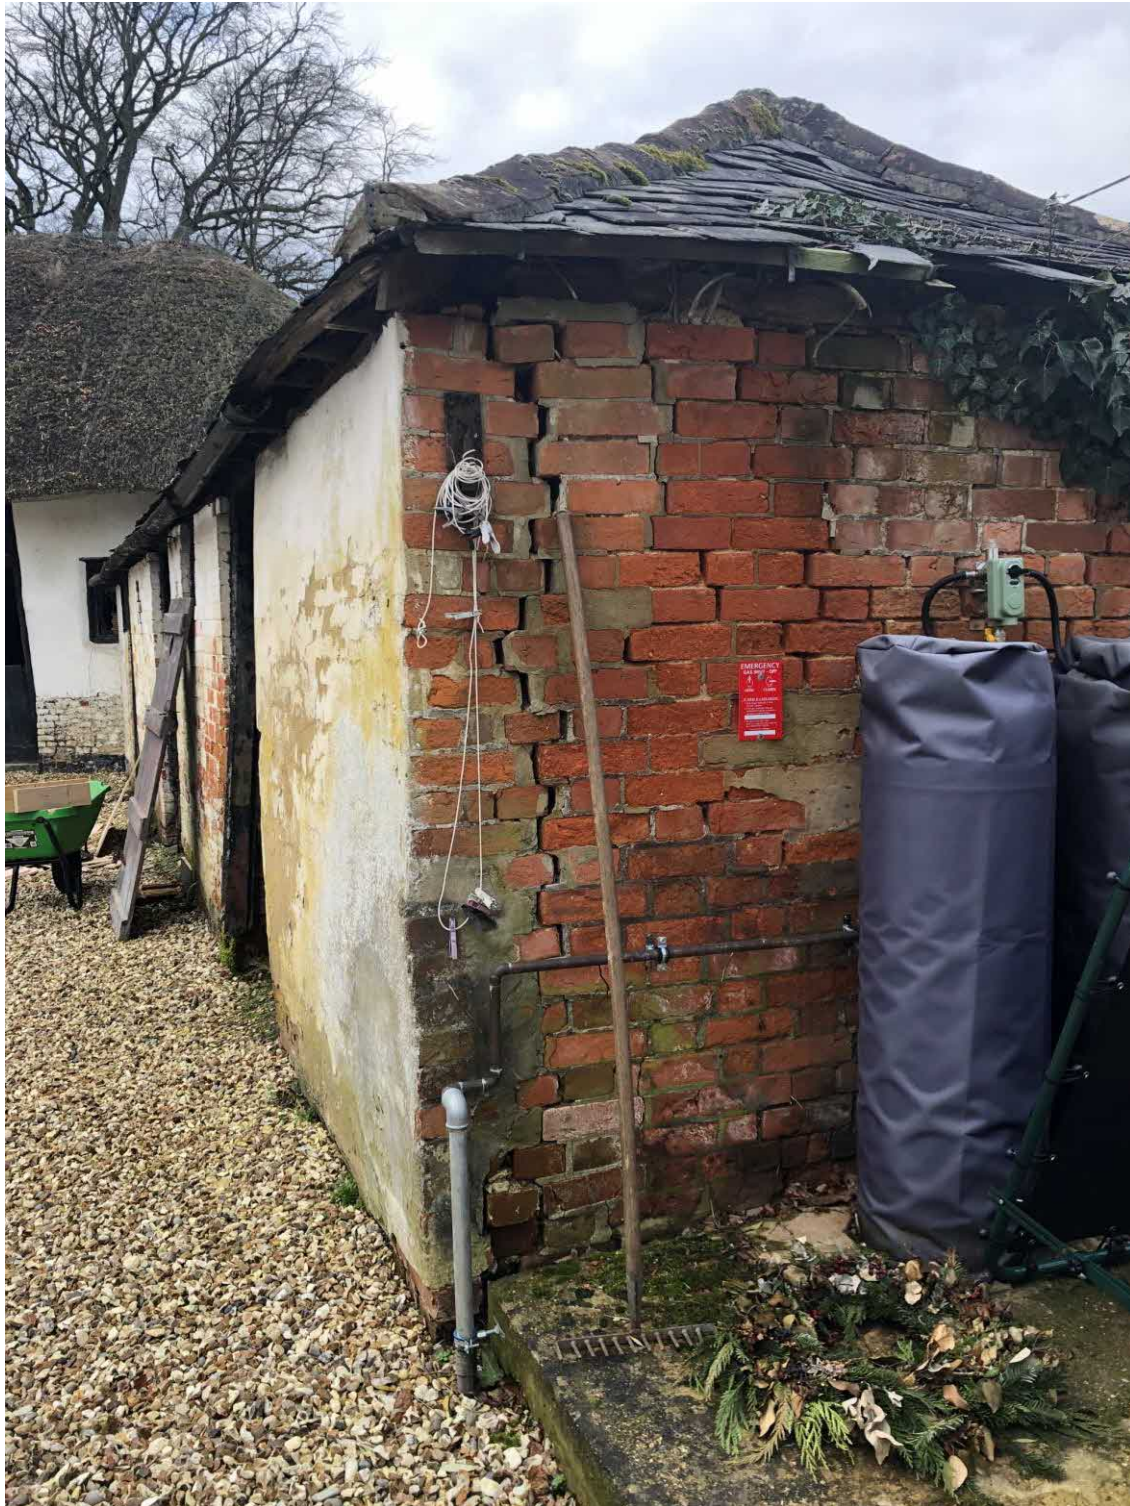
The yard side wall is of brick and is also leaning outwards.

Stables Yard Side Wall – Note Outward Lean and Cracking with return wall (also uneven failed roof structure)
