Current Structural Condition Report

Out - Building at Bec
House, Monxton,
Hampshire.

Project no.	877
Project title	Out - Building at Bec House, Monxton, Hampshire
Client	Mr and Mrs Brown
Document title	Current Structural Condition Report

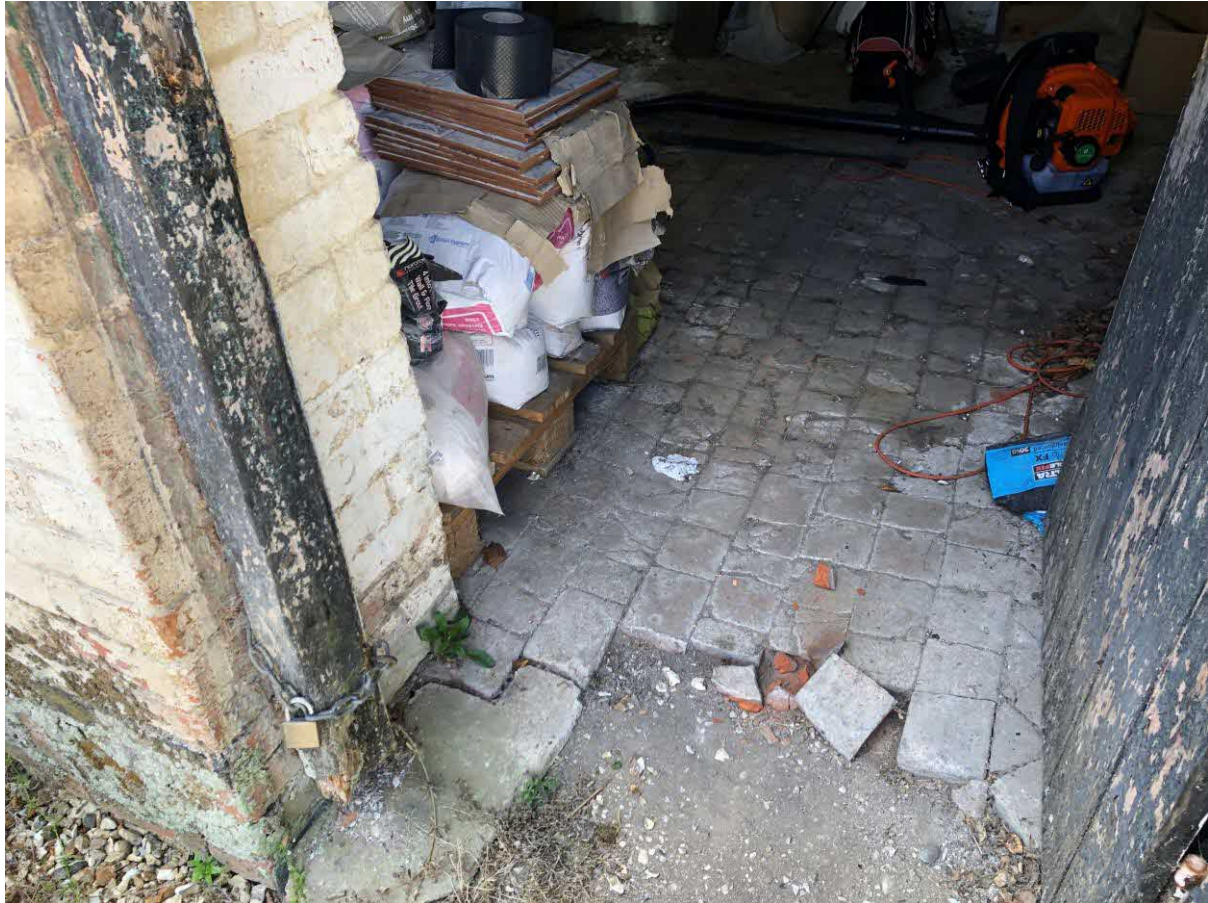
The floor to the whole building, barn and associated store is of brick paving of various forms but generally wholly insitu.

View of Part Bothy Floor

The whole existing ground floor will require to be levelled and brought up to a reasonable level of thermal performance and moisture resistance by overlaying with insulation and tanking.
