ADDENDUM ARBORICULTURAL REPORT

SUBSIDENCE CLAIM

Crawford Reference: SU2207230

26 Ashville Avenue

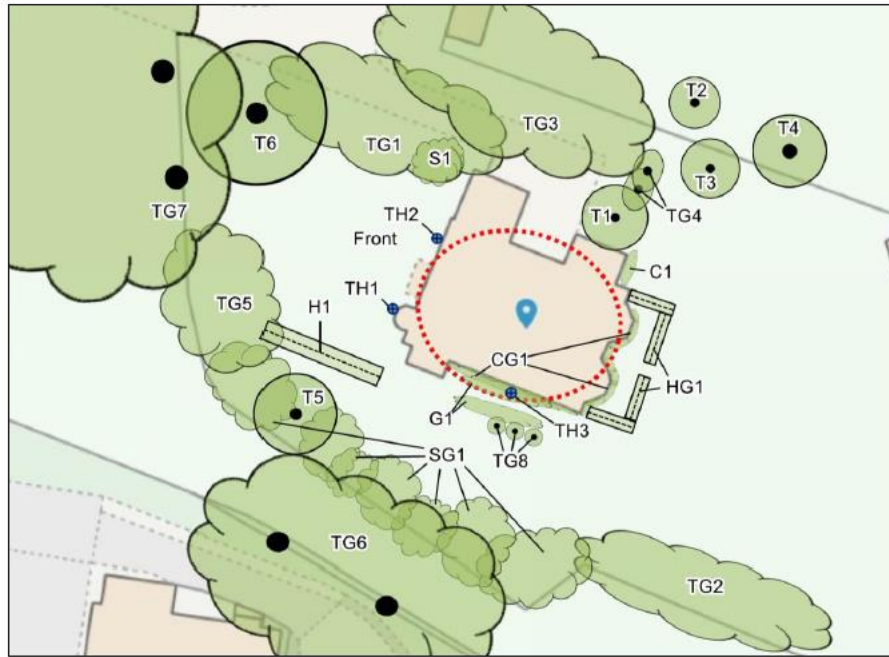
Approximate areas of damage

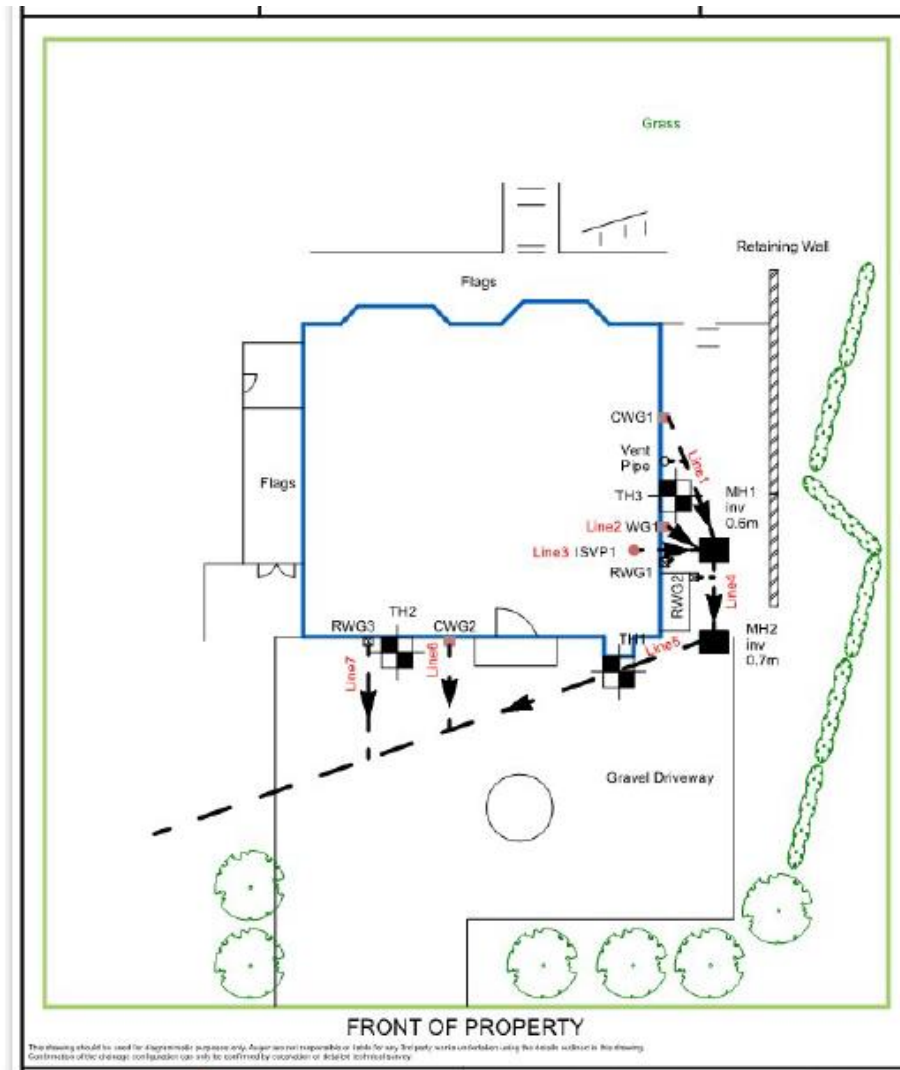
Site investigations confirm 400mm to 1200mm deep foundations bearing on clay that has very high plasticity.

Laboratory tests confirm significant desiccation has occurred where roots were observed in TH2 & TH3, the moisture contents being at or significantly less than 0.5x the Liquid Limit, this indicates abnormal soil drying in the presence of tree roots.

Roots were recovered from depths of up to 1.4m

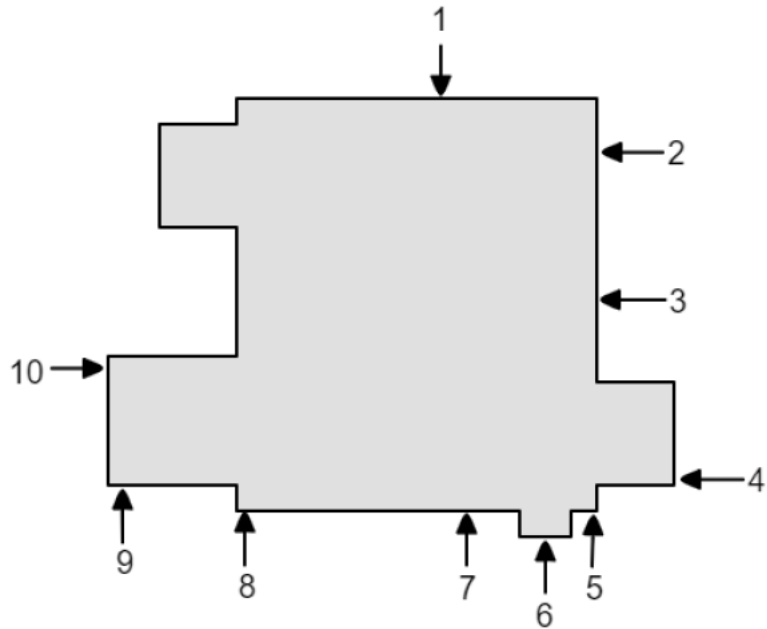
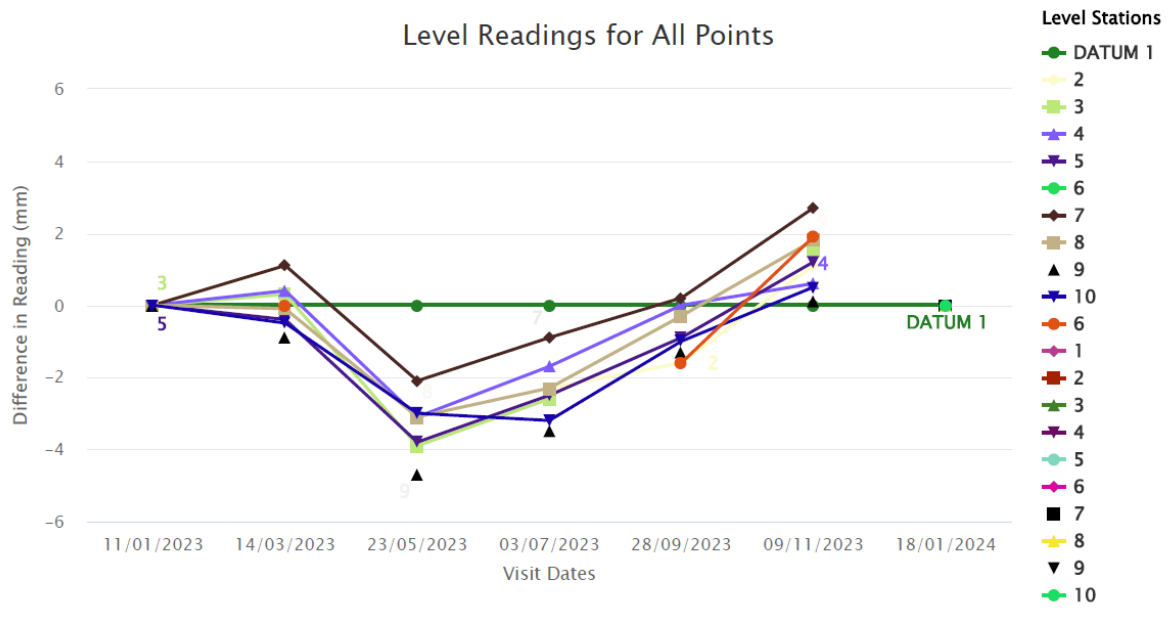
Precise Level Monitoring

The level monitoring indicates a clear seasonal and cyclical pattern of movement consistent with root induced clay shrinkage with the greatest amplitude of movement being consistent with the locations of the subject trees. Summer 2023 was considerably wetter than summer 2022 when

damage occurred, and we would expect a greater degree of seasonal foundation movement during a normal or a dry summer.
