Arboricultural Appraisal Report

Subsidence Damage Investigation at:

26 Ashville Avenue
Eaglescliffe
Stockton-on-Tees
TS16 9AX

CLIENT:	Crawford & Company
CLIENT REF:	SU2207230
MWA REF:	SUB230524-13138
MWA CONSULTANT:	Richard Percival (TechArborA)
REPORT DATE:	07/07/2023

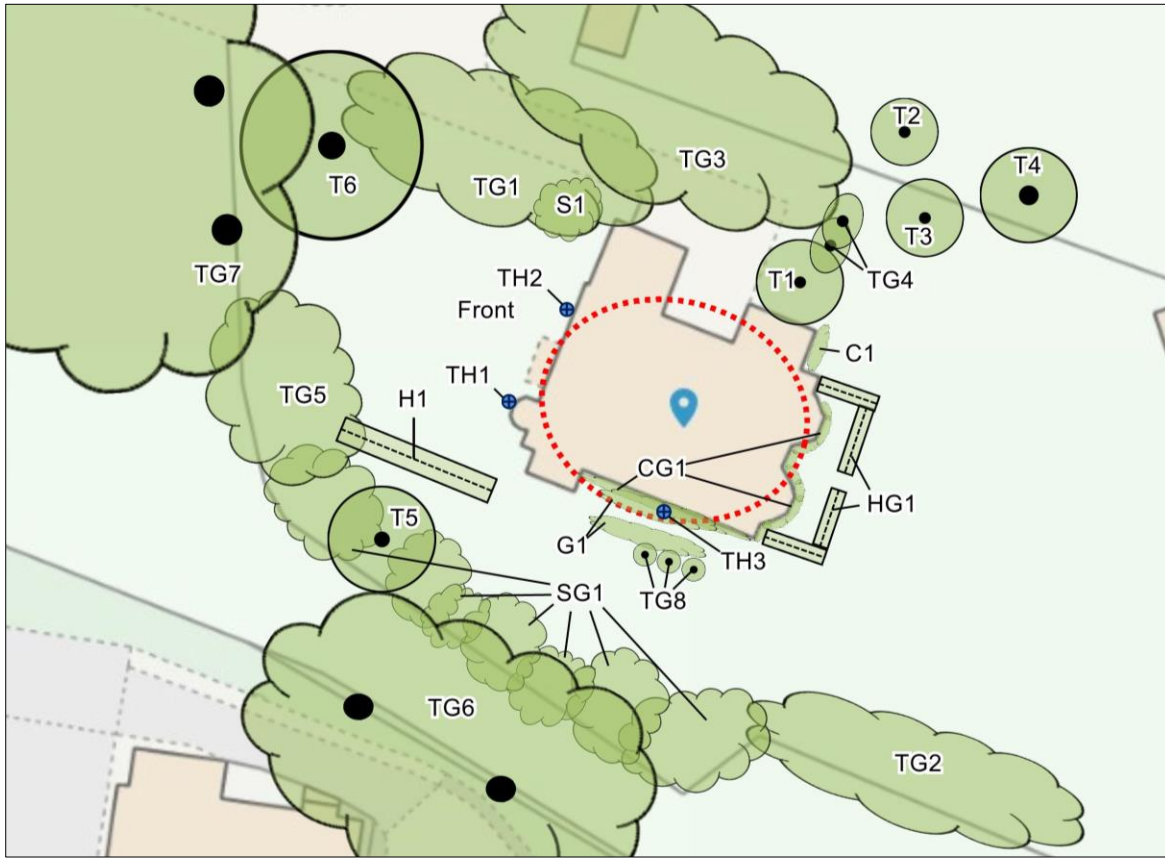
Site Plan

Approximate areas of damage
