**Poole Barton including  
adjoining wall to north (NHLE  
1170421), Cheriton Fitzpaine,  
Devon**

**Built Heritage Assessment and  
Impact Statement**

ISCA Report: **R01-0065-2**

**February 2024**

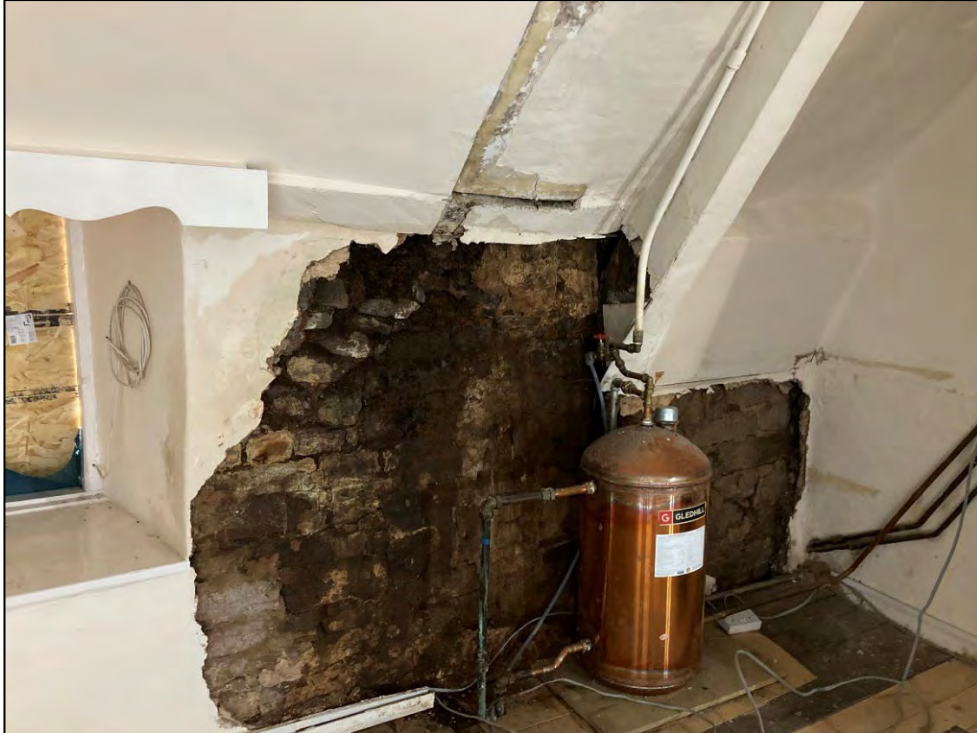
**Figure 20:** Damp damage to the fabric of the central stack and cob walls of Room 5 as a result of the installation of the slate roof in the 19th century. The oak true cruck truss (right) is still in a good state of preservation.

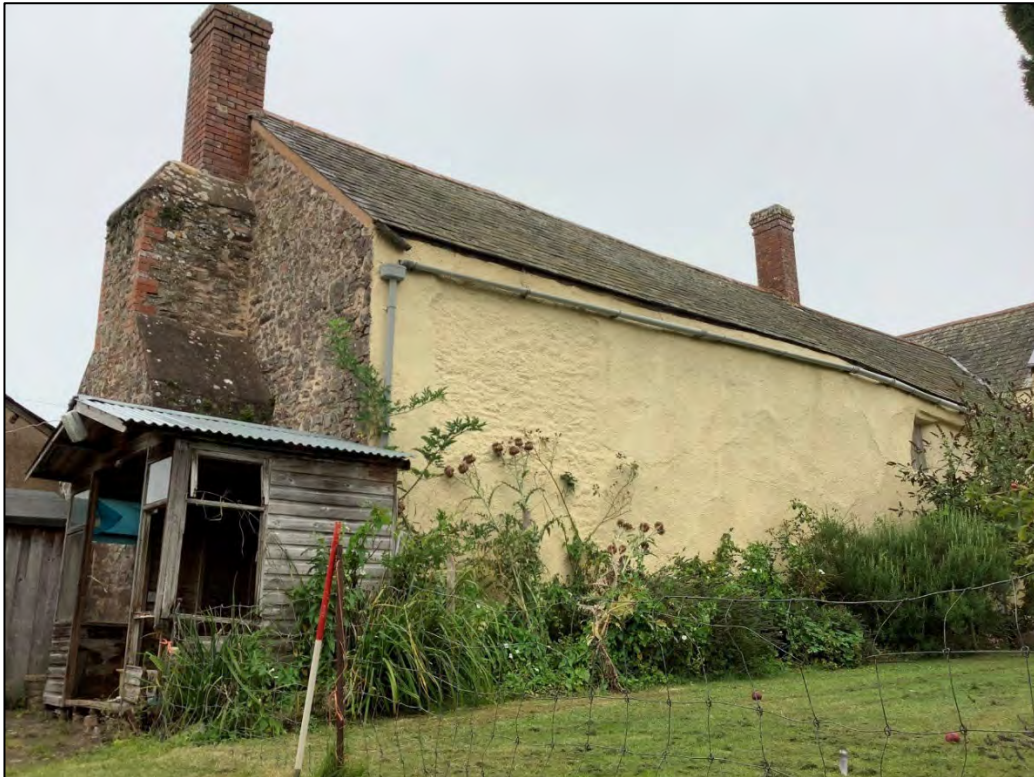
- 6.59. The eastern elevation of the block demonstrates less features, or additions, to that of the western elevation (Fig. 32). This elevation is warped and shows signs of being repaired to the southern end. Two windows are present north of centre, one of which, along the ground floor may well be largely original. The vertical bars of this window are consistent with late medieval to early post-medieval window fittings. The first-floor window is likely to date to the 17th century when this side of the building was likely floored.

Figure 32: The eastern elevation of the rear block. View to the north west.

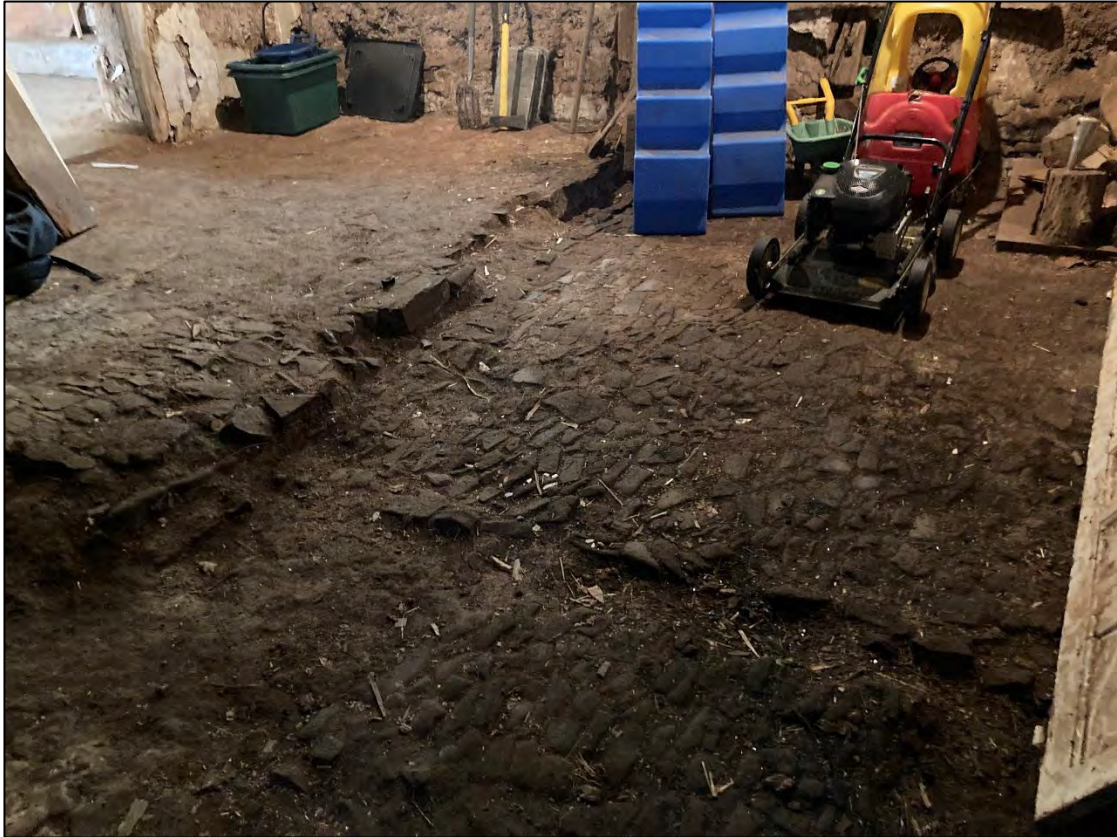
layer of cobbled floor. Within this lower level, a central drain likely suggests that the building originally functioned as a shippon for livestock. The cobbled surface is heavily abraded and worn, but does not show any signs of being replaced (Figure. 38).

**Figure 38:** The cobbled surface of Room 9 and its central drain.

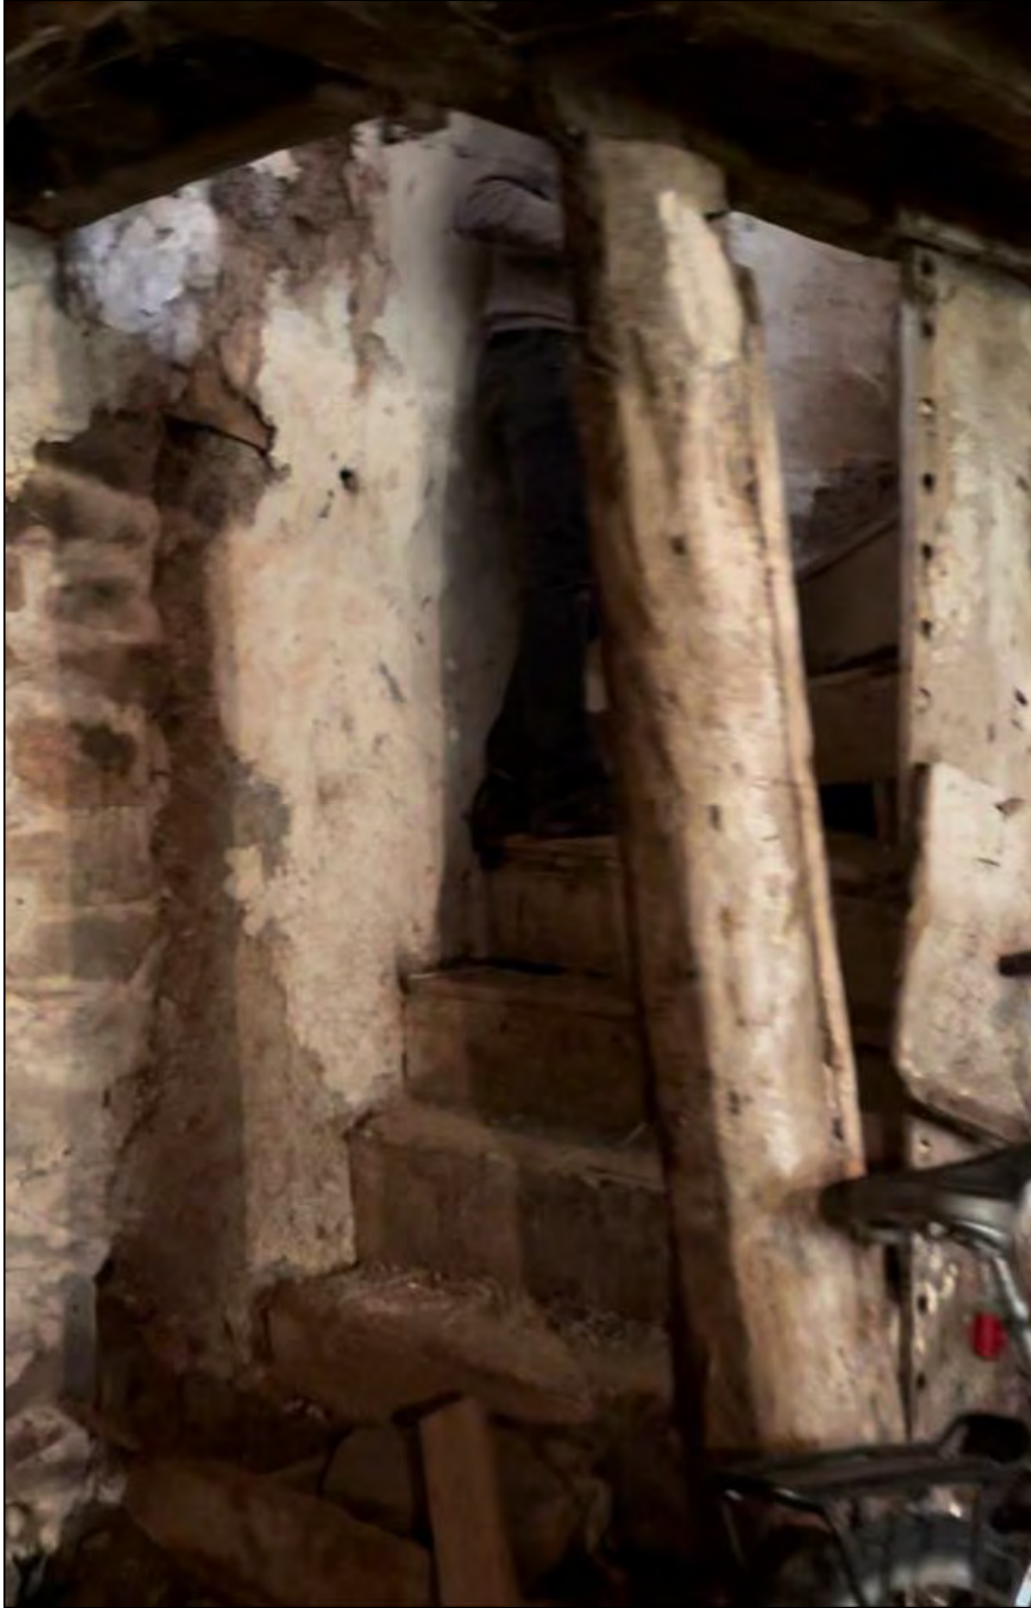
- 6.71. Much of the staircase on the western side of Room 9 is likely to be original, although it has likely been repaired various times throughout its history (Fig. 41). The stairs are now in a degraded state, and the first floor is not safely accessible from below.

**Figure 41:** Staircase within Room 9. The vertical beams are likely to be original although its stairs may have been replaced.

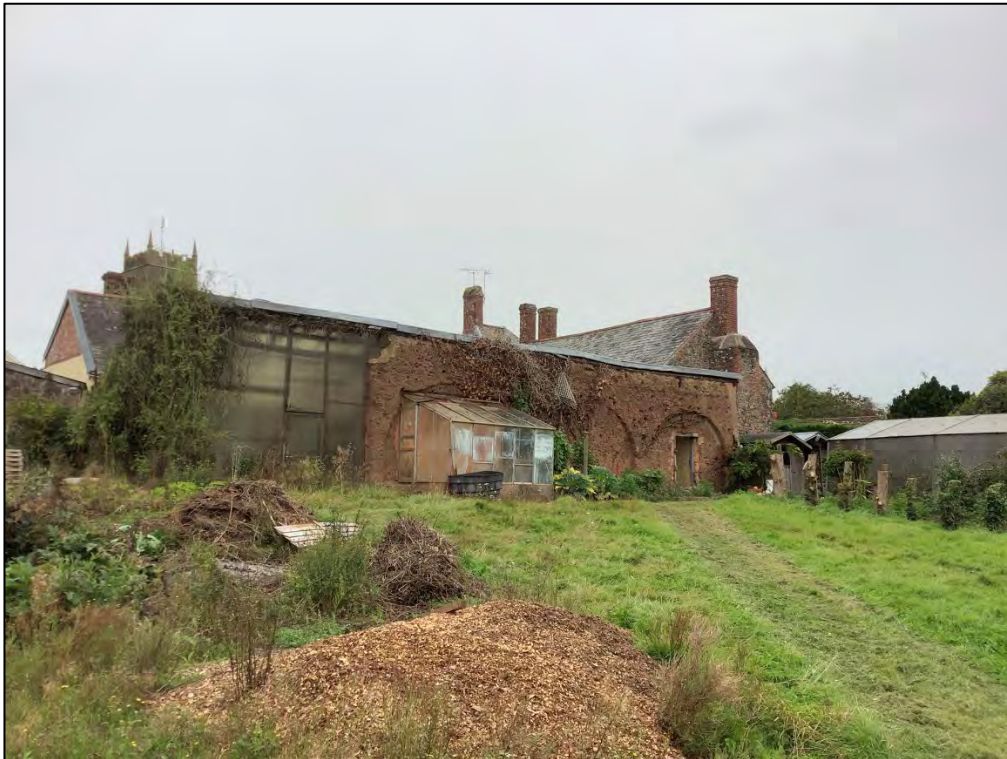
**Figure 54:** Cob wall to the rear of the southern stable block. View to the north east.

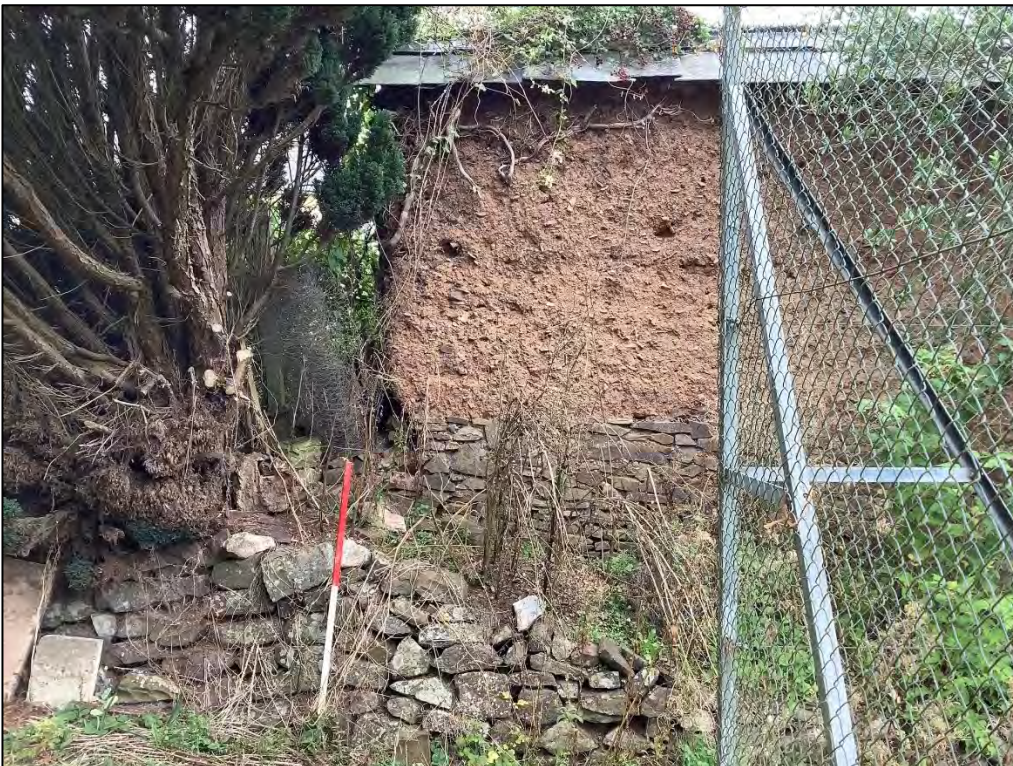
- 6.104. The fabric of this wall is suffering similar erosion to that of the cob wall to the south of the stable block. It is, however, although being broadly in line with the cob wall to the east, it is not observed to be of different construction to that of the western section of wall. It is therefore likely not to be originally part of the same wall. The eastern wall is protected by a hood of slates; however, these are in a state of disrepair which has resulted in a general erosion of the cob. The cob is no longer protected by what would have been a layer of earthen mortar.

**Figure 58:** Cob wall to demarcating the eastern boundaries of Poole Barton.

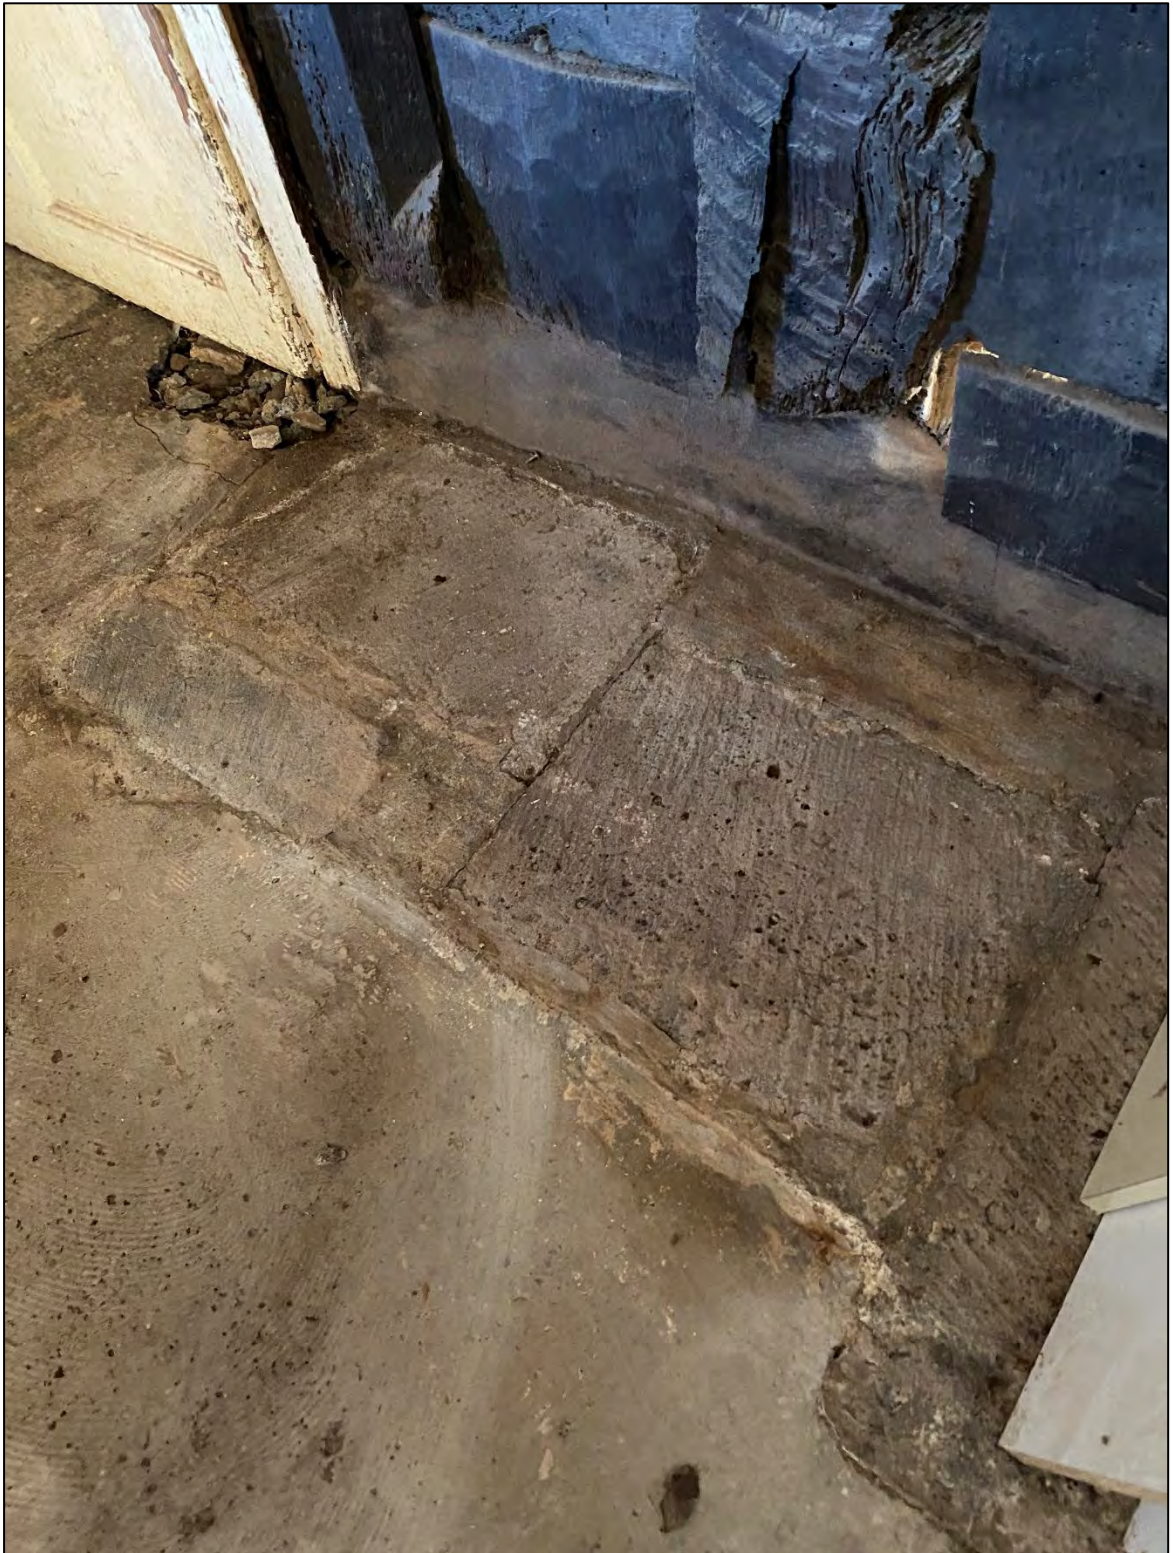
- 9.3. As previously established, this room relates to the former Main Hall. This work is deemed necessary as the current concrete floor directly overlays made ground resulting in damp coming through the floor. This has resulted in damp being transferred to the oak plank-and-muntin screens in this location. As these oak plank-and-muntin screens are imbued with a high degree of heritage significance, preservation of these features is paramount. Without the replacement of the concrete floor with an underlying layer of DPM plastic and insulation, the preservation of these features is under threat.

- 9.6. The modern concrete flooring is out of keeping with the original flagstone floor of the Main Hall House. Furthermore, as damp is being transferred through the concrete floor, this has resulted in potential damage to the walls and the oak plank-and-muntin screens within Room 1. The concrete flooring, as well as the fact that it has been laid directly atop made ground with no waterproofing or insulating layer, is therefore seen as a detriment to the overall heritage significance of the property.

**Figure 62:** Historic volcanic flagstones in the south west corner of Room 1

- 9.5. The proposal is to replace the current concrete flooring with volcanic flagstones sourced from the local Knowle Quarry (Fig. 63). Sizing would be consistent with the historic flagstones *in-situ*.

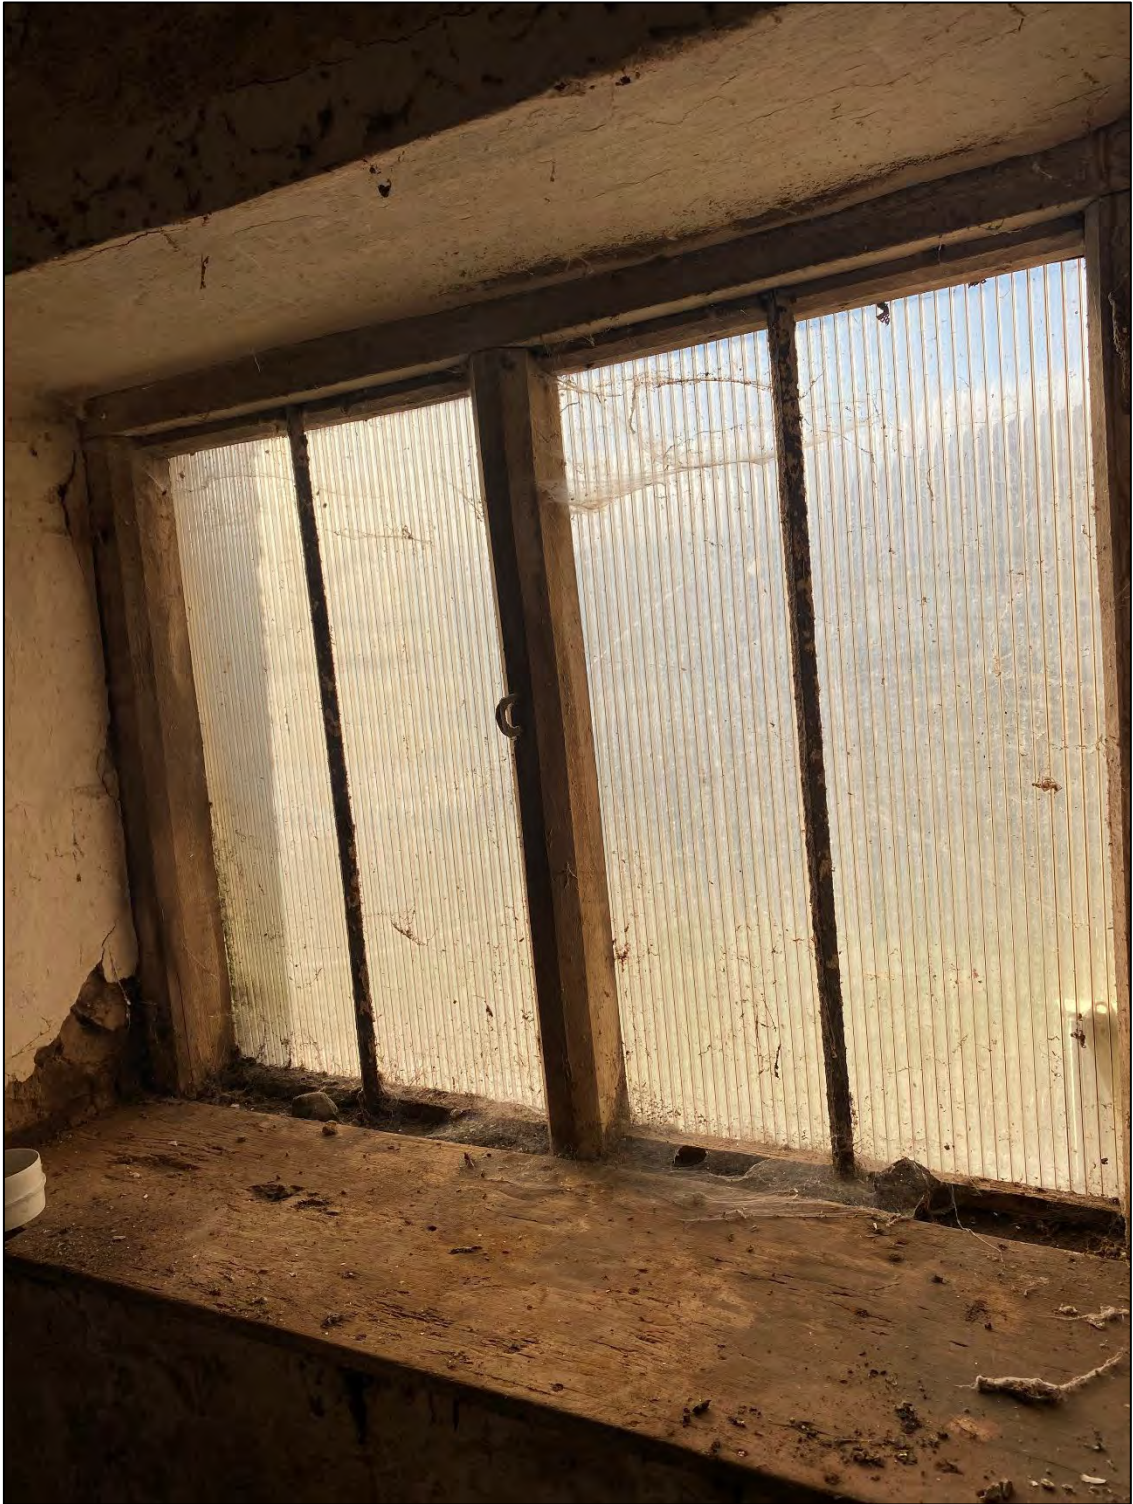
**Figure 63:** Historic window frame and ledge in Room 8 to be left in-situ, polycarbonate pane to be replaced with 12mm double glazing to provide warmth to the room and create a liveable space (Fig. 1, 3d)
