STRUCTURAL REPORT - PLANNING

THE BLUE CROSS

CHILTON CROSS, TIVERTON

EXISTING BARN BUILDING

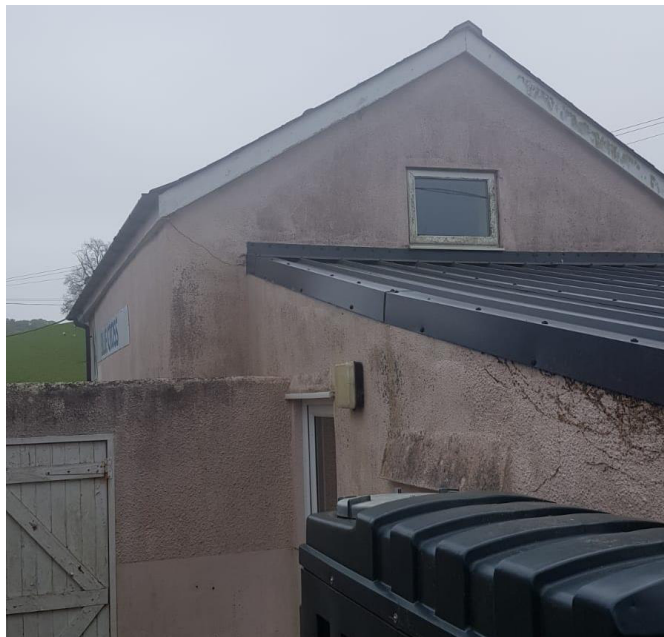
The existing building is rectangular on plan with a duo pitched roof and mono pitched lean too area to the North elevation.

Above: Barn building

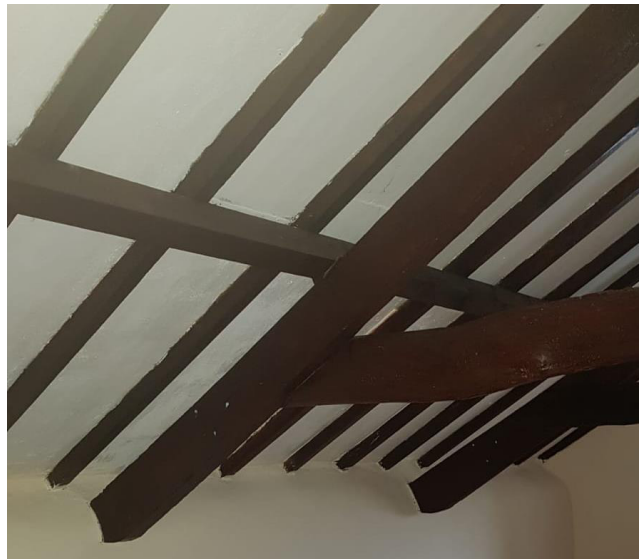
The two storey roof is supported on a series of timber rafters. These timber rafters are in good condition. Rafters are supported on timber purlins in turn supported on timber trusses. The purlins are also in good condition and all can remain as part of the converted scheme.

Above: Timber rafters on purlins on trusses

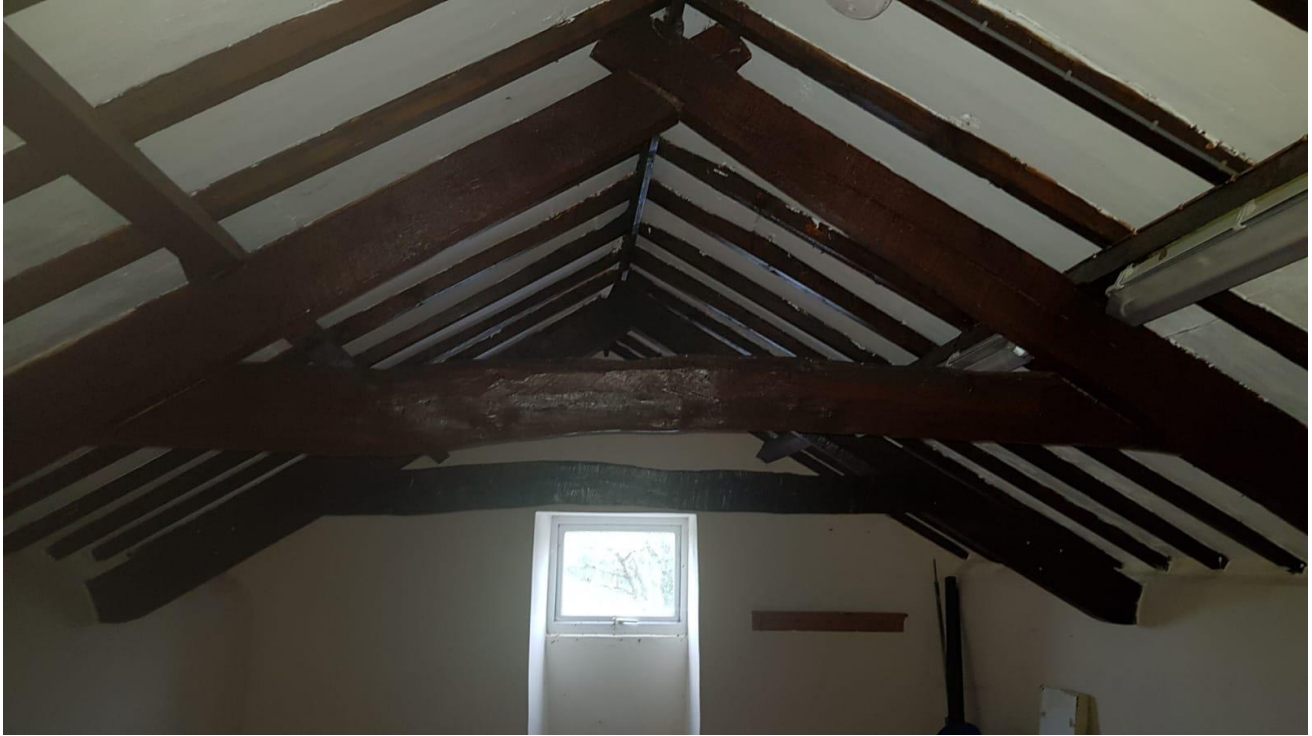
The trusses are raised collar scissor trusses. It is likely that the bottom chord will need to be raised in order to achieve greater head room to the first floor. Alternatively a ridge beam could be installed and the collars removed altogether to achieve a fully cut roof.

Above: Raised collar scissor trusses

The trusses are in good condition. Trusses bear directly onto the stone / cob perimeter walls.

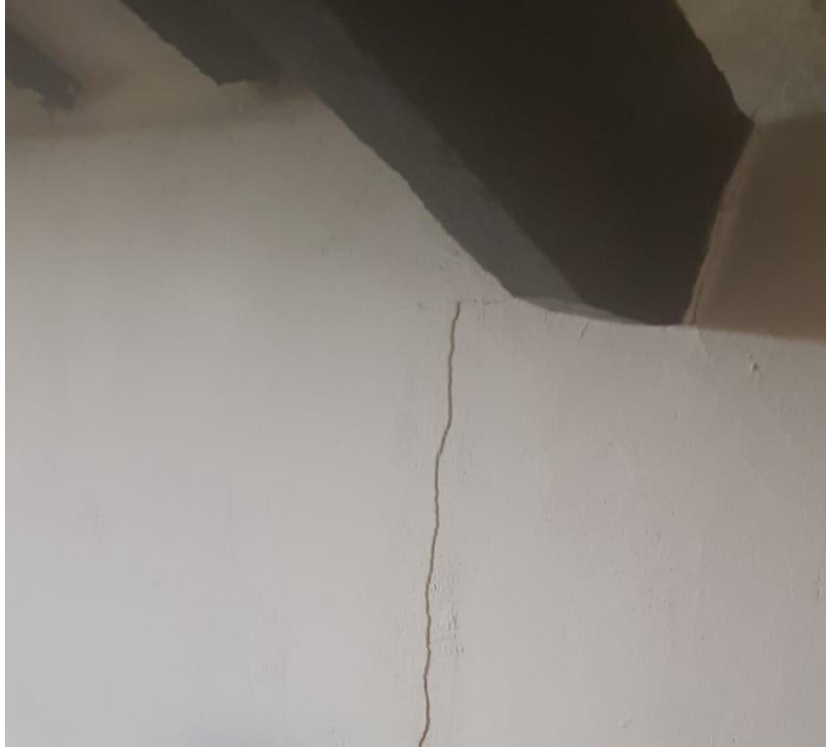
The perimeter walls are assumed to be a mix of stone and cob. Generally the walls are in good condition. In one location a crack was noted to the bearing of one of the roof trusses. The internal plaster finish to the walls should be locally removed so the crack be investigated. It is anticipated the worst case scenario will be to install helical crack stitching ties across the joint without the requirement for any major structural works.

Above: Crack under truss bearing at first floor level.

- The roof cladding is in good condition and can remain as part of the converted scheme.
- The perimeter and internal walls are in good condition. A local remedial repair is likely to be required at first floor level to stitch a crack in the wall.
- The timber first floor mezzanine is in good condition and the joists appear adequately sized to support domestic loadings imposed by modern design codes of practice.
- No elements of the primary structure require replacement it is therefore our recommendation that the existing structure is capable of conversion to a domestic dwelling.

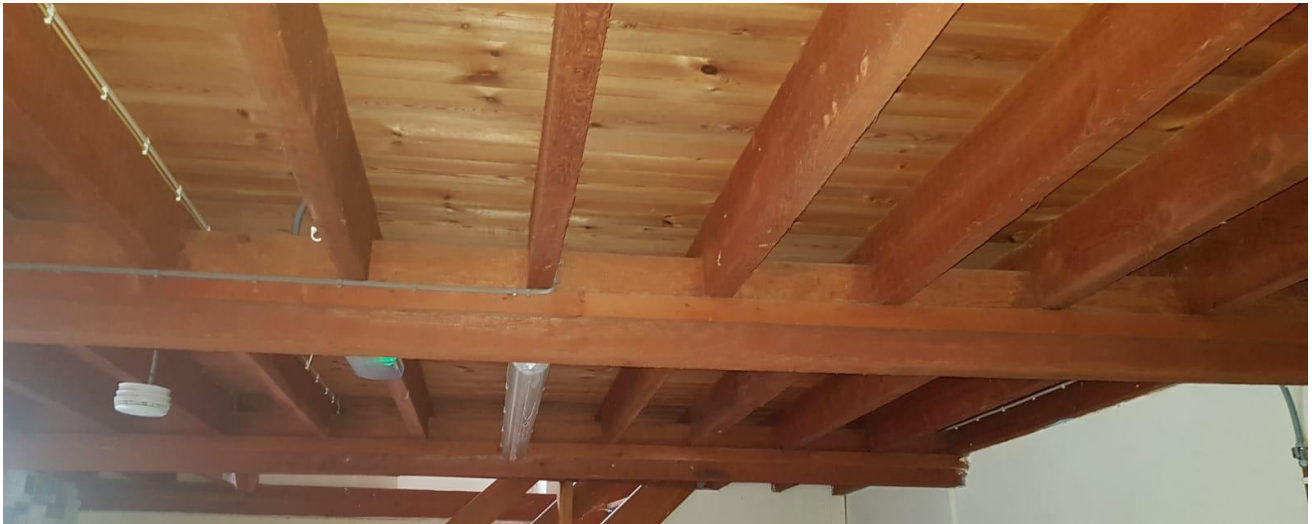
Above: Timber mezzanine viewed from ground floor.

The timber joists are in good condition. The supporting beams are in good condition. In order to comply with modern fire regulations it is likely the underside of the mezzanine will need to be plaster boarded. The joists are adequately sized to support the upgraded loads associated with these works.
