Preliminary Geo-Environmental and Coal Mining Risk Assessment Newark Road, Ollerton Delta-Simons Project Number 87854.545436

# Appendix F- Coal Mining Consultant's Report

# Appendix G – Refurbishment Asbestos Survey Report

Refurbishment
Asbestos Survey Report
of
Building B & Building A - Room F

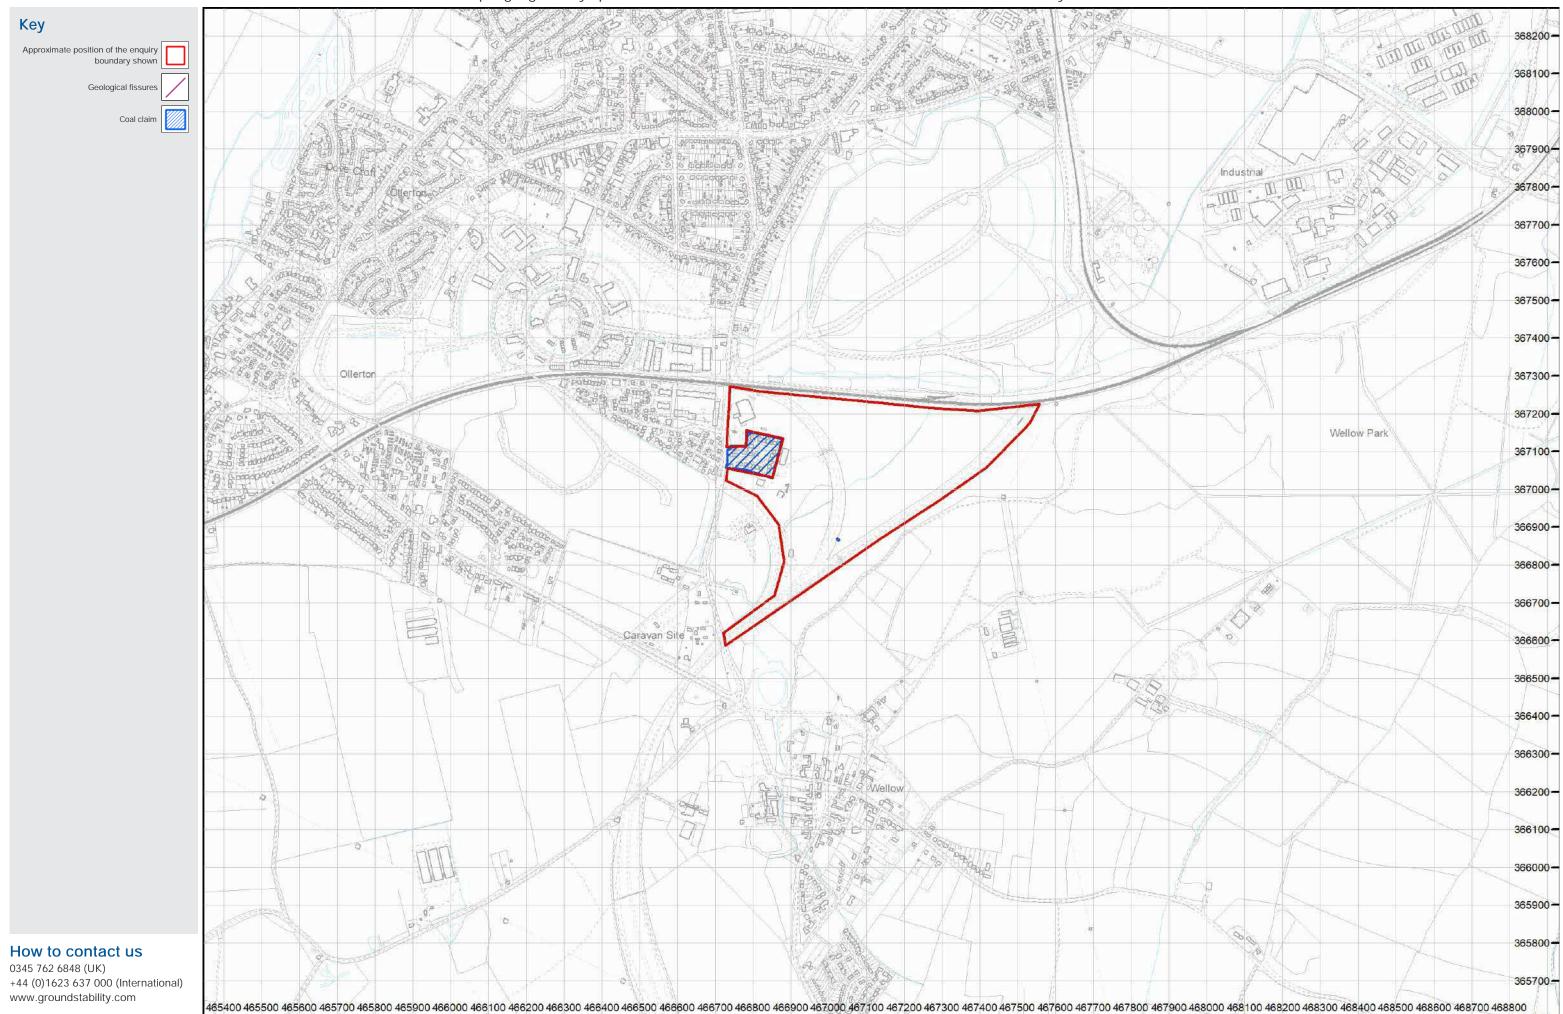
# Summary of findings

Fissure under or close to the property recorded.

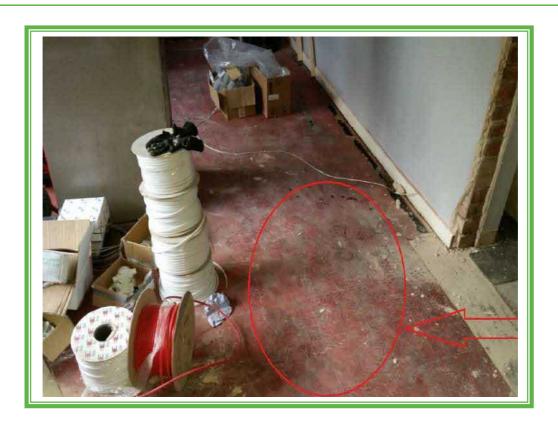
Sample No: B003

Location: Room C

I tem: Vinyl FI		es
I dentification: Sampled		
Approx quantity:	20M sq	
Accessibility	High	Assessment Score
Product type:	Product type: Vinyl Products	
Extent of Damage:	Extent of Damage: Low	
Surface Treatment:	Surface Treatment: Reinforced Composite	
Asbestos type:	Chrysotile	1
	Material Assessment Score:	3
Priority Assessment Score:		N/A
Action:	sulate	
Comments:	Non Licensed Form of	Asbestos

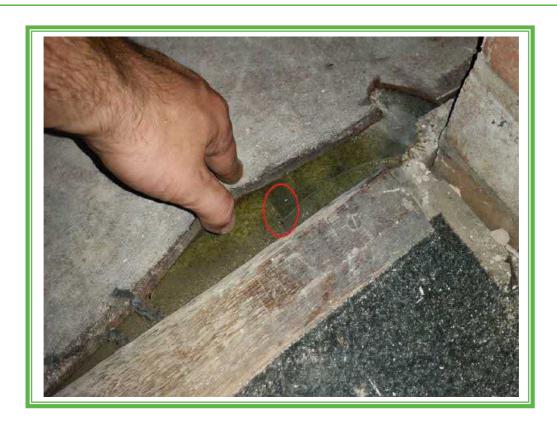
Sample No: B004

Location: Room D

I tem: Vinyl FI		es
I dentification: Sampled		
Approx quantity:	20M sq	
Accessibility	High	Assessment Score
Product type:	Product type: Vinyl Products	
Extent of Damage:	Extent of Damage: Low	
Surface Treatment:	Surface Treatment: Reinforced Composite	
Asbestos type:	Chrysotile	1
	Material Assessment Score:	3
Priority Assessment Score:		N/A
Action:	sulate	
Comments:	Non Licensed Form of	Asbestos

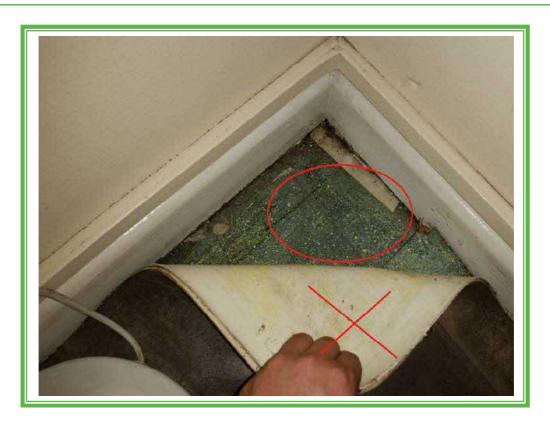
Sample No: B007

Location: Room H

I tem:	Vinyl Floor Tile	es
I dentification: Sampled		
Approx quantity:	20M sq	
Accessibility	High	Assessment Score
Product type: Vinyl Products		1
Extent of Damage: Low		1
Surface Treatment:	Reinforced Composite	0
Asbestos type:	Chrysotile	1
Material Assessment S		3
Priority Assessment Score:		N/A
Action:	Remove / Encaps	ulate
Comments:	Non Licensed Form of	Asbestos

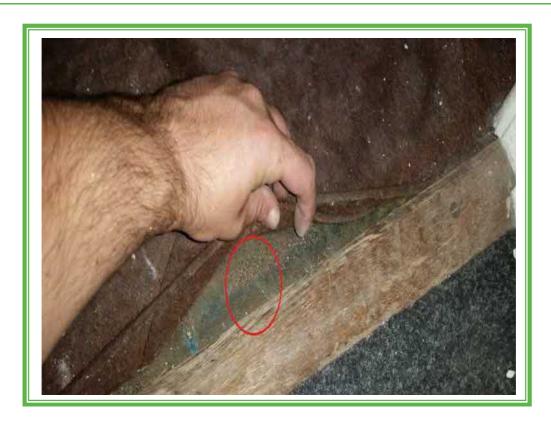
Sample No: B010

Location: Room I

I tem:	Vinyl Floor Tile	es
I dentification: Sampled		
Approx quantity:	20M sq	
Accessibility	High	Assessment Score
Product type: Vinyl Products		1
Extent of Damage: Low		1
Surface Treatment:	Reinforced Composite	0
Asbestos type:	Chrysotile	1
Material Assessment S		3
Priority Assessment Score:		N/A
Action:	Remove / Encaps	ulate
Comments:	Non Licensed Form of	Asbestos

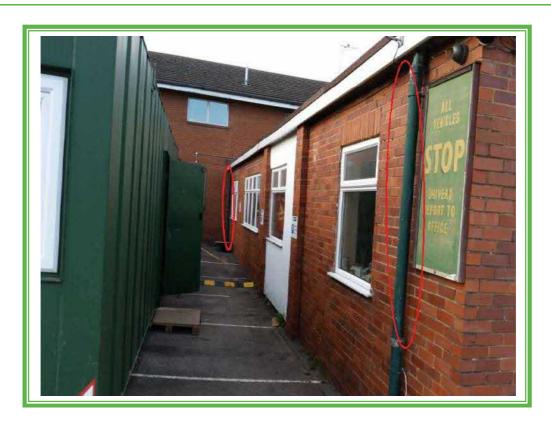
Sample No: B011

Downpipes & damp proof course both contain asbestos.

Location: Exterior

I tem:	Rainwater Gutter / D	ownpipe
I dentification:	Sampled	
Approx quantity:	6 LM	
Accessibility	Low	Assessment Score
Product type:	Asbestos Cement	1
Extent of Damage:	Low	1
Surface Treatment:	Asbestos Cement	1
Asbestos type:	Chrysotile	1
	Material Assessment Score:	4
	Priority Assessment Score:	N/A
Action: Undertake water absorption test		-
Comments:	Normally Non Licensed for	m of asbestos

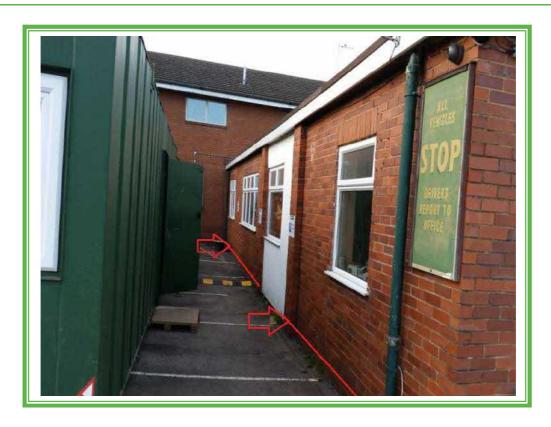
Sample No: B013

Location: Exterior

I tem:	I tem: Damp Proof Cou		
I dentification:	Sampled		
Approx quantity:	30 LM		
Accessibility	High	Assessment Score	
Product type:	Bitumen Products	1	
Extent of Damage:	Low	1	
Surface Treatment:	Sealed	1	
Asbestos type:	Chrysotile	1	
	Material Assessment Score:	4	
Priority Assessment Score:		N/A	
Action:	Manage		
Comments:	Non Licensed Form of Asbestos

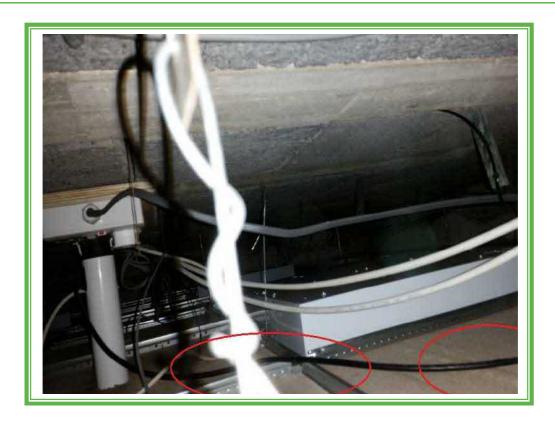
Sample No: A005

Location: Building A Room F

I tem:	I tem: Dust & Debris Above	
I dentification: Sampled		
Approx quantity:	15M sq	
Accessibility	Low	Assessment Score
Product type:	Unknown Origin	1
Extent of Damage:	High	3
Surface Treatment:	Unsealed	3
Asbestos type:	Chrysotile	1
	Material Assessment Score:	8
Priority Assessment Score:		N/A
Action: Remove / Clean Grid P		rior Works
Comments:	No Obvious Signs of Contan	nination Visually

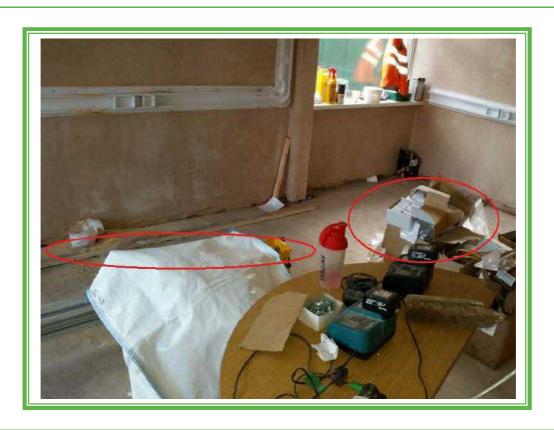
Sample No: B001

Location: Room A

I tem: Dust & Debri		S
I dentification:	Sampled	
Approx quantity:	20M sq	
Accessibility	Medium	Assessment Score
Product type:	Insulation Debris	N/A
Extent of Damage:	High	N/A
Surface Treatment:	Unsealed	N/A
Asbestos type:	None	N/A
	Material Assessment Score:	N/A
Priority Assessment S		N/A
Action: None		
Comments:	No Asbestos Detected	In Sample

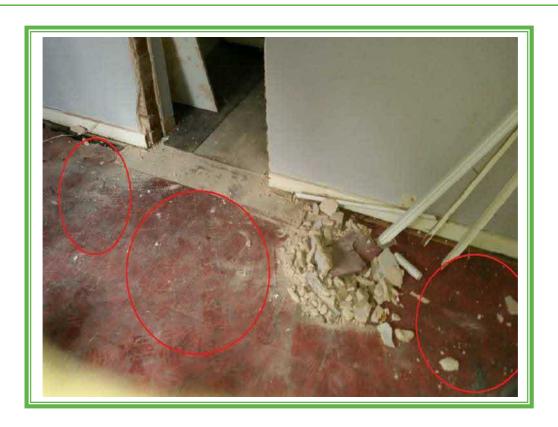
Sample No: B002

Location: Room C

I tem:	I tem: Dust & Debri	
I dentification:	I dentification: Sampled	
Approx quantity:	20M sq	
Accessibility	Medium	Assessment Score
Product type:	Insulation Debris	N/A
Extent of Damage:	High	N/A
Surface Treatment:	Unsealed	N/A
Asbestos type:	None	N/A
	Material Assessment Score:	N/A
	Priority Assessment Score:	N/A
Action: None		
Comments: No Asbestos Detected In Sample

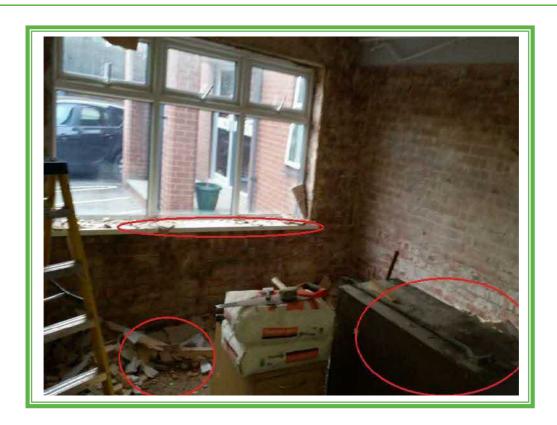
Sample No: B005

Location: Room D

I tem: Dust & Debri		S
I dentification:	Sampled	
Approx quantity:	15M sq	
Accessibility	Medium	Assessment Score
Product type:	Insulation Debris	N/A
Extent of Damage:	High	N/A
Surface Treatment:	Unsealed	N/A
Asbestos type:	None	N/A
	Material Assessment Score:	N/A
	Priority Assessment Score:	N/A
Action: None		
Comments: No Asbestos Detected In S		In Sample

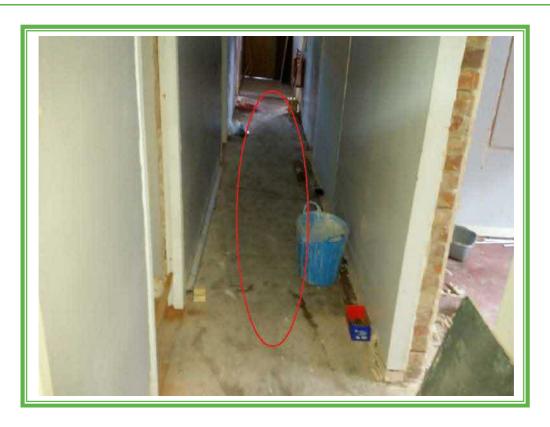
Sample No: B008

Location: Room J

I tem:	Dust & Debri	S	
I dentification:	Sampled		
Approx quantity:	32M sq		
Accessibility	Medium	Assessment Score	
Product type:	Insulation Debris	N/A	
Extent of Damage: High		N/A	
Surface Treatment:	Unsealed	N/A	
Asbestos type:	None	N/A	
	Material Assessment Score:	N/A	
	Priority Assessment Score:	N/A	
Action:	None		
Comments:	No Asbestos Detected	In Sample

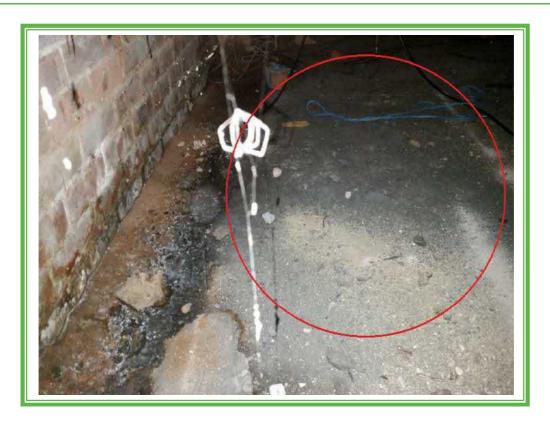
# Sample No: B009

Location: Below Floor - Throughout

I tem:	Dust & Debris		
I dentification:	Sampled		
Approx quantity:	128M sq		
Accessibility	Medium	Assessment Score	
Product type:	Insulation Debris	N/A	
Extent of Damage: High		N/A	
Surface Treatment:	Unsealed	N/A	
Asbestos type:	None	N/A	
	Material Assessment Score:	N/A	
	Priority Assessment Score:	N/A	
Action:	None		
Comments:	No Asbestos Detected	In Sample

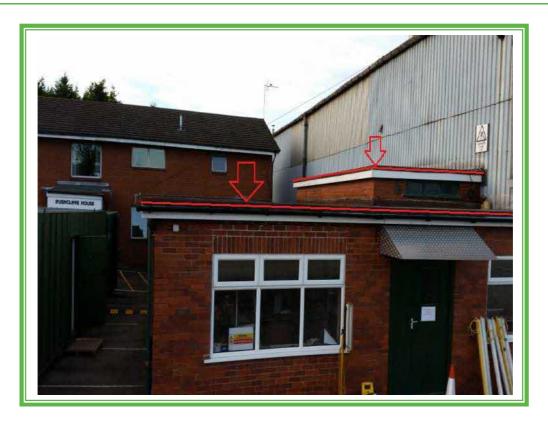
Sample No: B012

Location: Exterior

I tem:	Flat Roof / Roof	Felt	
I dentification:	Sampled		
Approx quantity:	128M sq		
Accessibility	Medium	Assessment Score	
Product type:	Bitumen Products	N/A	
Extent of Damage: Low		N/A	
Surface Treatment:	Sealed	N/A	
Asbestos type: None		N/A	
	Material Assessment Score:	N/A	
	Priority Assessment Score:	N/A	
Action: None			
Comments:	No Asbestos Detected	In Sample

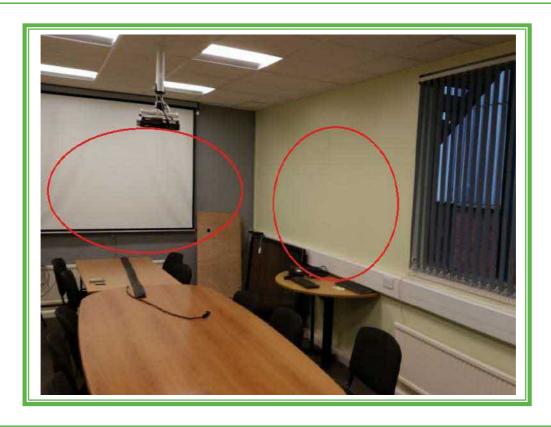
Sample No: A004

Location: Building A - Room F

I tem:	Wall Sample		
I dentification:	Sampled		
Approx quantity:	60M sq		
Accessibility	High	Assessment Score	
Product type:	Plaster	N/A	
Extent of Damage:	Low	N/A	
Surface Treatment:	Sealed	N/A	
Asbestos type:	None	N/A	
	Material Assessment Score:	N/A	
	Priority Assessment Score:	N/A	
Action:	None		
Comments:	No Asbestos Detected	In Sample
