Galley Tree Consultancy

Tree Report for:
Longfield House
Oakleigh Road
Clayton
Bradford
BD14 6NP

3.0 Tree Survey and work schedule

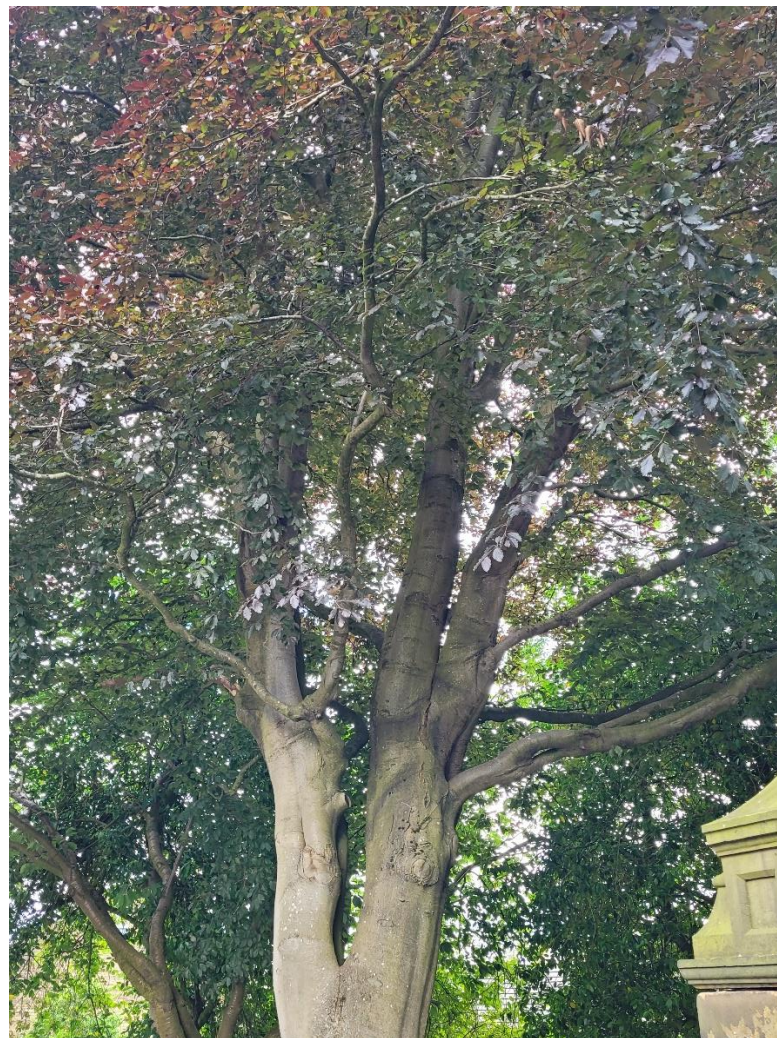
T002 is a mature copper beech with several compression forks, pictured below. A canopy reduction should reduce the risk of the forks splitting.

Ref.	Species	Description	Measurements	Recommendation	Work Timescale
T002	Copper Beech (<i>Fagus sylvatica purpurea</i>)	Car park	Height (m): 18 Crown Radius (m): 6 DBH (cm): 60 Life Stage: Mature	Reduce overall canopy by 4m to reduce loading on tight unions.	11-Jul-2024 (Medium 1 Year)
T010	Wild Cherry (<i>Prunus avium</i>)		Height (m): 7 Crown Radius (m): 4 DBH (cm): 50 Life Stage: Mature	Reduce lateral branches above road by 2-3m to suitable growth points.	11-Jul-2024 (Medium 1 Year)
T014	Horse Chestnut (<i>Aesculus hippocastanum</i>)	Garden area	Height (m): 6 Crown Radius (m): 1 DBH (cm): 75 Life Stage: Mature	Prune minor branches away from building.	11-Jul-2024 (Medium 1 Year)
T015	Sycamore (<i>Acer pseudoplatanus</i>)	Lapsed pollard, garden area.	Height (m): 18 Crown Radius (m): 5 DBH (cm): 65 Life Stage: Mature	Reduce overall canopy by 3-4m to suitable growth points to reduce risk of limbs tearing out from old pollard points.	11-Jul-2024 (Medium 1 Year)

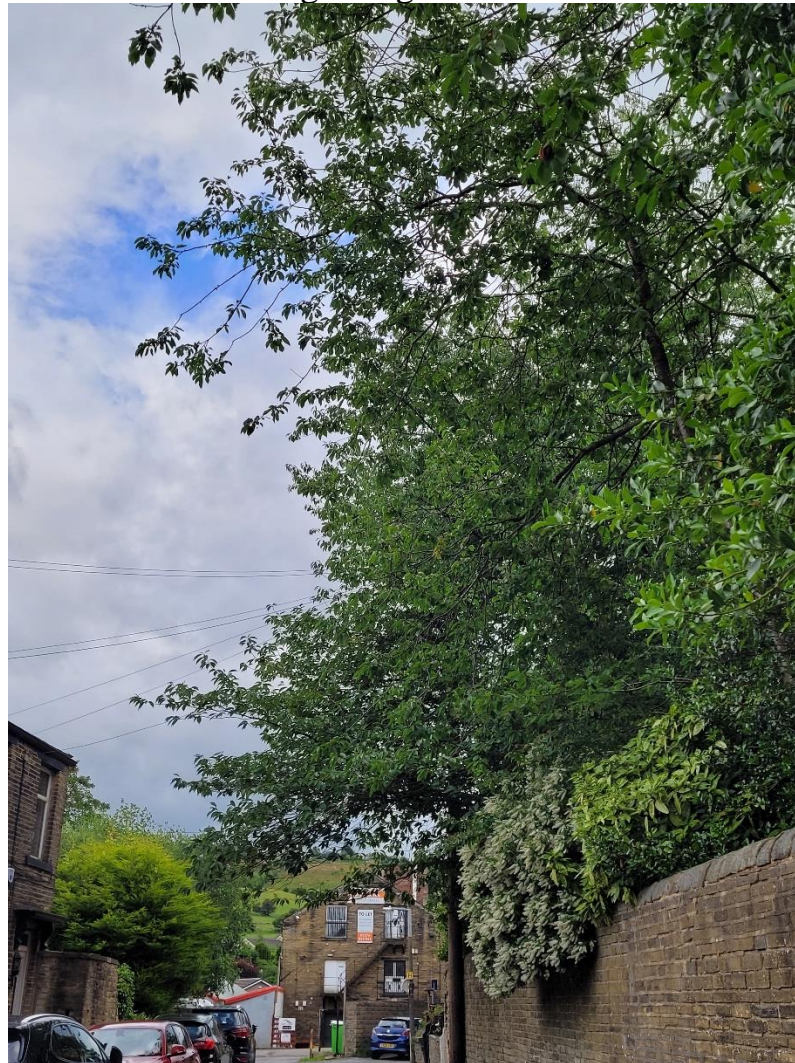
T010 has several minor branches beginning to interfere with the road. Pictured below.

T009	Wild Cherry (<i>Prunus avium</i>)	Car park	Height (m): 10 Crown Radius (m): 2 DBH (cm): 25 Life Stage: Mature	No obvious defects	Good	3 Years	No action required. Timescale: No Action
T010	Wild Cherry (<i>Prunus avium</i>)		Height (m): 7 Crown Radius (m): 4 DBH (cm): 50 Life Stage: Mature	Historic reduction wounds, suppressed branches growing mainly laterally.	Good	3 Years	Reduce lateral branches above road by 2-3m to suitable growth points. Timescale: 11-Jul-2024 (Medium 1 Year)

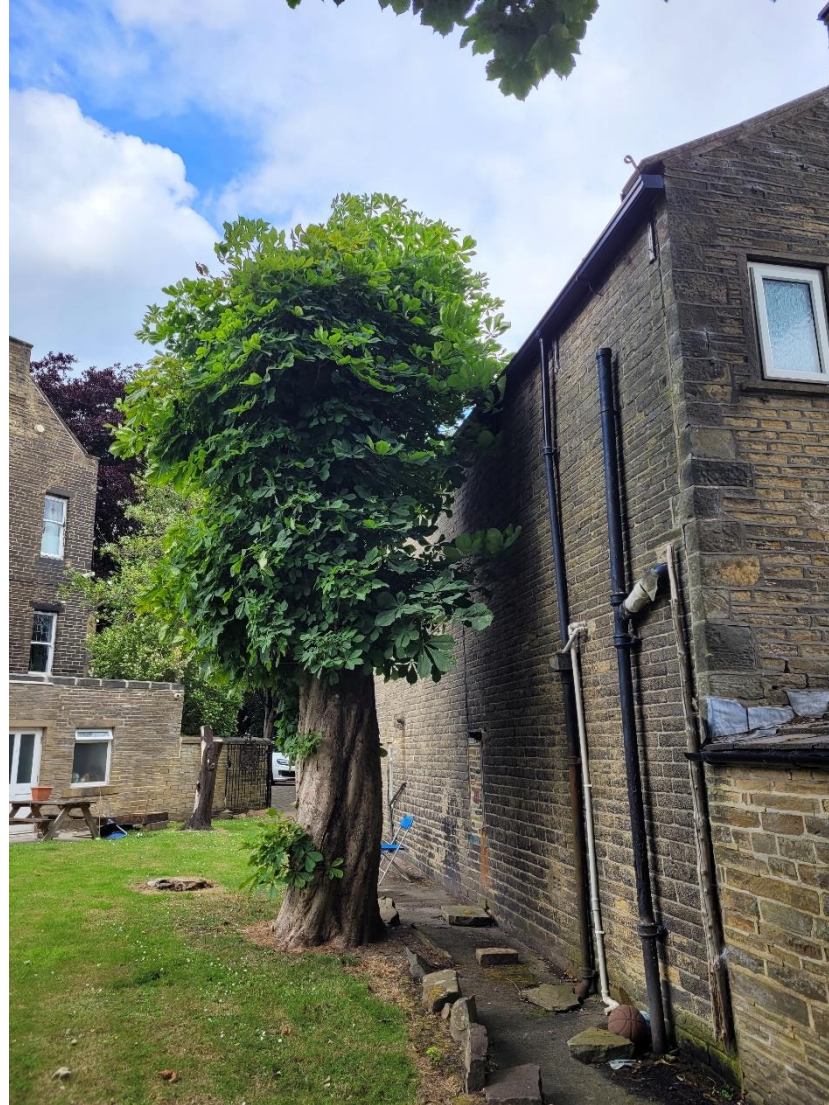
T014 has been previously pollarded, the regrowth is coming into contact with a neighbouring structure, this should be pruned to create 2m clearance.

Ref.	Species	Description	Measurements	Survey Notes	Vitality	Inspect Period	Recommendations
T011	Common Holly (<i>Ilex aquifolium</i>)	Car park	Height (m): 4 Crown Radius (m): 1 DBH (cm): 10 Life Stage: Early Mature	No obvious defects	Good	3 Years	No action required. Timescale: No Action
T012	Wild Cherry (<i>Prunus avium</i>)		Height (m): 12 Crown Radius (m): 4 DBH (cm): 65 Life Stage: Mature	Large specimen for the species, historic pruning work away from neighbouring structure.	Good	3 Years	No action required. Timescale: No Action
T013	Common Holly (<i>Ilex aquifolium</i>)	Path to garden	Height (m): 5 Crown Radius (m): 1 DBH (cm): 30 Life Stage: Mature	Reduced vitality, close proximity to wall.	Fair	3 Years	No action required. Timescale: No Action
T014	Horse Chestnut (<i>Aesculus hippocastanum</i>)	Garden area	Height (m): 6 Crown Radius (m): 1 DBH (cm): 75 Life Stage: Mature	Heavily pollarded tree, minor branches encroaching on gutter of adjacent building.	Good	3 Years	Prune minor branches away from building. Timescale: 11-Jul-2024 (Medium 1 Year)

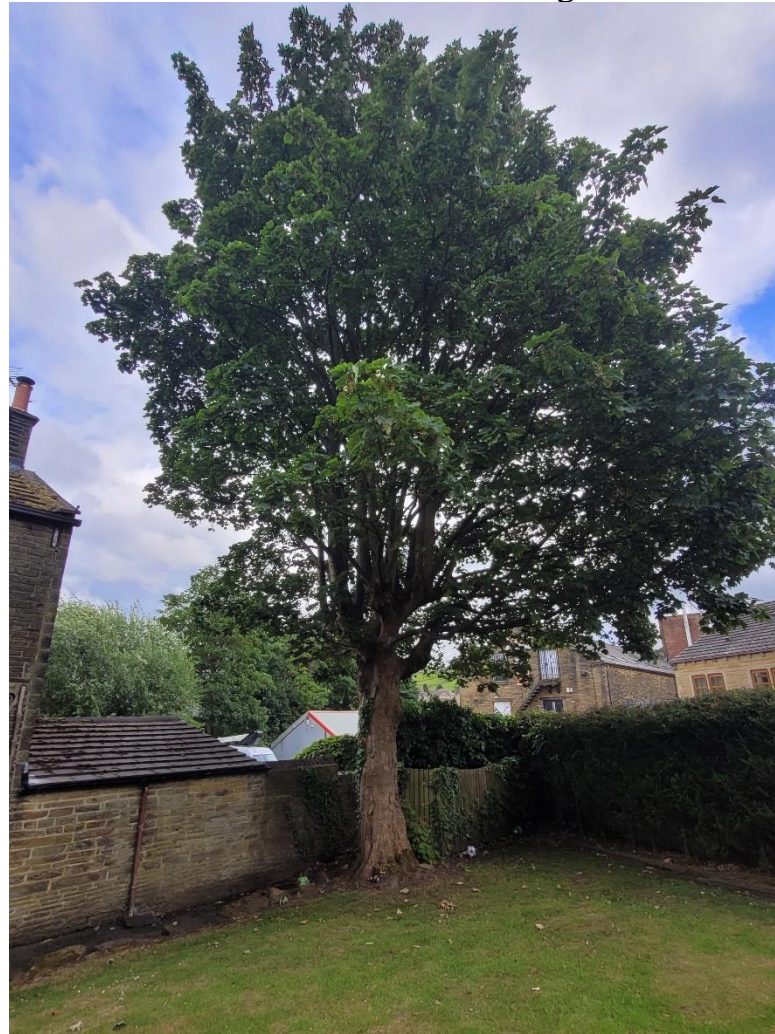
T015 is a lapsed pollard, the regrowth is of a size where snap outs may become more likely, a crown reduction will reduce the risk of this occurring.

T015	Sycamore (<i>Acer pseudoplatanus</i>)	Lapsed pollard, garden area.	Height (m): 18 Crown Radius (m): 5 DBH (cm): 65 Life Stage: Mature	Tree previously pollarded to 5m, regrowth is likely to have poor attachment points.	Good	3 Years	Reduce overall canopy by 3-4m to suitable growth points to reduce risk of limbs tearing out from old pollard points. Timescale: 11-Jul-2024 (Medium 1 Year)
