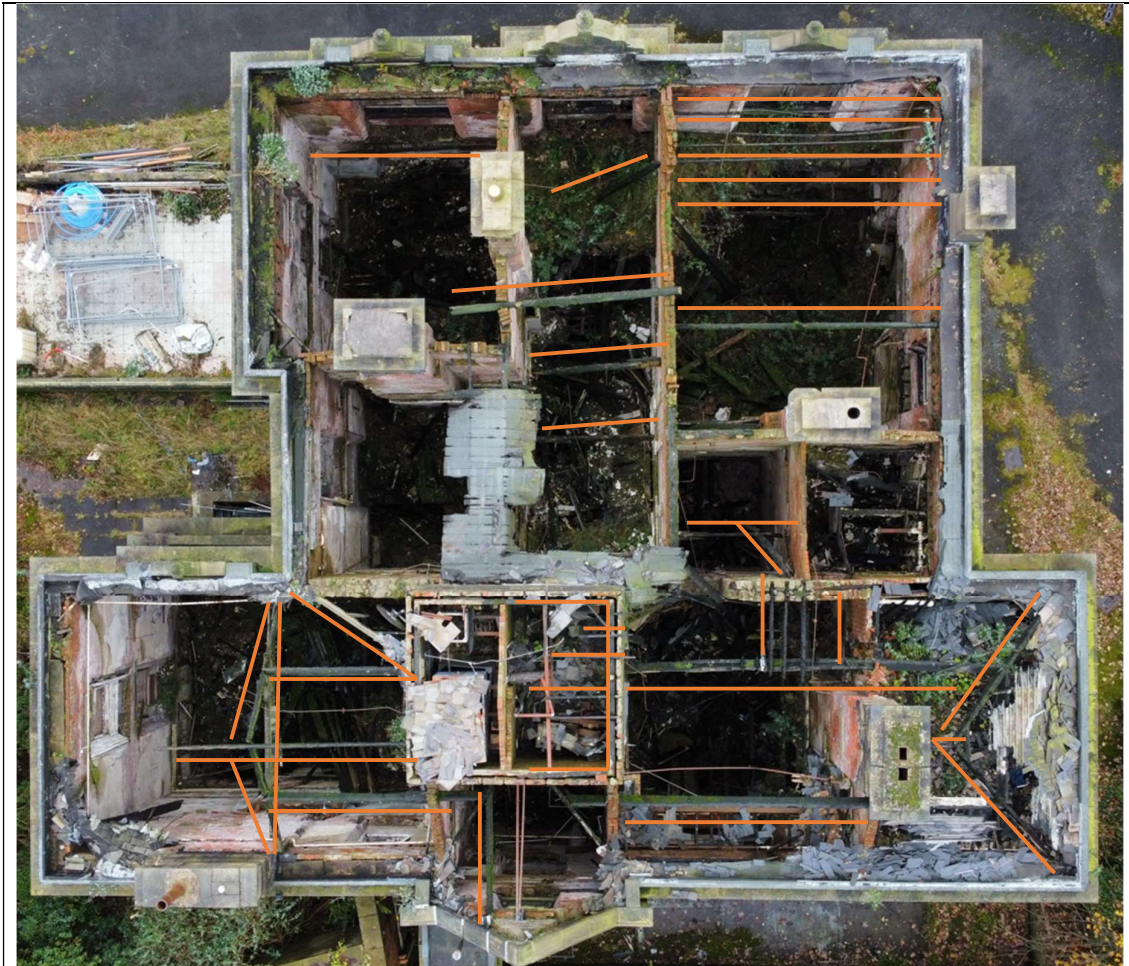
Below is an overhead photo of the building. We have highlighted the timbers we can see that need to be removed on the photo (orange lines) and included close-up photos below. We have not highlighted all of the slates and debris etc. as some may only become apparent when close-up in person. We have 86 drone photos of the site, we have not included all of these in this report, however, we would be happy to send these over to the Local Authority if needed.

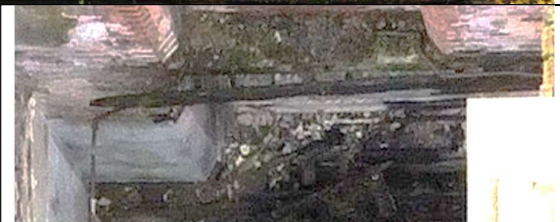
Remains of one ground floor joist – this looks to be hanging out of a pocket in one of the internal walls. As there is no floor, we envisage that the contractors will have to stand in the former cellars and this joist hanging down presents a danger to them. It cannot be re-used.

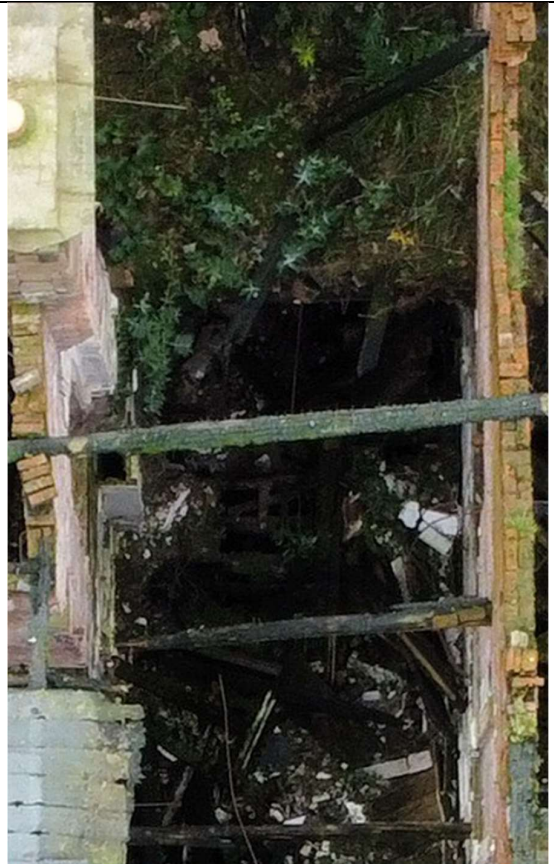
Former hallway area - removal of 4 fire-damaged timbers which formed parts of the roof and floor structure.

These cannot be re-used.

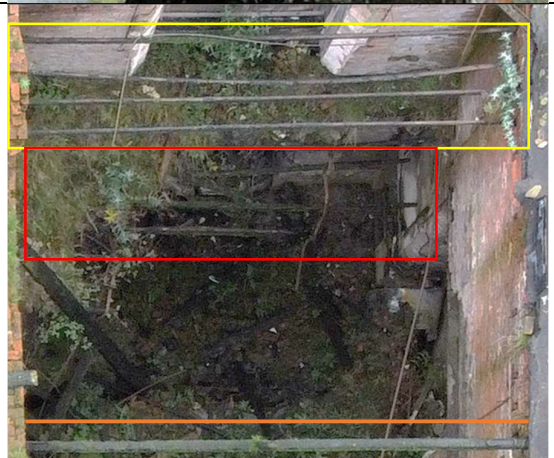
Front left-hand room – removal of the fire-damaged roof and floor timbers.

These cannot be re-used.

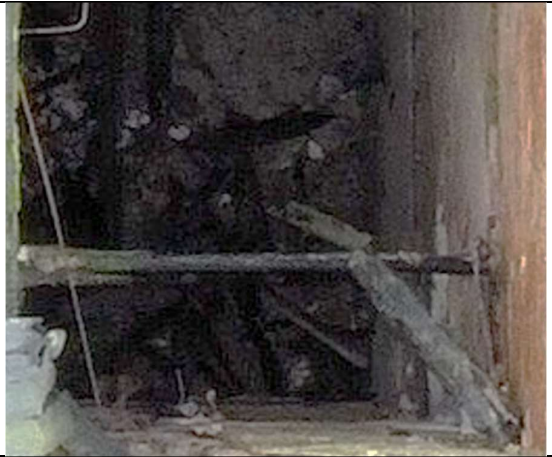
Centre-right-hand room – removal of timbers.

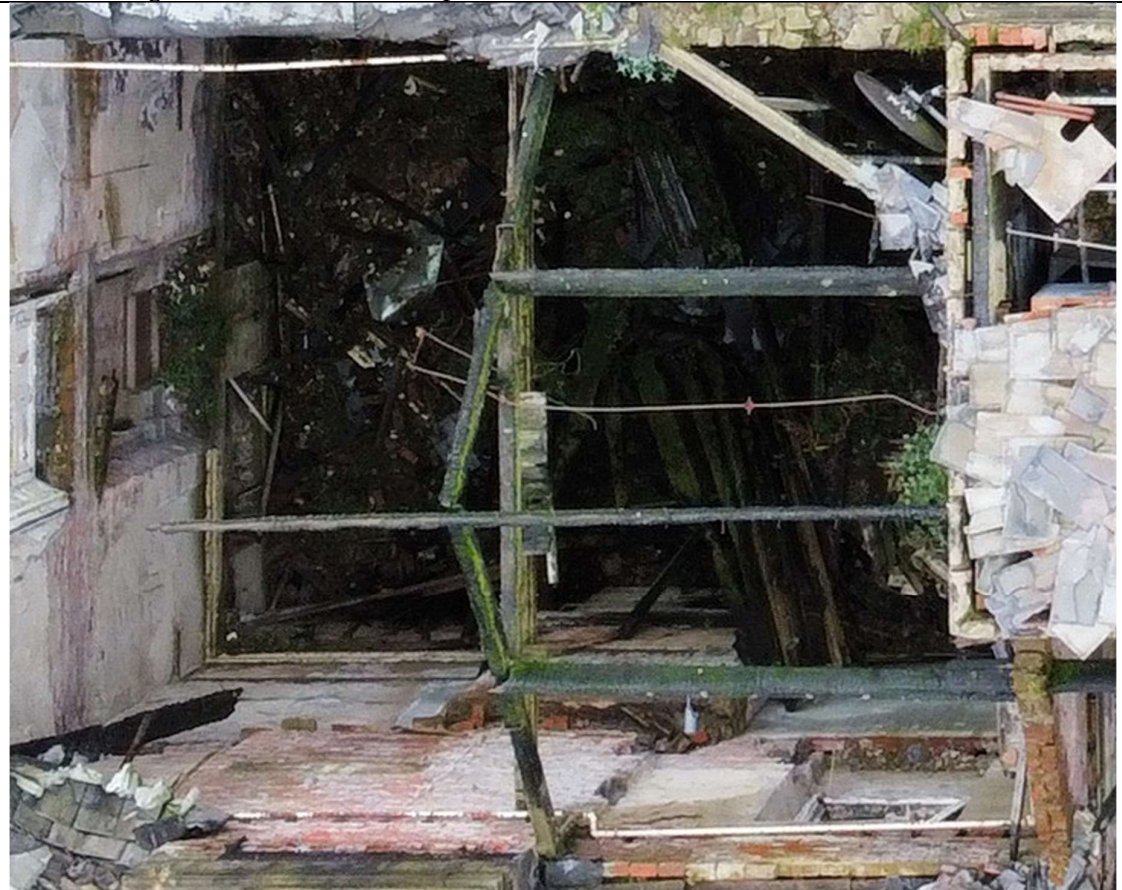
Rear right-hand room – removal of the remaining fire-damaged roof structure and slates etc. These cannot be re-used and we are concerned that as there is no longer a loaded structure above the timbers and they are not adequately braced, they could begin to dislodge the masonry and brickwork around the wallheads causing further damage to the building and creating additional risks to trespassers.

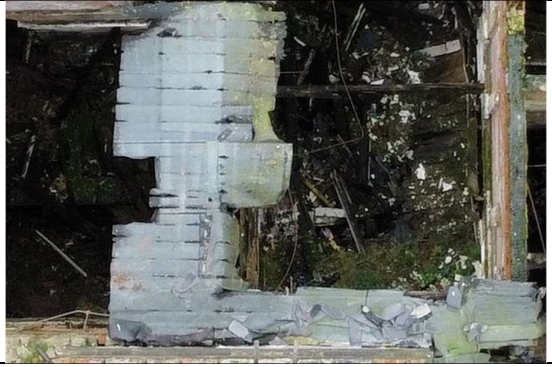
Centre – remove flat roof covering.

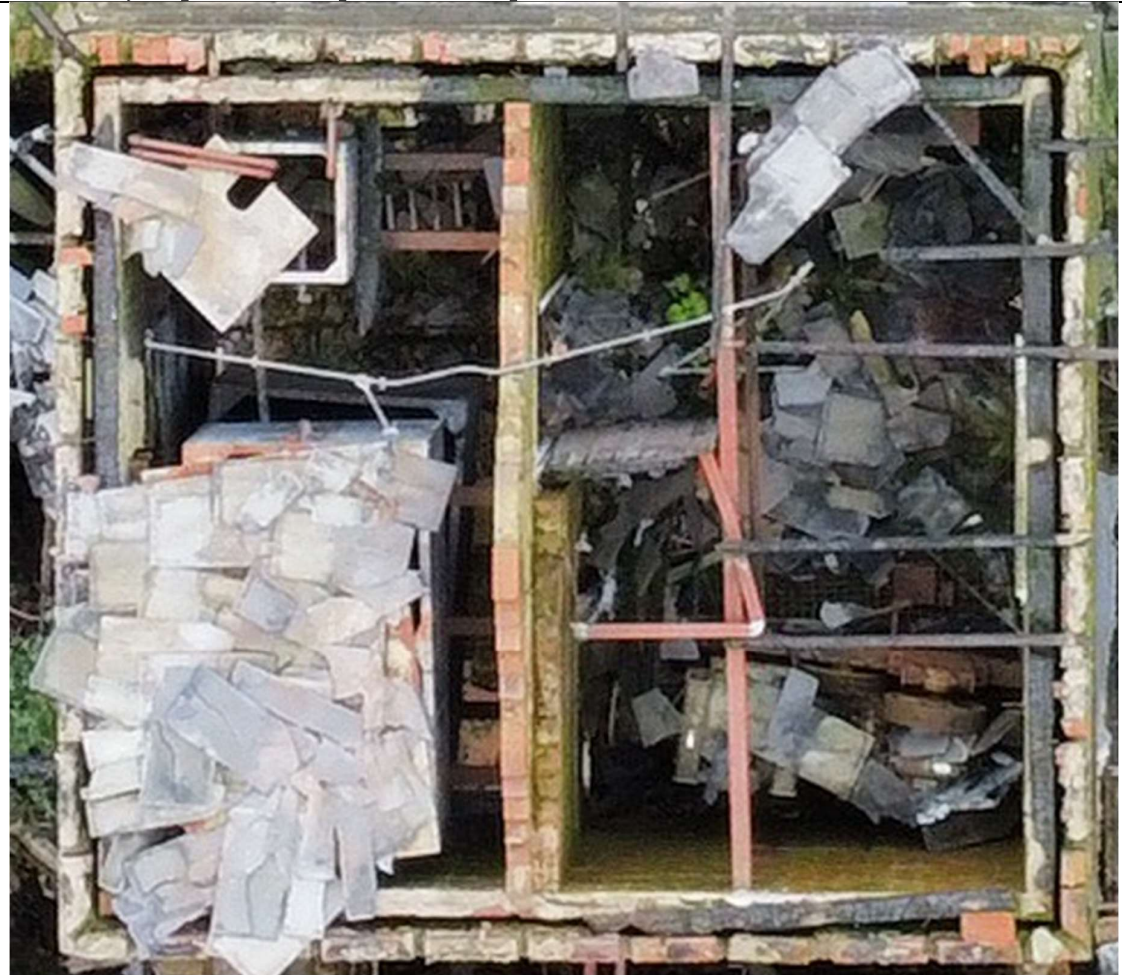
Centre tank room and lift shaft – removal of timber, loose materials and tanks and machinery (if possible) (to prevent attempted theft).

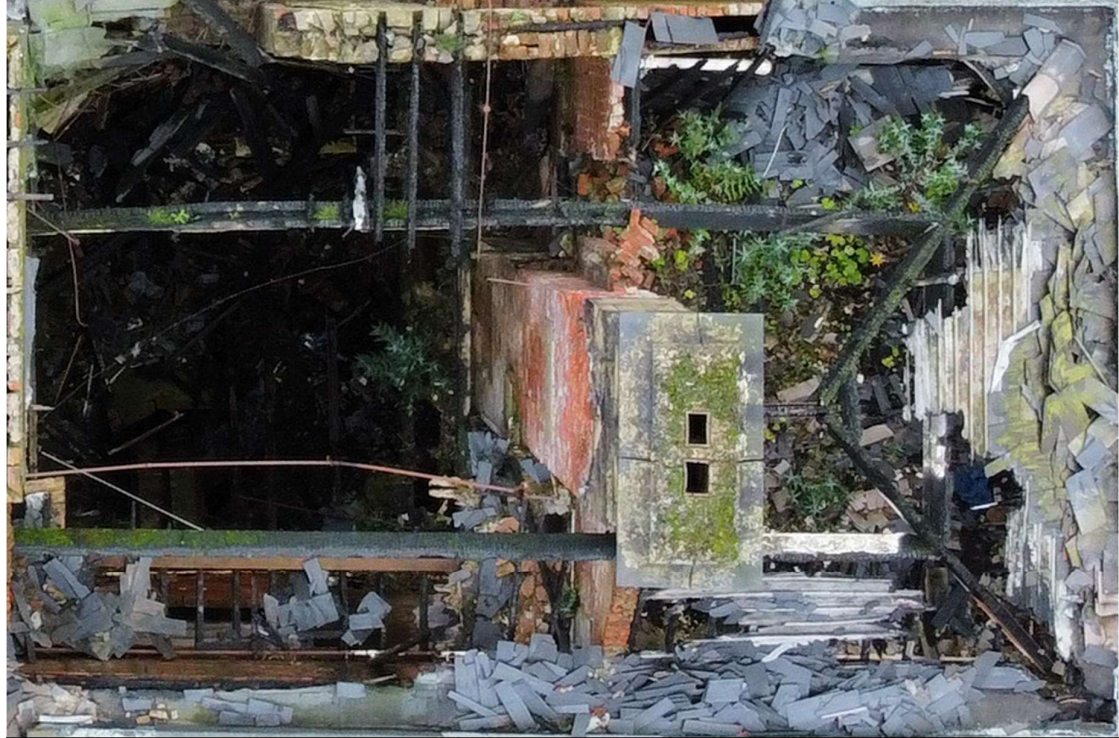
Rear left-hand rooms – removal of the remaining roof structure and slates, vegetation etc.

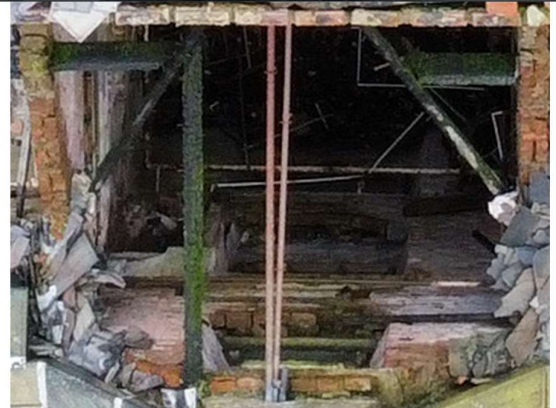
Rear centre room – remove fire-damaged timbers and loose material.

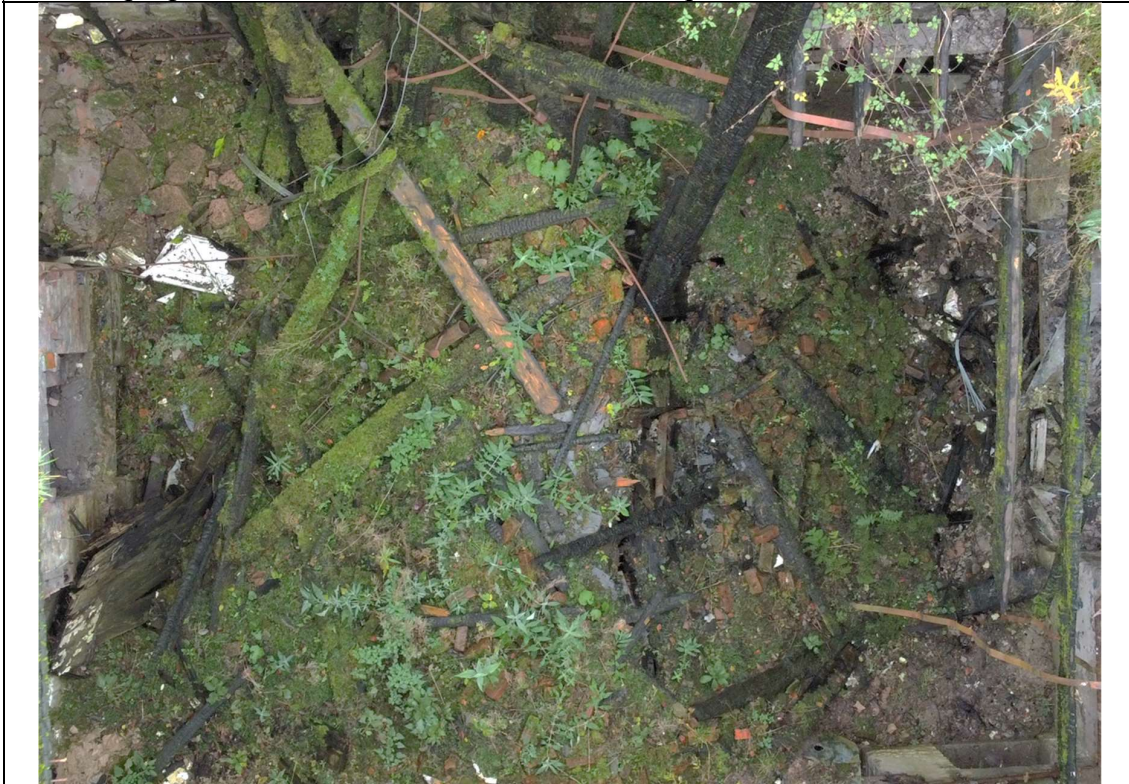
To clear out the fire/water damaged remains contained within the building structure. At present, the interior of the building is too dangerous to access to document this. A further complication is that everything above the cellar has fallen into the cellars. It will therefore be difficult to determine which rooms the remains are from. The photos in Section 7.3 illustrate what the applicant is up against here.

An example photo of the interior of the house. Further photos can be seen in Section 7.3.

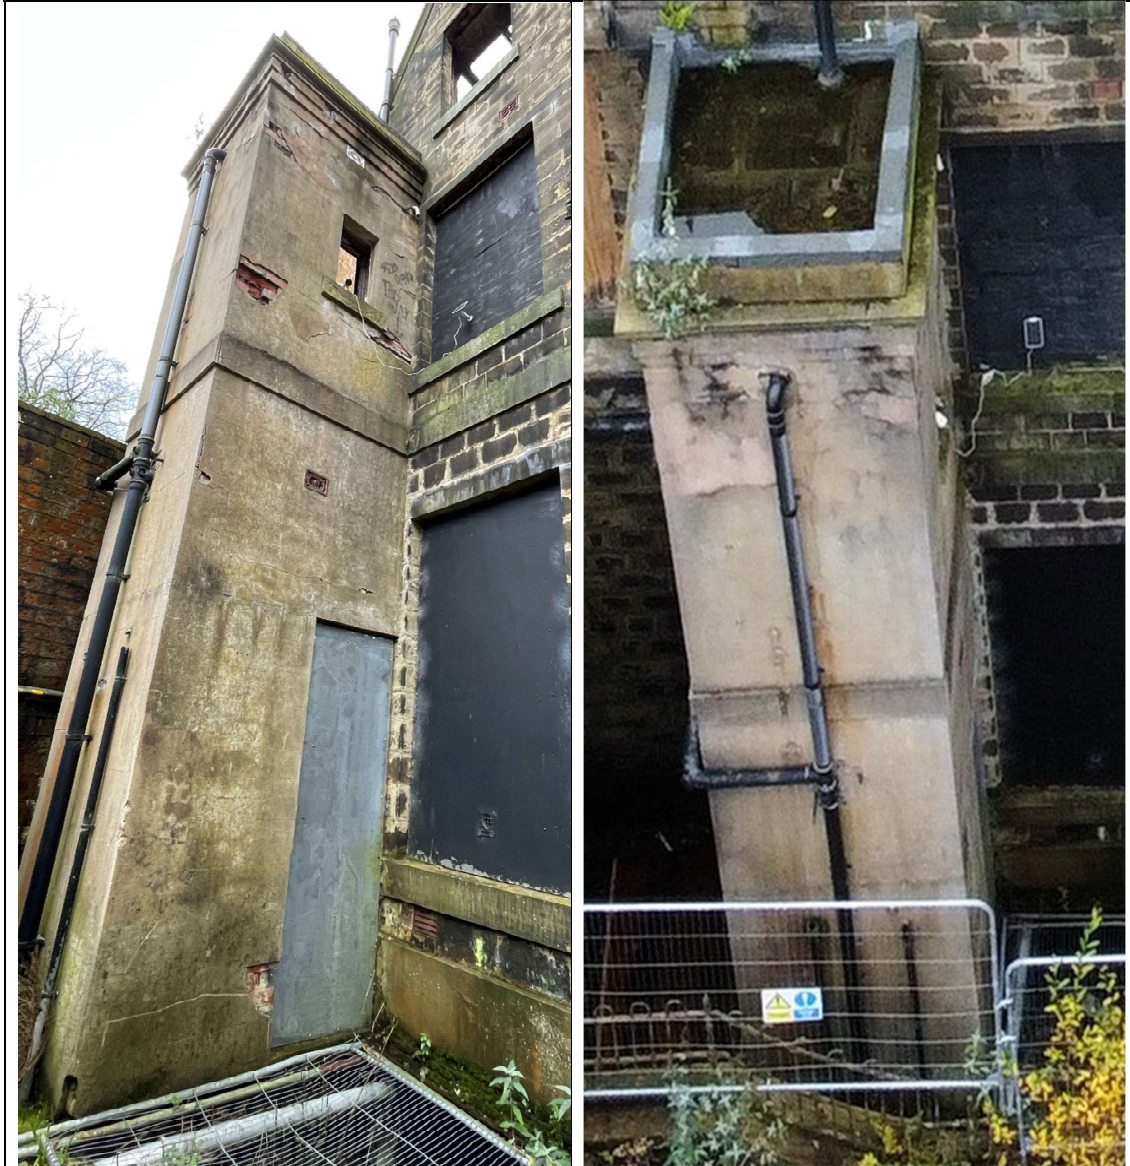
Two-storey brick-built rendered off-shot, pictured below and the original rear elevation that this section is 'built off'.

The off-shot is constructed from brick with a stucco-type finish and a decorative stone cornice and a flat mineral felt roof. The quality of materials used in this addition are, bar the cornice, of a vastly inferior quality to those used in the main house as evidenced by its comparatively dilapidated condition.

The proportions of this part of the building including its windows and doors do not match those of the main house, and its positioning immediately adjacent to two of the windows on the main house confuses the proportions and appearance of this elevation.

Permission is sought to demolish this structure and undertake appropriate repairs to the original rear elevation as part of the wider restoration and refurbishment project.
