HORNCLIFFE MANSION BURY ROAD, EDENFIELD, BB4 6JS

PROPOSED PHASE 2 WORKS MAIN HOUSE

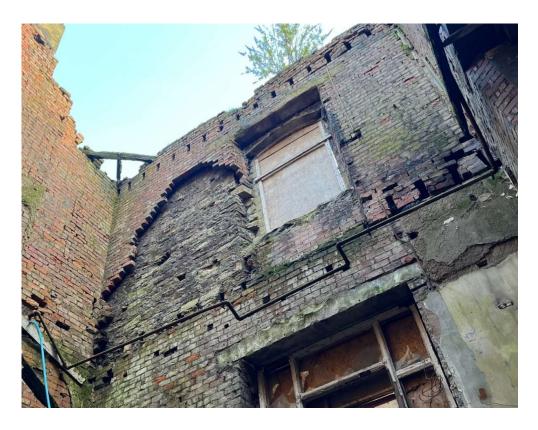
Photo 1, Room F3 Rebuild brickwork to support brickwork above.

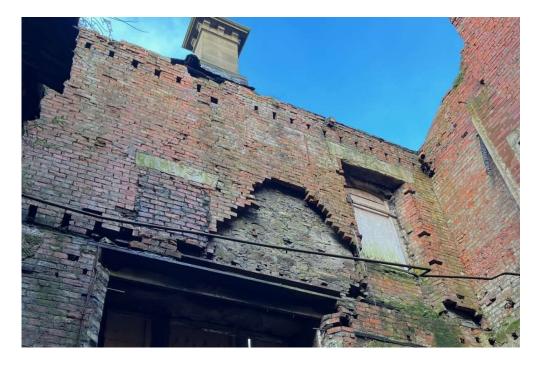
Photo 2 Room F1 Rebuild brickwork to support brickwork above.

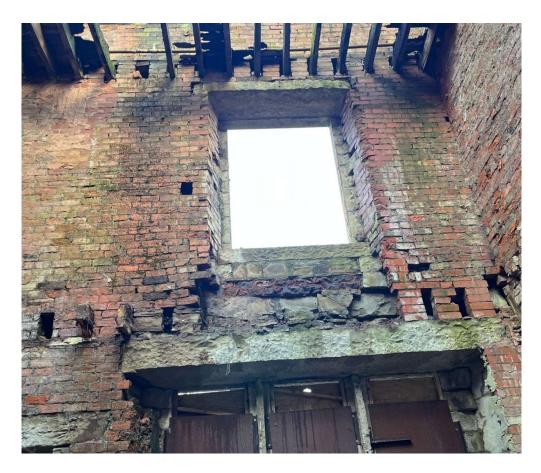
Room F9, rebuild brickwork under window.
