## Arboricultural Report

Alleged Root Damage to:

Trinity Court  
Trinity Street  
Ryde  
PO33 2AU

| REPORT DATE: | 13/12/2023 |

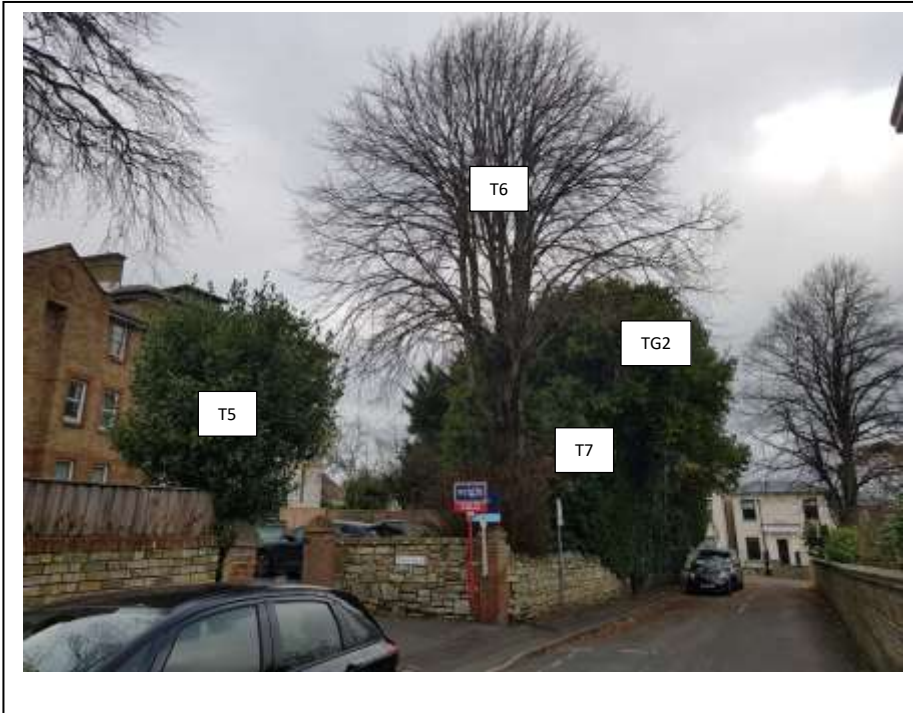
View of front boundary

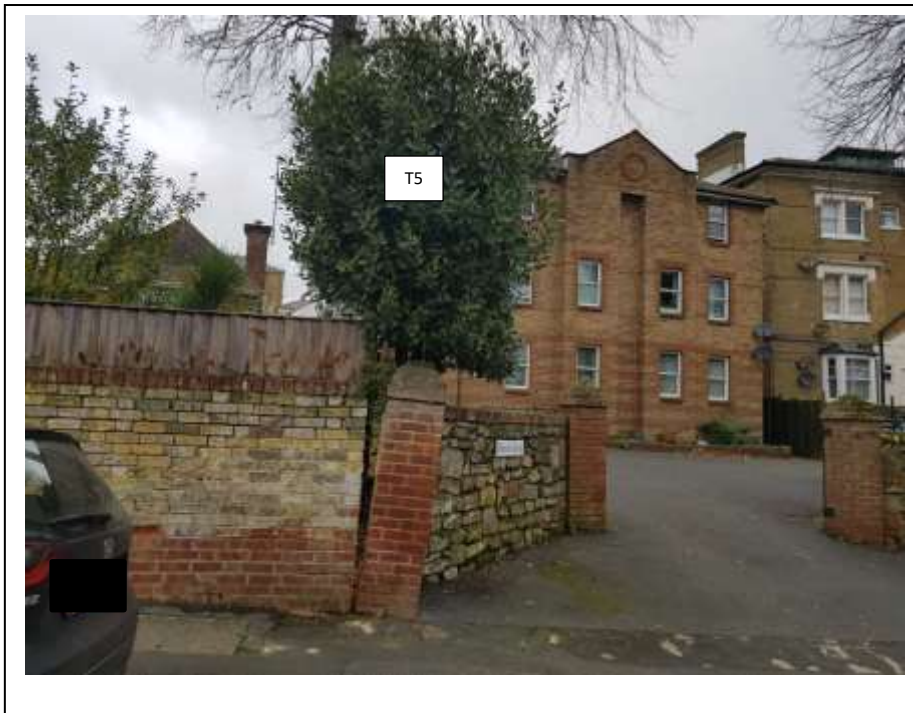
- 3.1 The damage relates to bulging of the front wall adjacent to T6. We also noted that the pier adjacent to T5 was also leaning with cracks where it meets the adjacent wall.

- 4.2 A similar situation exists at T5 which is at the junction of the front and left boundary walls. Again, the base of the tree is in contact with the base of the wall and cracking is present in the adjacent wall, with movement of the adjacent pier also apparent. It is therefore also highly likely that the tree is causing direct damage to the wall as it grows in this location as well.

View of pier adjacent to T5

- 4.6 There is insufficient room in both cases for mitigation works such as pruning, so it would either be necessary to remove the offending trees or to rebuild the walls to accommodate the trees, including room for future growth.

| Tree No. | Species | Ht. (m) | Dia. (mm) | Crown Spread (m) | Dist. to building (m) | Age Classification | Location/Ownership |
|---|---|---|---|---|---|---|---|
| Recommendation | | Remove (fell) to near ground level and treat stump to inhibit regrowth. | | | | | |

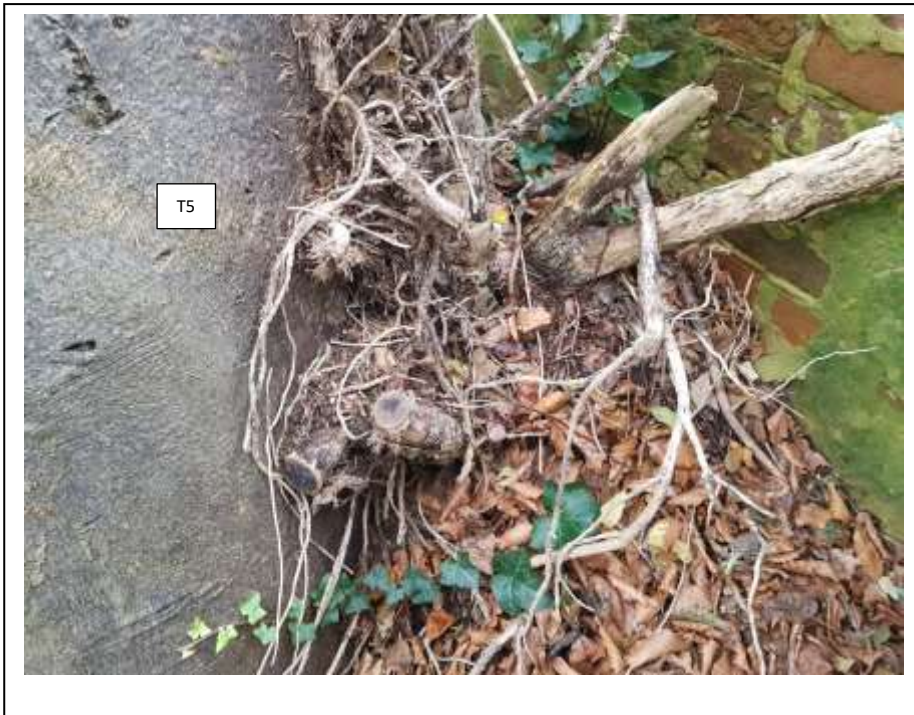
View of base of T5

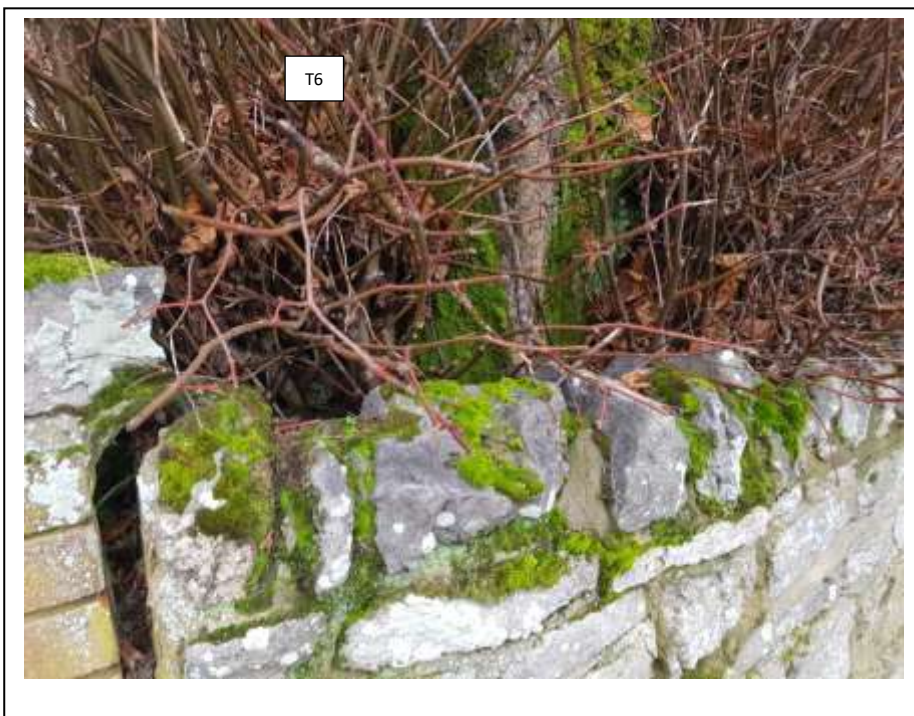
- 4.1 T6 is growing in close proximity to the front wall and has a large amount of basal growth which is in contact with the wall. The bulge in the wall and other cracking is directly adjacent to the base of the tree and no gap was visible between the base of the tree and the wall. It is therefore highly likely that the tree is causing direct damage to the wall.

View of base of T6

| Tree No. | Species | Ht. (m) | Dia. (mm) | Crown Spread (m) | Dist. to building (m) | Age Classification | Location/Ownership |
|---|---|---|---|---|---|---|---|
| Recommendation | | Remove (fell) to near ground level and treat stump to inhibit regrowth. | | | | | |

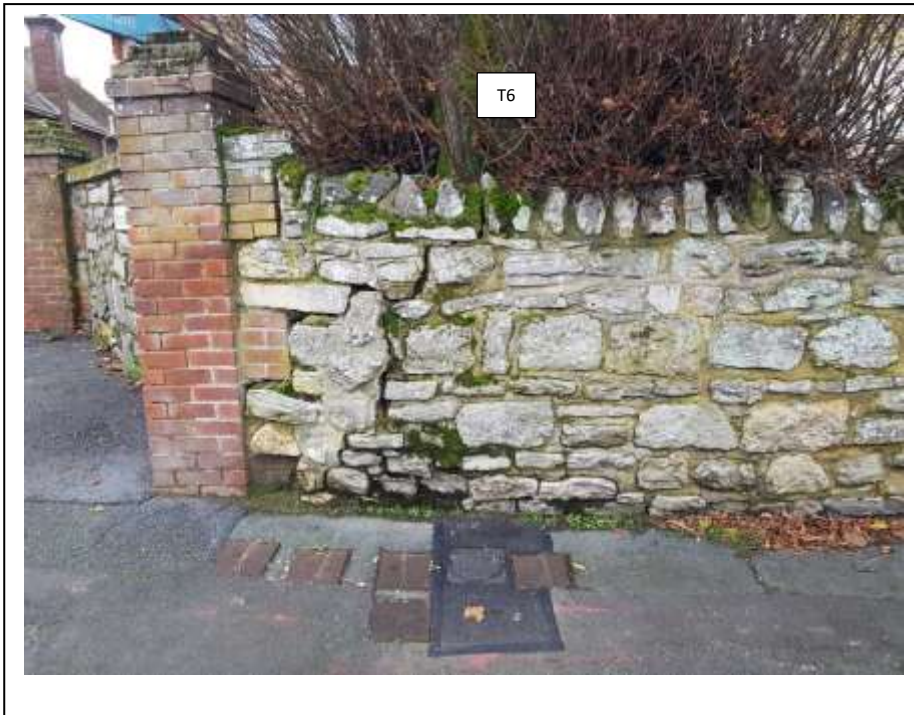
View of damage adjacent to T6

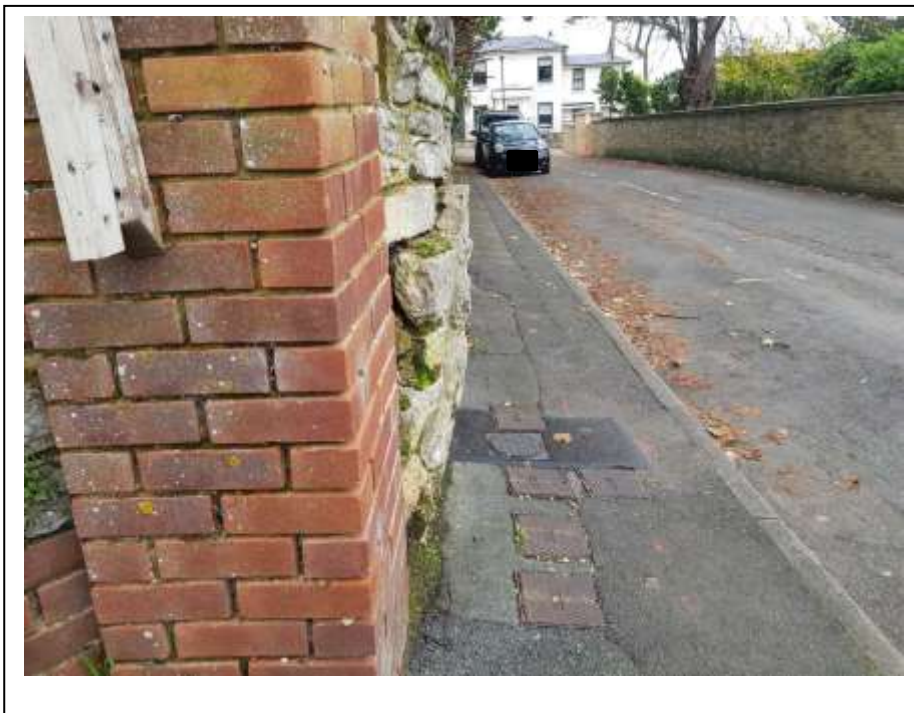
View of bugle adjacent to base of T6
