Tree Condition Report

Wigan Golf Club,
Arley Ln, Haigh, Blackrod,
Wigan WN1 2UH

Wigan Golf Club

Job Ref: 1839

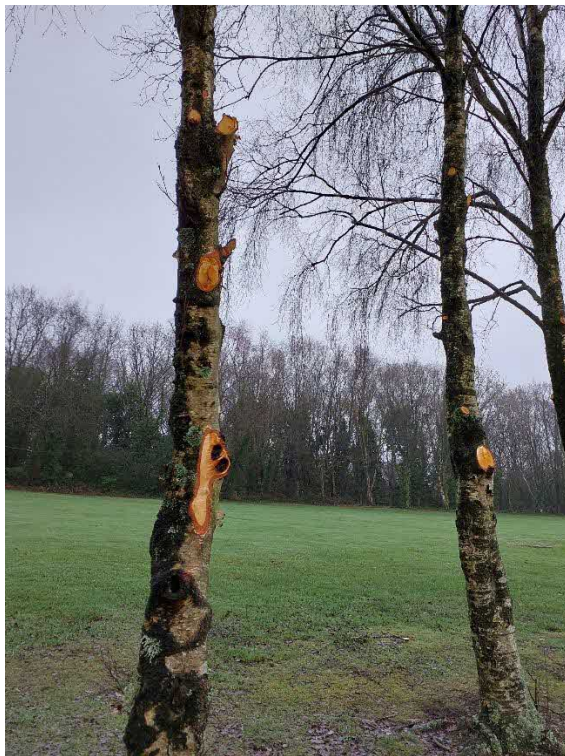
G006 – poor pruning cuts.

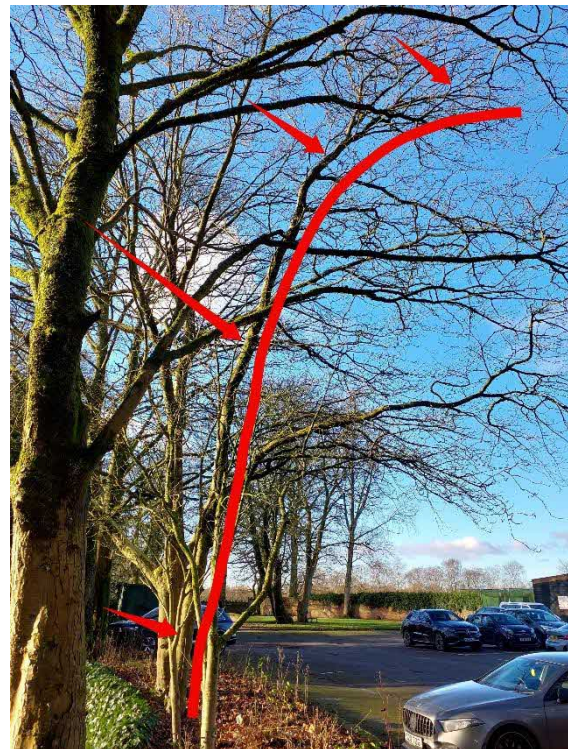
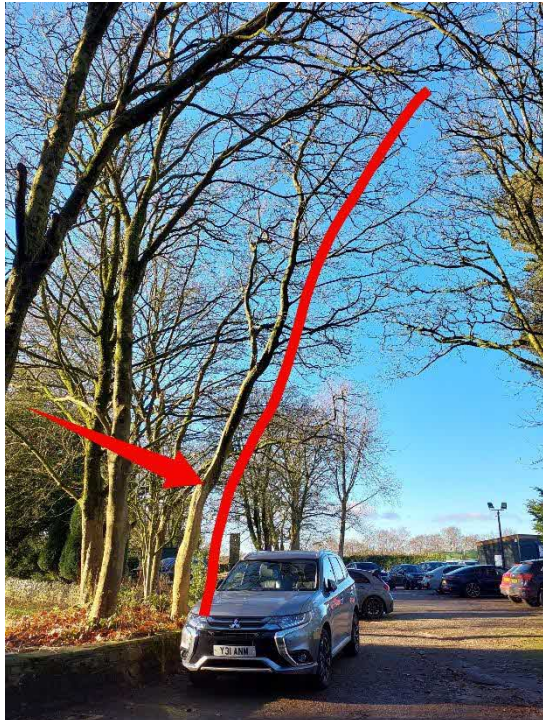
T117 – suppressed tree to be removed.

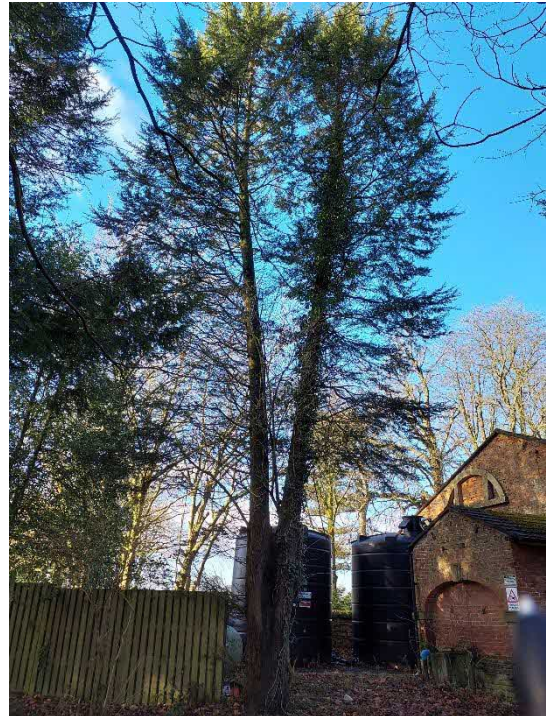
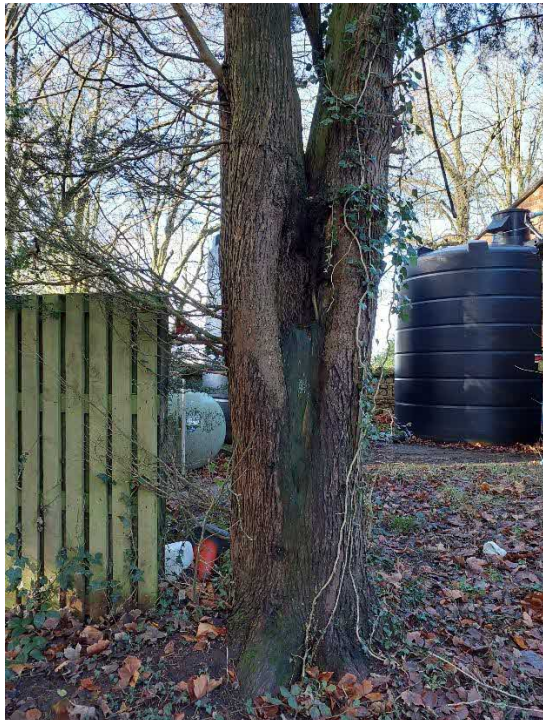
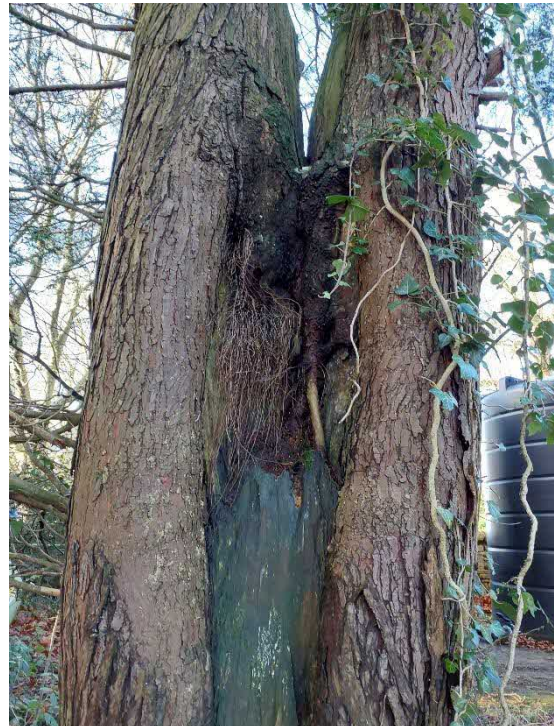
T127 – weak union – remove.

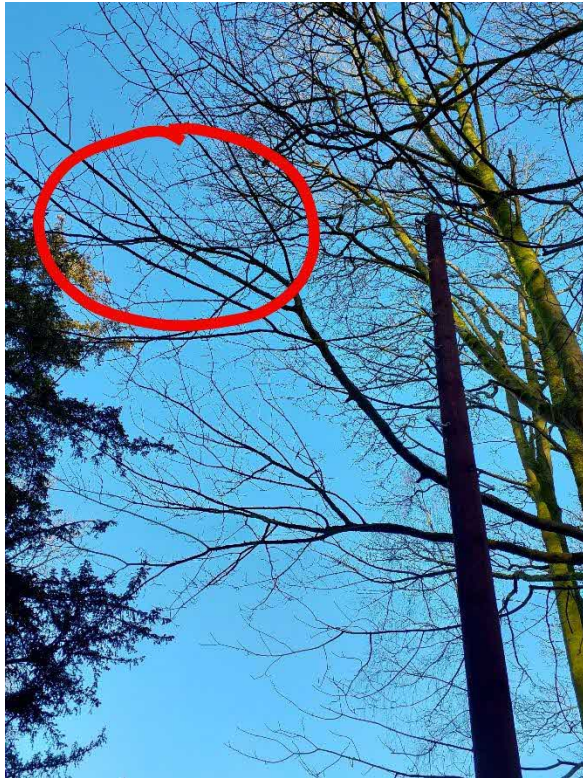
T141 – prune to clear utilities.

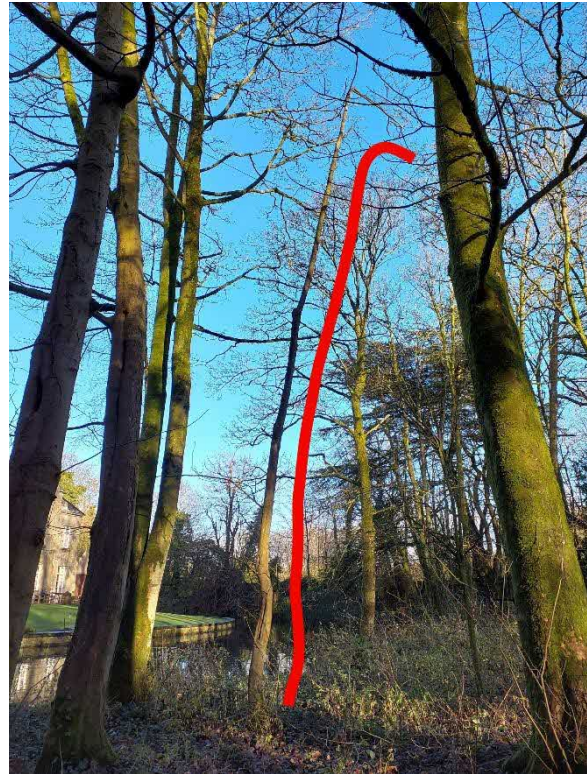
T142 – remove to ground level.

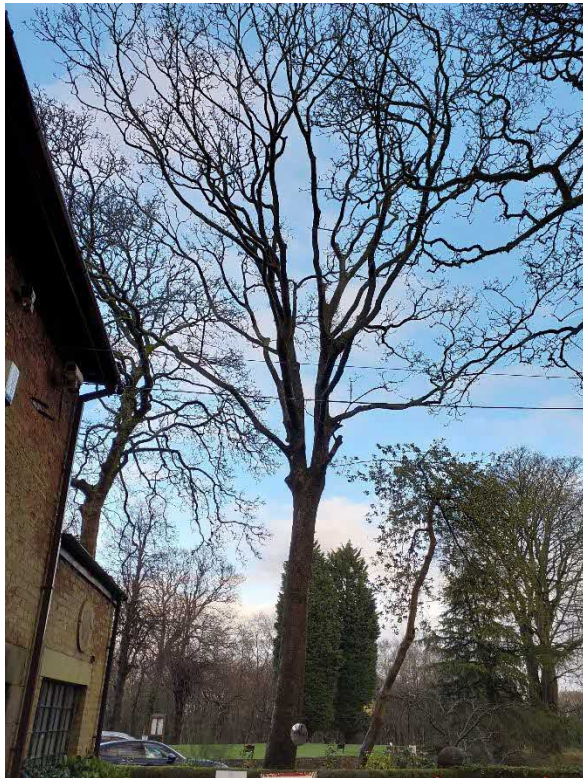
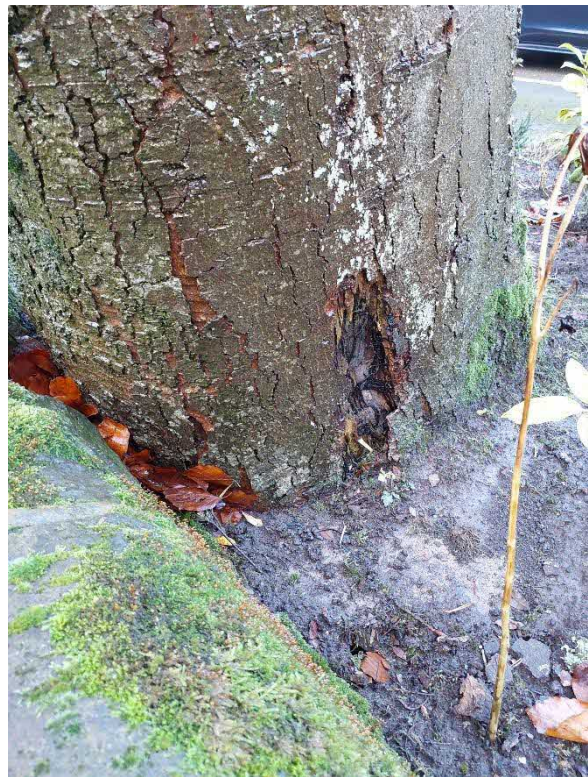
T154 – remove to ground level – NOT covered by TPO, this work can be carried out now, previous report documented honey fungus and decay at base of tree. Client informed prior to this report.

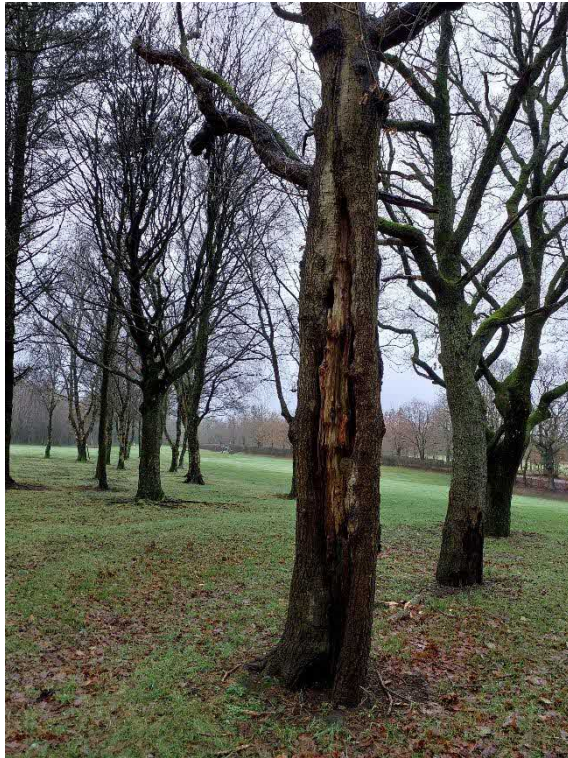
T182 – remove to ground level.

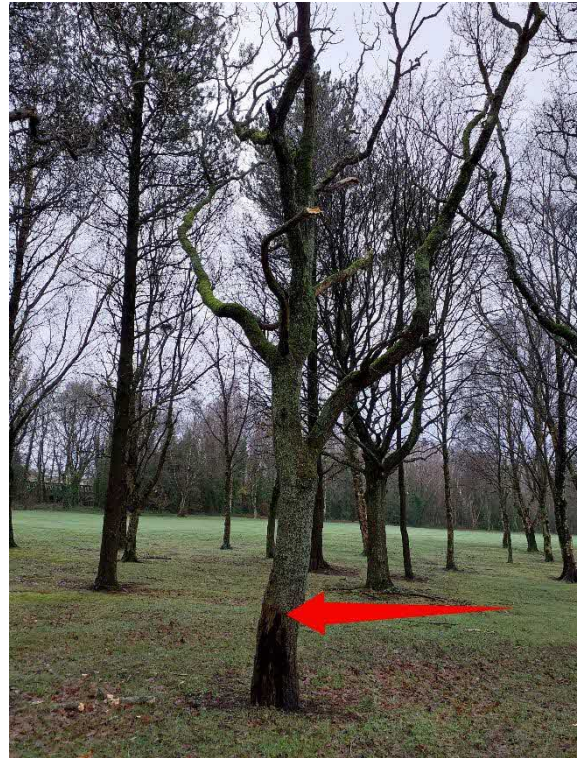
T183 – remove to ground level

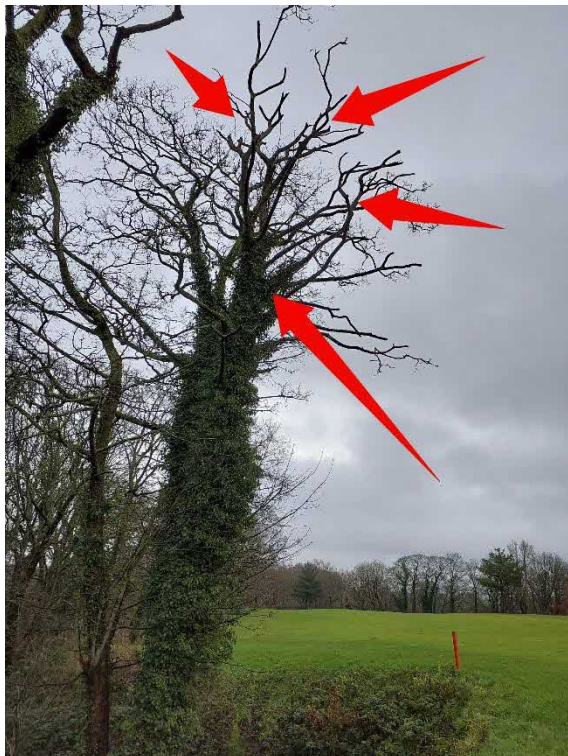
T189 – dieback within canopy – reduce to monolith <10m (can be removed to ground level).

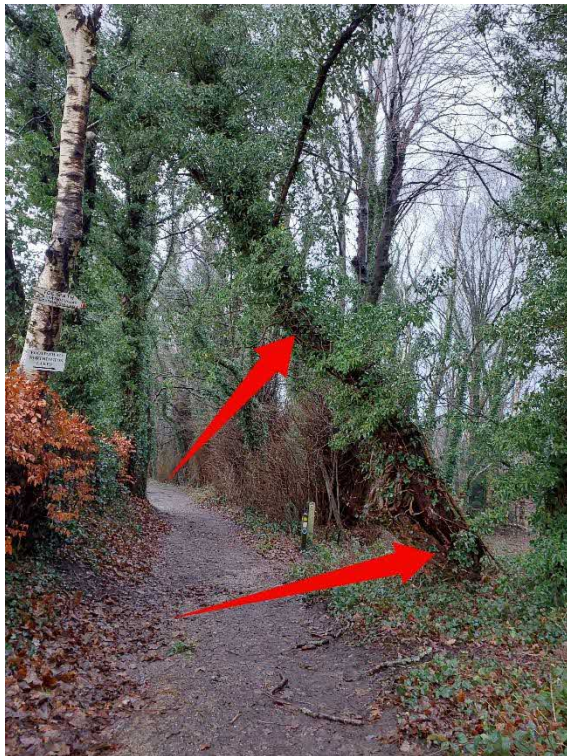
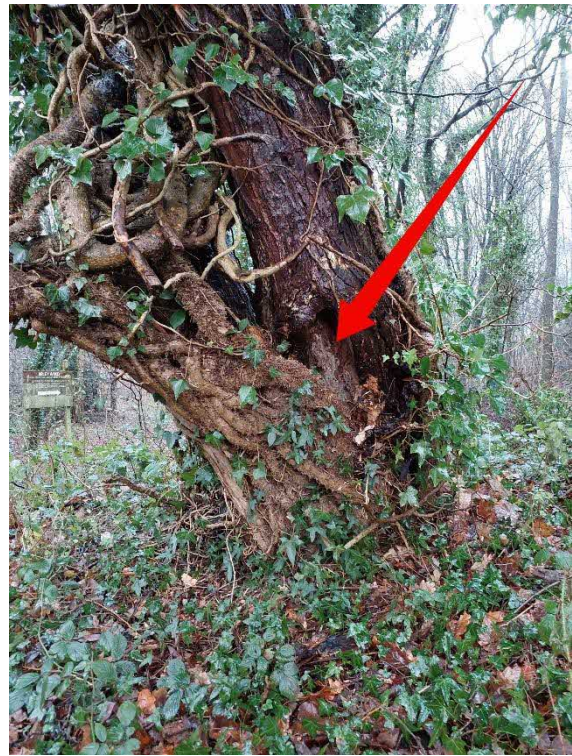
T193 – remove to ground level due to risk of failure over footpath.
