Widdington Recycling Road Improvement Scheme

Highways Works Report

REPORT TITLE: Highways Works Report

Hollow Road – Highways Condition Report

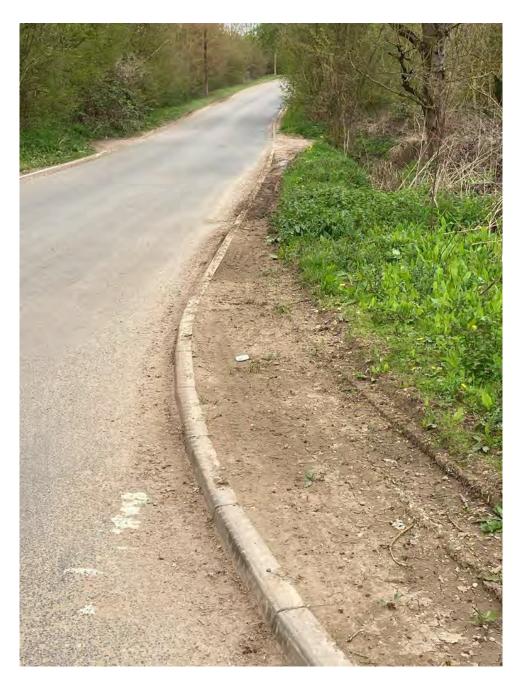
General picture of North Hall Road (looking north from junction with Hollow Road)

5.8 This length of road was found to be in good condition. There was no deterioration of the wearing course of the road. All kerbing was in place and in good condition. All drains were open, and whilst inspection did not extend to checking them, a visual inspection indicated they were free draining.

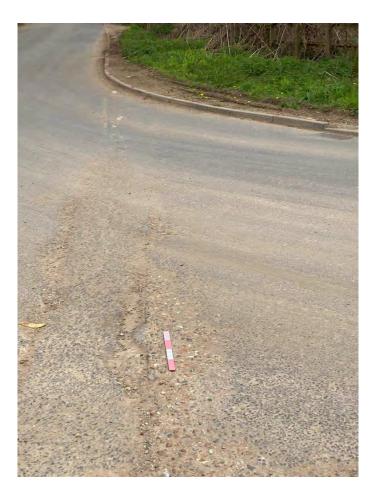
Edge of Junction with Hollow Road and North Hall Road

5.9 The Hollow Road junction is suffering from some disintegration of the wearing course along sections of the edge of the junction.

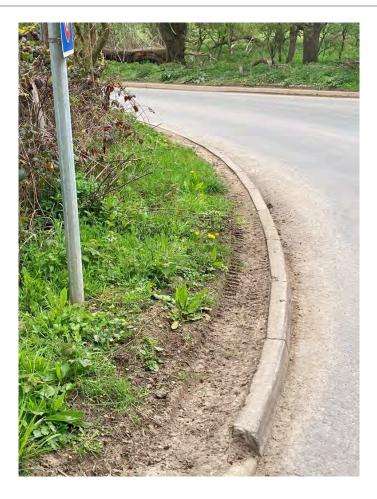
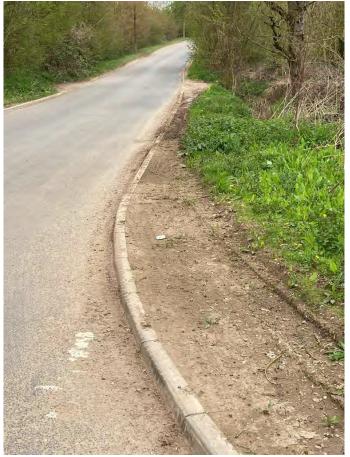
5.10 It is evident that some HGVs are having to cut the corner of the junction as indicated by the worn verge. The Kerbing is not currently damaged.

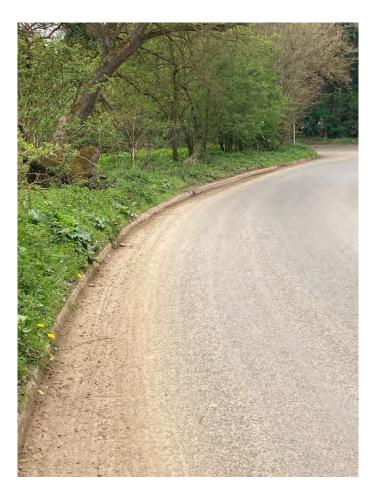
- 5.11 The wearing course is generally in good condition on this section, however there was a significant amount of mud which had been allowed to build up against the verges.
- 5.12 There was evidence of a few cracked kerbs on the southern side of the highway close to the junction.

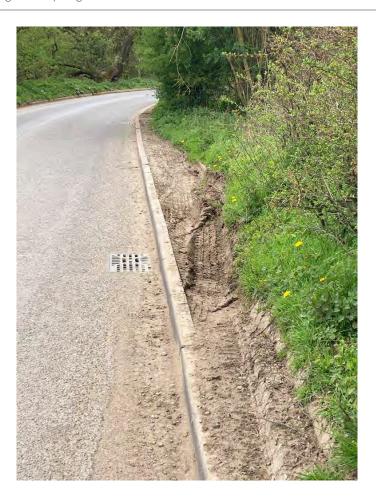
5.13 Drains along this appeared to be fully operational at the point of the junction with North Hall Road, however other drains along this section were noted as being blocked by mud and other debris.

- → A supplier approved by the Local Authority is to be instructed to conduct a CCTV drainage survey and confirm where the existing drainage layout aligns with the records obtained and where it differs. The CCTV to also record where the existing sewers are damaged and require replacement / upgrade.

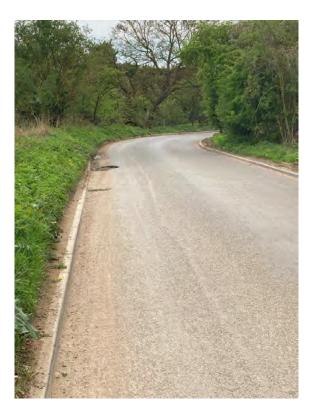
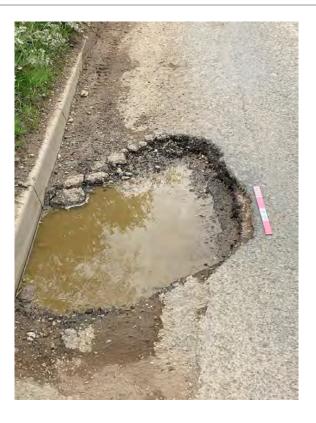
5.14 Past the first corner is a pothole on the southern side of the road which has developed, through the wearing course and sub-base.

- 5.15 The pothole is approximately 1.0m x 1.5m
- 5.16 Confirmation on the status of the road surfacing:

- 6.3 Repair works to fill these potholes are to be conducted as per the following methodology:
- 6.3.1 Confirm the existing carriageway buildup layers at the repair location by the excavation of a trial hole(s). Using standard details of an existing road type design from the Local Highway Authority agree reconstruction for the different types of repair required, noting that at some locations, it will be prudent to replace the carriageway foundation with concrete.

- 6.3.2 Contractors approved by the Local Authority are to be instructed to conduct the following:
 - → Clear potholes of surface water and debris.
 - → Plane the carriageway buildup layers at 300mm wide steps around the pothole down to the layer at which remedial works are required.

- → Fill pothole with build-up materials to tie into surrounding carriageway build-up as per agreed (see para 6.3.1 above) details.
- 6.4 Minor resurfacing works will also be required at locations identified in points 5.21 and 5.33 of the Highway Condition Survey.

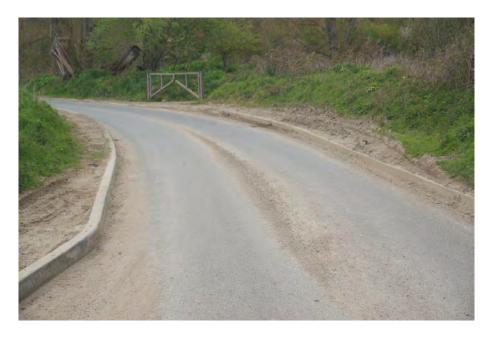
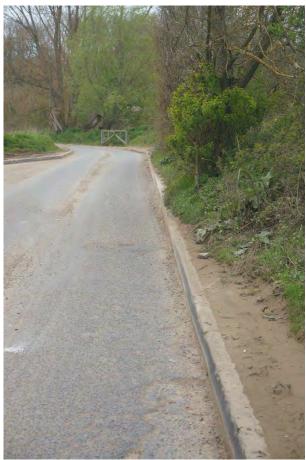
5.17 This section includes the length of highway under the railway bridge. The highway is kerbed and whilst there has been significant disturbance of the verge through vehicle movements, the kerbing is in good condition.

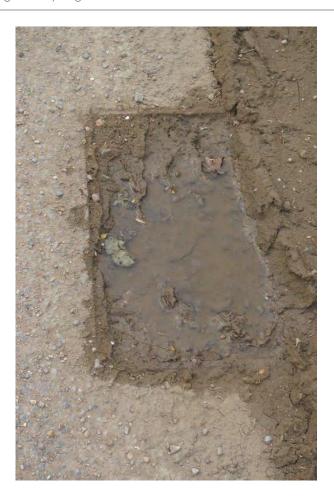
5.18 There does not appear to be any drainage along this section of the highway, however there is evidence of where drain covers may once have been.

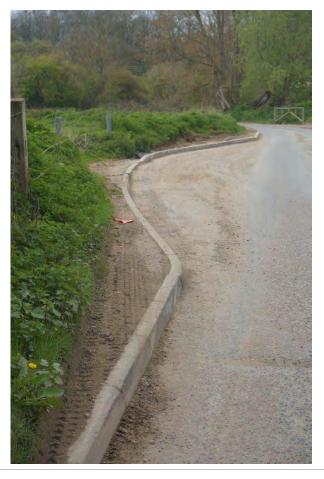
5.19 The road surface prior to the railway bridge appears to be in generally good condition.

- 7.1 Three bituminous paved passing bays have been identified in the Widdington Highway Condition Survey and can be seen in points 5.19 (immediately West of the Railway Bridge), 5.24 (immediately East of the Railway Bridge) and 5.31 (West of the bend prior to the Widdington site access).

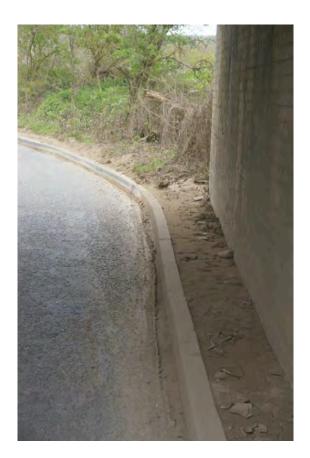
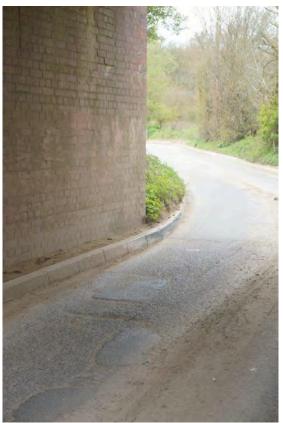
5.20 Under the railway bridge, there is evidence of several historic repairs, all of which are still in reasonable condition.

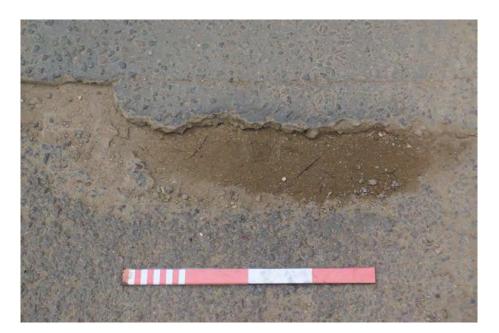
5.21 On the eastern side of the railway bridge, the highway surfacing is starting to degrade and break up in small areas, principally where previews repair work has been undertaken.

- 6.4.1 These resurfacing works are to be conducted using the same methodology as above; plane to an appropriate depth and tie in to the existing carriageway build-up and then replace with materials agreed with the local highway authority.

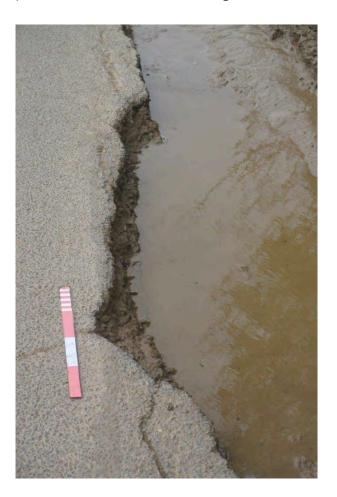
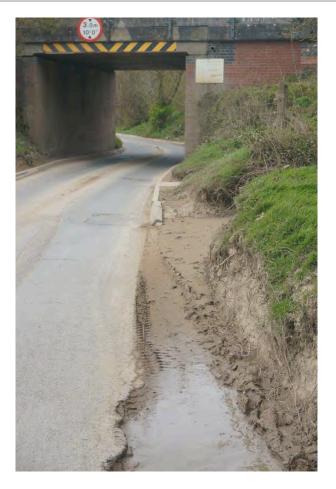
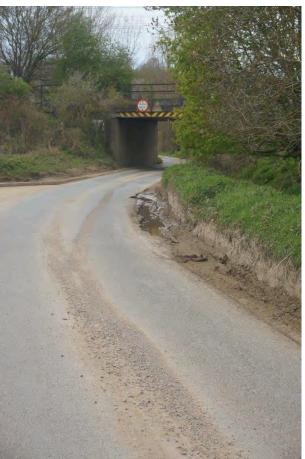
5.22 Where vehicles have travelled beyond the surfaced highway and where there is no kerbing evident, significant potholes are in evidence, at the edge of the constructed highway.

- 7.3 Ad hoc passing bays have been created by HGVs within the verge and provide reason to introduce new bituminous paved passing places. The Highway Condition Survey identified such locations in points 5.22, 5.24 and 5.30. Kerbs are not present to the existing layout at these locations and the edge of the carriageway surface has been directly worn by vehicles.

- 7.5 As part of improvement works to the highway it is proposed that these areas of carriageway surface be repaired and kerbs introduced. Kerb standard details and standards for construction of passing bays can be obtained from the local highway authority and installed. The following methodology outlines how these works will be conducted by contractors approved by the local authority:

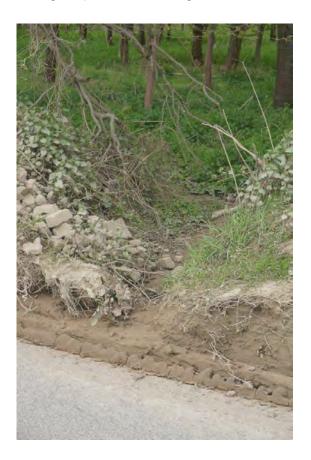
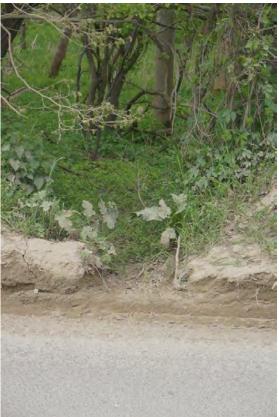
5.23 It is also apparent that there are drainage issues along the length of roadway on the eastern side of the railway bridge. At the time of the inspection, the road was dry, but there was evidence of silt/mud along the edge of the highway and into the verges.

- 8.3.7 Point 5.23 of the Highway Condition Survey shows evidence of washout from the North onto the carriageway. The verge appears to have worn away and created channels for surface water to carry debris into the carriageway. The adopted highway boundary lies a minimum of 3m from the face of the verge and such works can be conducted to repair this wear. This could include raising the verge whilst staying within the adopted highway boundary.

- 8.3.8 The above works are proposed to be conducted under the following methodology by suppliers approved by the local authority:
 - → Clear worn areas and adjacent verge of any vegetation. The waste materials from these works are to be removed and disposed of offsite.

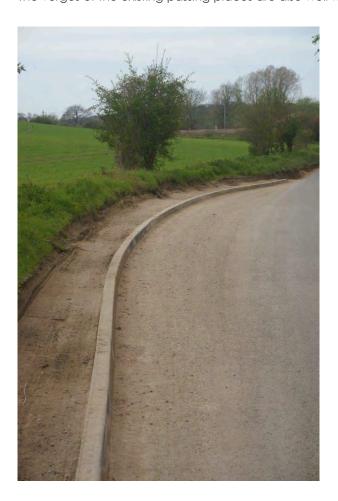
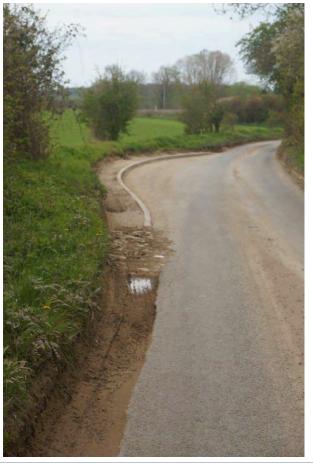
5.24 The verges of the existing passing places are also well worn by HGVs trafficking over the kerbing.

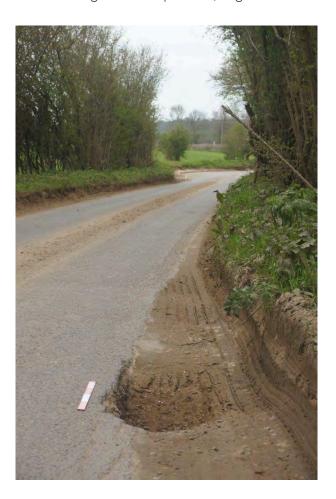
5.25 This is creating issues with potholes/degradation of the road edge.

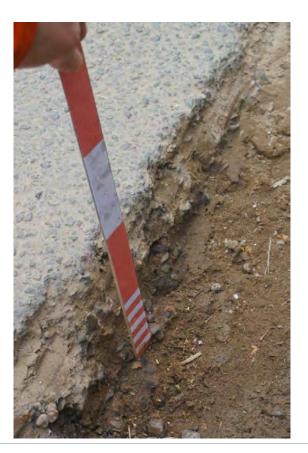
5.26 Deep potholes over 200mm deep are being created through HGV movements on the verges of the road.

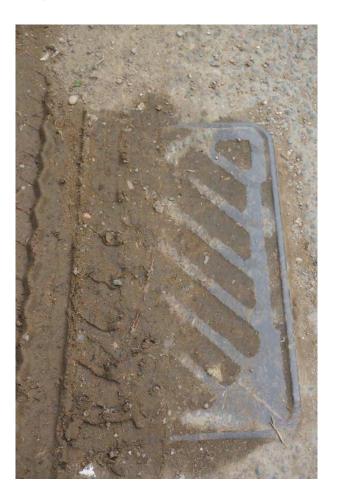
- 8.3.5 Point 5.27 of the Widdingdon Highway Condition Survey shows an existing drain (observed to be blocked) further Eastbound in the carriageway. This suggests a surface water sewer is present in the highway and may connect to the drainage identified to the West of the railway bridge. This shall be confirmed by existing drainage records /the drainage CCTV survey to be obtained during the clearance of blockages in the existing drainage system.

5.27 Drains to the east of the bridge are evident however they are not operational, due to blockages caused by mud/silt run-off.

- → If the above is confirmed additional gullies can be introduced between the railway bridge and drain shown in point 5.27 of the Highway Condition Survey. The number and spacing of the drainage required will be agreed with and subject to the requirements of the local authority based on a maximum distance between drainage inlets and catchment area.

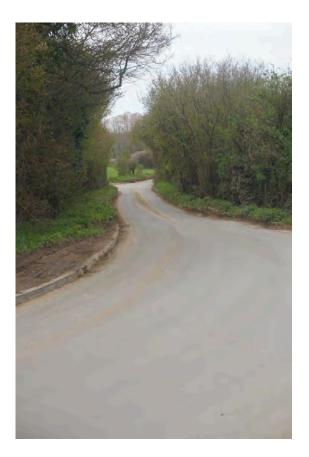
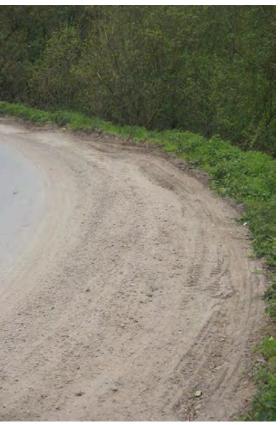
5.28 This section of highway is generally in good repair, however there is some trafficking beyond the engineered surface of the road by HGVs apparent.

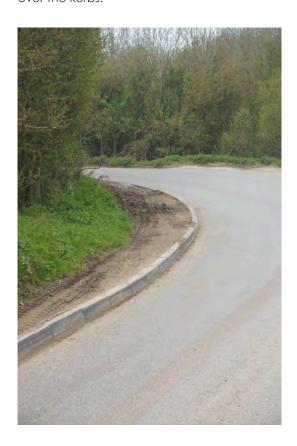
5.29 Where kerbing is in place, it is generally in a good state of repair, notwithstanding the movement of vehicles over the kerbs.

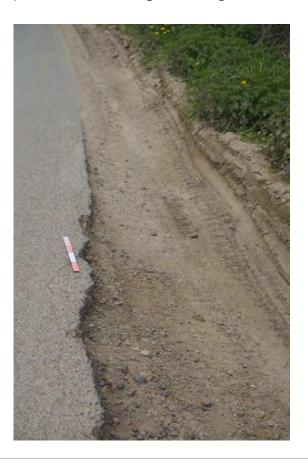
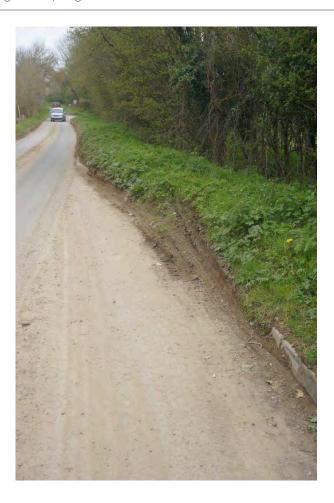
5.30 'Unofficial' passing bays have been created through vehicles travelling on the verges. This has created potholes where the edge of the engineered road surface abuts the verge which is being eroded away.

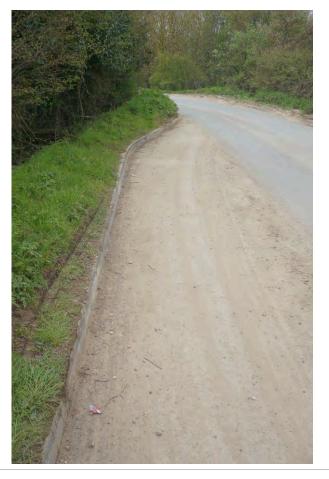
5.31 The 'approved' passing bays along this section of the road appear in a good state of repair.

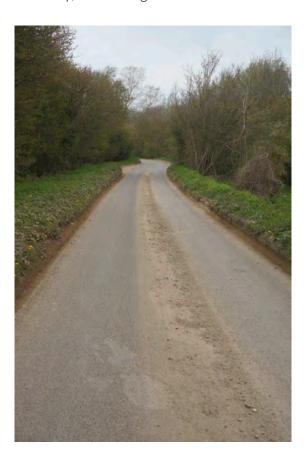
5.32 Generally, the wearing course is in a reasonable condition along this length.

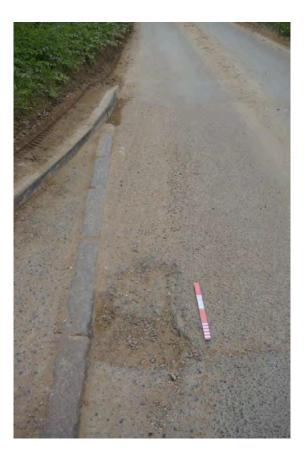
5.33 There is evidence of surface degradation at the site entrance/highway interface.
