# 47 FERNBANK ROAD, ASCOT

# PRELIMINARY ROOST ASSESSMENT

A Report to: Landmark Group

Date: July 2023

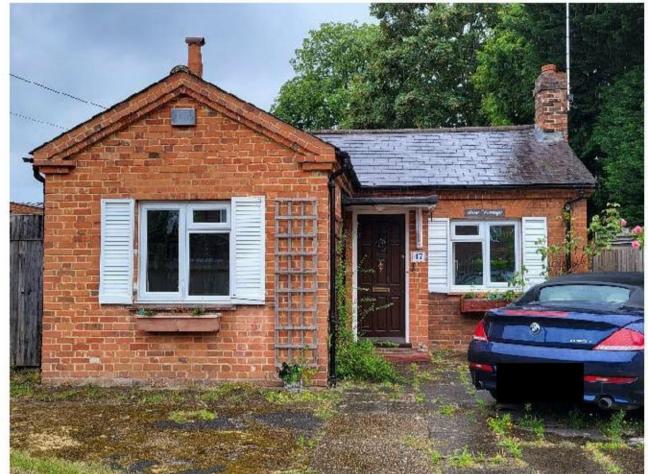
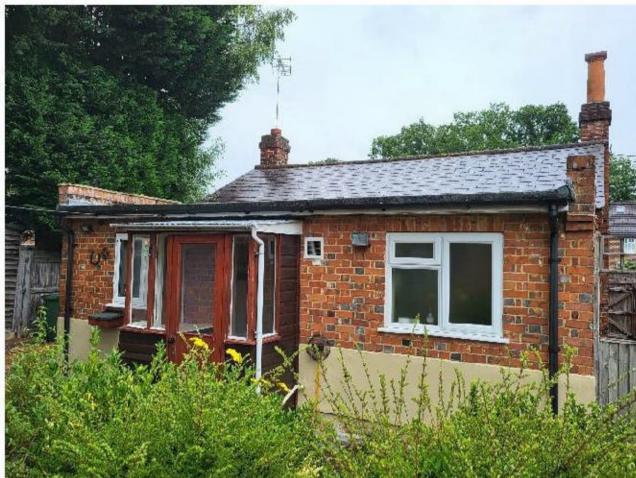
The vacant dwelling on site is a detached, single-storey, brick building with pitched roofs covered by slates. To the rear is a single-storey extension with a flat roof, covered by roofing felt. The brickwork is in a good condition with no cracks, areas of missing mortar or holes present. The roofing felt is also in a good condition with the edges being well-sealed.

Figure 2. View of the front and rear elevations of the dwelling

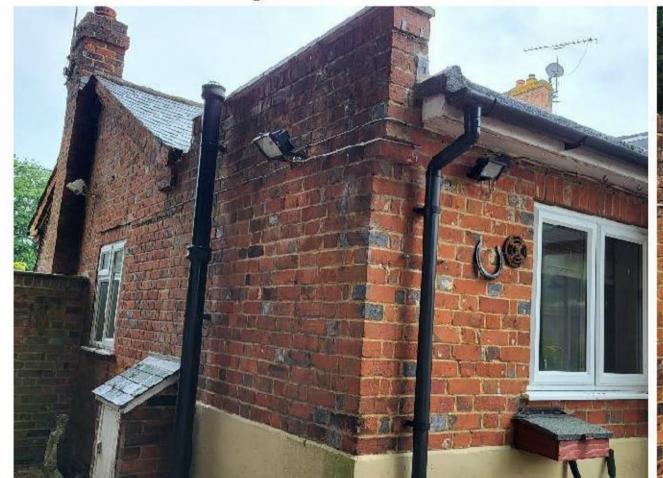
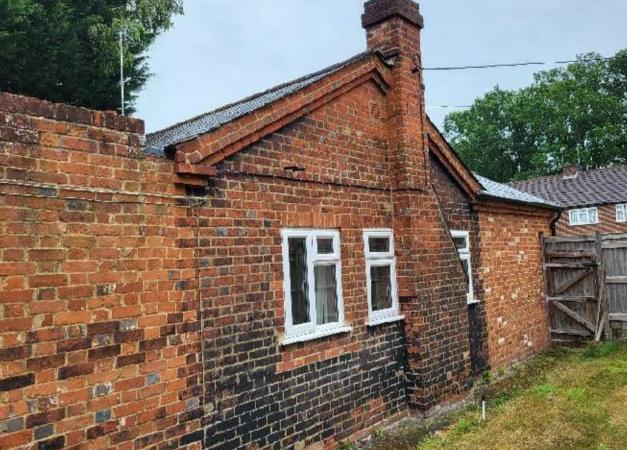
Figure 3. View of the side elevations

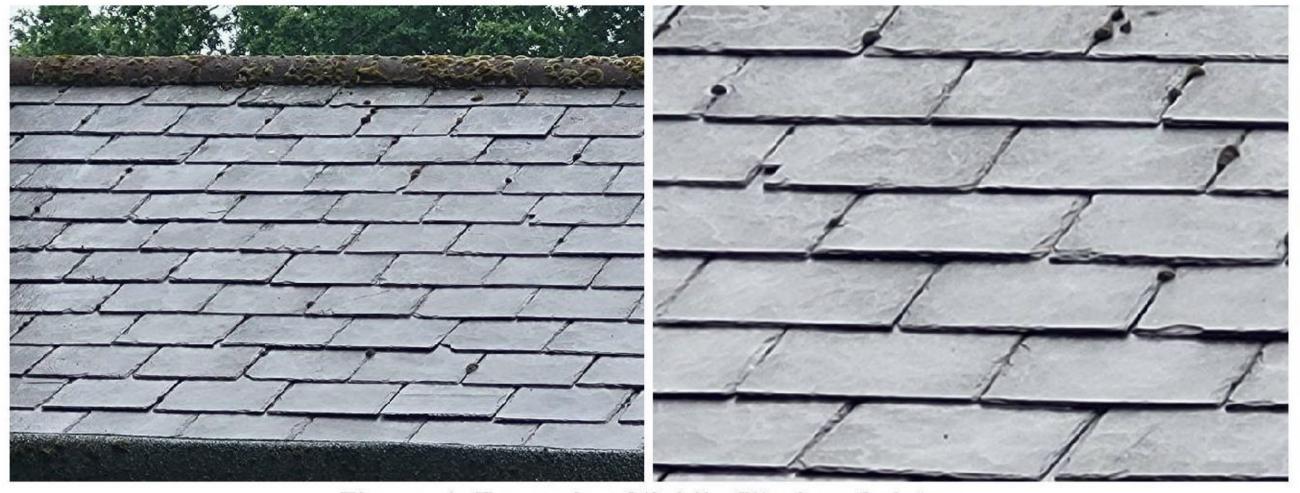
Figure 4. Example of tightly fitted roof slates

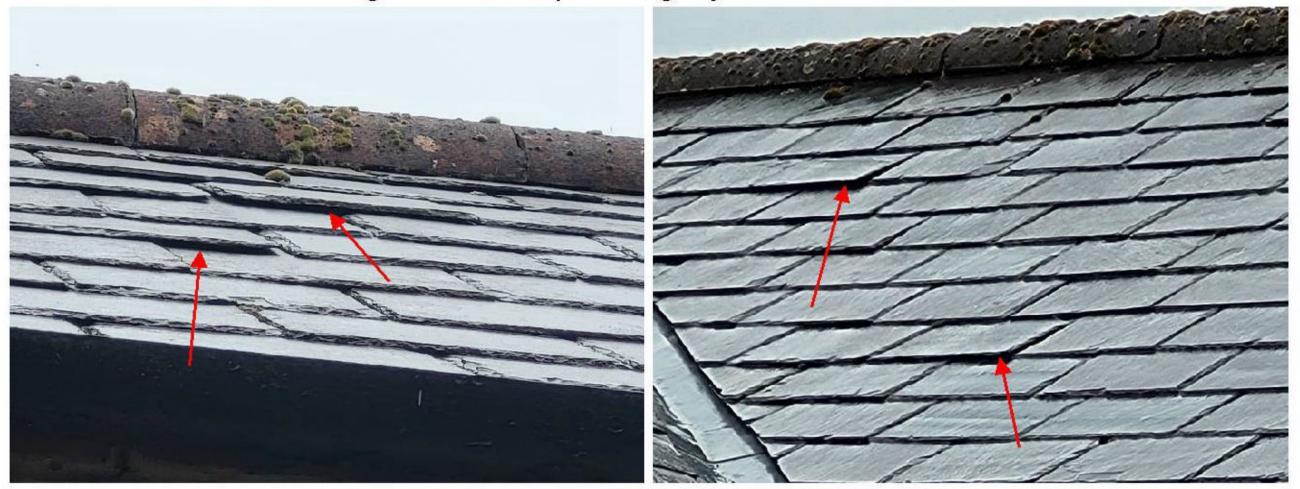
Figure 5. Example of slightly lifted roof slates

A number of potential entry points and roosting features for bats in the form of slightly lifted roof slates were recorded at the time of survey. As such, based on the external inspection, the dwelling on site is considered to be of moderate potential for bats.

The external inspection of the dwelling confirmed the presence of a number of potential features providing entry points into roosting areas for bats, in the form of minor gaps under roof slates. The dwelling is therefore considered to be of moderate potential for roosting bats.

The dwelling on site has been identified to moderate potential for roosting bats. Bat Surveys: Good Practice Guidelines published by the Bat Conservation Trust (Collins, 2016) recommends that for structures with moderate potential, two dusk emergence/dawn re-entry surveys are undertaken during the bat active season to determine the presence/likely absence of bats. Peak bat survey season extends from May to August.

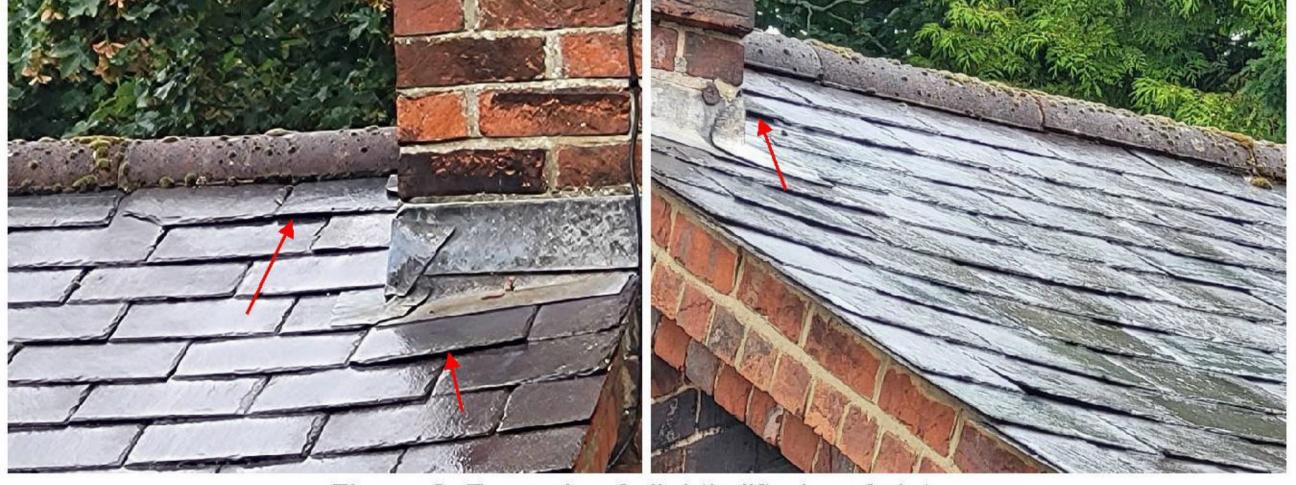
Figure 6. Example of slightly lifted roof slates

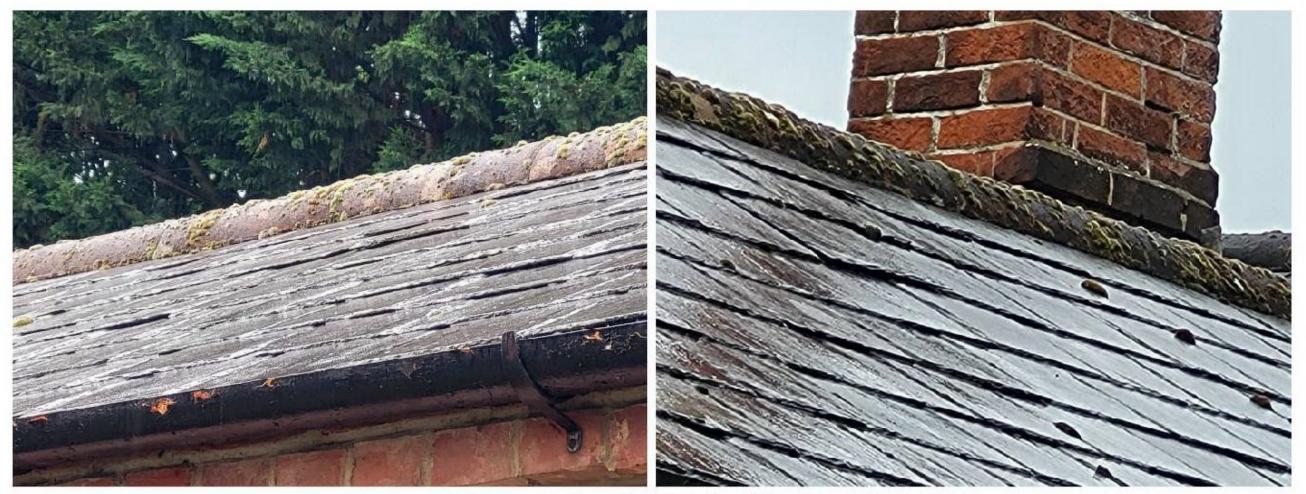
Figure 7. Example of slightly lifted roof slates

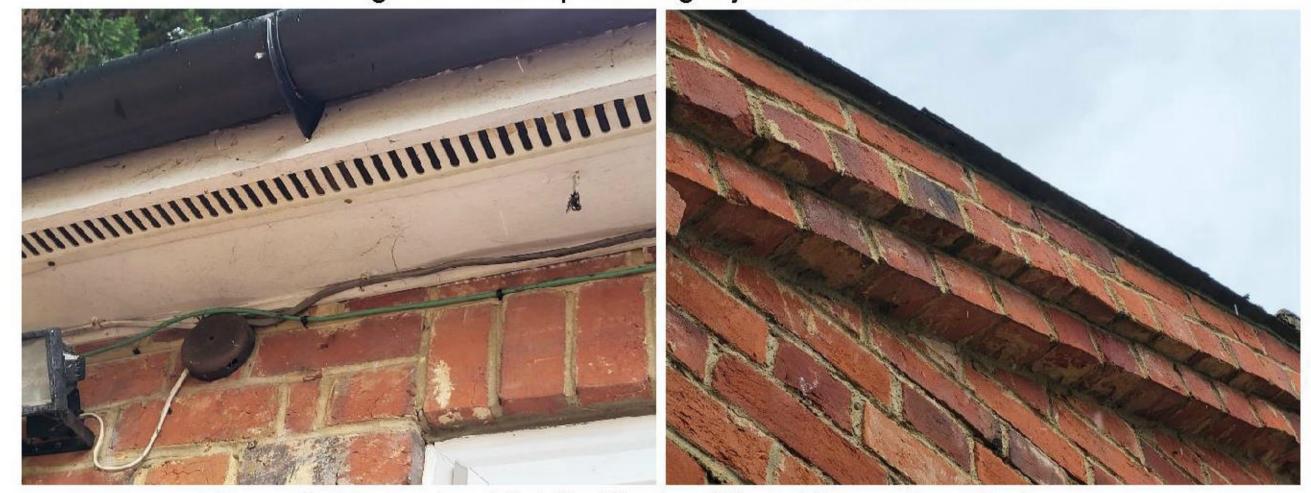
Figure 8. Example of tightly fitted soffit and the well-sealed eaves

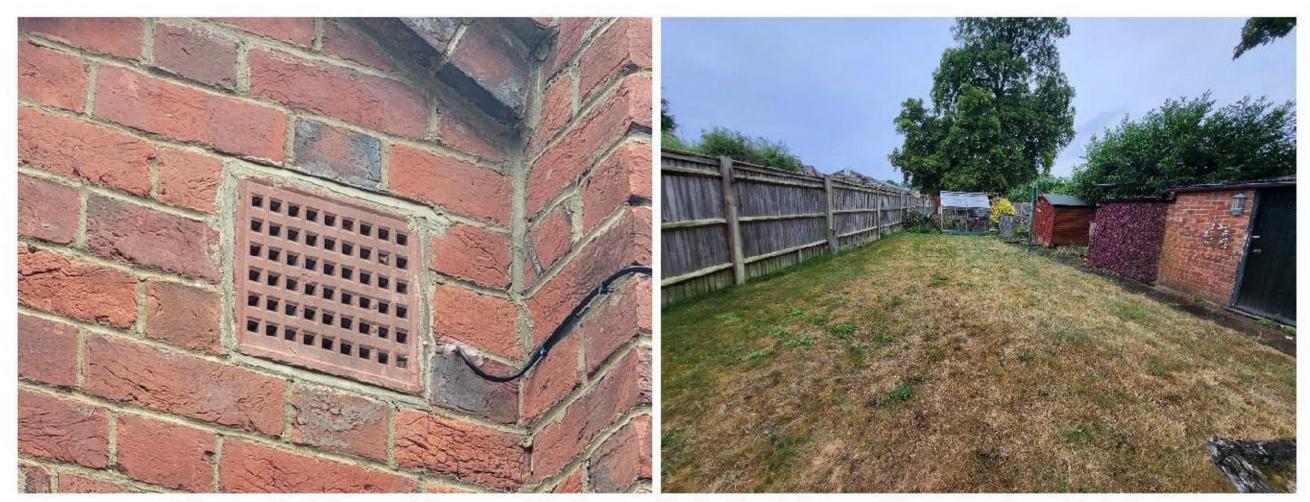
Figure 9. View of the ventilation grill (left) - View of the garden (right)

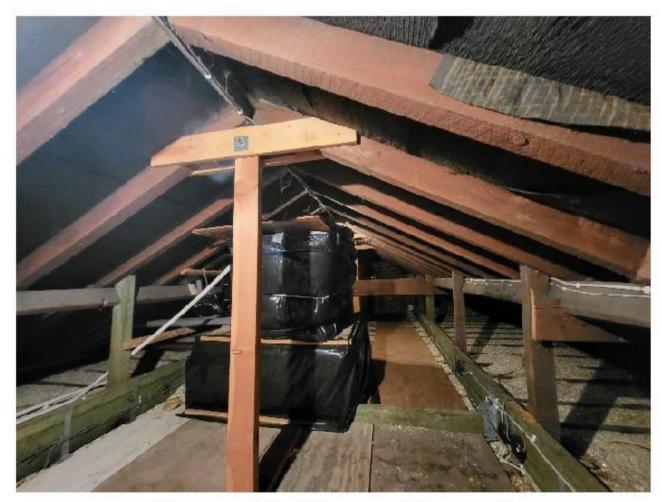
Figure 10. View of the loft

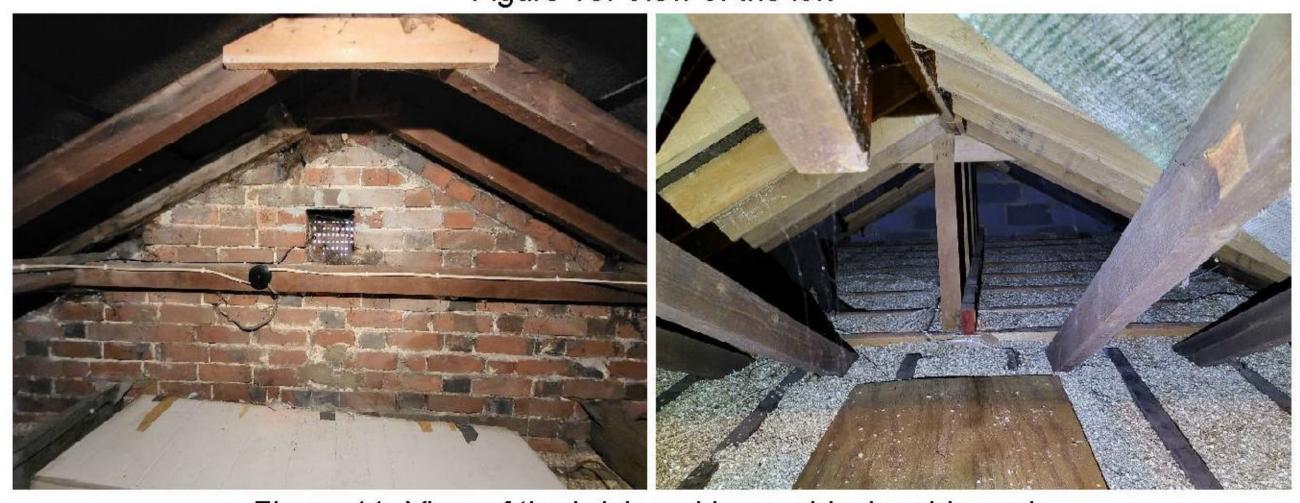
Figure 11. View of the brick and breezeblock gable-ends

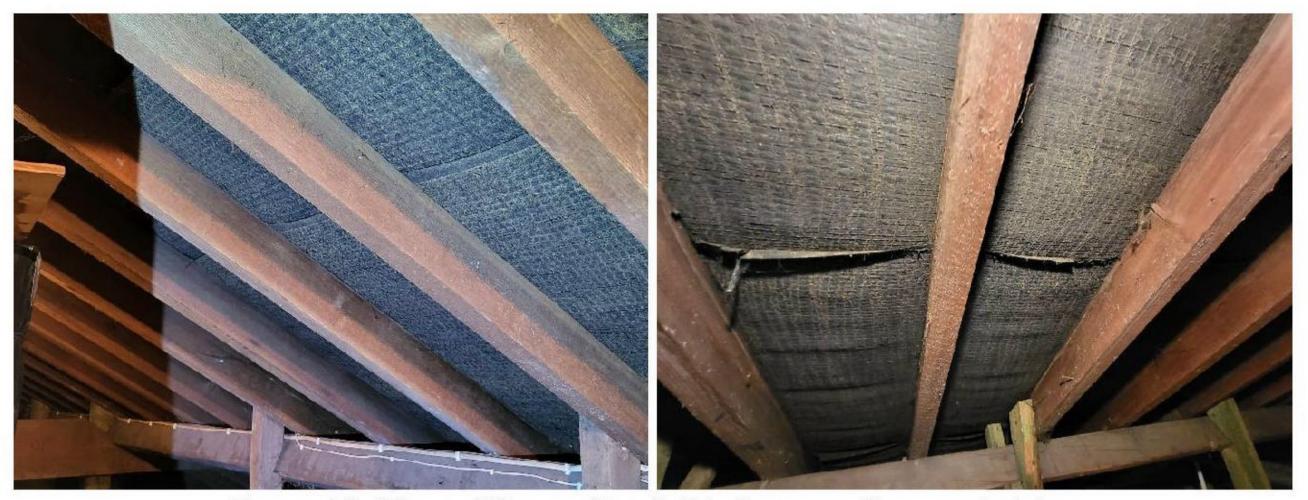
Figure 12. View of the roofing felt between rafters and slates

During the internal inspection, no evidence of roosting bats in the form of bat droppings, feeding remains, scratch marks, etc. was recorded. This however could be attributed to the presence of roofing felt being in good condition.

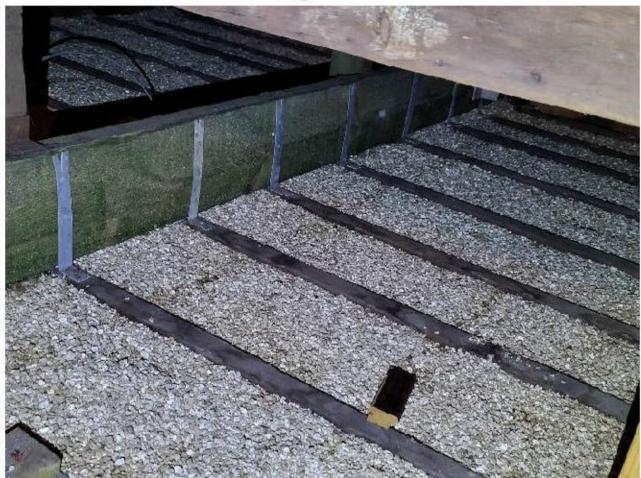
Figure 13. View of the loose fill insulation
