Tree Safety Survey Cwm Yr Allt House Cwm Yr Allt Lane CF82 8AW

05/02/2024

Tree Check has been instructed by Carl Miller to carry out a survey of the trees at Cwm Yr Allt House in order to determine their condition in relation to risk posed to the general public.

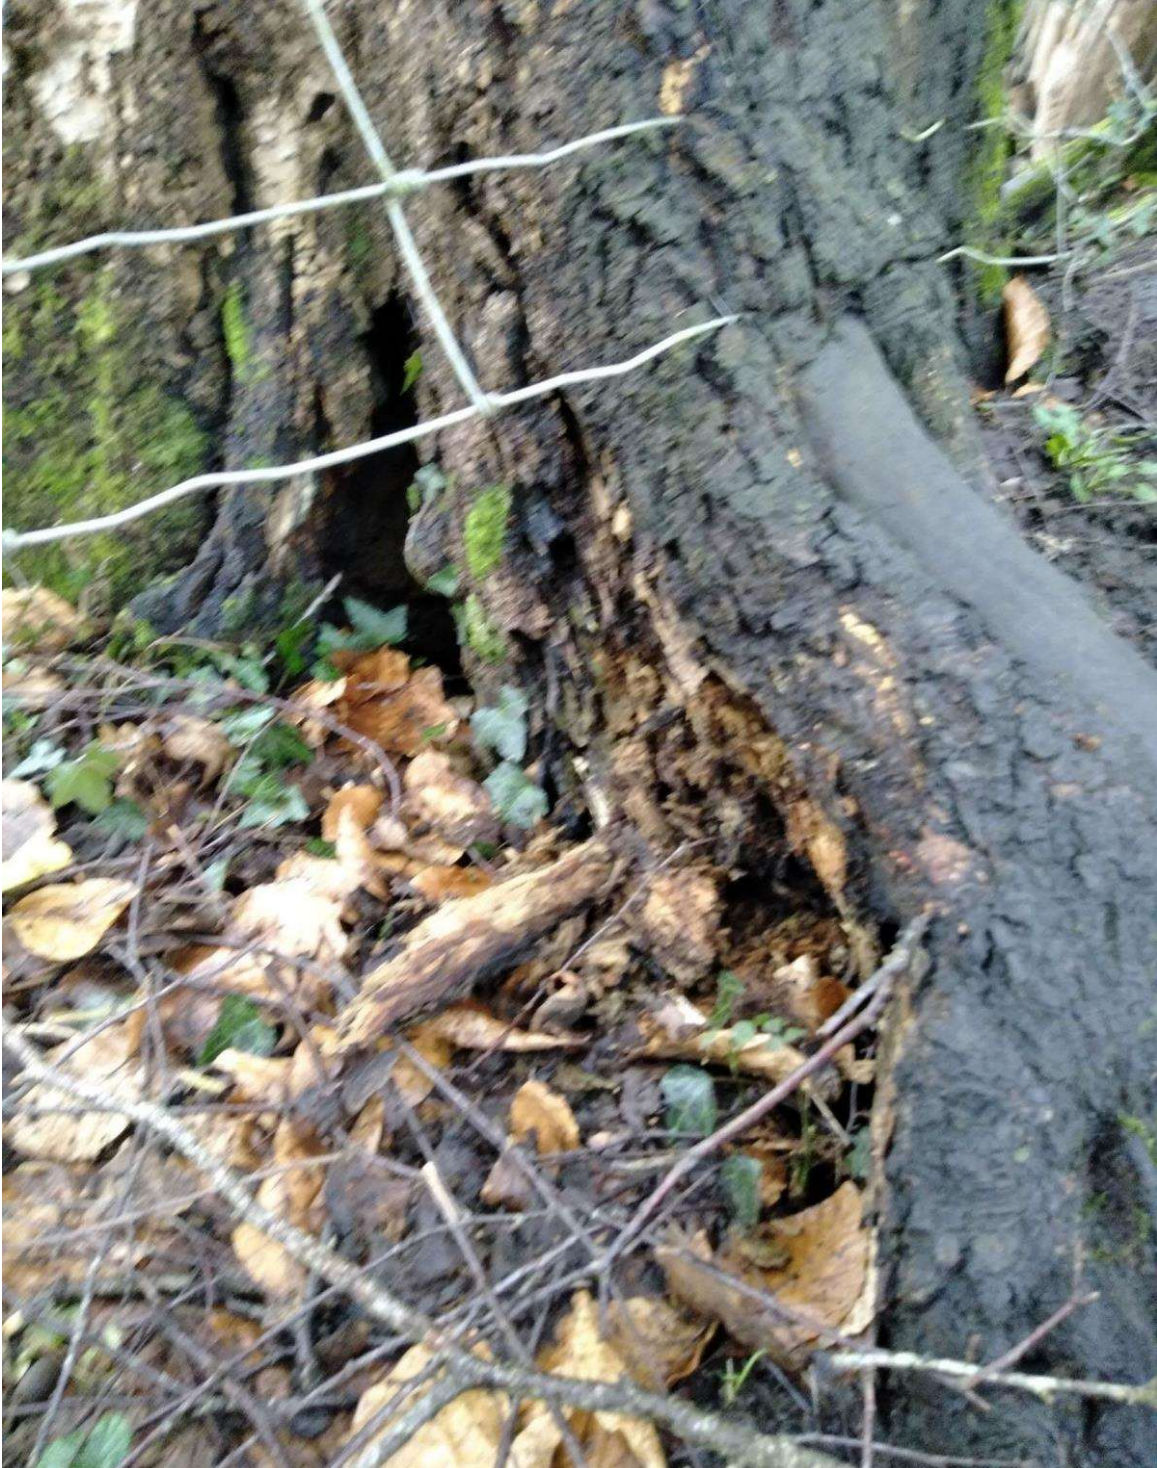
T4	0068	Silver birch (<i>Betula pendula</i>)	T4	Height (m): 11 Crown Radius (m): 4 Stem Diameter (mm): 300 Life Stage: EM	Twin stemmed tree at the top of garden in goat enclosure. Moderate target occupancy.	Cavity at base with extensive decay spreading into structural roots.	Remove tree to ground level.	M	N/A	I

Photo 1: T4, Decaying base of Birch tree.

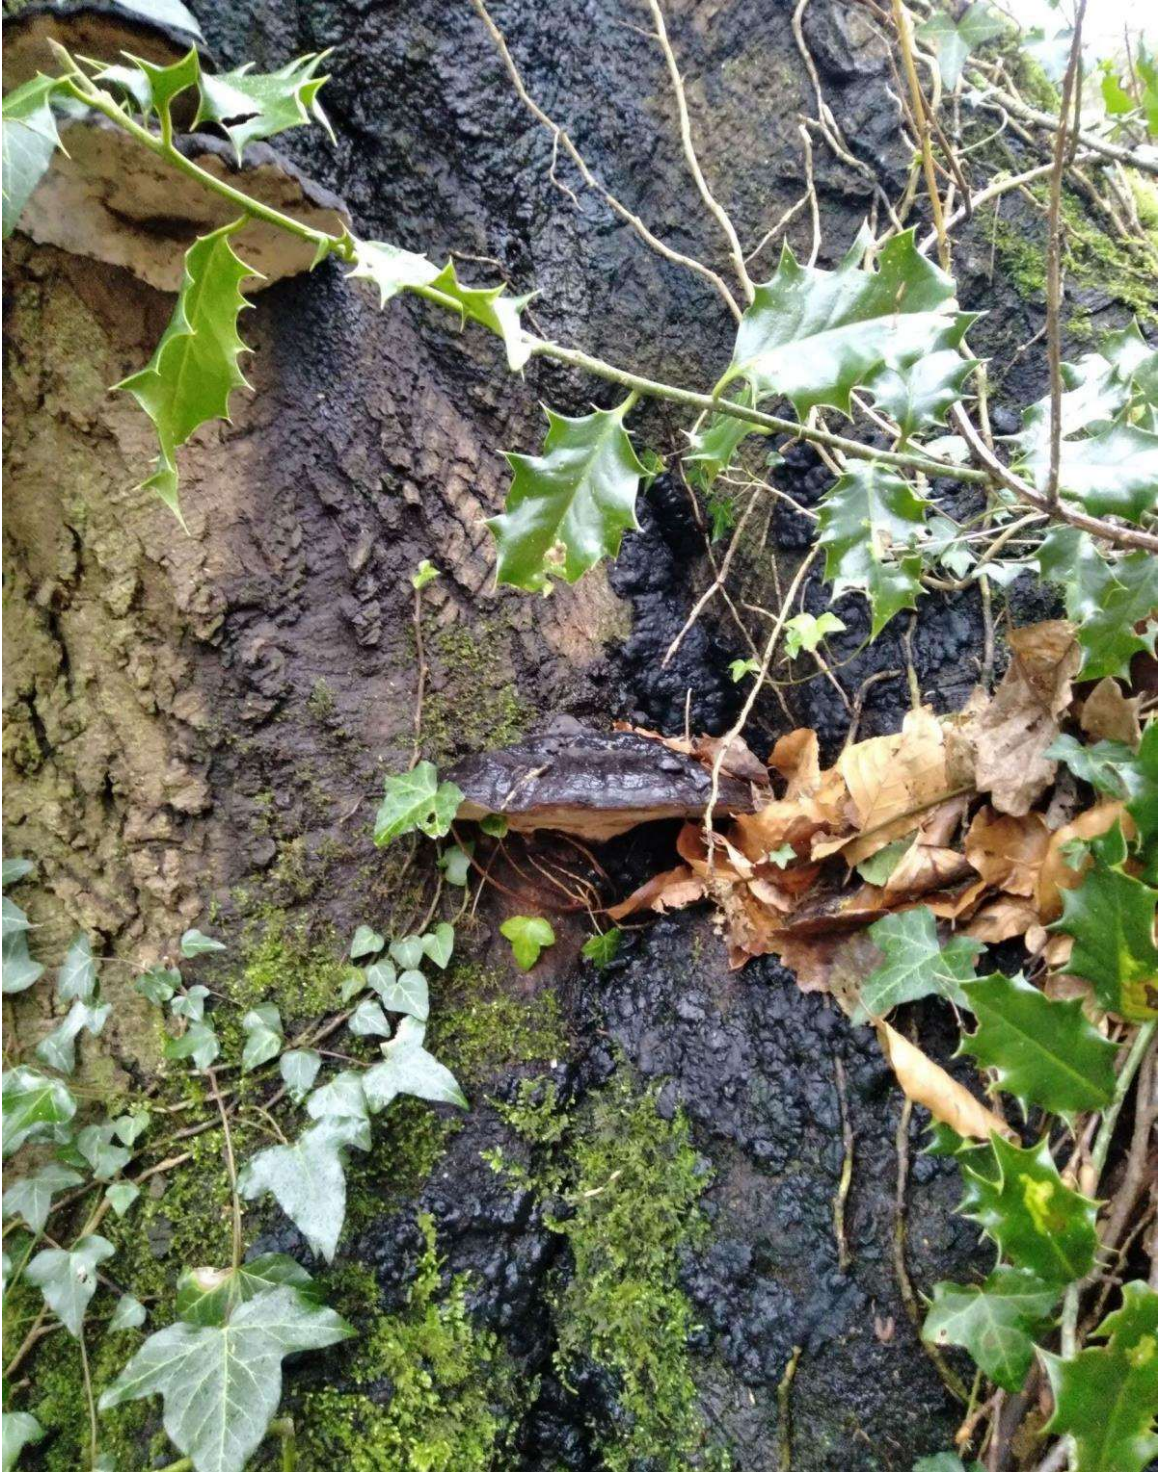
Ref	Tag Number	Species	Google Maps	Measurements	Description	Survey Notes	Recommendations	Work Priority	Minimum Inspection Frequency (months)
T8	0066	Common beech (<i>Fagus sylvatica</i>)		Height (m): 17 Crown Radius (m): 10 Stem Diameter (mm): 1500 Life Stage: M	Large tree overhanging driveway into property and power line. High target occupancy.	<i>Ganoderma australe</i> (Southern Bracket) fungal fruiting body observed with brackets reaching heights of 1.5m from base. <i>Kretzschmaria deusta</i> (Brittle Cinder) fungal fruiting body observed in large quantities. Previously a twin stemmed tree with fork near the base. One stem has failed leaving a decaying stump, basic resonance testing indicates that this decay has spread to near the base.	Remove tree to ground level.	H	N/A
T9	0062	Common beech (<i>Fagus sylvatica</i>)		Height (m): 8 Crown Radius (m): 6 Stem Diameter (mm): 750 Life Stage: M	Tree growing out on edge of rocky outcrop. Low target occupancy.	Evidence of annual fungal fruiting body around root plate. Suspected to be <i>Meripulus giganteus</i> but unable to identify due to degradation. Though there is a low target occupancy, damage to other trees could occur if the tree was to fail.	Monitor for signs of decline and the progression of fungal fruiting body.	BP	18

Photo 2: T8, Ganoderma Australe brackets and Kretzschmaria Deusta on stem of Beech tree.

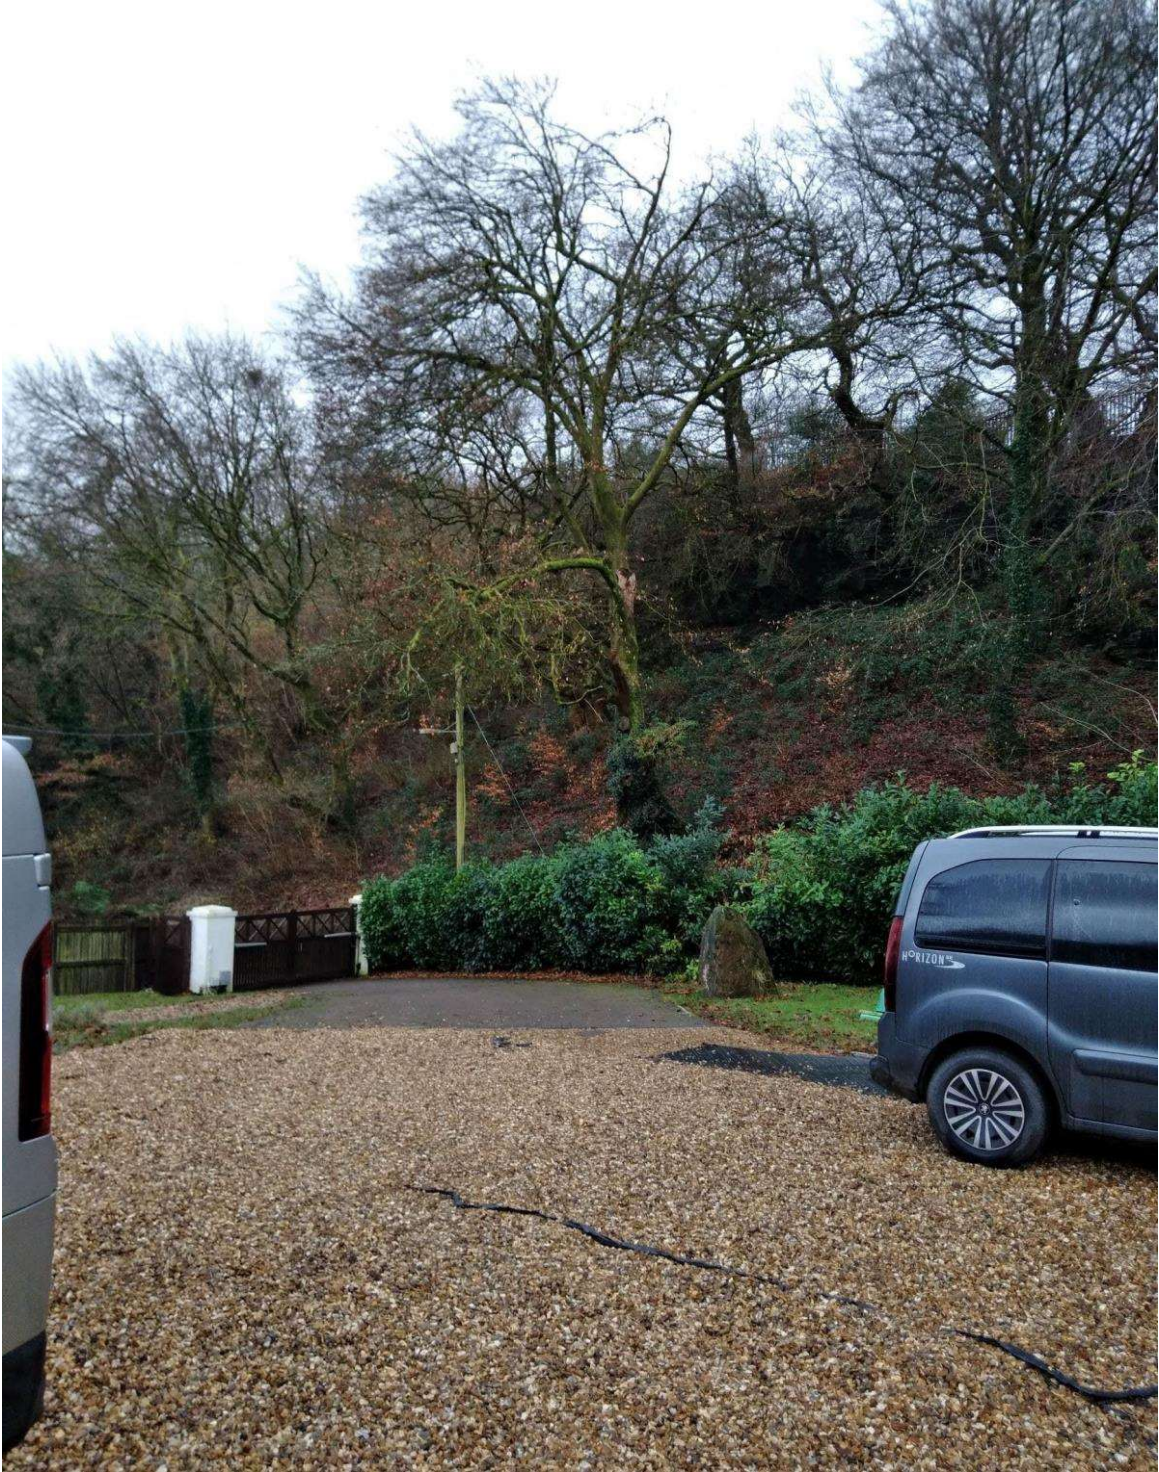
Photo 3: T8, Large Beech tree overhanging driveway and powerlines.

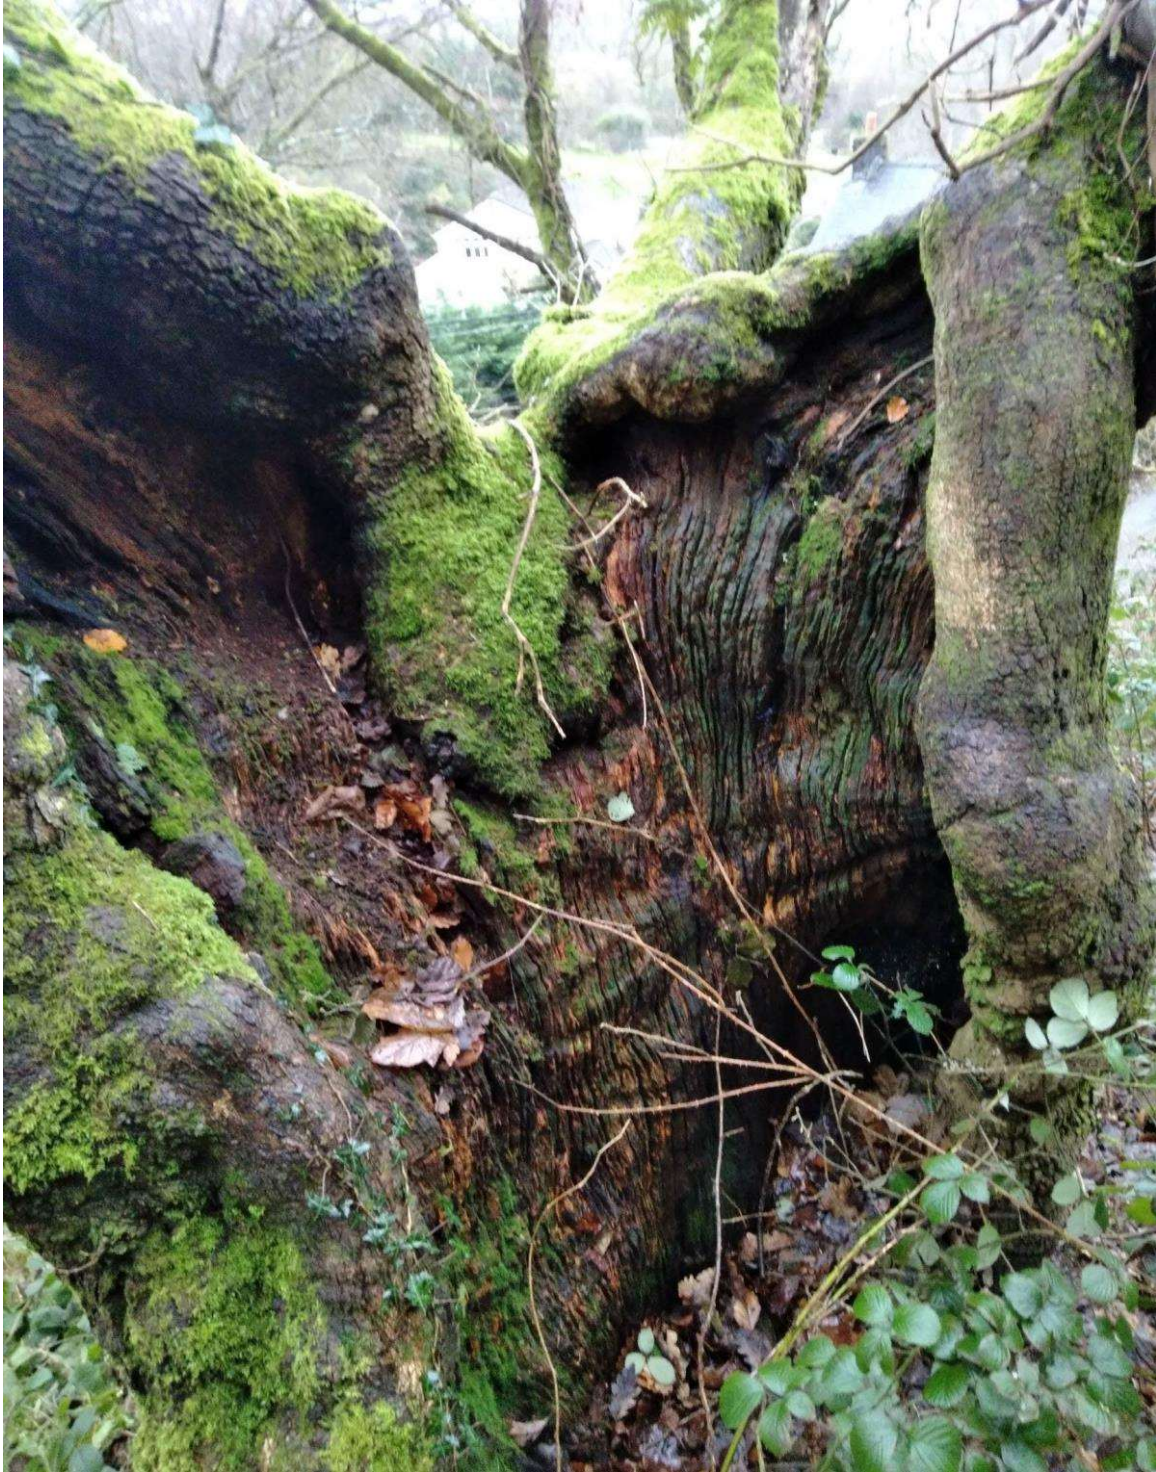
Photo 4: T11, Veteran oak tree.
