COASTAL VULNERABILITY ASSESSMENT REPORT

**SITE: PROPOSED NEW BOATHOUSE AT
HIGHWOOD, RESTRONGUET POINT, FEOCK.**

Our Ref: TJG/CVA/004.Restronguet Boat House.Rev0

Proposed new boathouse development at Highwood, Restronguet Point, Feock, Cornwall, TR3 6RB

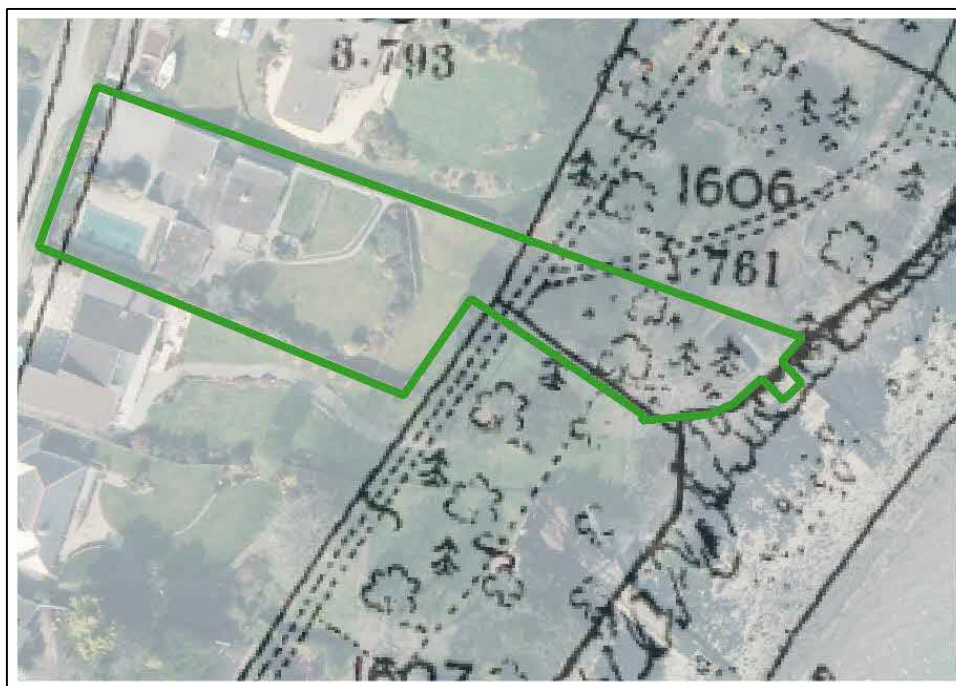
The historical OS maps indicate a negligible (<1.0 metre regression) recorded extent of erosion and regression of the shoreline (since 1880) of along the eastern boundary of the property.

Figure 03: Historic rates of coastal erosion, Ordnance Survey dataset from 1880 overlaid onto mc satellite imagery (property outline in green).

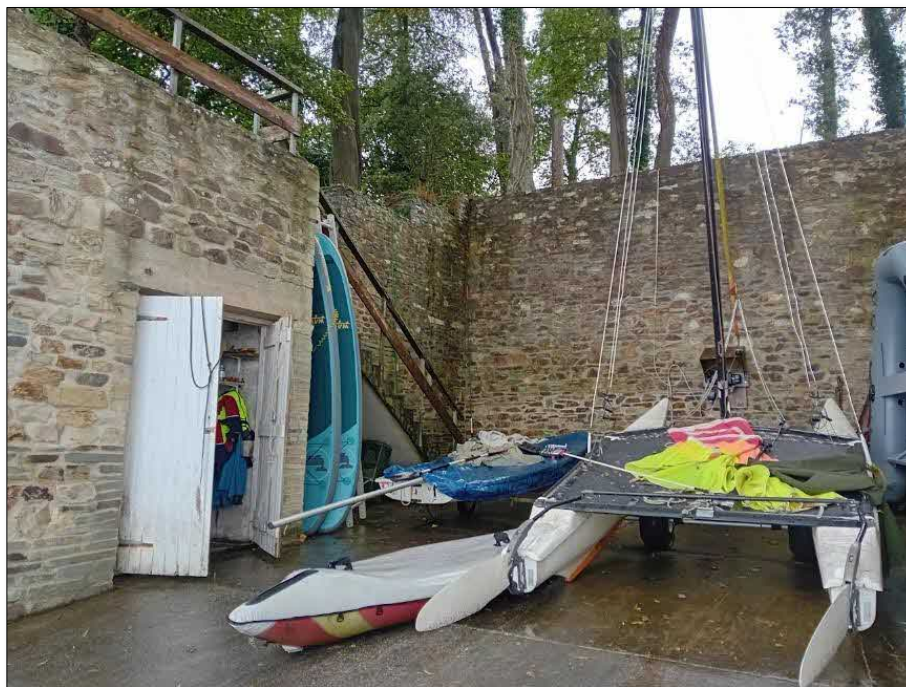
Figure 04: The existing boat storage area, from the beach looking west.

The existing boat storage area is approximately 4.0 metres in width and 3.5 metres in depth, the walls of the structure are approximately 2.5 metres in height. The walls are believed to be constructed of concrete block and masonry with 100 mm diameter drainage weepholes towards the base to facilitate drainage. The walls are approximately 350 mm in thickness and are stepped up to the rear elevation to accommodate the sloping garden. The floor of the structure is concrete and the slipway is constructed of mass pour concrete. At the time of the inspection the structure including the walls, concrete floor and slipway were observed to be in a good state of structural repair, with no observation of structural damage such as cracking, that may be indicative of structural failure of ground movement.

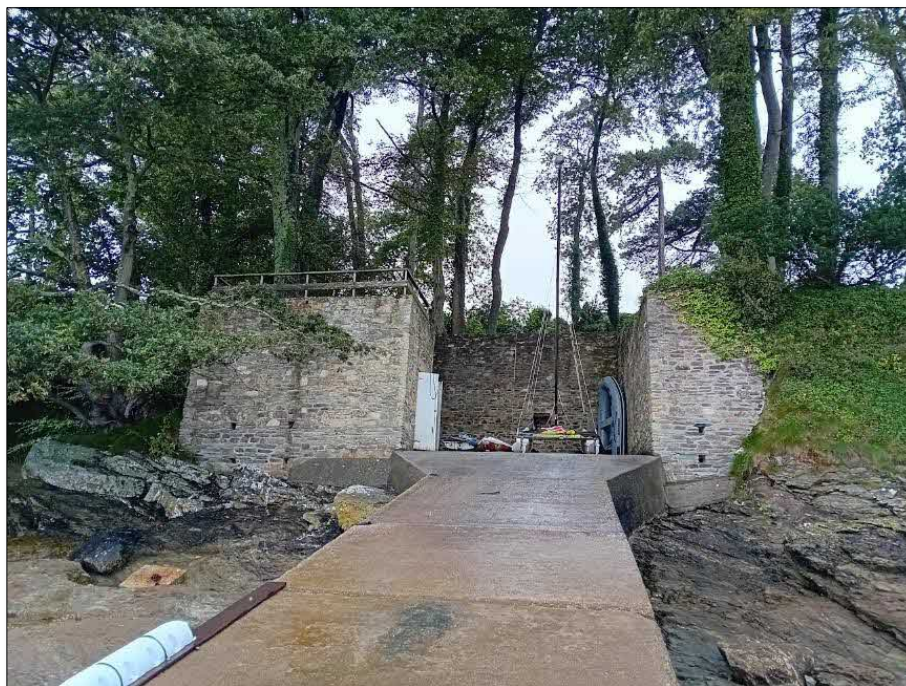
Figure 05: The existing boat storage area with sea walls along the shoreline, from the beach looking west.

At the time of the inspection the sea walls were observed to be in a good state of structural repair, with no observation of structural damage such as cracking, that may be indicative of structural failure or ground movement.

No differential erosion was observed between the sea walls and the adjacent shoreline and there was no sign of flood staining or tidal inundation observed to the seawalls, boat storage area or any other adjacent structures along the shoreline.

On the understanding that the sea walls should be maintained and utilised, the proposed development should therefore be considered safe through its planned lifetime (100 years) without increasing risk to life or property, or the requirement of new or improved coastal defences.

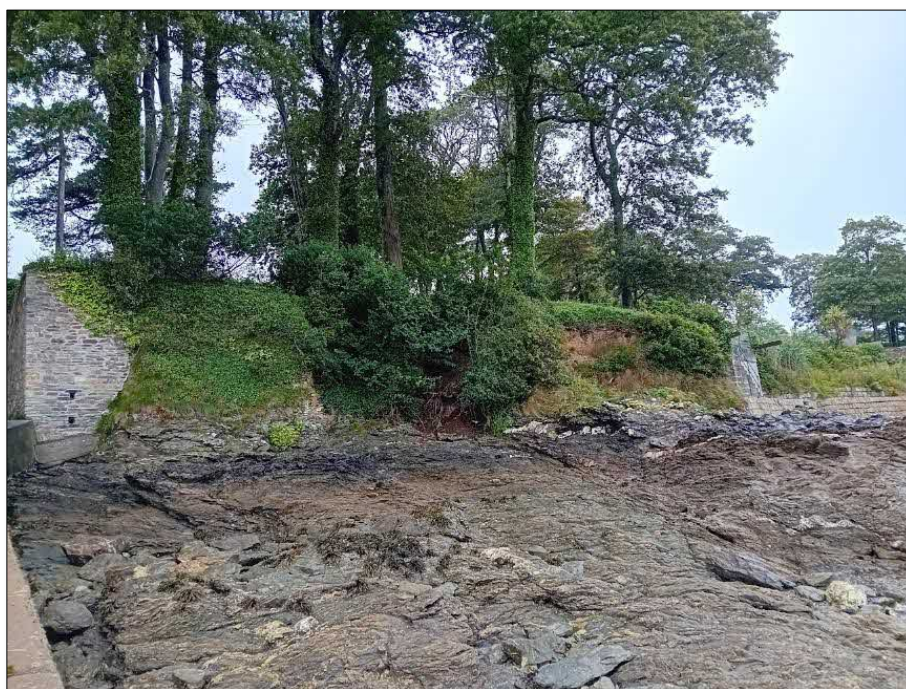
The walkover inspection was undertaken at low tide, however the high tide mark was observable as the rock ledge was discoloured and covered with intertidal flora and fauna. The high tide mark was observed to be approximately 1 to 3 metres to the east (seaward) of the sea walls and the shoreline.

Figure 06: The beach and intertidal area, with MHW and shoreline adjacent to the property north).

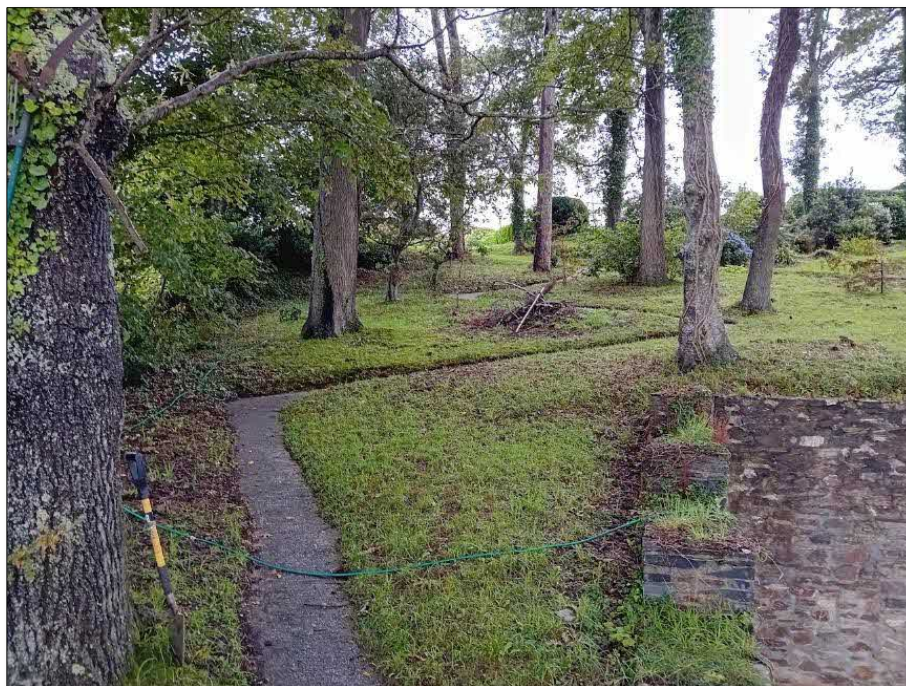
The garden to the dwelling is elongate and extends down to the shoreline. The garden is approximately 80 metres in length and 30 metres in width and extends down to the shoreline with a regular fall to the east. The garden is lawned and interspersed with large mature trees.

Figure 07: The garden area behind the existing boat storage area.
