Asbestos Management Survey

**99 High Street
Yatton
Bristol
BS49 4DR**

Project Number:	Survey Date:	Issue Date:
N-42284	15 August 2023	23 August 2023

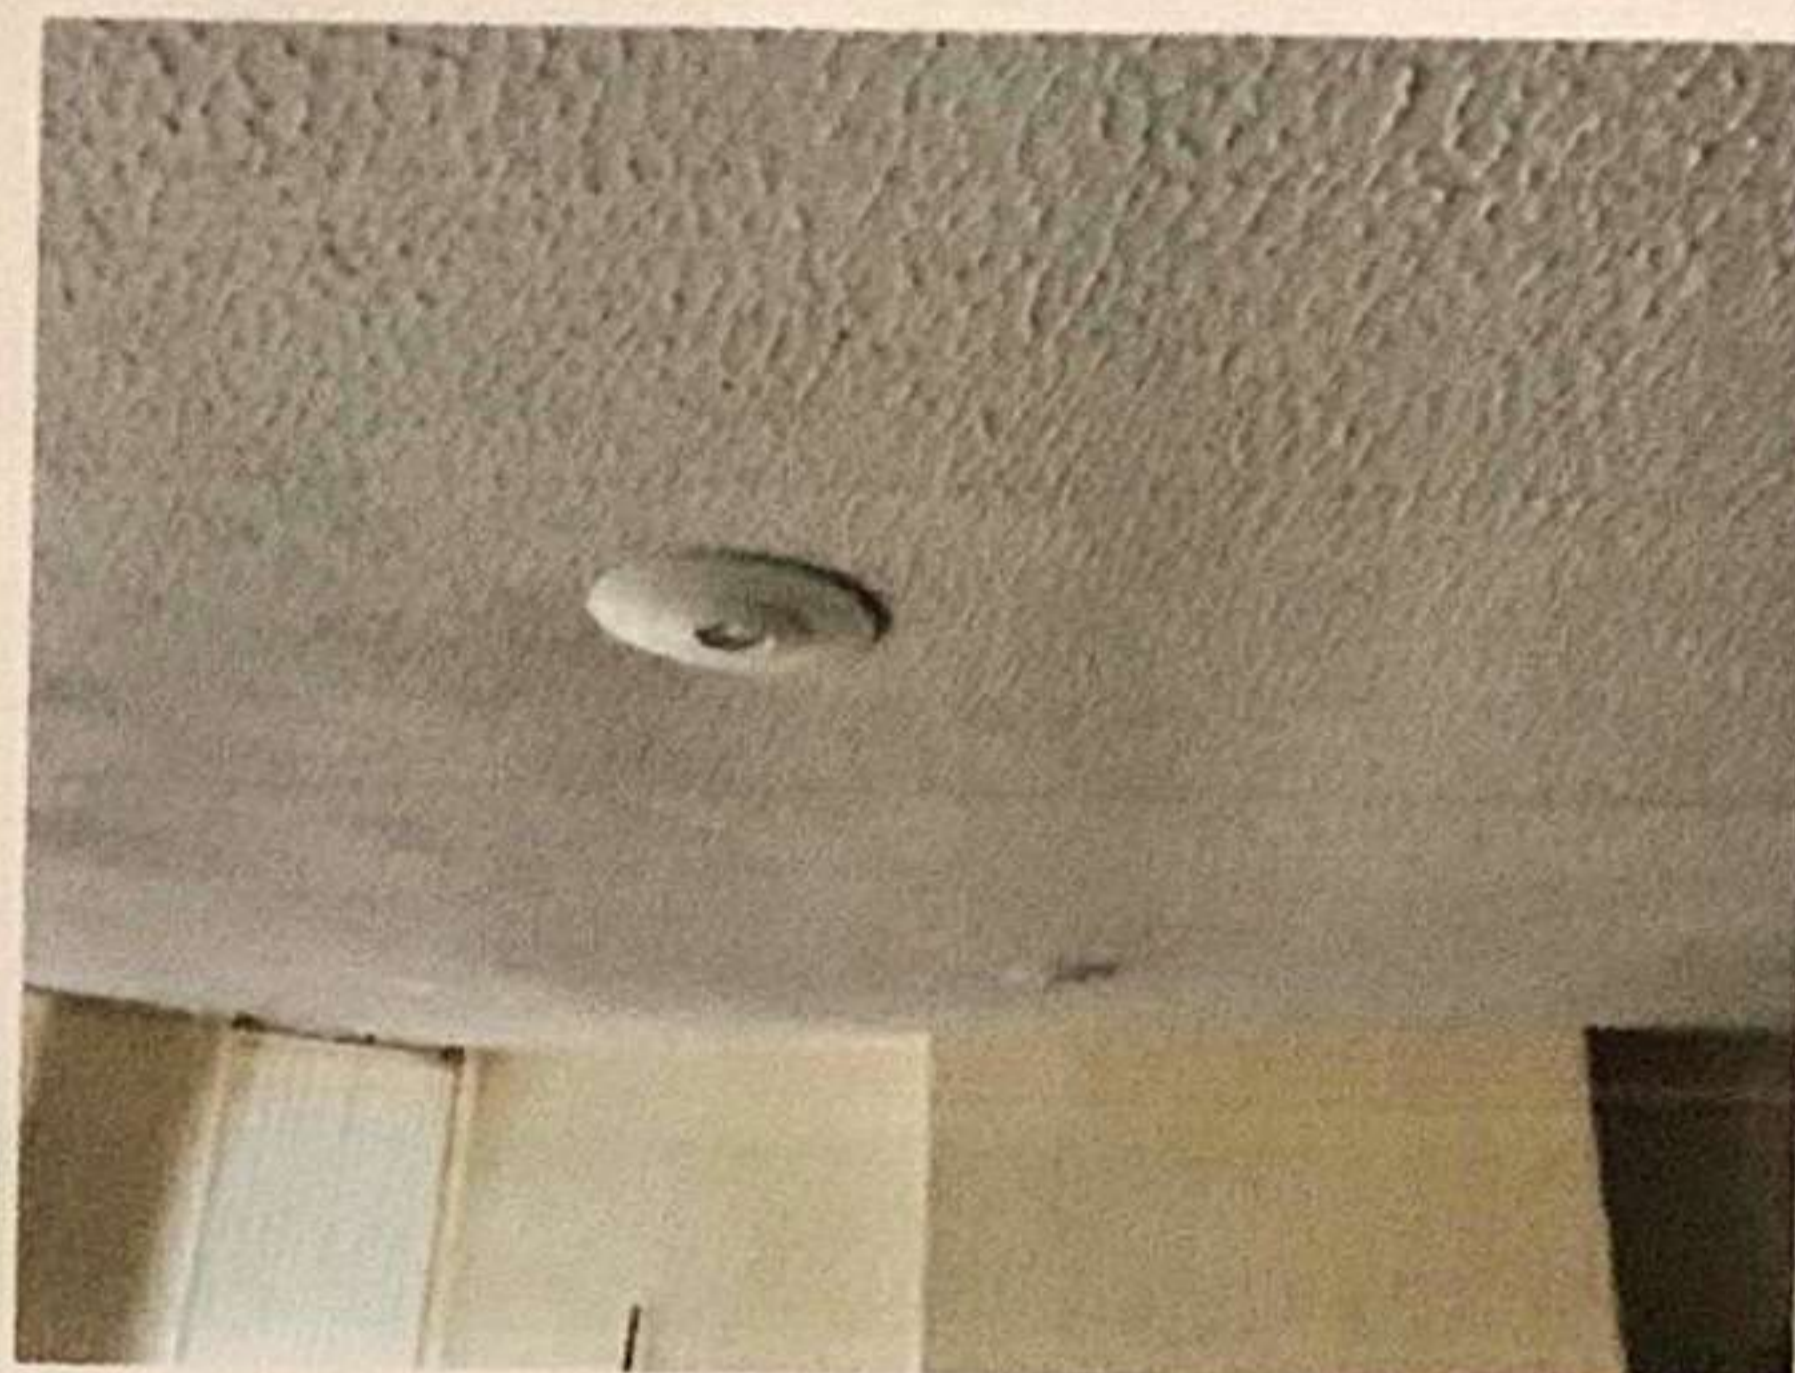
Building	99 High Street
Floor	Basement
Room	001 - Office
Description	Textured coating to ceiling.
Sample Reference	S001
Quantity	25 m ²

Analysis Result	
Chrysotile	1
Product Type	
Textured Coating	1

Condition	
Low Damage	1
Surface Treatment	
Composite (Self Sealed)	0

Occupancy Activity	Location	Accessibility
1	2	1
Extent of Material	No of Occupants	Frequency of Use
2	1	3
Average Time	Maintenance Activity	Freq of Maintenance
3	1	1
Material Risk Score:		Priority Risk Score:
3		6
Total Risk Score:		Risk Description:
9		Low Risk

A sample was taken from multiple locations.

Whilst the asbestos containing material continues to remain undisturbed, no immediate action is required. However a system of ongoing management should be implemented which includes routine condition inspections.

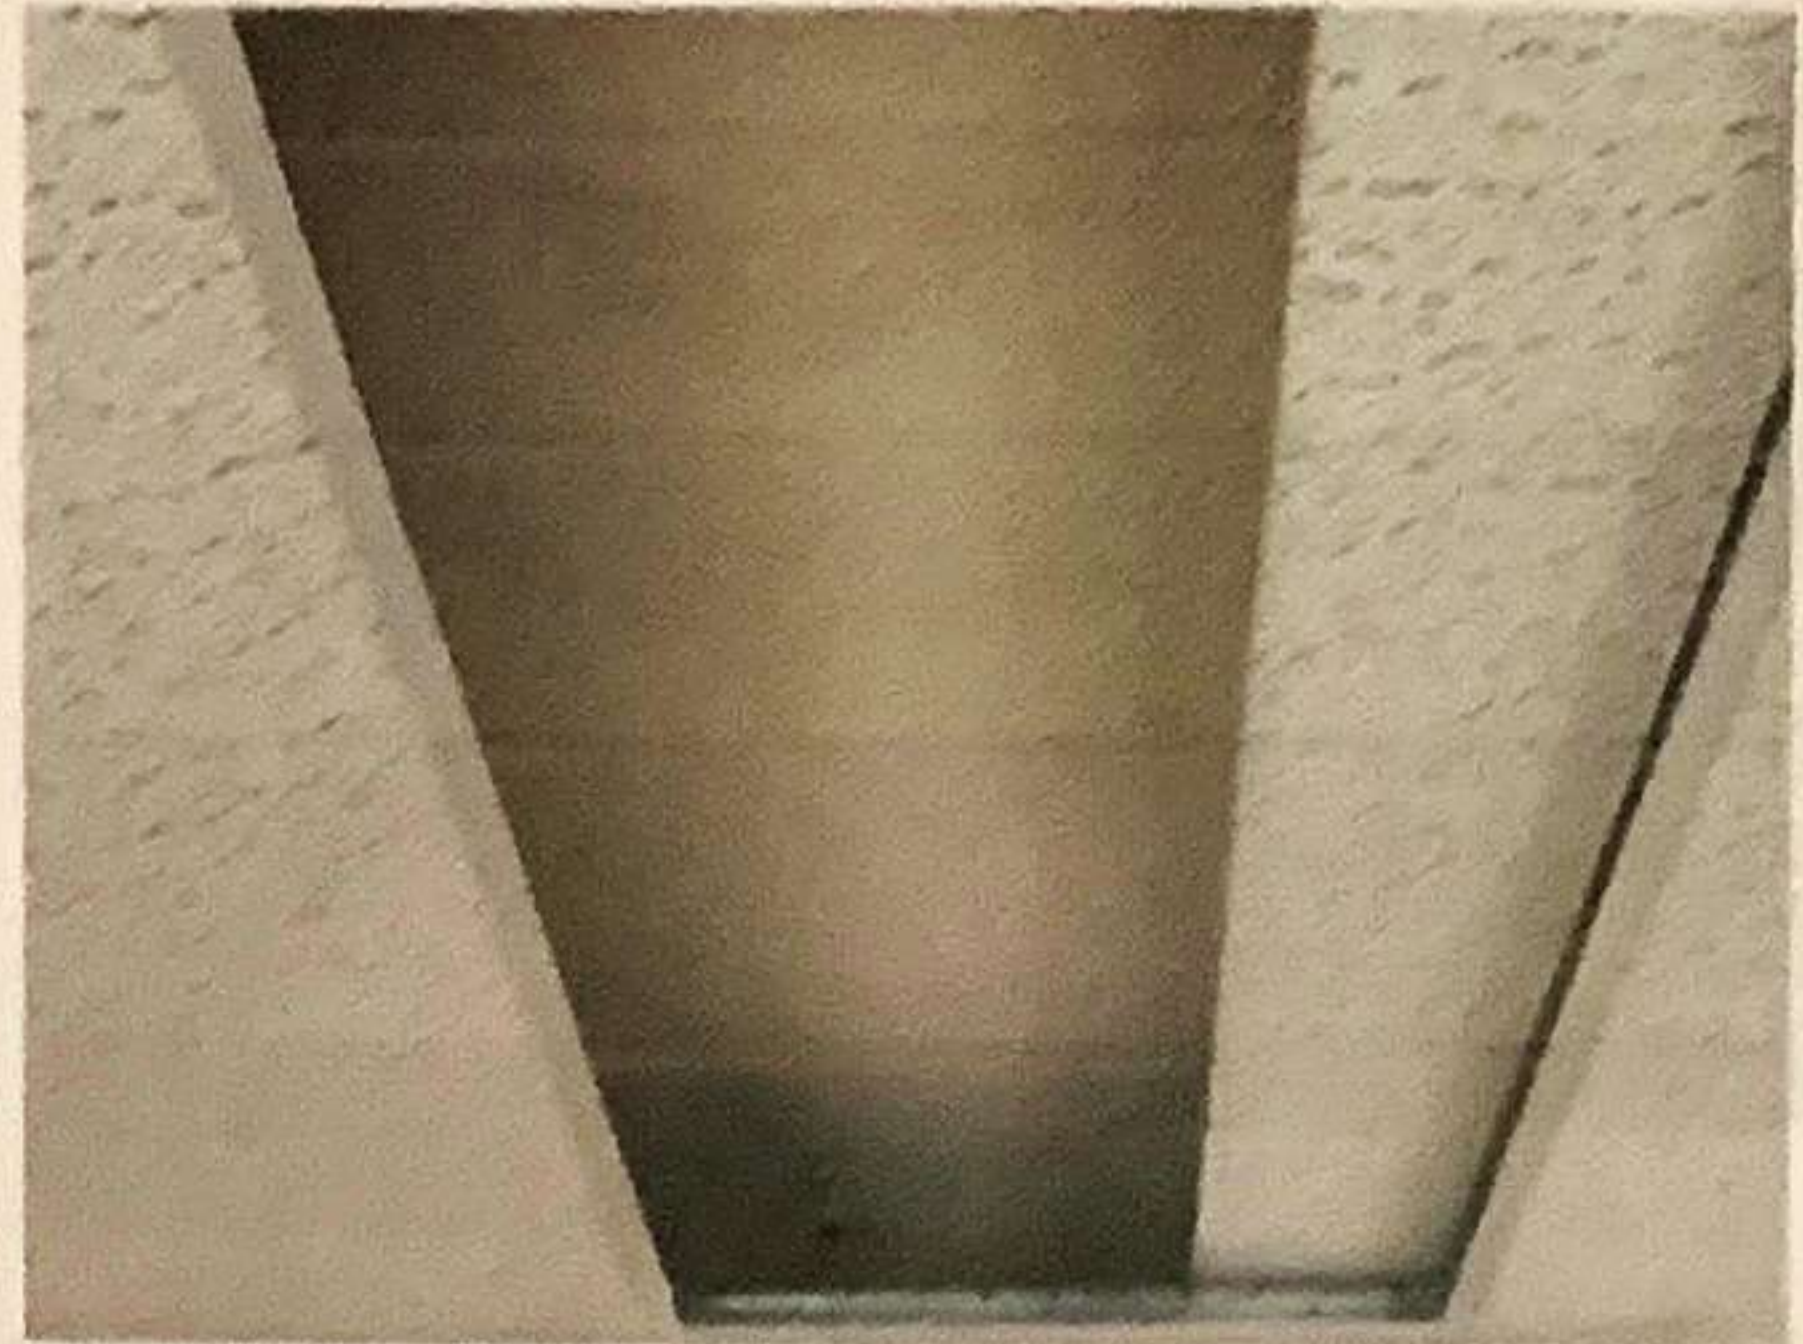
Building	99 High Street
Floor	Ground Floor
Room	003 - Office
Description	Textured coating to ceiling above suspended ceiling.
Sample Reference	S003
Quantity	34 m ²

Analysis Result	
Chrysotile	1
Product Type	
Textured Coating	1

Condition	
Low Damage	1
Surface Treatment	
Composite (Self Sealed)	0

Occupancy Activity	Location	Accessibility
1	2	1
Extent of Material	No of Occupants	Frequency of Use
2	2	3
Average Time	Maintenance Activity	Freq of Maintenance
3	1	1
Material Risk Score:		Priority Risk Score:
3		7
Total Risk Score:		Risk Description:
10		Low Risk

A sample was taken from multiple locations.

Whilst the asbestos containing material continues to remain undisturbed, no immediate action is required. However a system of ongoing management should be implemented which includes routine condition inspections.

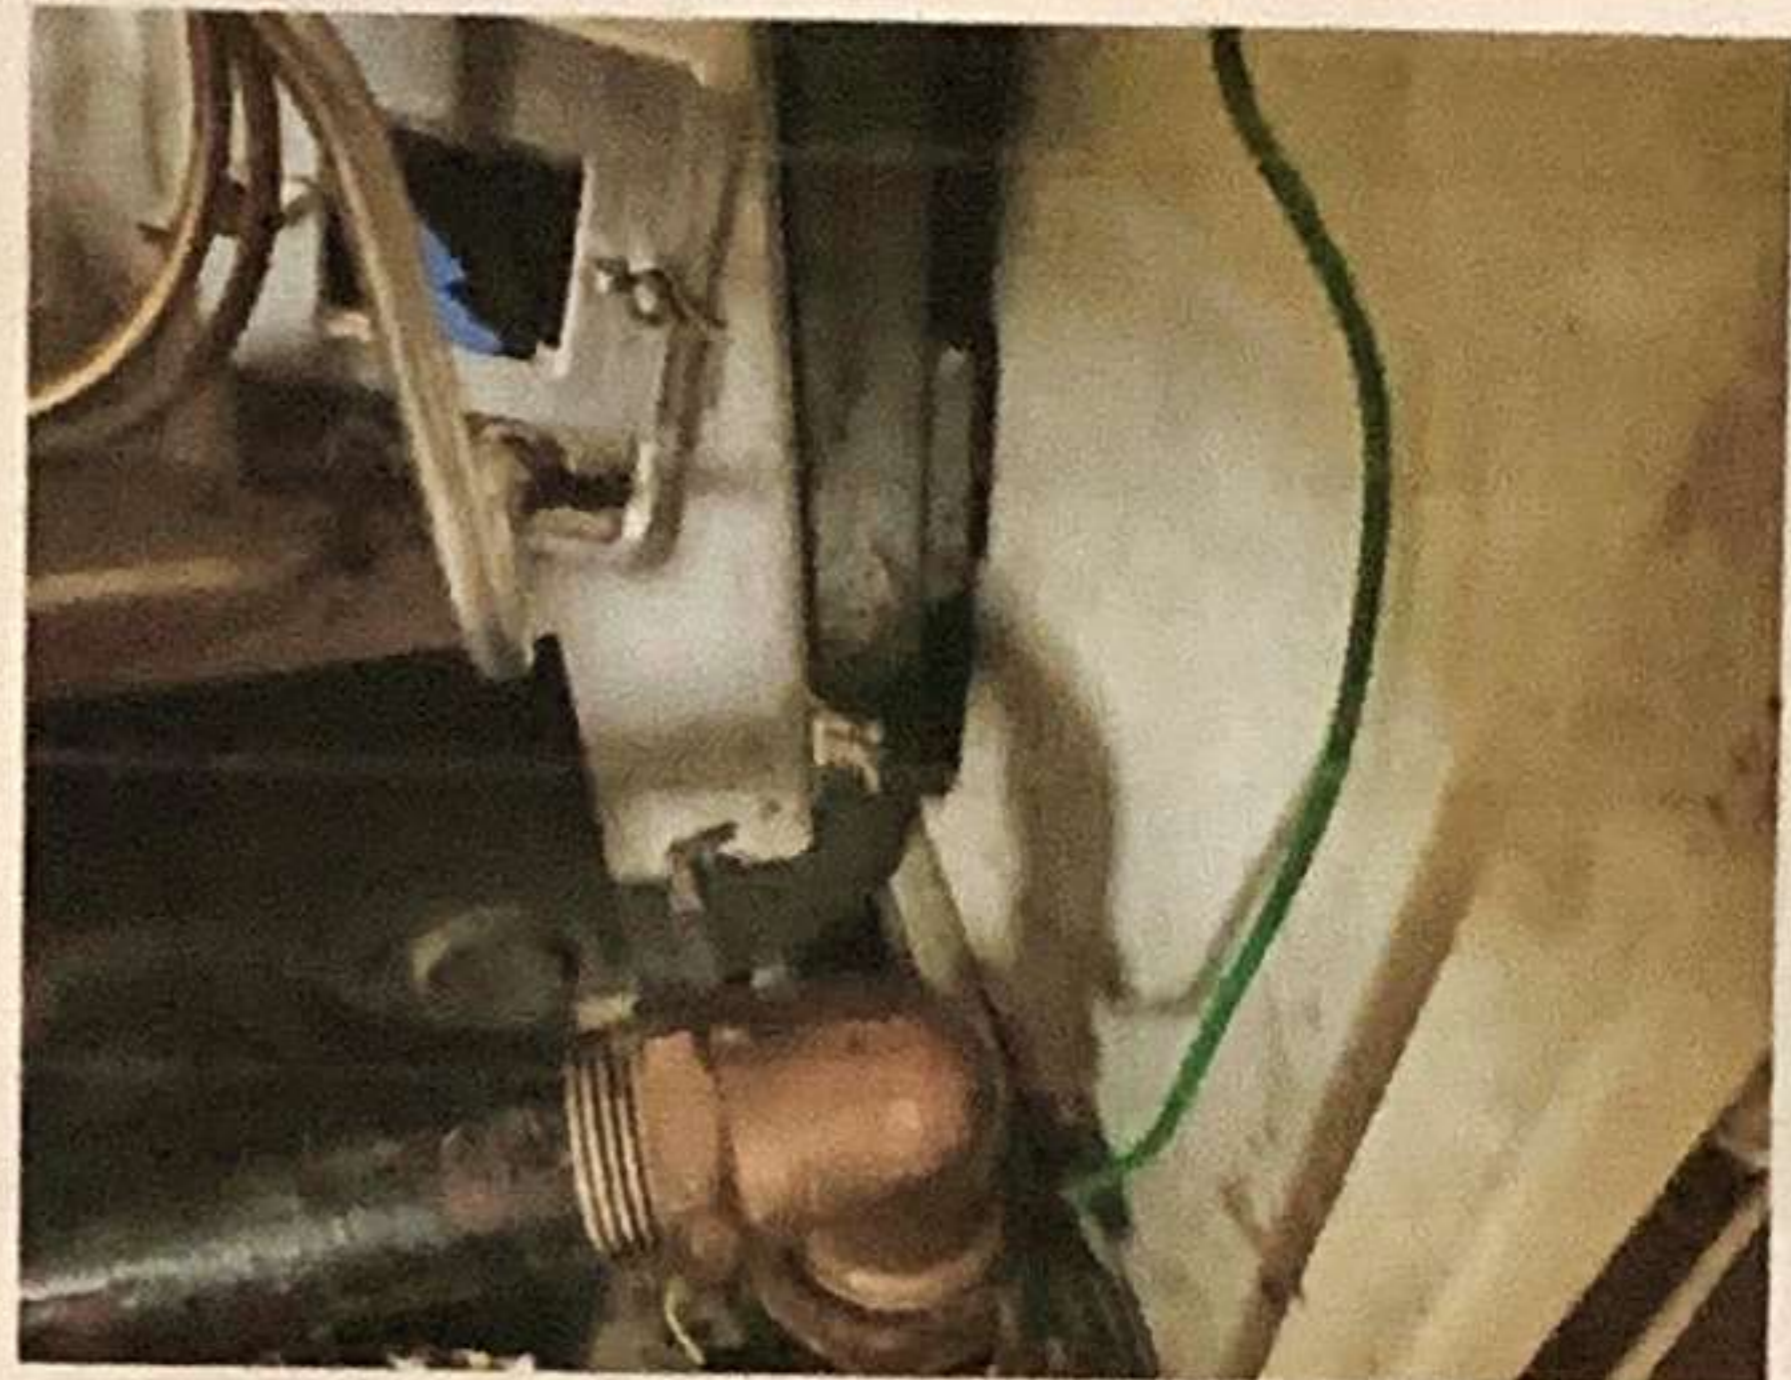
Building	99 High Street
Floor	Ground Floor
Room	003 - Office
Description	Rope seals to old boiler unit.
Sample Reference	S004
Quantity	1 Units

Analysis Result	
Chrysotile	1
Product Type	
Rope & String	2

Condition	
Low Damage	1
Surface Treatment	
Unsealed Woven	2

Occupancy Activity	Location	Accessibility
1	2	0
Extent of Material	No of Occupants	Frequency of Use
0	2	3
Average Time	Maintenance Activity	Freq of Maintenance
3	0	1
Material Risk Score:	Priority Risk Score:	
6	6	
Total Risk Score:	Risk Description:	
12	Low Risk

The rope seal is to multiple locations to the boiler unit.

Whilst the asbestos containing material continues to remain undisturbed, no immediate action is required. However a system of ongoing management should be implemented which includes routine condition inspections.

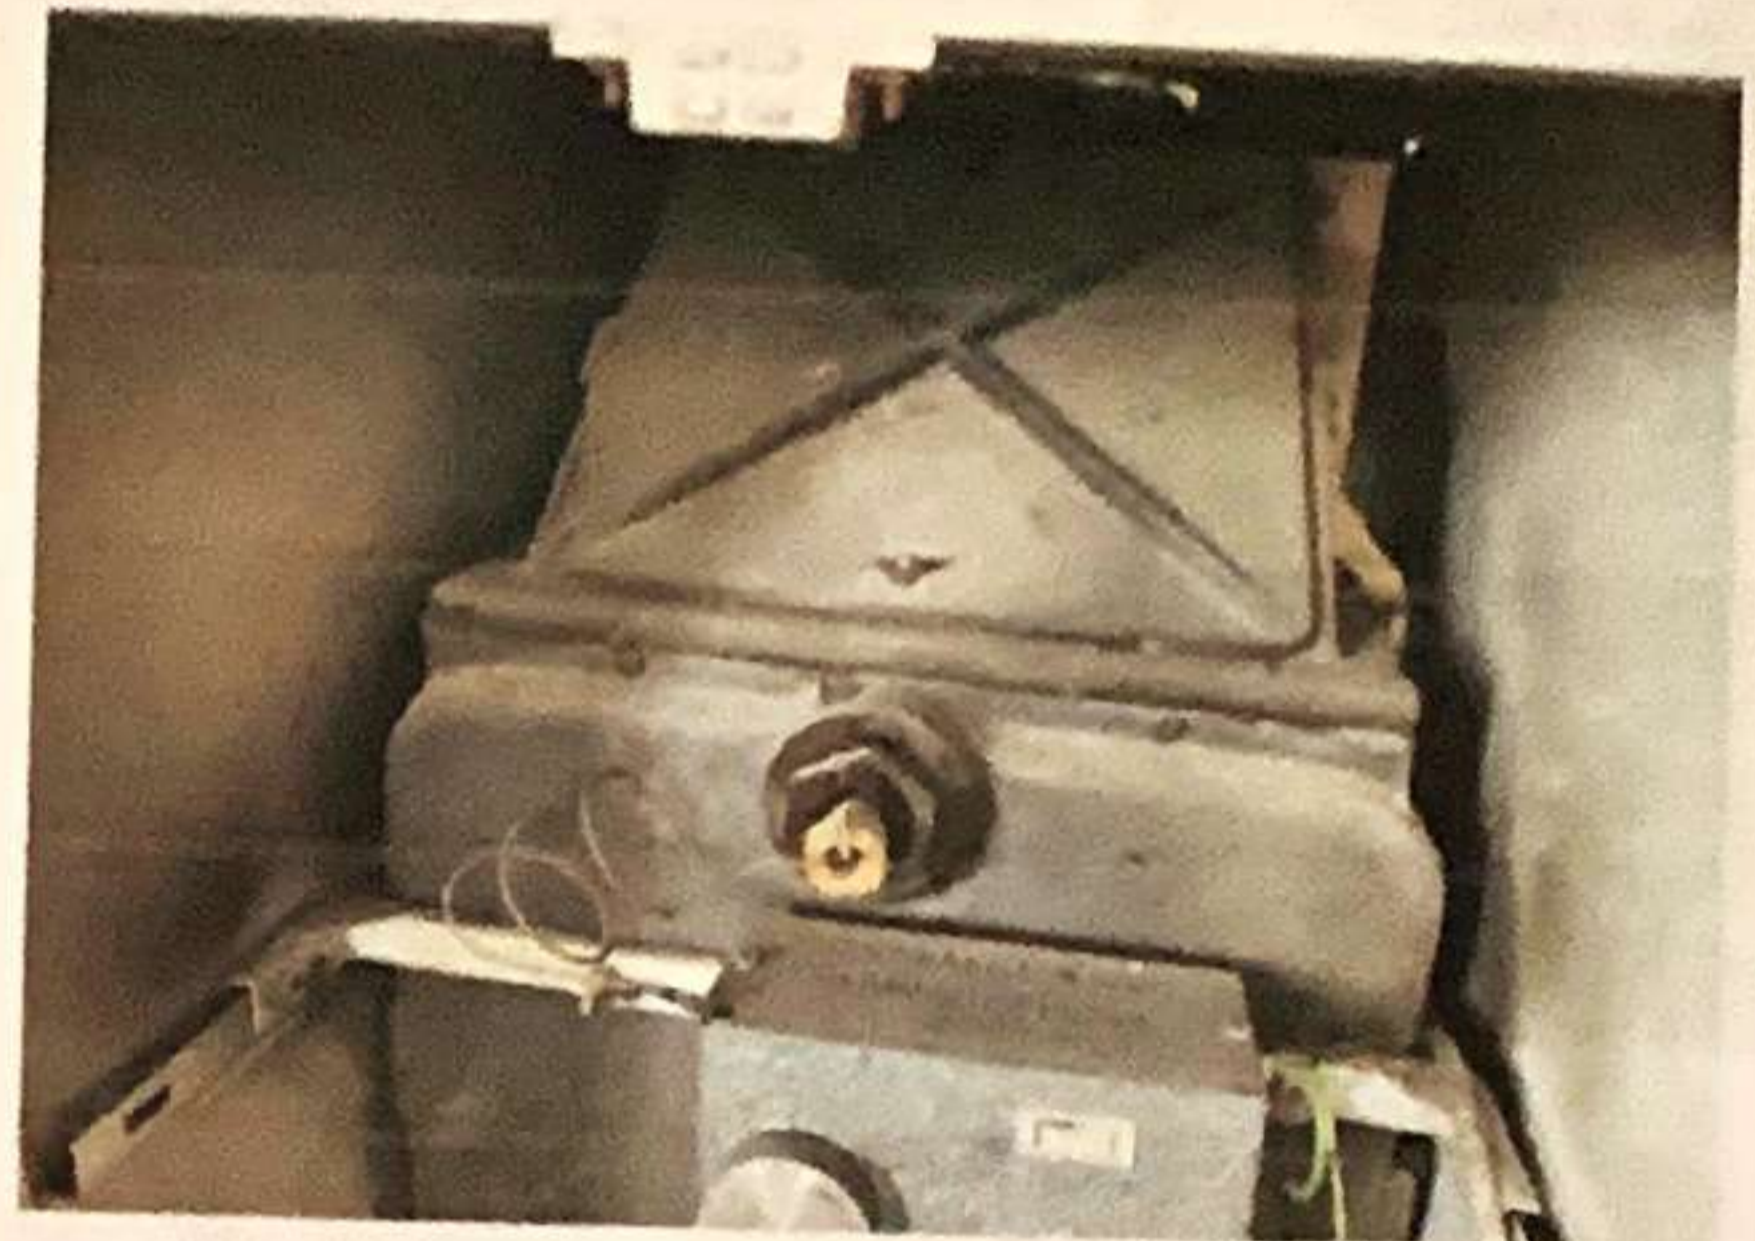
Building	99 High Street
Floor	Ground Floor
Room	003 - Office
Description	Black putty seal to old boiler unit.
Sample Reference	S005
Quantity	1 Units

Analysis Result	
No Asbestos Detected	0
Product Type	
Putty	1

Condition	
Low Damage	1
Surface Treatment	
Composite (Self Sealed)	0

No asbestos was detected within the sample collected and as such no further action is required.

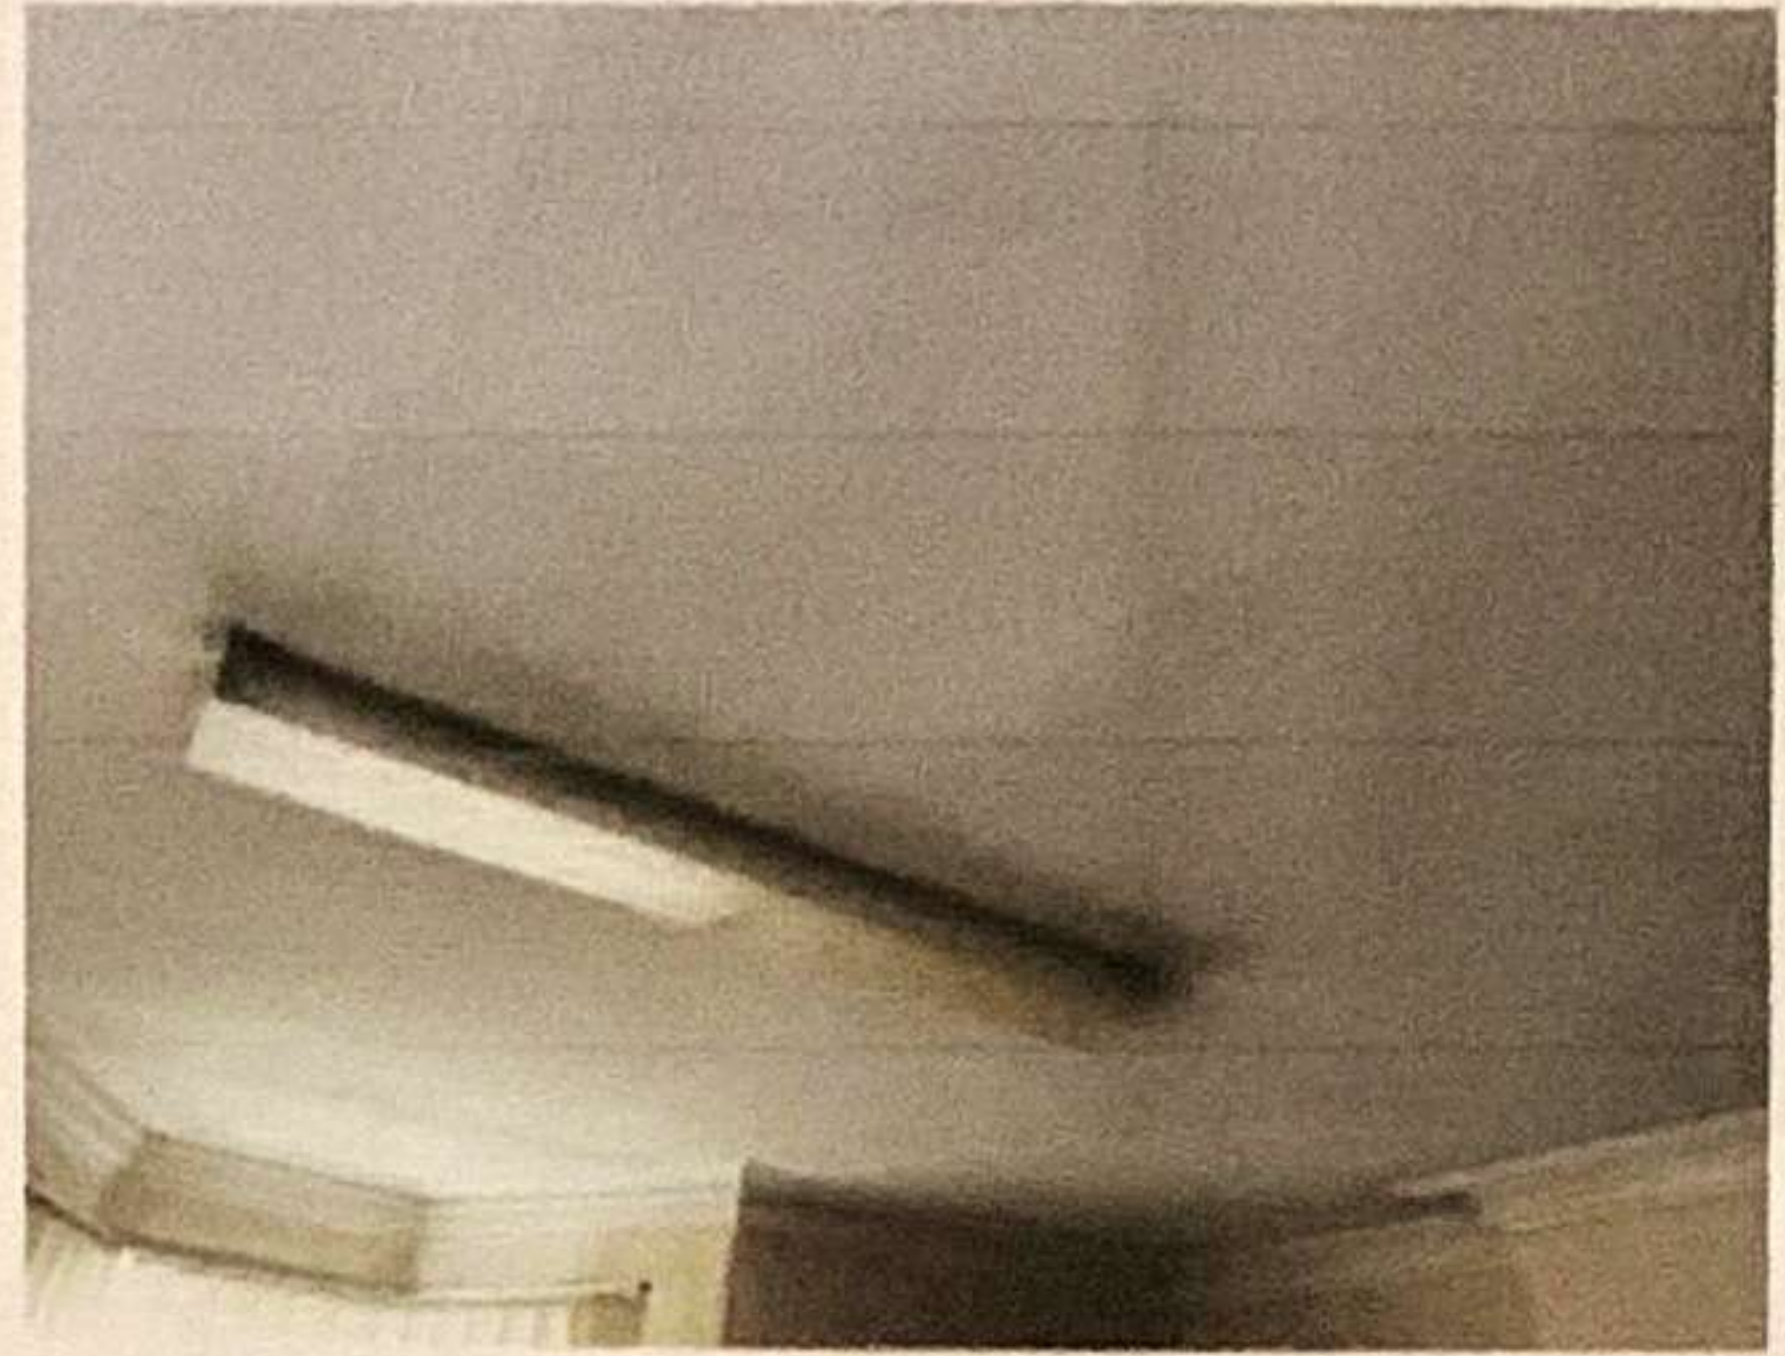
Building	99 High Street
Floor	Ground Floor
Room	004 - Office
Description	Textured coating to ceiling.
Sample Reference	S002
Quantity	19 m ²

Analysis Result	
Chrysotile	1
Product Type	
Textured Coating	1

Condition	
Low Damage	1
Surface Treatment	
Composite (Self Sealed)	0

Occupancy Activity	Location	Accessibility
1	2	1
Extent of Material	No of Occupants	Frequency of Use
2	1	3
Average Time	Maintenance Activity	Freq of Maintenance
3	1	1
Material Risk Score:		Priority Risk Score:
3		6
Total Risk Score:		Risk Description:
9		Low Risk

A sample was taken from multiple locations.

Whilst the asbestos containing material continues to remain undisturbed, no immediate action is required. However a system of ongoing management should be implemented which includes routine condition inspections.

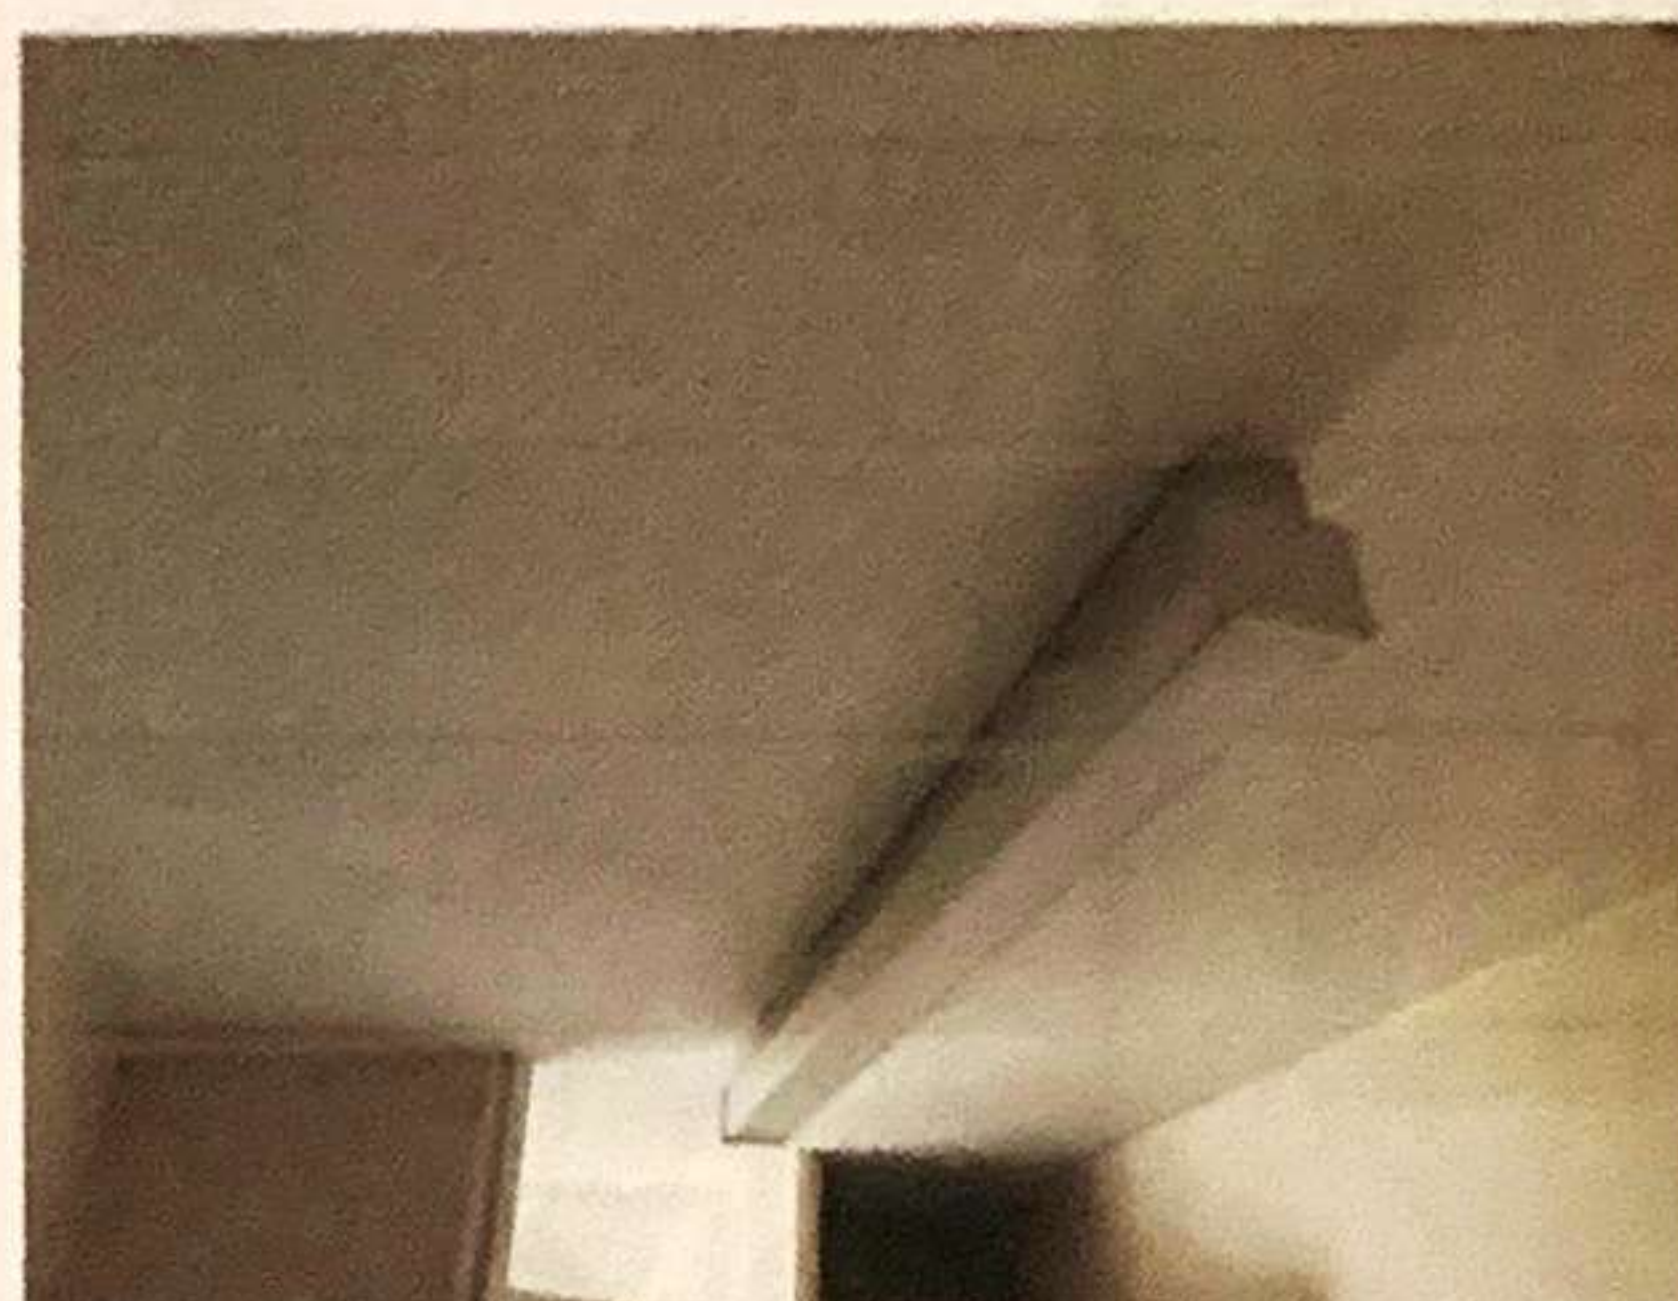
Building	99 High Street
Floor	Ground Floor
Room	007 - Kitchen
Description	Textured coating to ceiling.
Sample Reference	Ref S007
Quantity	6 m ²

Analysis Result	
Chrysotile	1
Product Type	
Textured Coating	1

Condition	
Low Damage	1
Surface Treatment	
Composite (Self Sealed)	0

Occupancy Activity	Location	Accessibility
1	2	1
Extent of Material	No of Occupants	Frequency of Use
1	1	3
Average Time	Maintenance Activity	Freq of Maintenance
1	1	1
Material Risk Score:		Priority Risk Score:
3		5
Total Risk Score:		Risk Description:
8		Very Low Risk

Whilst the asbestos containing material continues to remain undisturbed, no immediate action is required. However a system of ongoing management should be implemented which includes routine condition inspections.

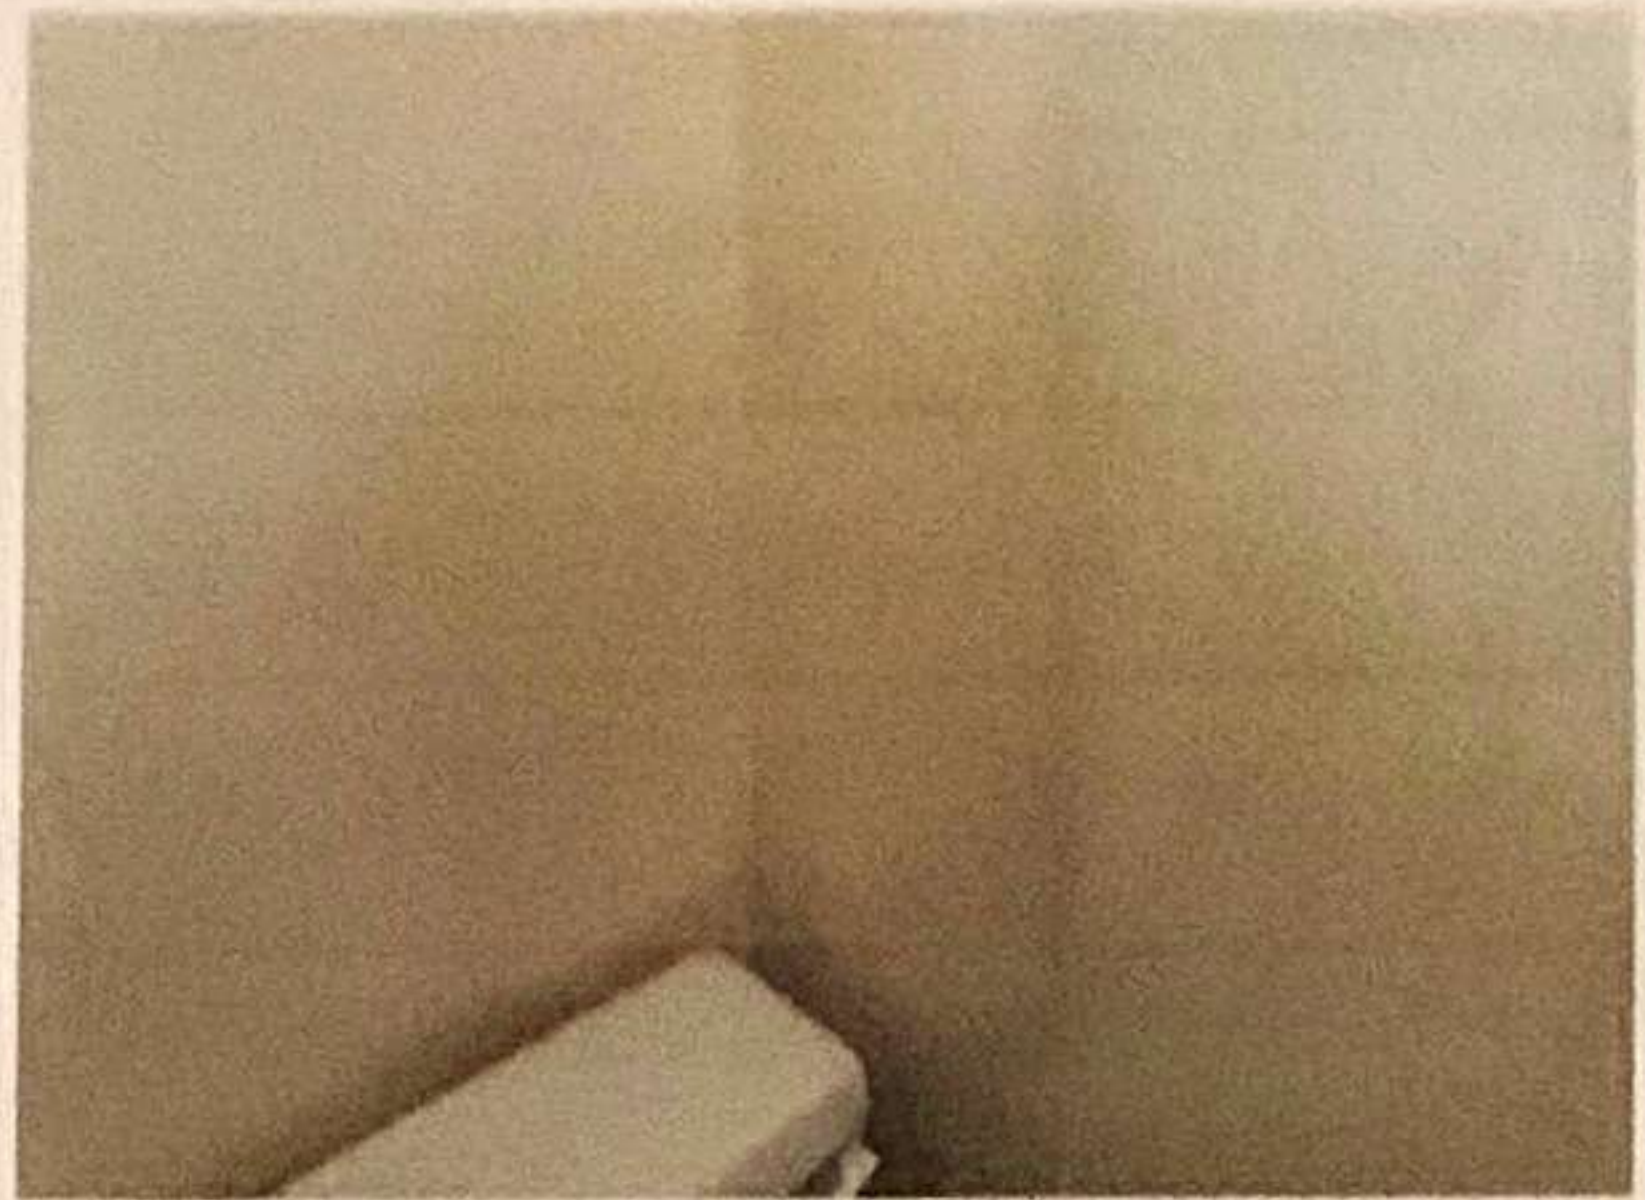
Building	99 High Street
Floor	Ground Floor
Room	009 - WC
Description	Textured coating to walls.
Sample Reference	S008
Quantity	12 m ²

Analysis Result	
No Asbestos Detected	0
Product Type	
Textured Coating	1

Condition	
Low Damage	1
Surface Treatment	
Composite (Self Sealed)	0

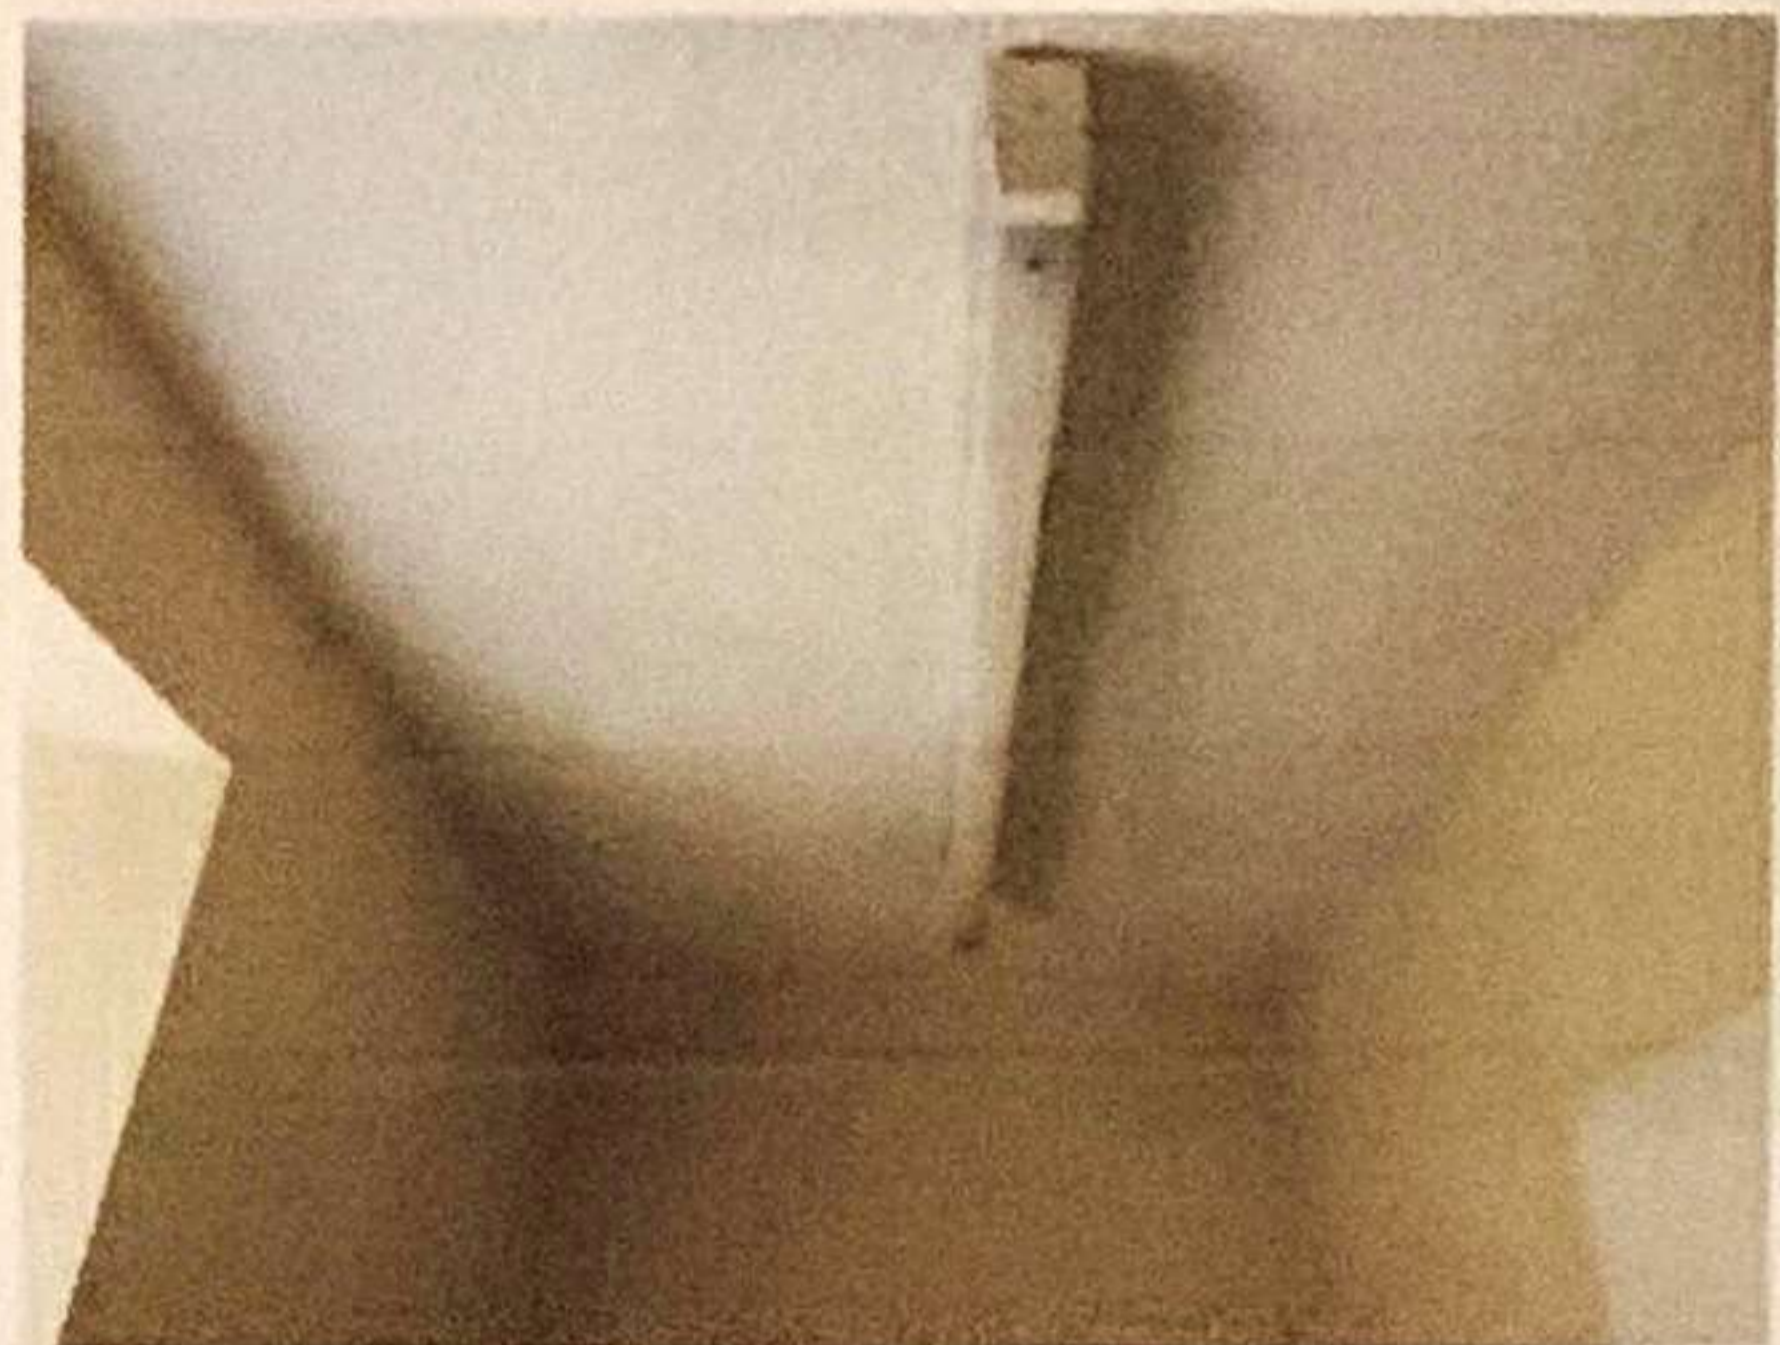
Building	99 High Street
Floor	Ground Floor
Room	009 - WC
Description	Textured coating to ceiling.
Sample Reference	Ref S007
Quantity	4 m ²

Analysis Result	
Chrysotile	1
Product Type	
Textured Coating	1

Condition	
Low Damage	1
Surface Treatment	
Composite (Self Sealed)	0

Whilst the asbestos containing material continues to remain undisturbed, no immediate action is required. However a system of ongoing management should be implemented which includes routine condition inspections.
