Land at Carr House Drive, Newton Hall, Durham, DH1 5RP (Grid reference NZ 27975 45041).

Tree Survey & Arboricultural Impact Assessment (V2) – 11<sup>th</sup> October 2023

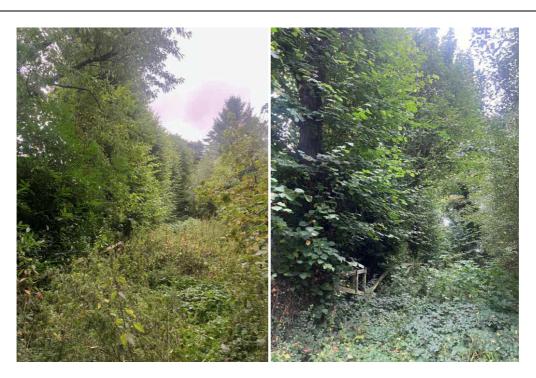
Photographs 1 – The overgrown / unmanaged condition, limiting visual inspection of the trees

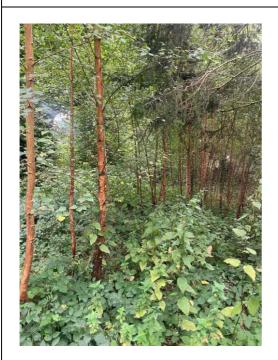
Photographs 2 – The small low quality Birch trees growing across the site (to be removed a spart of the development)

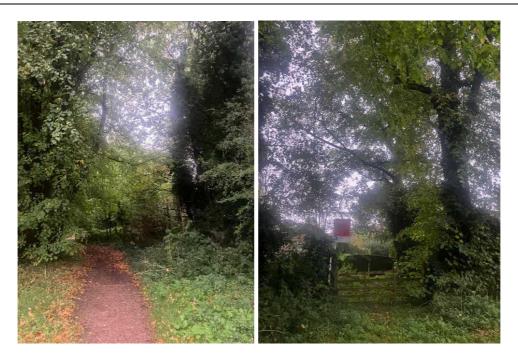
The existing access at the north eastern side of the drive is to be upgraded as part of the scheme. Additionally, the proposed access encroaches into the RPA of T11 (untagged) and T1845. The proposed driveway is sited as far away from these trees as possible, however encroachment into the trees RPA remains.

Photographs 4a & b – The existing access at the front of the site that leads on to Carr House Drive. Tree T11 and T1845 can be seen in the photograph.

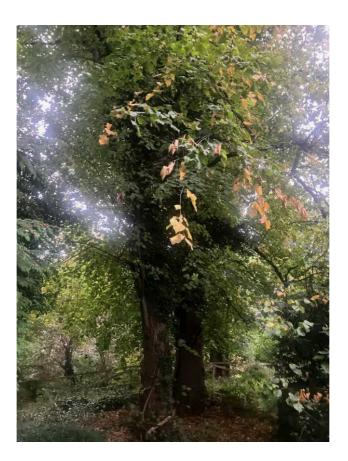
Photographs 5 – Tree T1850 & T1841

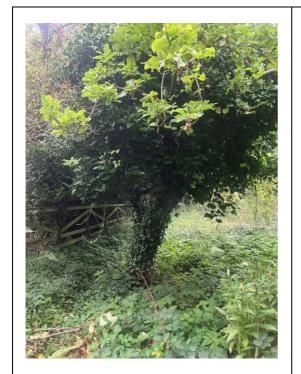
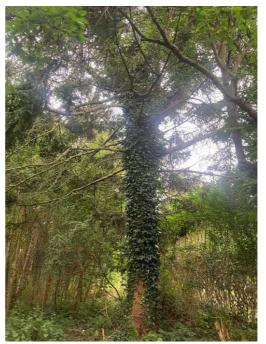
Photograph 6 – T1853

Trees T1852 (Apple), and T1853 (Spruce) will need to be removed for the construction of the proposed dwelling. Both trees are low quality (Grey - C category trees). They are visually localised to the site and their removal will have no significant impact upon the site or wider area.
