## Structural feasibility report for conversion

Project ref: 24026

**RE: Timber outbuilding at Staithe Farm House, Staithe Road, Burgh St Peter, Beccles NR34 0DE**

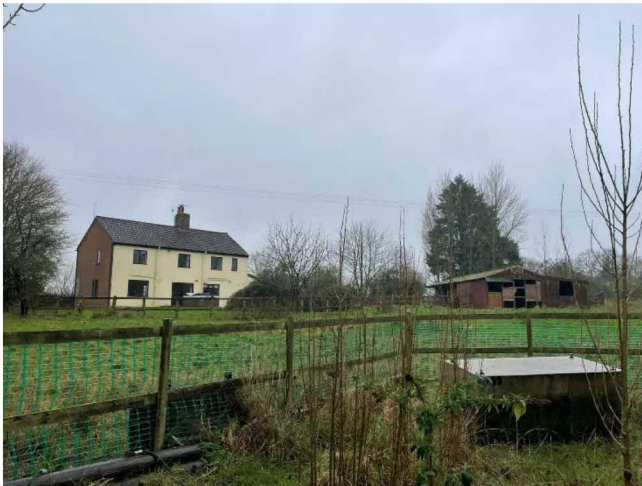
*Fig. 1. View of the House and outbuilding*

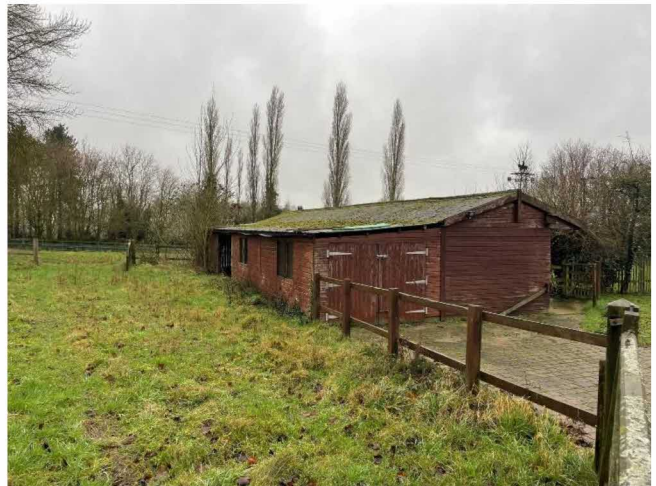
*Fig. 2. View of the outbuilding*

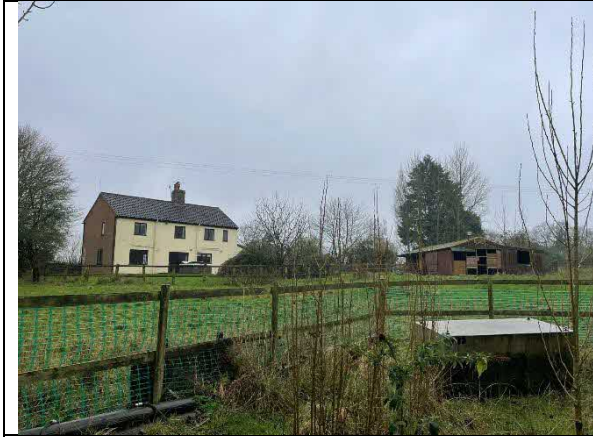
Photo 1 – View of the property from the north with the outbuilding visible to the right

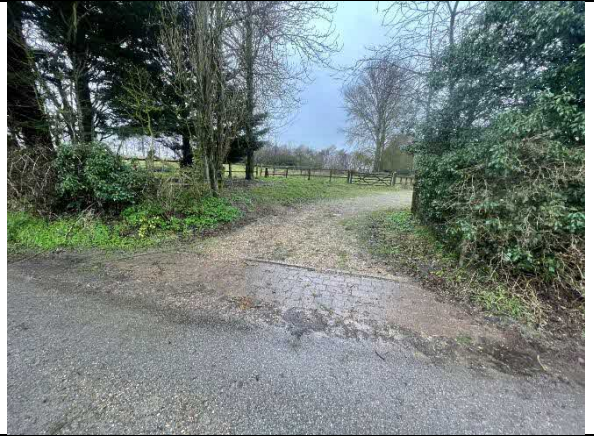
Photo 2 – Entrance from Staithe Road

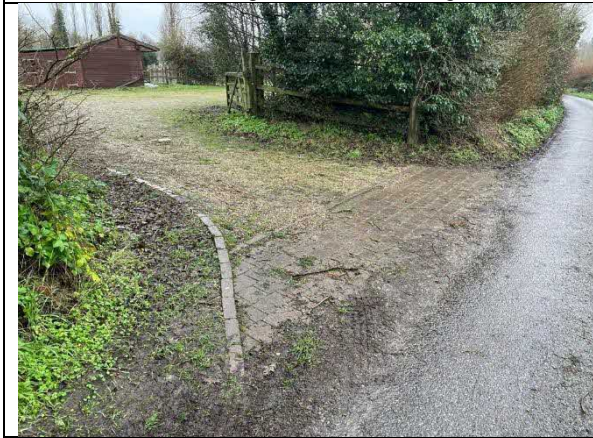
Photo 3 – View from the entrance showing the outbuilding

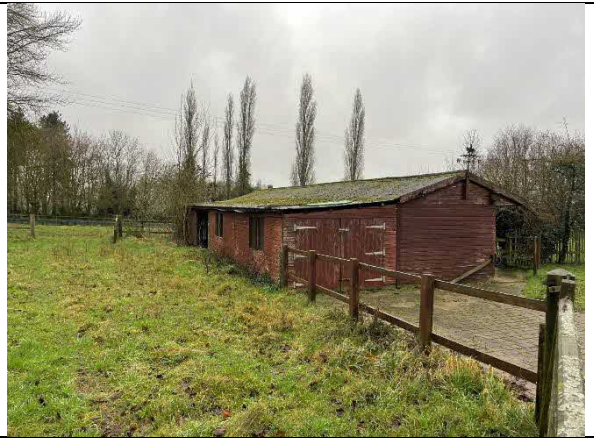
Photo 4 – General view from the south-west

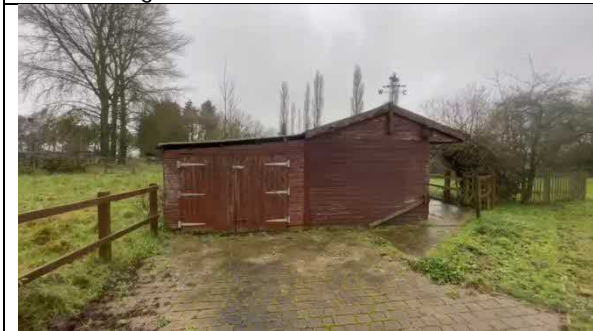
Photo 5 – South gable

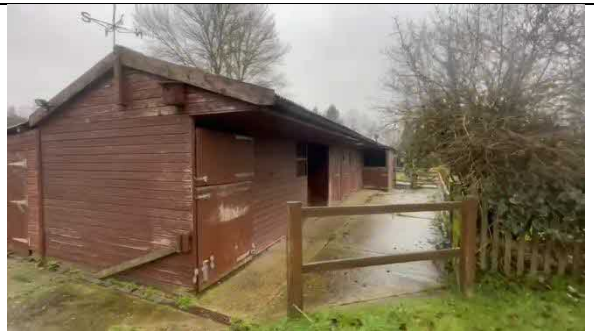
Photo 6 - General view from the south-east

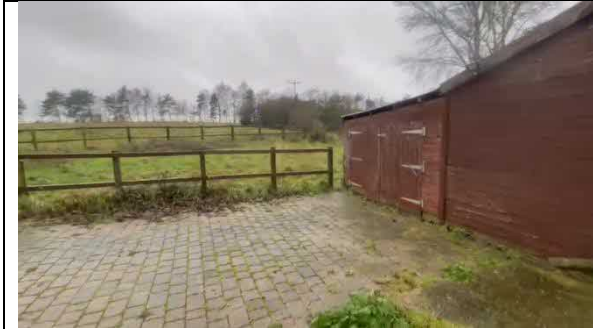
Photo 7 – South gable detail showing the adjacent lean-to structure

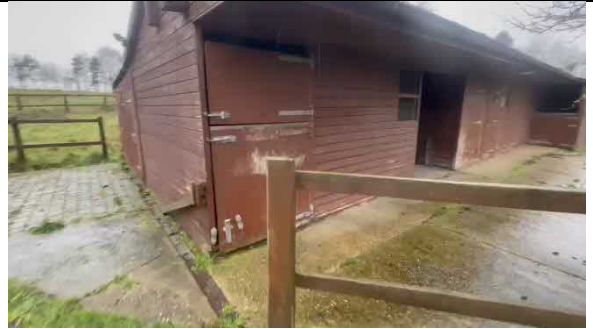
Photo 8 – East flank wall detail

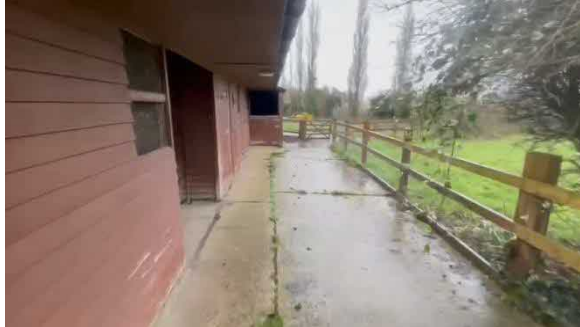
Photo 9 – View along the east flank wall

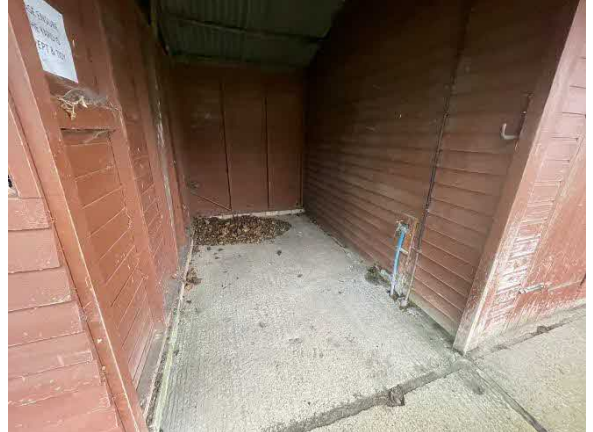
Photo 10 – Recess on the east flank

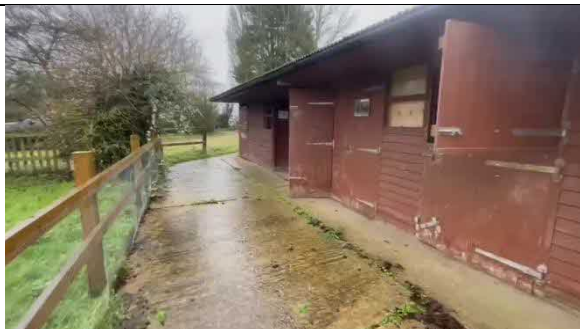
Photo 11 – View from the north-east

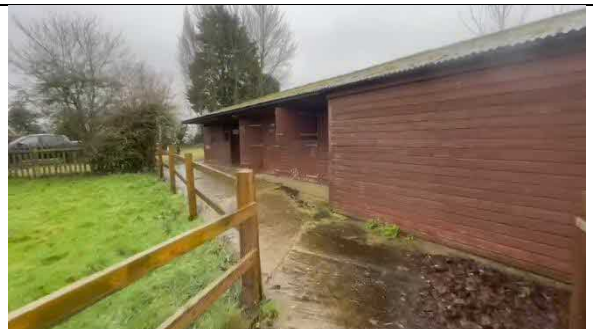
Photo 12 - View of the east flank wall from the north-east

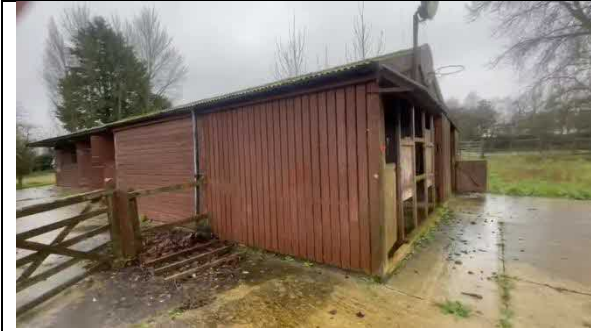
Photo 13 – North east view of the east flank wall and north gable

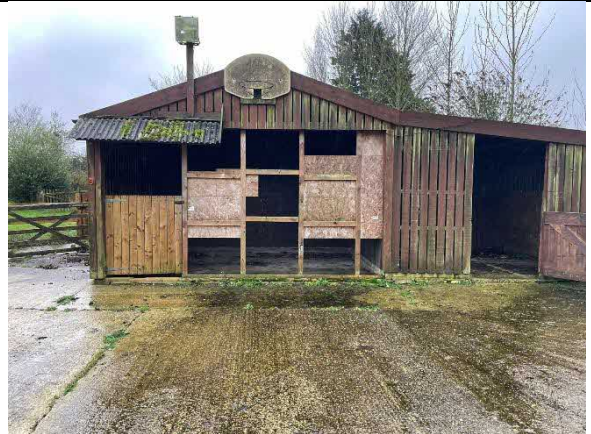
Photo 14 – North gable elevation

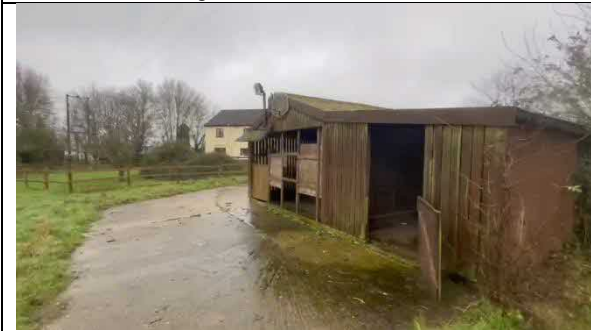
Photo 15 – View along the north gable with the west lean-to in the foreground

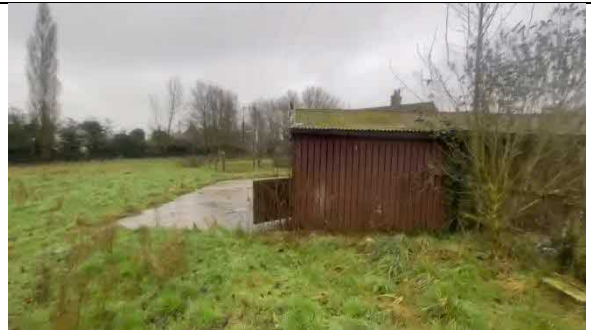
Photo 16 – West elevation detail

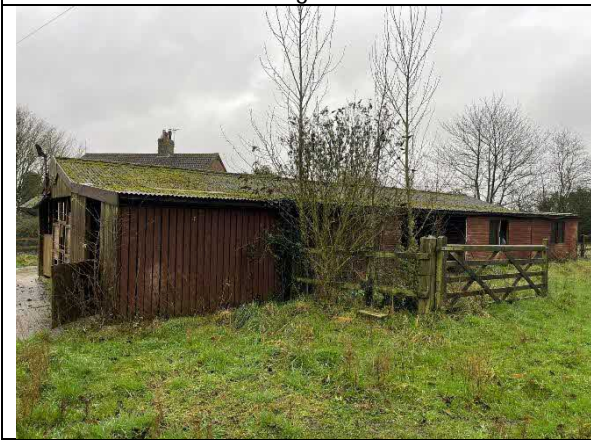
Photo 17 – West elevation

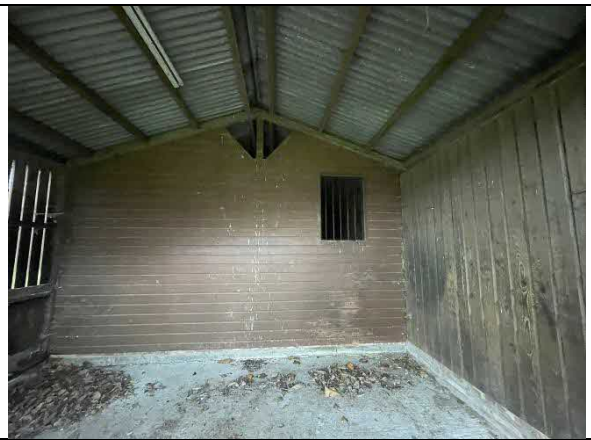
Photo 18 – Internal view at the northern end

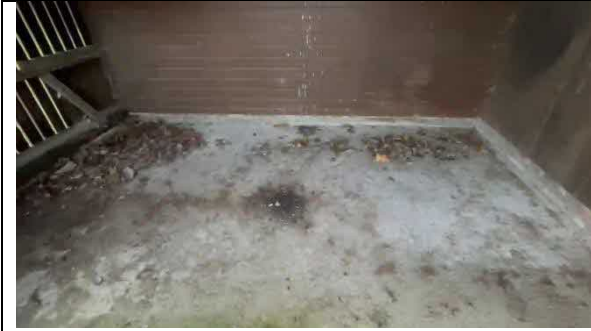
The ground floor slab is sound and appears suitable to take the required insulation and floor finish that will be required to bring the building to habitable standard.

Photo 19 – Internal concrete floor slab

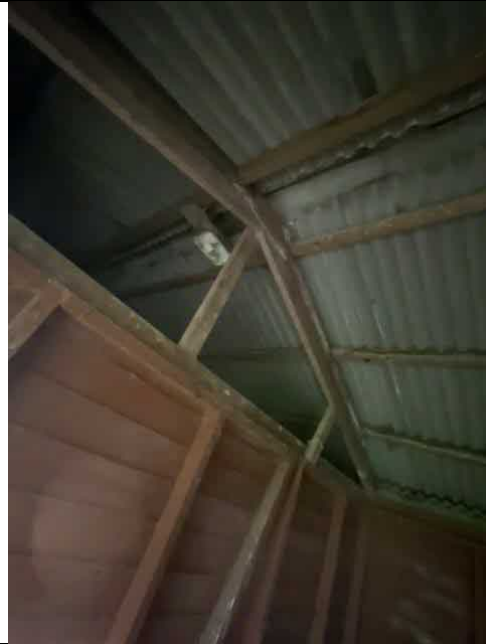
The roof purlins are relatively shallow. Therefore, the required roof insulation will not fit between the purlins and will need to be positioned below. Depending on the specification of the insulation to be used, additional timber counter-battening may be required for the insulation zone.

Photo 20 – Internal roof view showing timber purlins supporting corrugated sheeting off an internal loadbearing wall

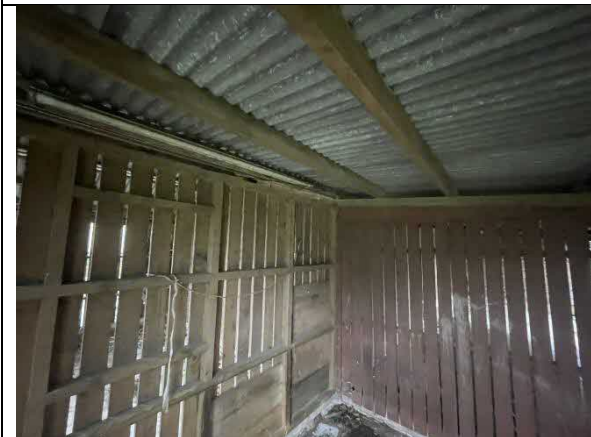
Photo 21 – Internal view of the lean-to

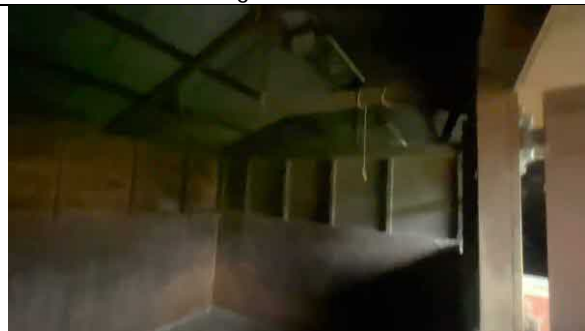
Photo 22 – Internal view of the main building
