Schedule of Works

Park Farm Braiseworth Lane, Braiseworth, Suffolk, IP23 7HB

Listed building Grade 2

This 17th century farmhouse has suffered neglect through lack of occupation, ransacking and well-meaning but in appropriate past maintenance.

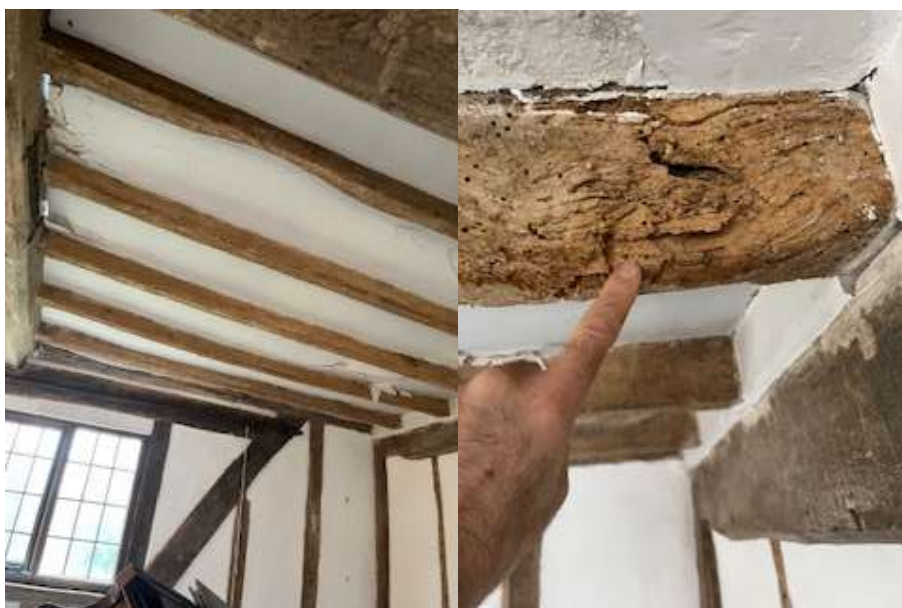
Replacement of up to and no more than five failed floor joist timbers.

One bay of the house seems to have suffered a particularly virulent infestation of wood boring insects over a prolonged period. There is evidence that the attack has eroded one timber through. It is suspected that any or all may have suffered equal fate. If there are any substantial elements not deteriorated to point of severe weakness, then repairs shall be made and strong timber retained.

This element of work is necessary to facilitate further repairs to flooring and plasterwork and retain the integrity of the building.

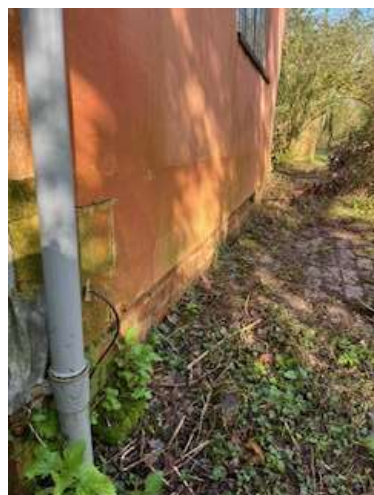
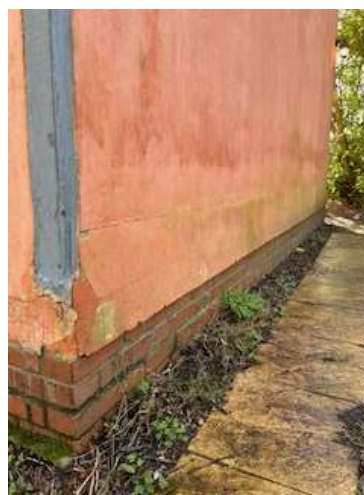
Removal of cement render, low level.

Externally a lower 'skirt' of cement render has been applied presumably following some repairs to brick work beneath the sole plate. The proposal is to remove this render and replace in traditional lime. It is felt that this section of any old building is particularly vulnerable to moisture. Breathability is of particular benefit in this area. The thinking is that lime above the sole plate is key to protecting what seems to be the original sole plate from damage arising from damp. This work will be conducted by Edward Fitch who is skilled in traditional building methods.

We acknowledge the comments from Conservation Officer regarding securing condition following removal of this lower 'skirt.' As the nature of the building allows simple and uninhibited access to the inside of the sole plate, it is clear that the timber is likely to have structural integrity. If upon inspection from the outside the timber is found to be in poor repair, we shall seek to retain all material possible and effect suitable repairs following further consultation and collection of evidence. This work shall be conducted by Rick Lewis.

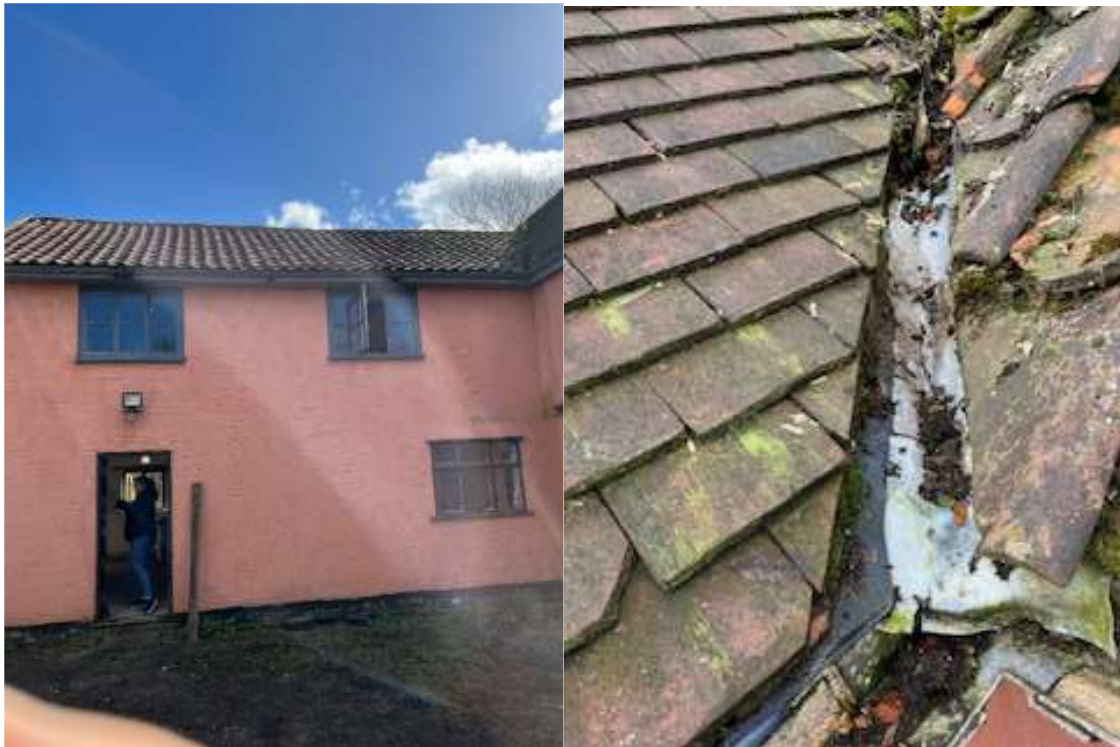
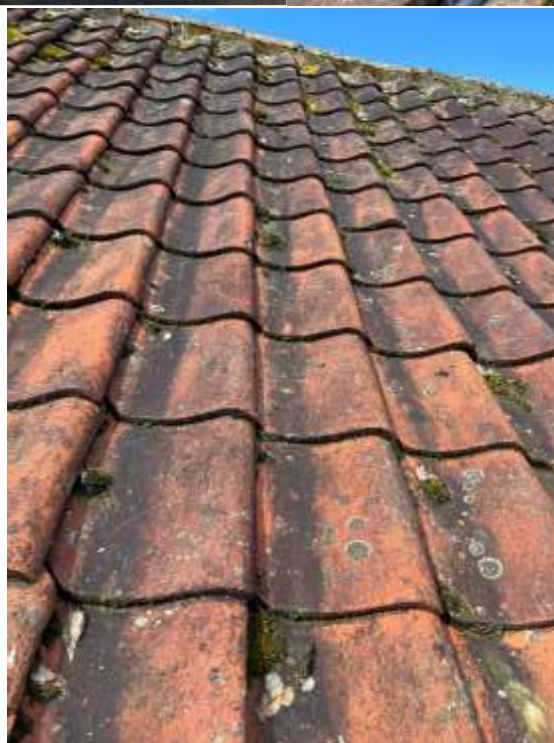
Roof repairs.

The pantile roof that shelters the rear brick extension shows many key elements of the original. As such the owner is keen to retain it as is. Some tiles need replacing at the current time only one single tile is missing. This shall be replaced as soon as access can be arranged. Early inspection indicates that the lead valley that joins with the much older peg tile roof (seemingly with some recent attention) need replacement. There are many faulty repairs visible and a sound replacement in lead should ensure the valleys success for many years.

Upon inspection internally it is clear that the roof is doing an effective job of keeping the building dry. The original torching is still in place. However, the valley has failed and is letting in water in a number of places. The homeowner is therefore seeking permission to replace the lead valley urgently.

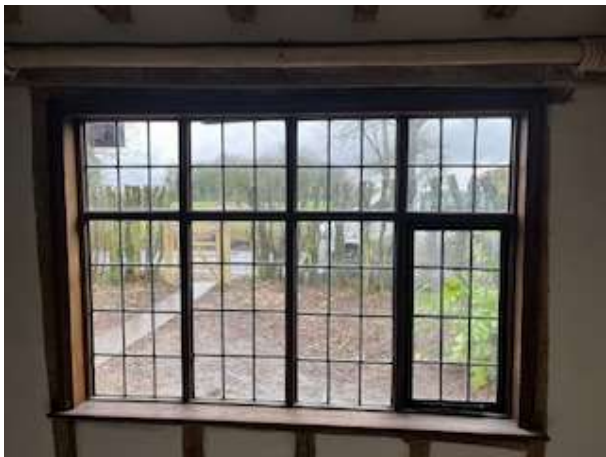
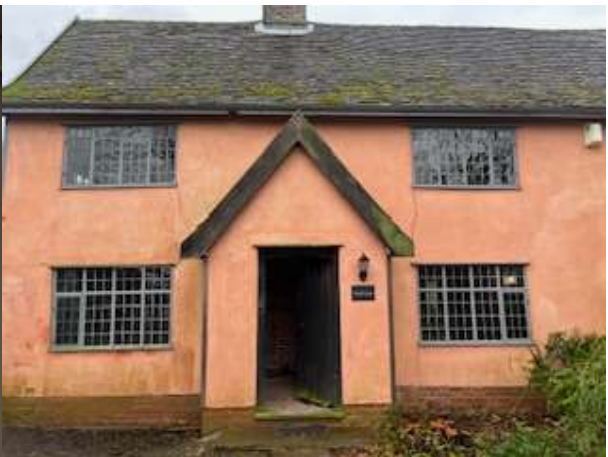
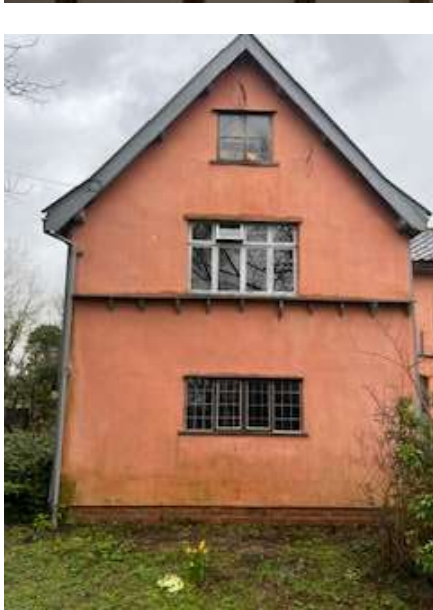
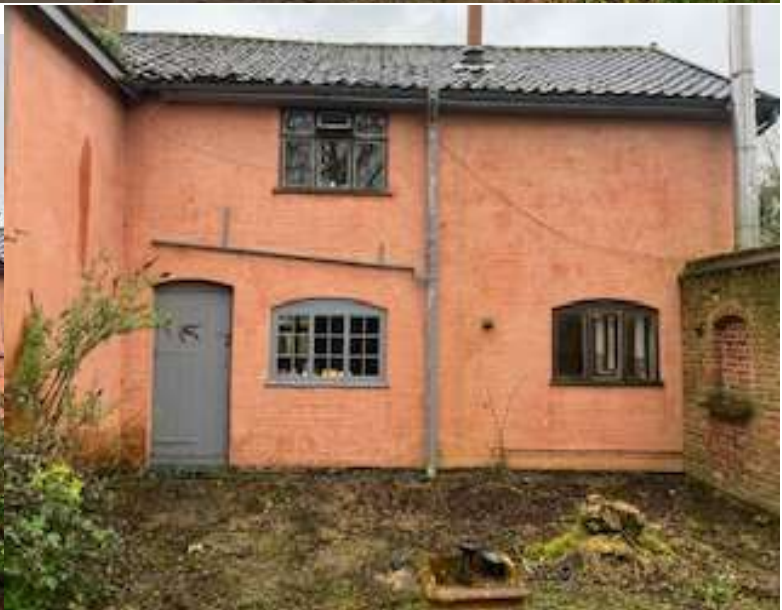
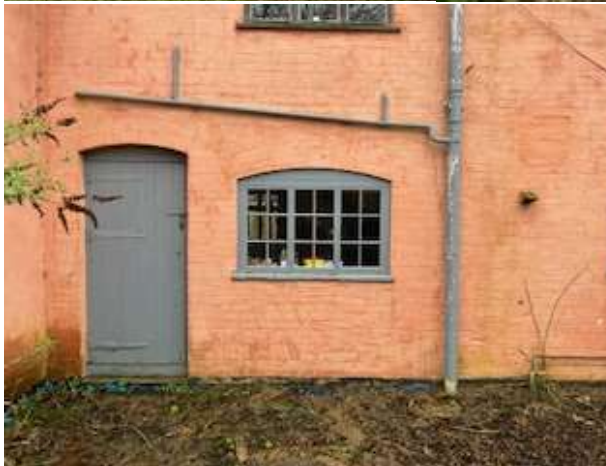
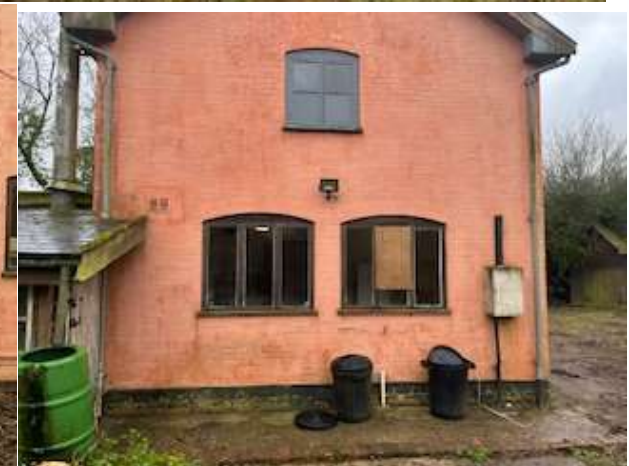
Window repairs.

Generally, all windows and their frames are to be retained in entirety. The applicant is of the opinion that the conservation team at Mid Suffolk would be pleased to see simple small repairs to the lower say 10% of the frames where splicing in in hard wood to match existing will extend the life and durability of the windows. There are notably four windows in total that on inspection need some form of timber repair.

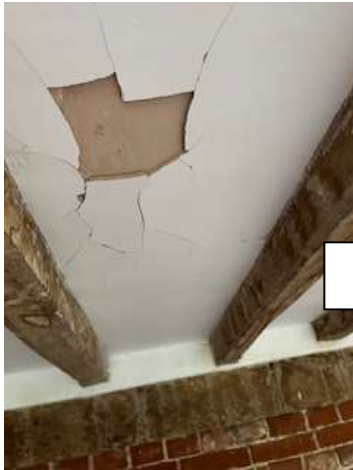
A

A: Nine infill panels damaged during ransacking previously skimmed with gypsum plaster, seeking permission to replace wooden laths with lime plaster.

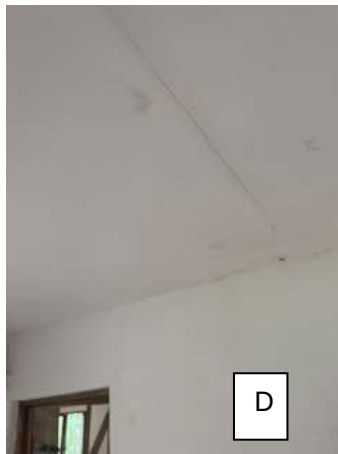
D

D: Entire ceiling all plasterboard with gypsum plaster. Seeking permission to replace this damaged modern material with wooden laths and lime plaster.

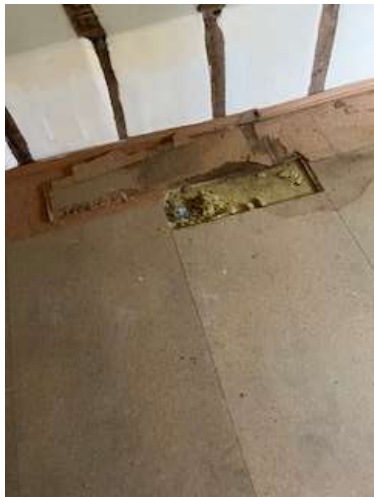
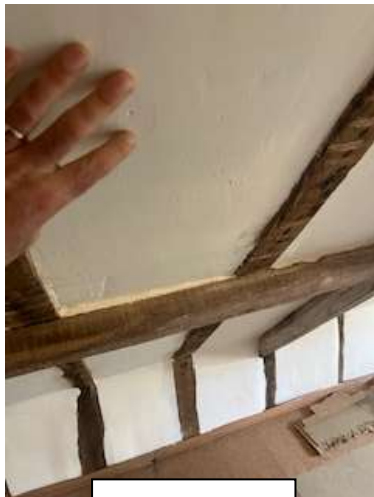
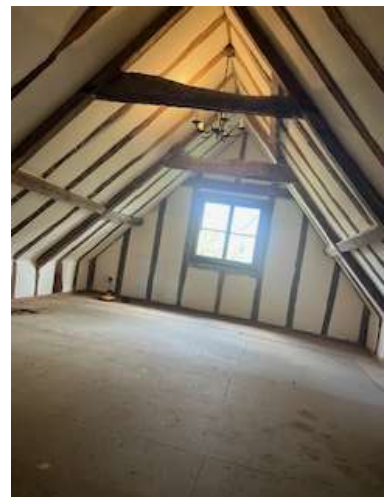
G

G: This room can be seen to have been plaster boarded on all of the infills. This is visible from the picture provided from inside the loft space. This room has also been boarded out and chip boarded over a layer of plastic and inappropriate glass fibre insulation. The applicant is seeking to remove up to 25% of the infills in this room and replace with timber laths and lime plaster. The applicant also wishes to remove the chipboard flooring, plastic and glass fibre insulation and replace with square edged wide oak floorboards.

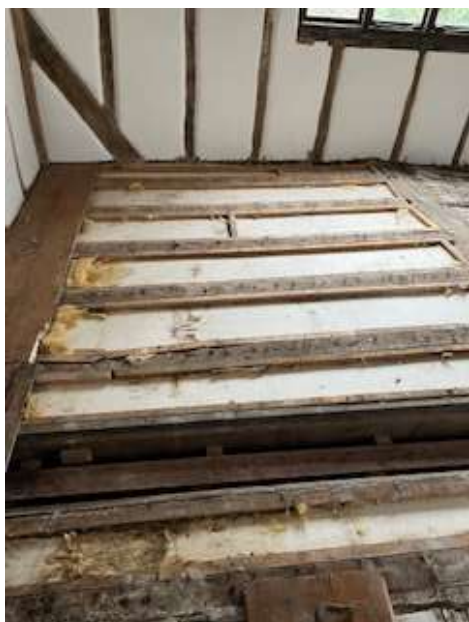
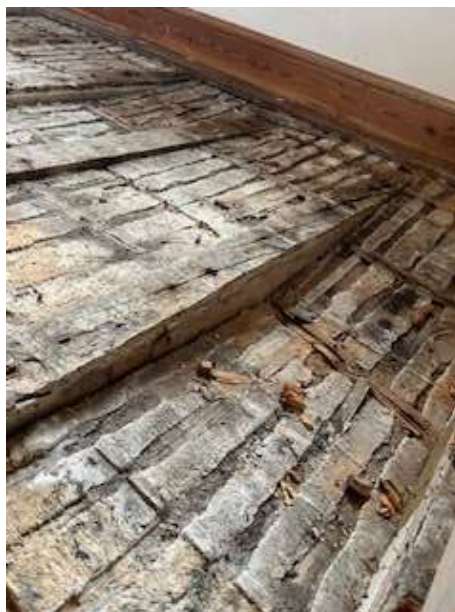
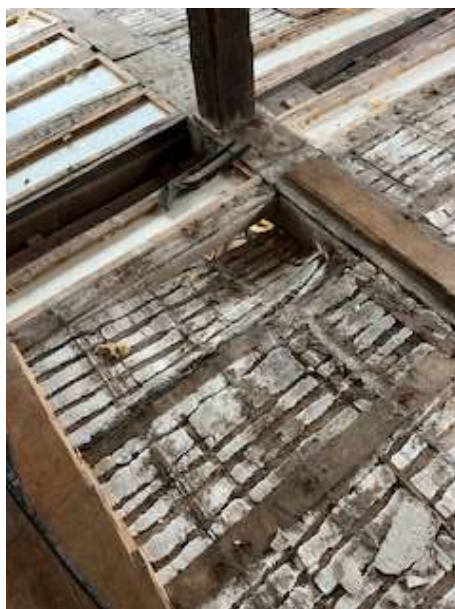
As can be seen in the pictures below almost all of the floorboards have been stolen. The homeowner feels it may be better not to fuel demand for reclaimed materials. And replace in new. The homeowner would be grateful to know the current policy of the Heritage department.

The proposal is to reinstate the stolen flooring with new square edged boards made from oak.

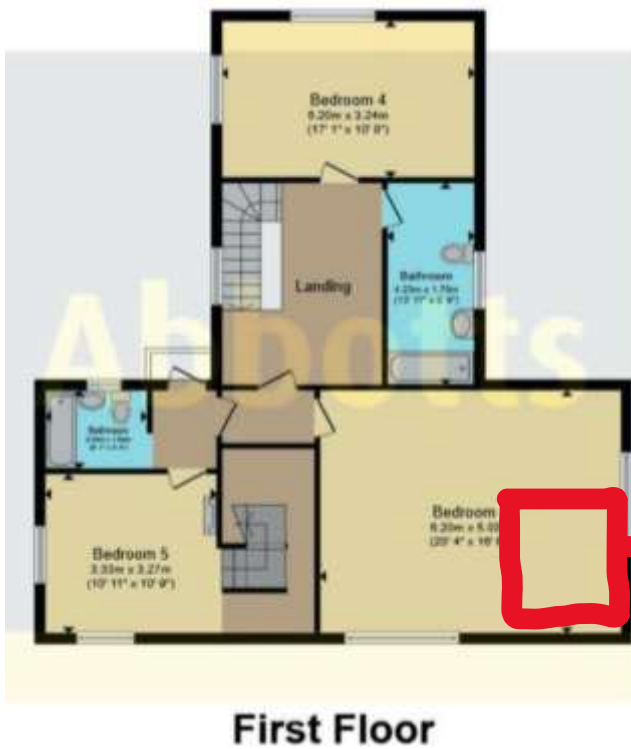
Floor joists.

The thick red band illustrates the corner of the house that is affected by extreme insect infestation.

It is proposed that up to five floor joists be replaced with new oak timbers.

Were timbers are found to have structural stability repairs will be affected.
