Shane and Anne have recently taken ownership of a grade II listed 17th century farmhouse. Park Farm Braiseworth, Suffolk IP23 7HB.

Proposed work at Park Farm Braiseworth:

Updated 20/02/2024

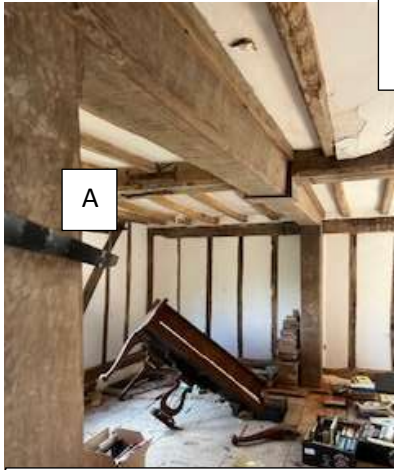
A

An RSJ has been inserted in place of a replacement timber.

The above illustrations show a significant timber {A} within the frame has been replaced with a metal RSJ housed in an oak panelling.

Following consultation with Rick Lewis it seems that this RSJ may well be best left in situ.

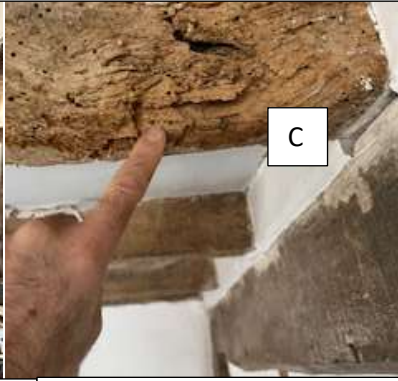
C

Whilst most timbers appear sound, the most easterly bay shows as many as 5 badly deteriorated floor joists. One is visibly broken through.

{C} A few timbers have suffered chronic destruction from boring insects.

Smaller degraded timbers would be replaced with aged oak or elm to suit the frame and restore integrity.

The buildings owner is discussing this work with Rick Lewis known as a leading expert in timber frame manufacture and repair. The owner of the building will seek to carry out such work only with a reputable timber framer and with the permission and direction of the conservation department. The proposal here is simply to replace up to five in number timbers that have quite literally been bored out to destruction.

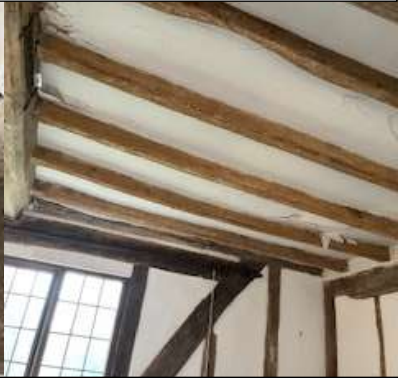
Boxing, hiding the RSJ beneath

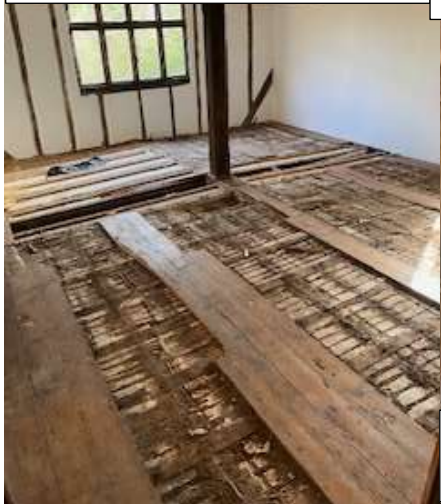
B

{B} The RSJ inserted in place of a timber.

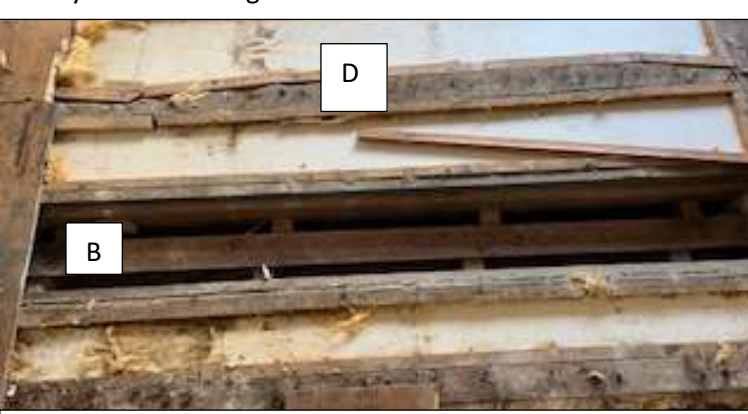
D

RSJ replacement of original timber

{D} The sections of Lath and plaster have been removed and replaced with plaster board.

During these works any disturbed plaster work would be replaced with laths and lime plaster in the traditional style and method. Increasing breathability of the building.

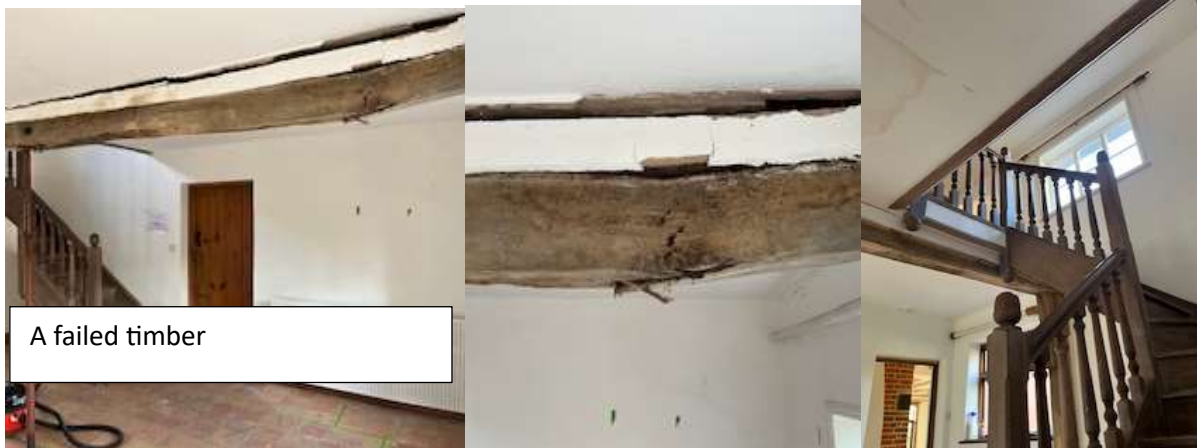
REF 2

The pictures show a failed timber. Seemingly the timber has been placed at some stage to support timbers cut through to form a large stair way. The timber seemingly has succumbed to water damage, rot and death watch beetle attack over a period, possibly relating to an historical water leak from the roof.

This timber is a relatively modern (old reclaimed timber has been used) addition to the building estimates of 20 years. The timber itself does not as such form part of the timber frame. This section of the building is probably Victorian and is of solid brick construction. The proposal is simply to replace this timber like for like. The timber shall be bought into position through an open window with the removal and replacement of the same bricks around the supportive section of the external wall.

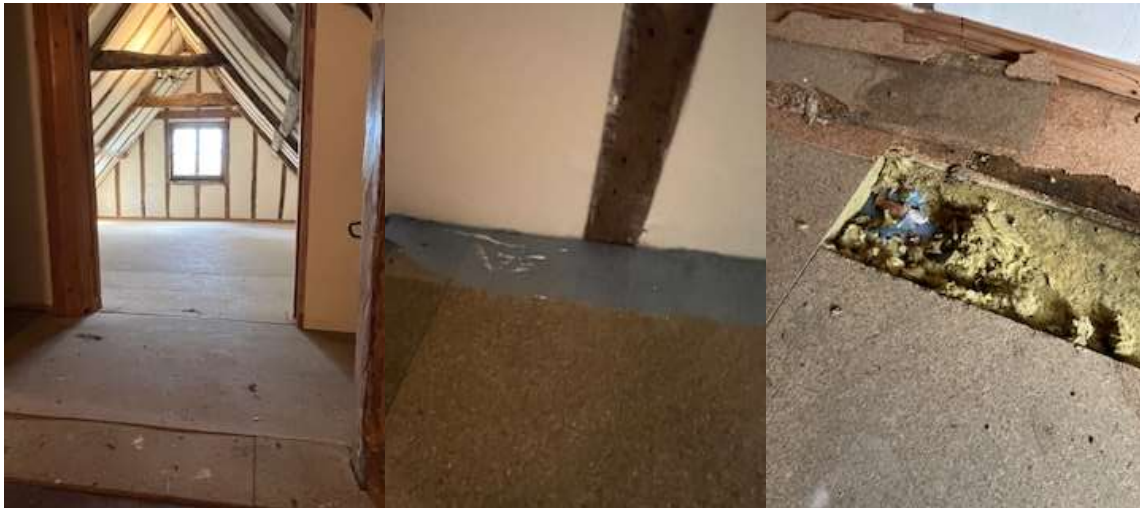
The attic room has been boarded in chipboard laid on insulation on a layer of plastic. The homeowner intends to remove this modern material. It is expected that the conservation department will agree that this kind of vapour barrier will have potential to cause condensation and associated deterioration. The homeowner would like to know the thoughts from the conservation department regarding replacement boards. Weather new solid oak boards are preferable to reclaimed older boards.

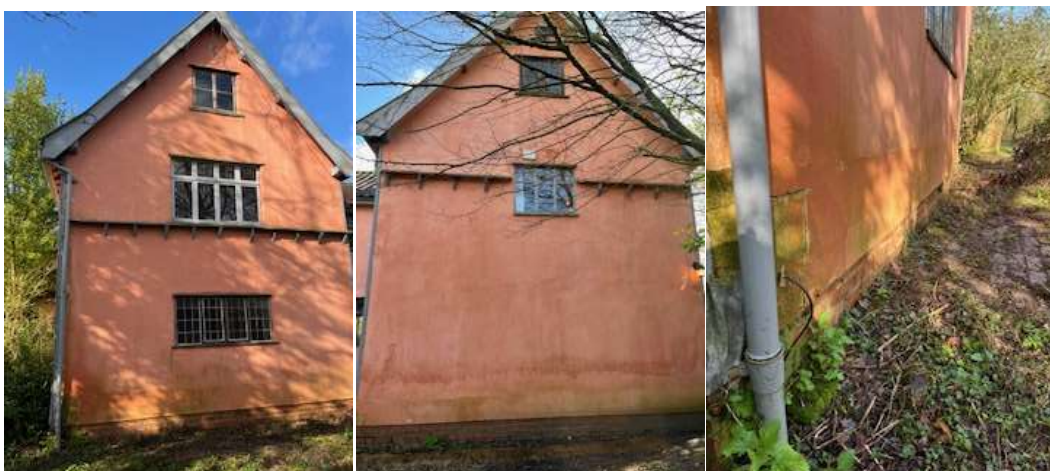
REF 3

It seems that possibly at the time of sole plate repairs the lower section of rendering were replaced and repaired using cement. The homeowner intends to seek permission to remove any sign of cement render particularly at the lower level say 900mm and inspect small sections and replace with lime to improve the aesthetic and to better honour the construction methods used in history. It is believed that the lime will encourage better breathability at lower levels. Also, at low level on the southeast corner there is signs of brick work disturbance. Currently it seems that tree roots and damaged rainwater goods have caused the disturbance. It is proposed that the brick work should be removed a small excavation in order to evaluate then replace and re-mortared in lime.

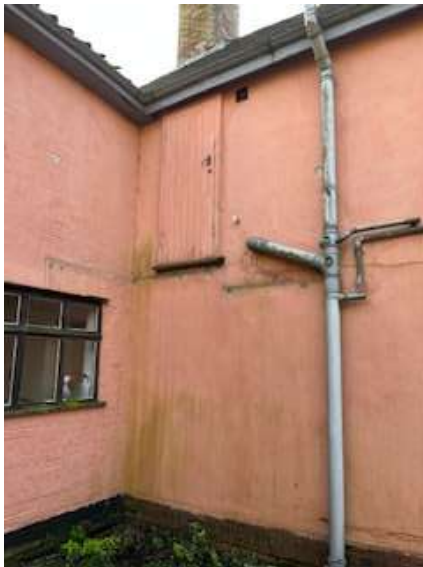
REF 4

This door seems to have been created to service a self-contained flat within the building. There is evidence of a modern fire escape set up. The proposal is to remove the door and replace a timber that may have been removed from the frame. The owners would like to glaze between these timbers to create light and retain the opening as a feature.

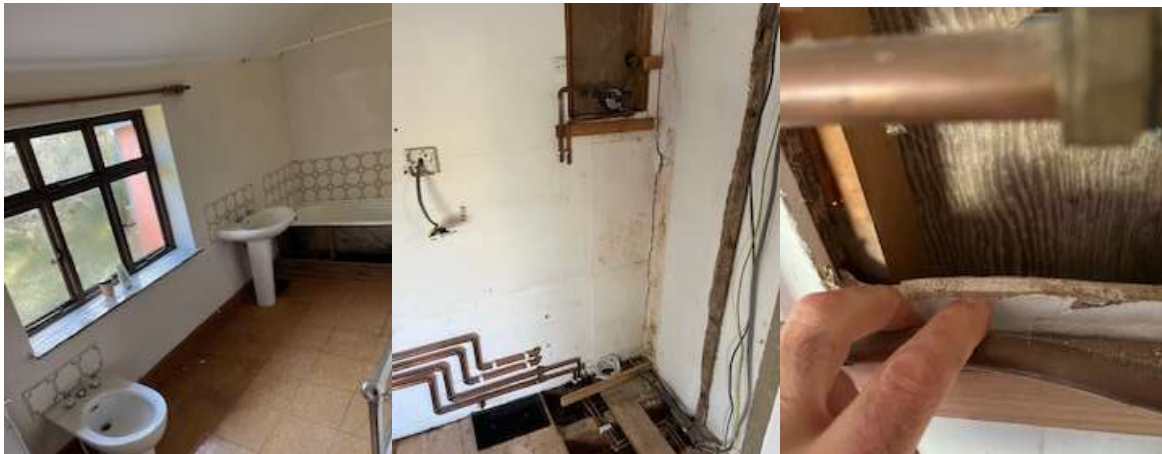
Large bathroom to be divided in two. Modern plasterboard seen. Modern timbers to stud work. Fibre glass insulation.

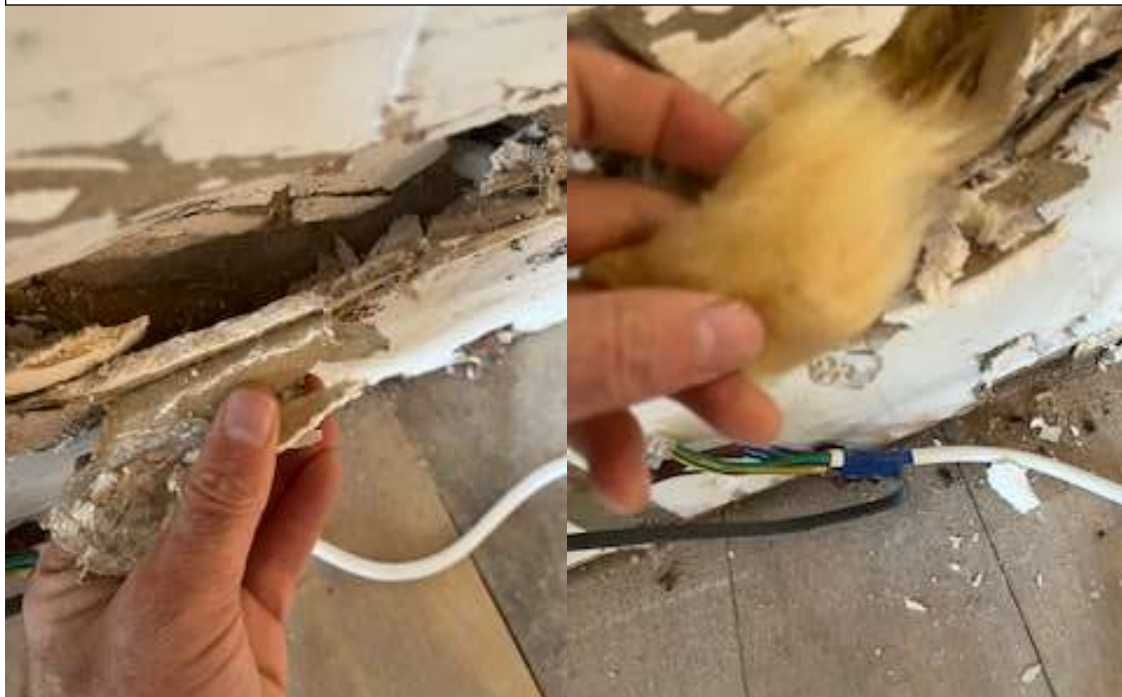
The homeowner wishes to for a second bathroom from the existing main family bathroom space. This section is entirely modern stud work formed of plaster board and modern timbers. It is in the solid brick extension.

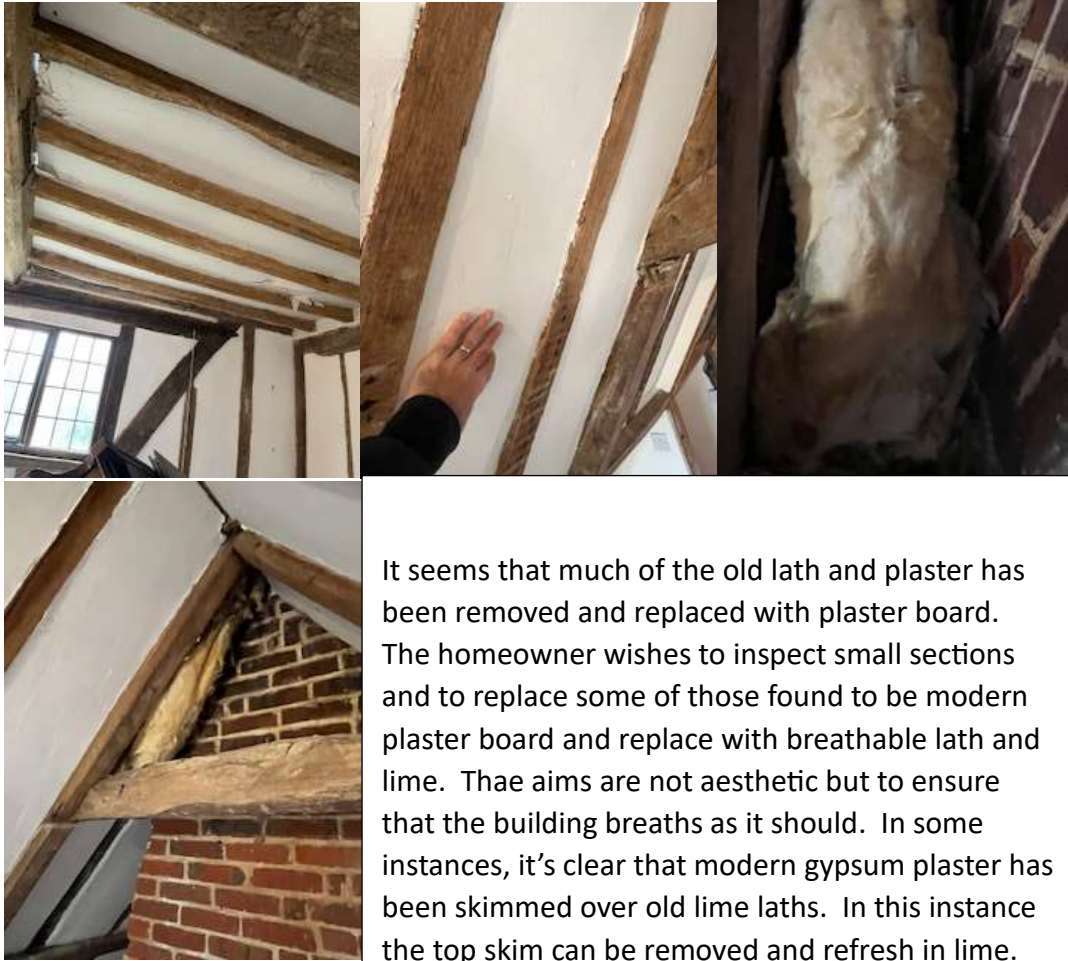
It seems that much of the old lath and plaster has been removed and replaced with plaster board. The homeowner wishes to inspect small sections and to replace some of those found to be modern plaster board and replace with breathable lath and lime. Thae aims are not aesthetic but to ensure that the building breaths as it should. In some instances, it's clear that modern gypsum plaster has been skimmed over old lime laths. In this instance the top skim can be removed and refresh in lime.
