THE OLD FORGE HOUSE

SURVEY PHOTOGRAPHS/
SCHEDULE OF WORKS.

RBD 5423

MR/MRS LU

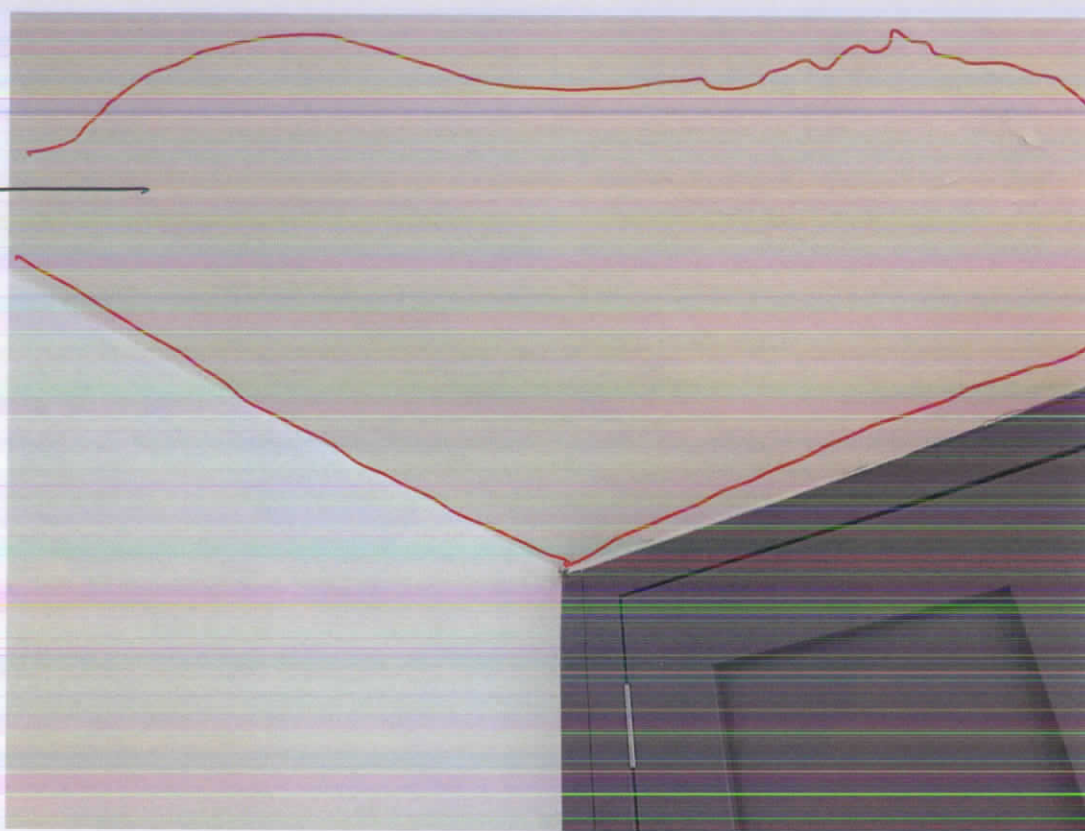
KITCHEN.

CEILING
AREA
REPAIRED
RE-DECORATED.

EVIDENCE OF
FORMER INGRESS
OF WATER.

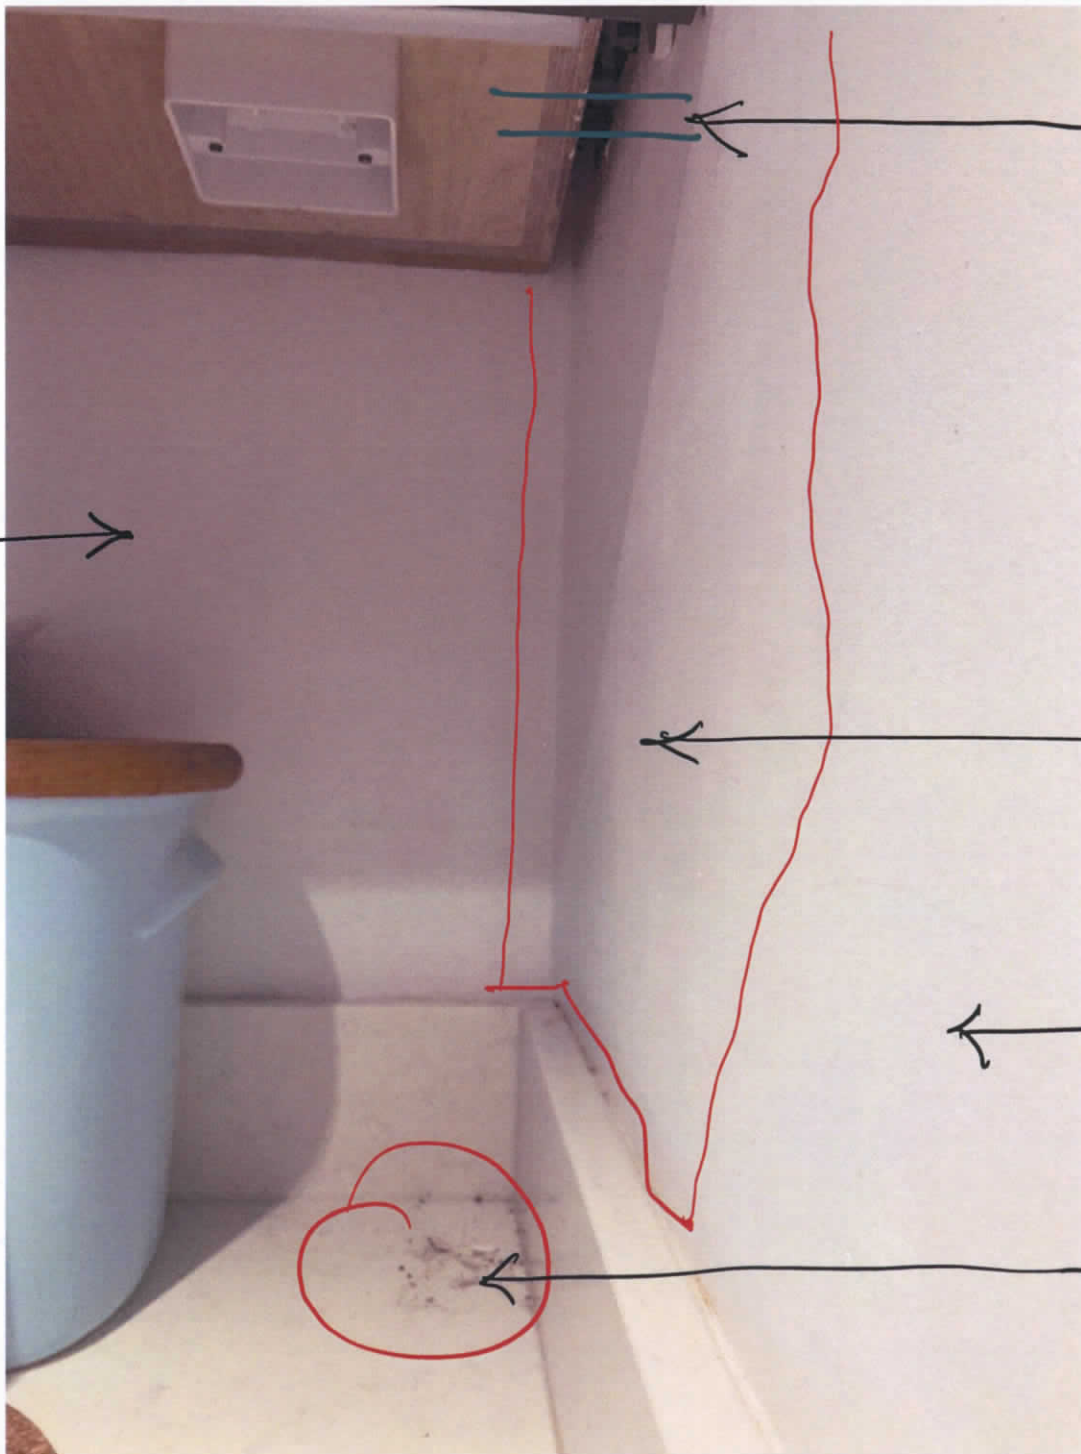
KITCHEN.

ELECTRIC
CABLE ROUTE
FROM HOLE
CUT IN
CHIMNEY
INTO
CUPBOARD

← DAMP ON WALL

← CHIMNEY

← DETRITUS
FROM GAP
ABOVE

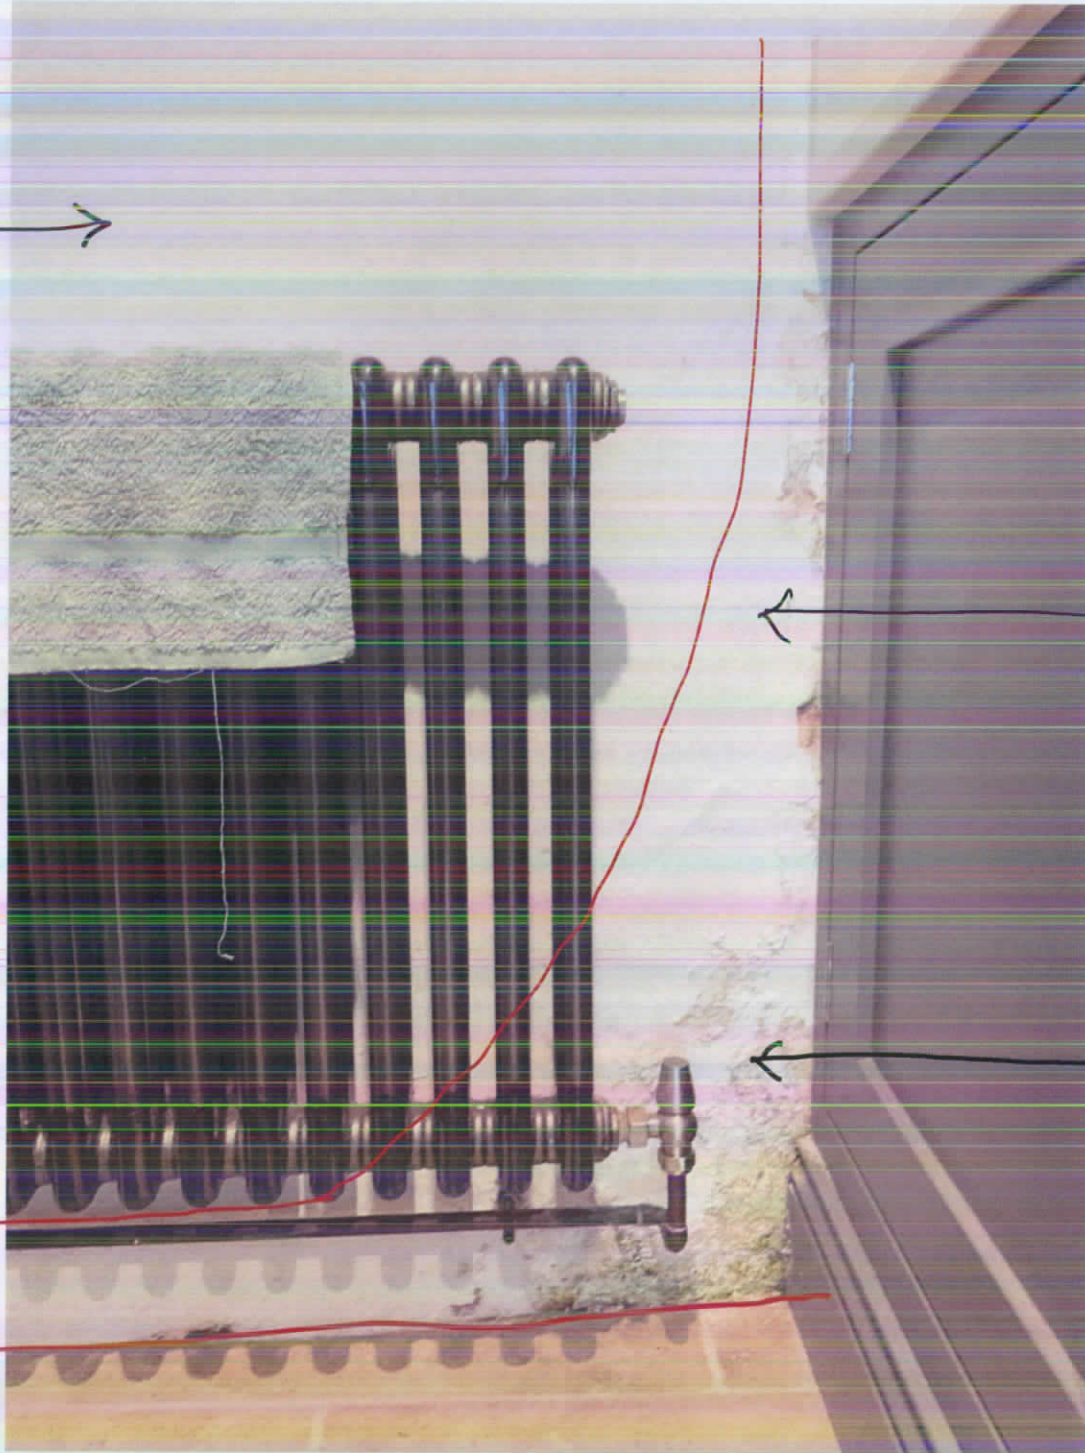
KITCHEN.

← DAMP WALL

← EFFLORESCENCE

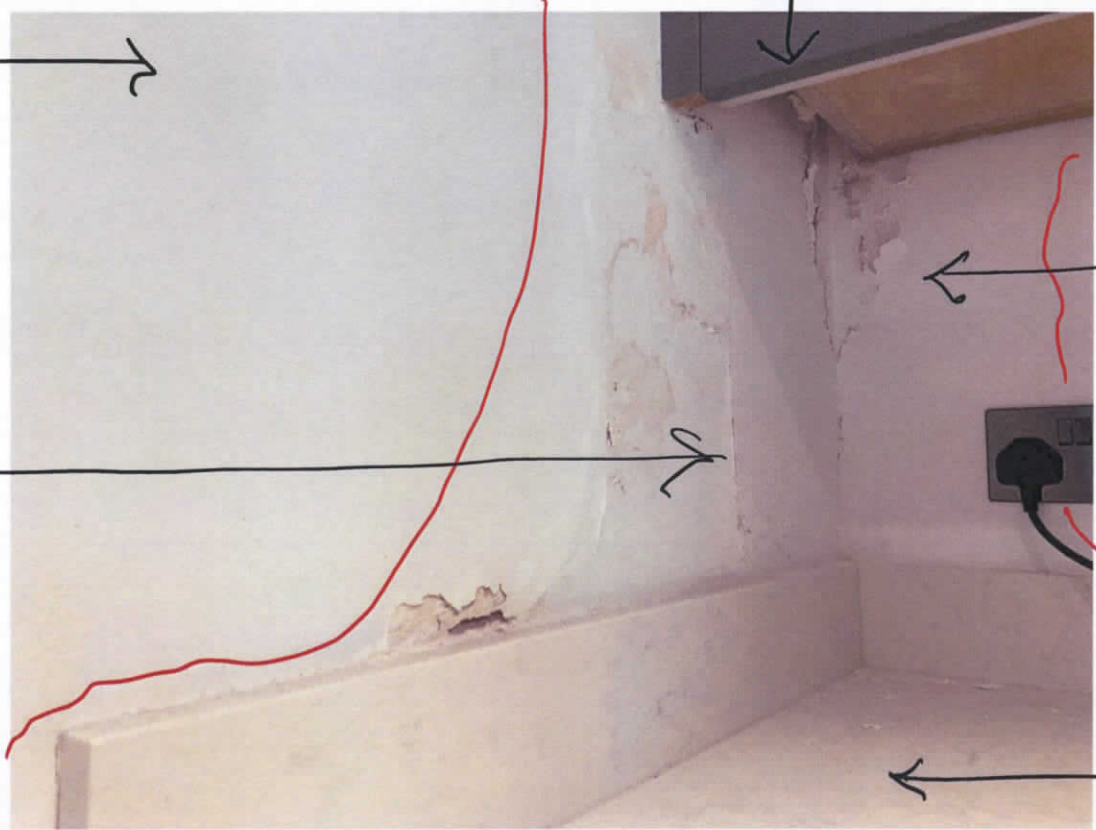
KITCHEN.

DAMP WALL
PLASTER
BLOWN.

WALL
CUPBOARD -
DAMP WALL
← PAINT
PEELING.

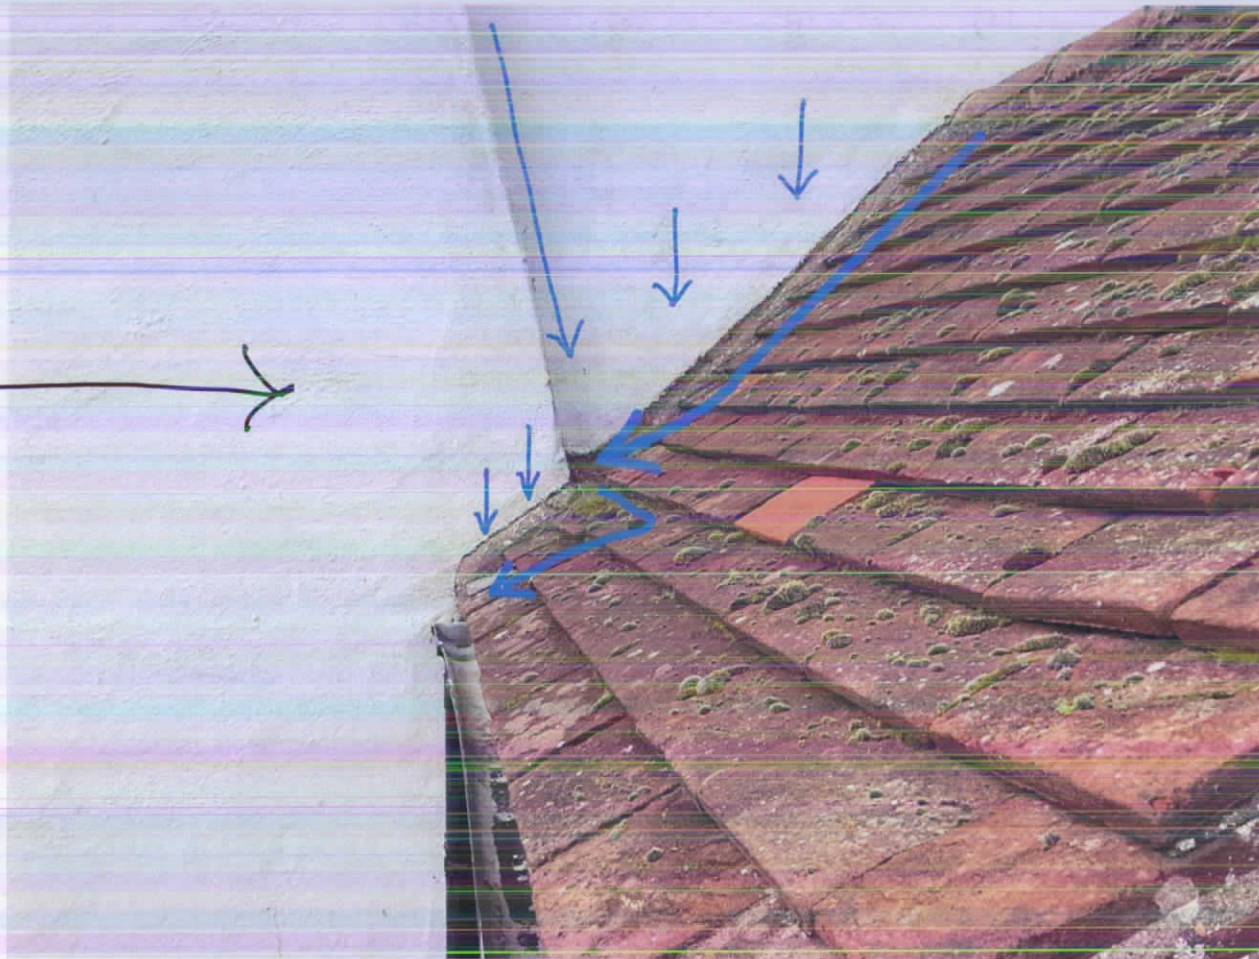
CHIMNEY
STACK
FACING
EAST.

ROUTE OF
RAIN WATER
DOWN RENDER
AND LOG STORE
ROOF INTO
SIDE OF
CHIMNEY
STACK

INSTALL LEAD FLASHING LOCALLY TO
PROTECT SIDES OF CHIMNEY STACK

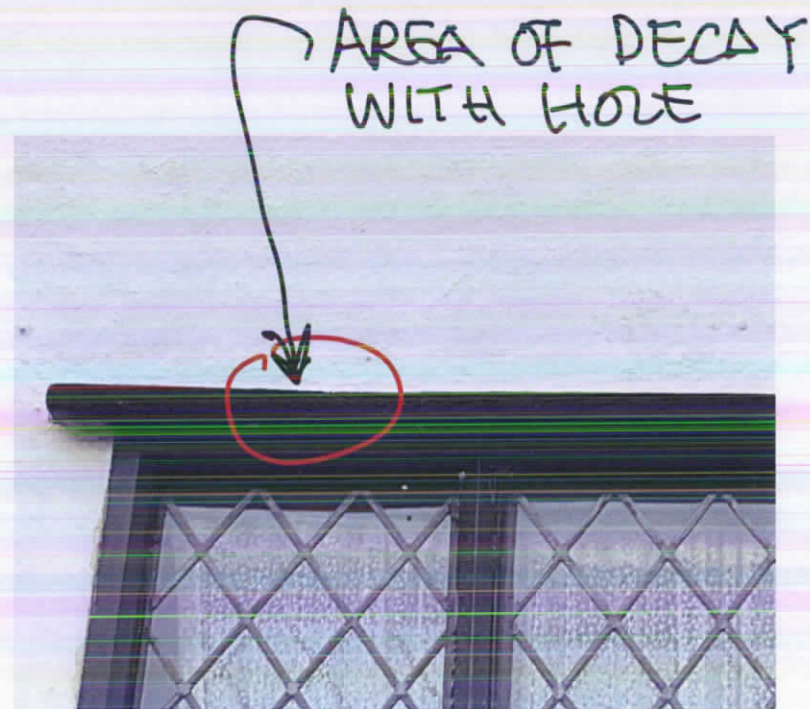
AREA OF DECAY WITH HOLE

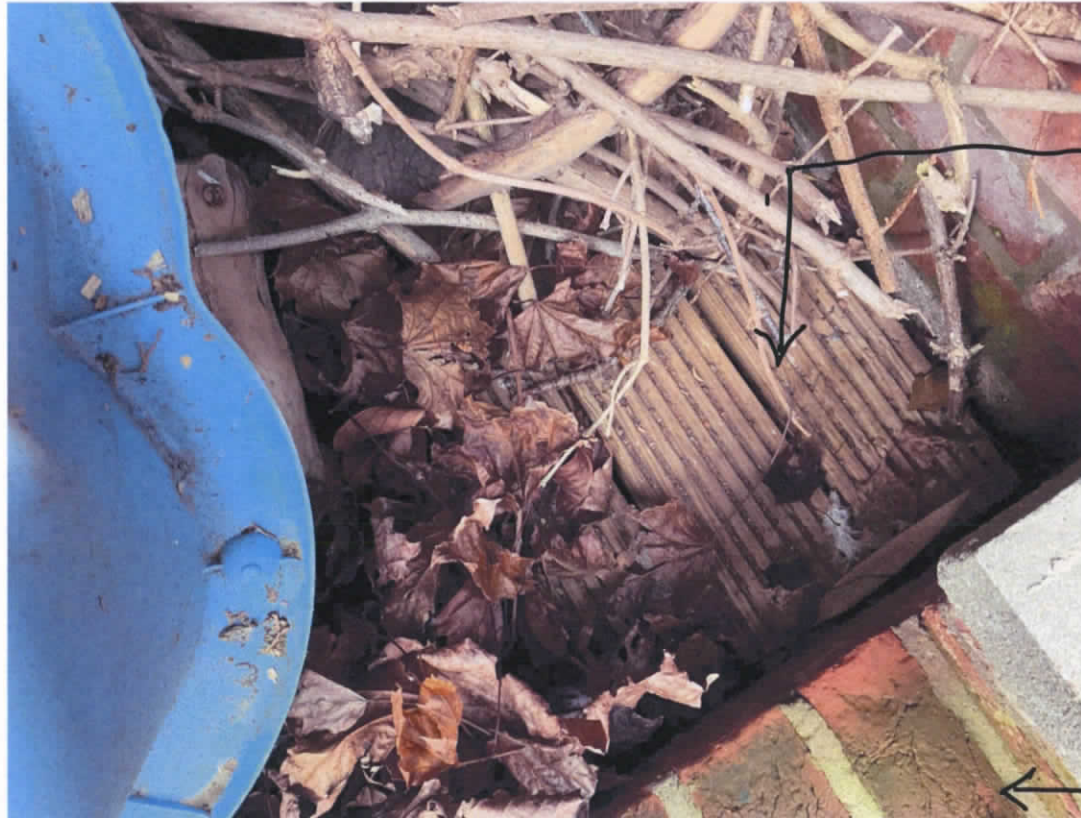
EAST ELEVATION - LOG STORE

VOID BELOW
DECKING

←
DAMP/SATURATED
LOG STORE
BRICK PIERS

LOG STORE FLOOR - RAISED TIMBER
DECKING FLOOR OVER VOID WITH
BRICK PIER SURROUND.

VOID TO BE INVESTIGATED. POTENTIAL FOR THIS AREA TO BE COLLECTING
WATER AND IT MIGRATING INTO THE KITCHEN.

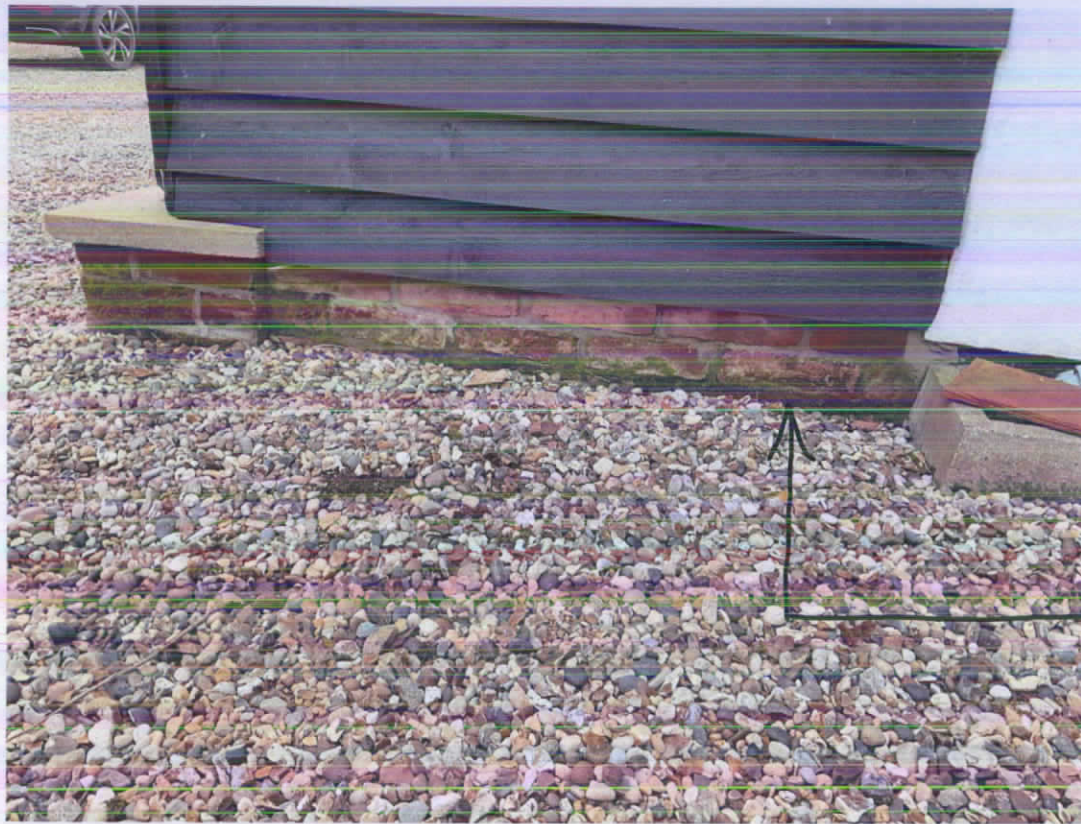
DAMP / SATURATED
LOG STORE
BRICK PLINTH

LOG STORE - BRICK PLINTH

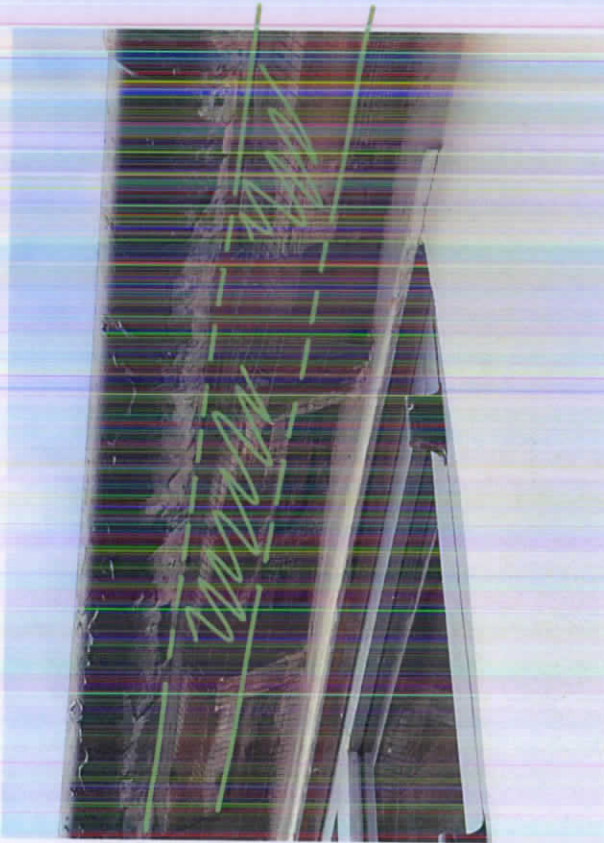
EAVES FILLET TIMBER
ON RAFTER FOOT IN
THIS LOCATION IS
MISSING & ROTTEN
EITHER SIDE -
TO BE REPLACED.

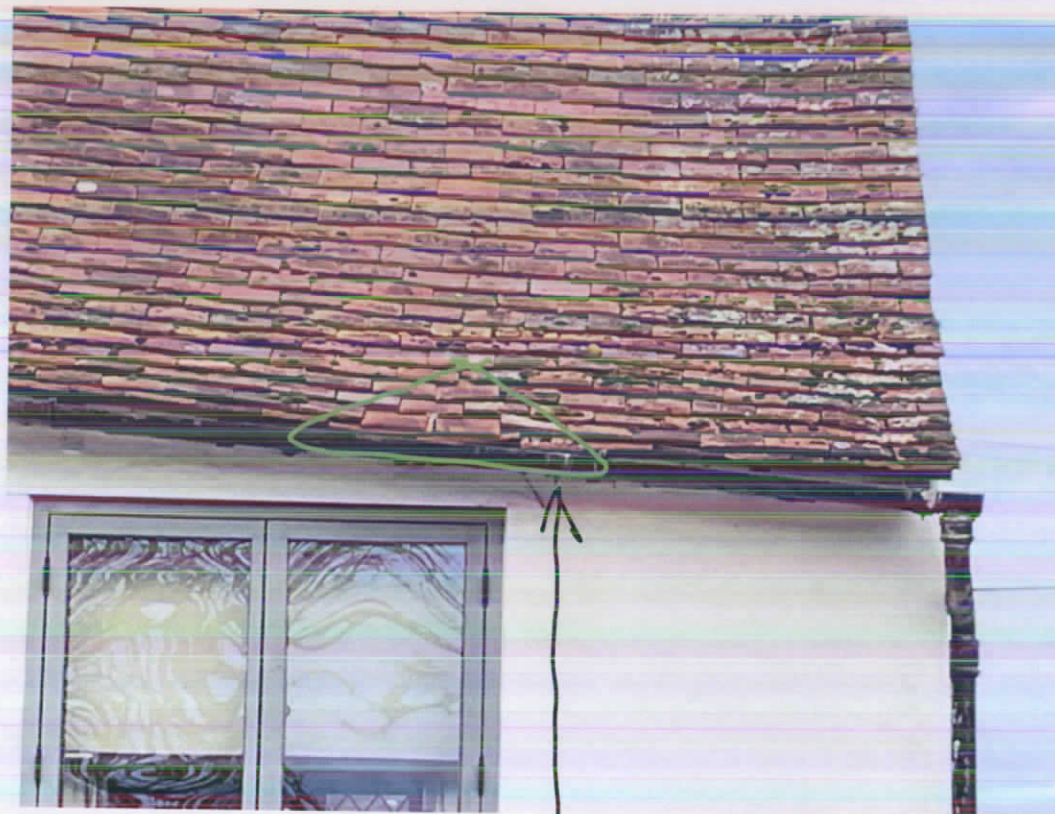
SOUTH ELEVATION - EAVES LEVEL.

ROOF TILES NOT
SUPPORTED. TILES
TO BE REMOVED
AND REINSTATED.

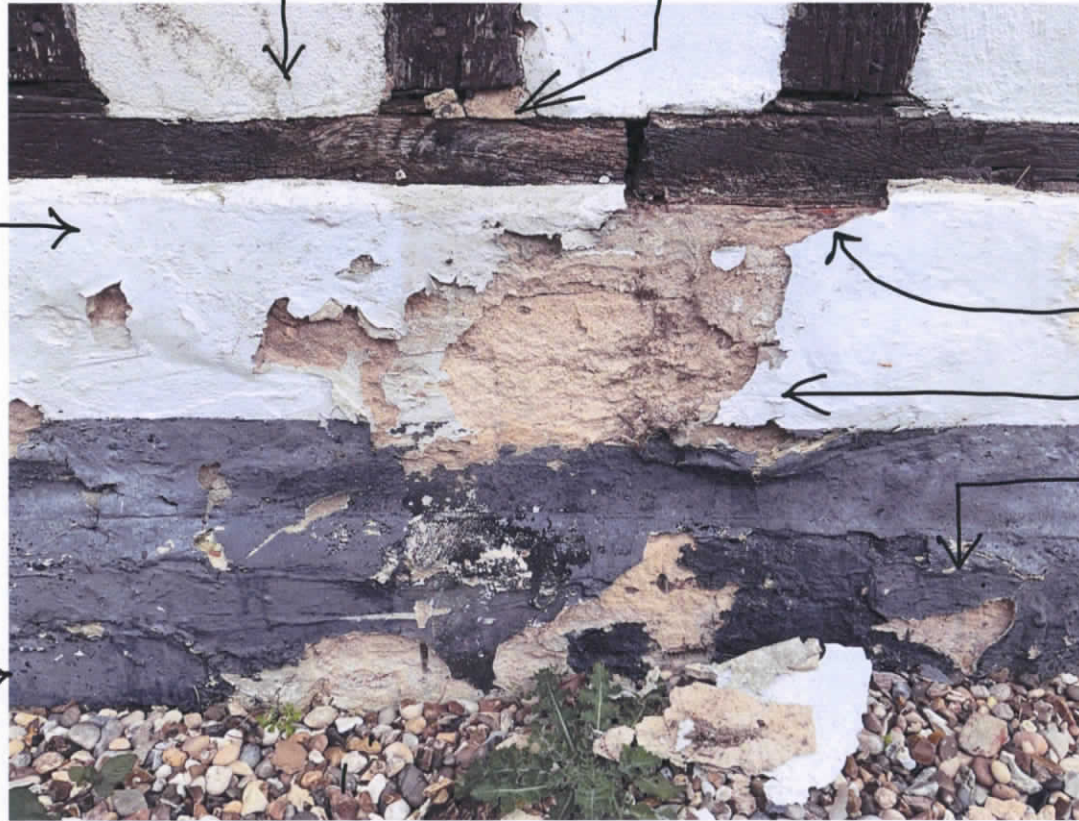
WEST ELEVATION - RENDERED BRICK PLINTH.

← WALL PLATE

← BRICK PLINTH

← NON-BREATHABLE
PAINT PEELING

RENDER OVER
BRICK PLINTH
IS FAILING.
IT IS TRAPPING
MOISTURE IN THE
BUILDING.
CONSIDERATION IS
TO BE GIVEN TO
THE RENDER
BEING REPLACED
WITH A BREATHABLE
LIME BASED RENDER

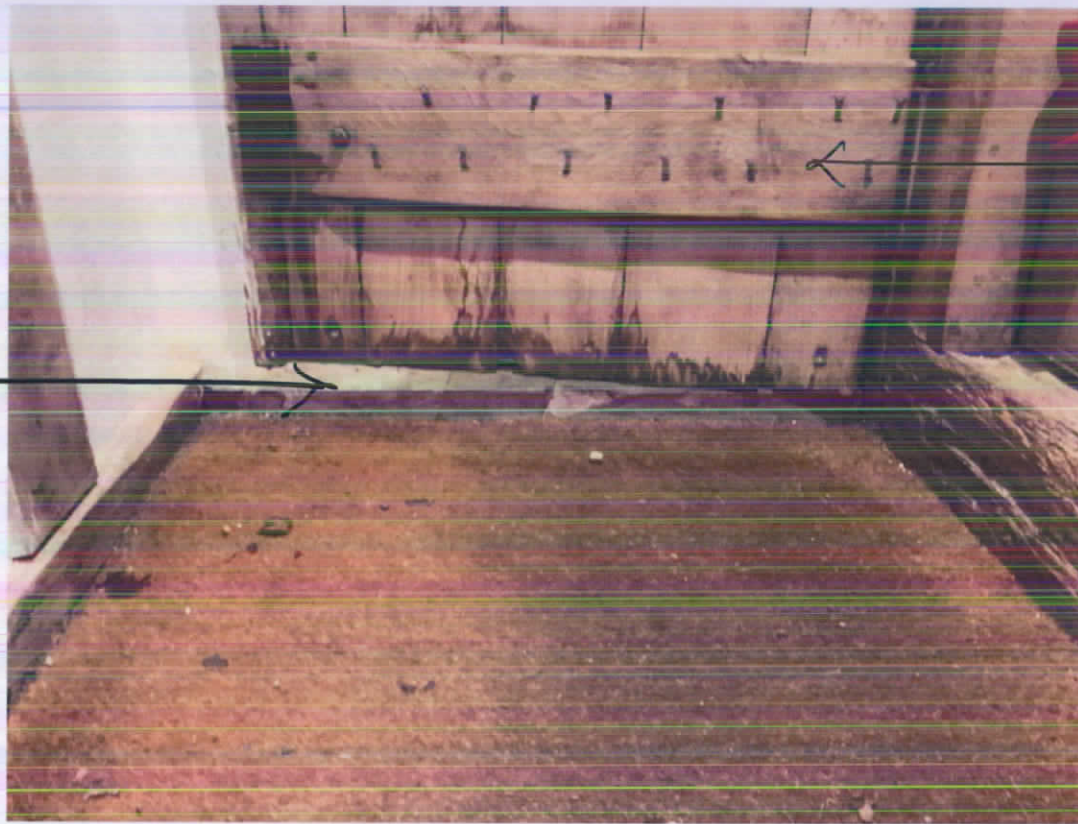
FRONT DOOR

SOLID TIMBER
BOARDED
DOOR.

WATER
TRACKING
UP DOOR LEAF
VIA
CAPILLARY

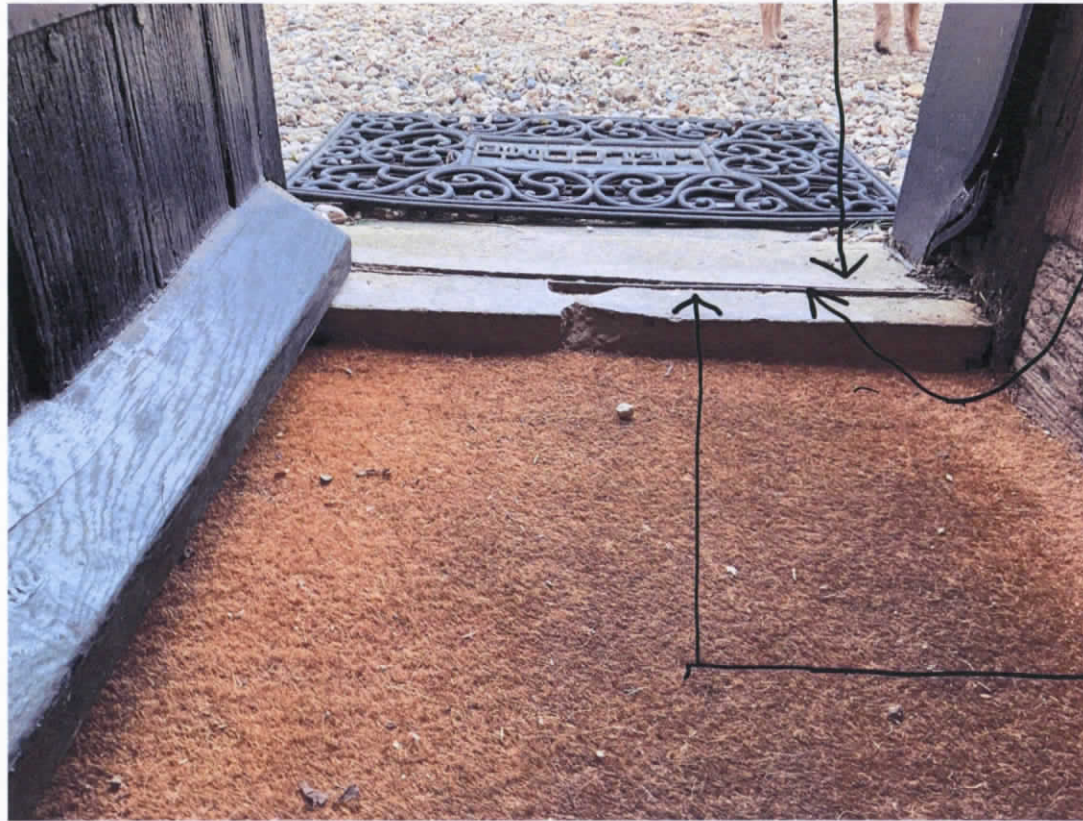
FRONT DOOR / THRESHOLD.

EXTERNAL
CEMENT
THRESHOLD.

INTERNAL
CEMENT
THRESHOLD.

LOW EDGE
OF DOOR
LEAF
SITS IN
WATER

BOTTOM EDGE
TIMBER
ROTTEN /SOFT.

METAL
WEATHER
STRIP - LEVEL
WITH EXTERNAL
AND INTERNAL
THRESHOLDS

EXTERNAL CEMENT THRESHOLD STRIP TO BE LOWBROD CIRC. 20mm AND
NEW METAL WEATHER STRIP INSTALLED WHEN FRENCH DRAIN IS INSTALLED
