# ARBORICULTURAL REPORT

Root Morphology Investigation

Nether Hall

Pakenham

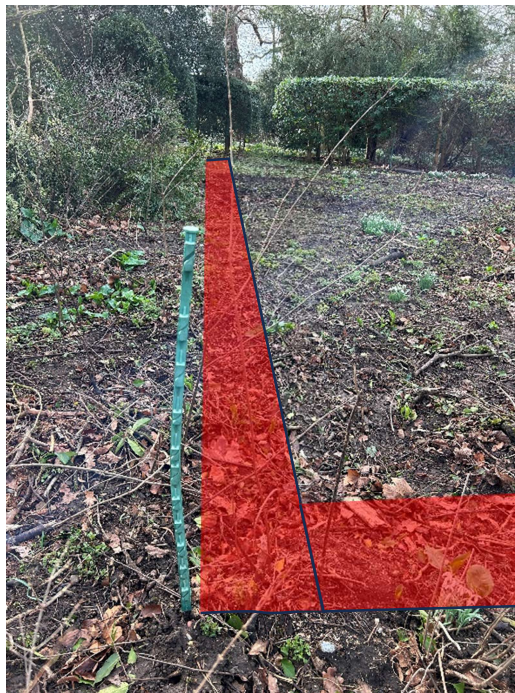
**Photo 1;** Location of excavation shown in red, prior to commencement.

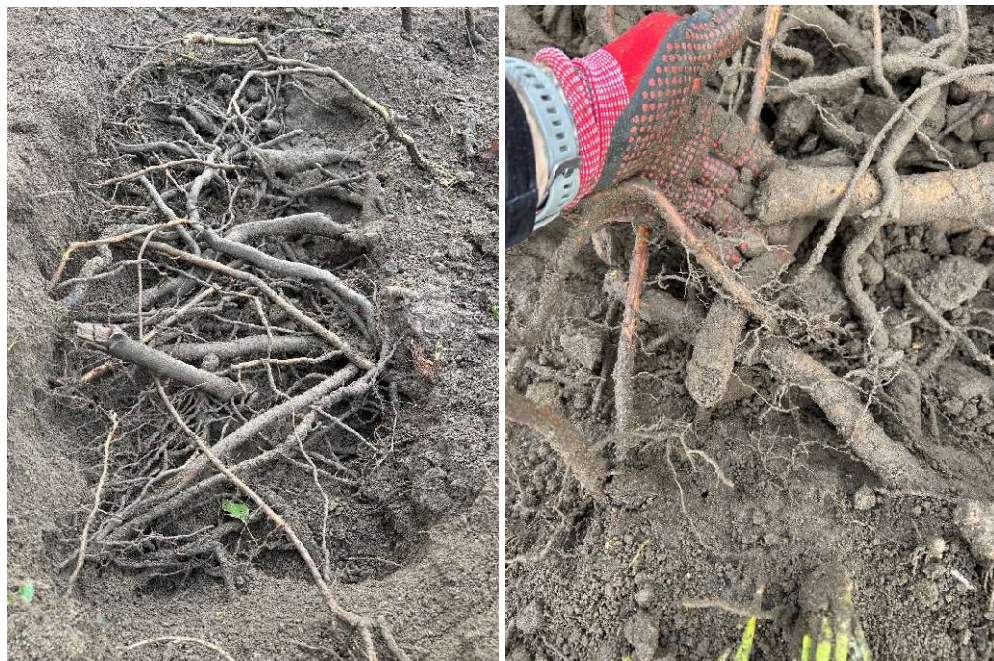
Roots to 30mm diameter were encountered in this area. They were predominately located in the top 300mm of soil, with some smaller roots at the bottom of the excavation.

There were a mix of roots of live appearance and those which were damaged or broken with dry, discoloured ends.

The general orientation of roots was west to east, determined by division of rooting material and decreases in root diameter.

The results of laboratory root identification indicates that the roots in Area 1 belong to *Acer* (includes maple/sycamore) and *Fraxinus* (ash) *spp.* trees.

The species and orientation of the roots suggests that they belong to the previously removed ash and sycamore trees located in the northwest area of the site. This is further supported by their general degraded condition.

**Photo 2 (left);** section of Area 1 excavation (not shown to full depth). **Photo 3 (right);** examples of severed roots encountered in Area 1.

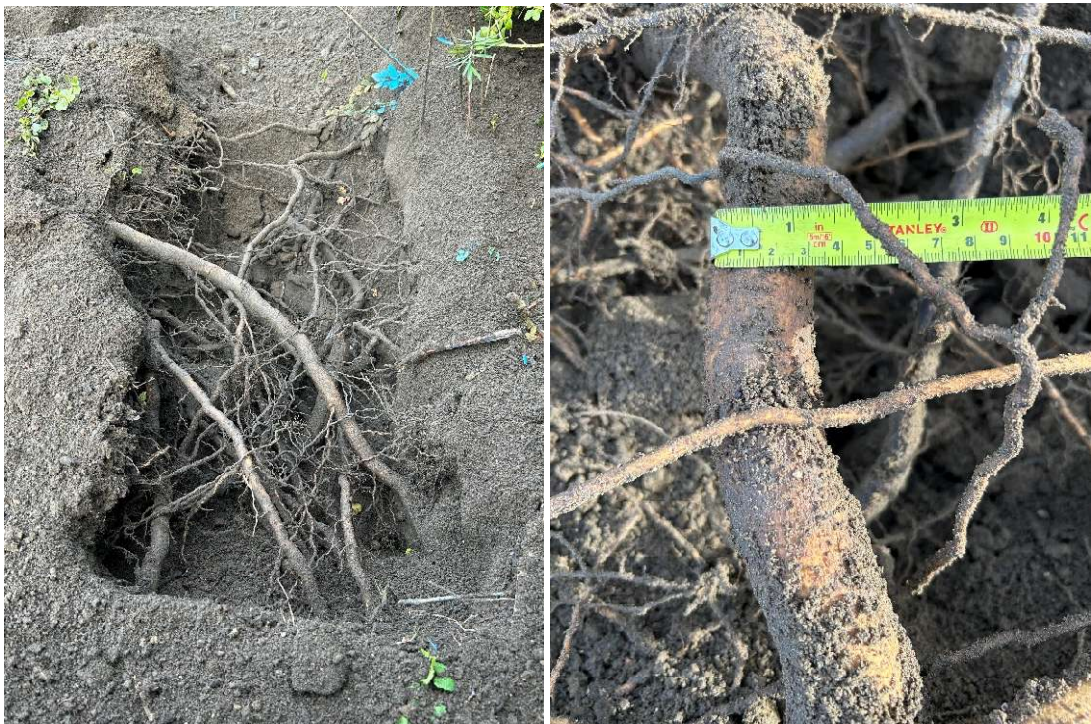
Roots to 35mm diameter were encountered in this area. They were predominately located in the top 300mm of soil, with some smaller roots at the bottom of the excavation.

The roots in Area 2 were of the same physical appearance to those in Area 1 with a similar general orientation indicating they likely part of the same root systems.

One significant root 35mm in diameter was observed to enter the excavation from the east with an orientation heading southwest at 150mm below ground level. A sample of a secondary section of this root approximately 5mm in diameter was taken and sent for identification.

The result of laboratory root identification indicates it is an *Acer* (includes maple/sycamore) *spp.* root.

The species and orientation of the roots suggests that the majority belong to the previously removed ash and sycamore trees located in the northwest area of the site, with the sampled root likely belonging to the previously removed maple/sycamore tree located to the east of the area, adjacent to the public footpath.

**Photo 4 (left);** Roots encountered within Area 2. **Photo 5 (right);** Root in Area 2 of alternate orientation, identified as *Acer spp.*

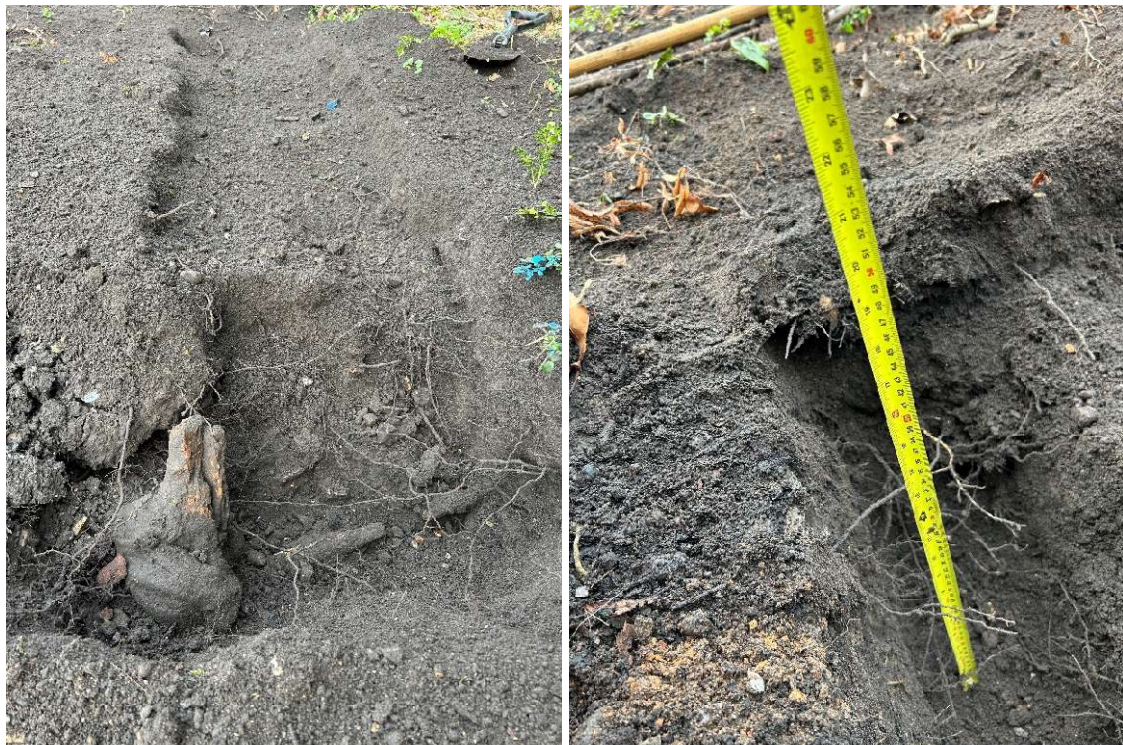
Roots to 30mm diameter were encountered sparsely in this area to a depth of 400mm below ground level. The majority of roots in the area were to approximately 15mm diameter and broke easily. The roots were generally orientated west to east.

Two root boles belonging to small, previously removed trees were encountered in the excavation. The larger roots in the area were traced to these plants.

The result of laboratory root identification indicates they are *Acer* (includes maple/sycamore) and *Fraxinus* (ash) *spp.* roots.

The species and orientation of the roots suggests that the roots likely belong to the previously removed ash and sycamore trees located in the northwest and west areas of the site.

**Photo 6 (left);** root bole and associated broken root encountered in Area 3. **Photo 7 (right);** Section of Area 3 excavation, showing excavation depth with small diameter roots present.

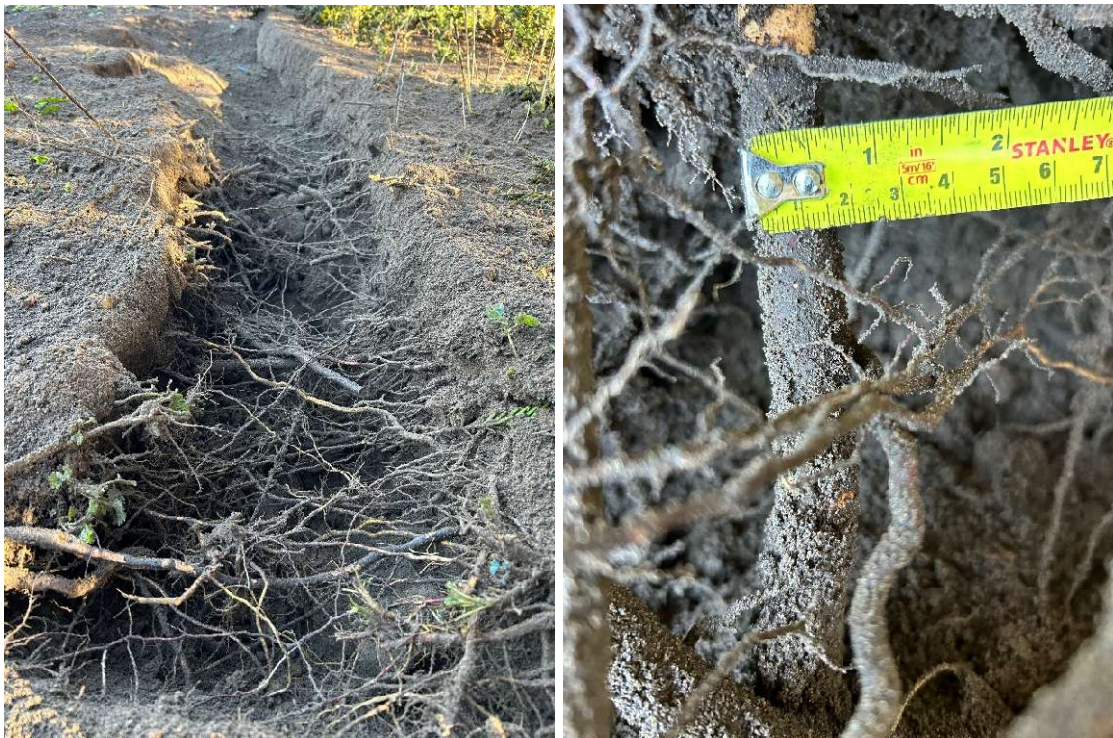
Roots of live appearance to 20mm diameter were encountered in this area. They were predominately located in the top 150mm of soil.

The roots in Area 4 were observed orientated in all directions.

The results of laboratory root identification indicates that the roots in Area 4 predominantly belong to *Taxus* (yew), *Acer* (includes maple/sycamore) and *Quercus* (oak) *spp.* trees.

Area 4 is adjacent to a group of small yew trees, and it is most likely that the *Taxus spp.* roots belong to them. Trees T8, T9 and T10 are semi-mature holm oaks. Given the proximity and size of the roots it is most likely that the *Quercus spp.* roots belong to these trees. The *Acer spp.* roots most likely belong to the previously removed sycamore tree which was located in the southwest corner of the site.

**Photo 8 (left);** roots encountered in Area 4. **Photo 9 (right);** 15mm diameter root, suspected to be yew in Area 4.

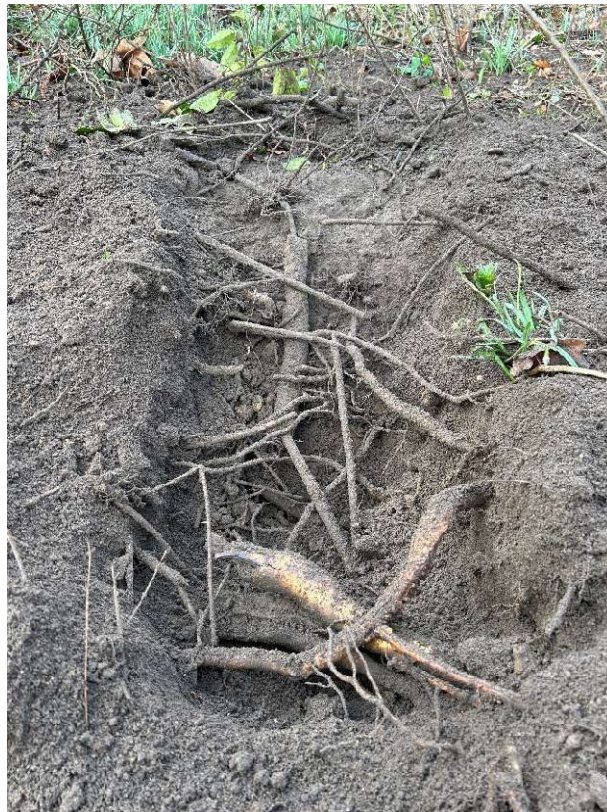
Roots predominantly 10-20mm diameter, with a maximum 40mm diameter were encountered in this area, to a depth of up to 350mm below ground level.

The majority of the larger roots had been previously severed and were orientated roughly north to south.

The larger roots were of the same appearance as those encountered in Area 1 and are considered likely to part of the same root systems. Given the proximity, they are considered to be from the previously removed sycamore and ash trees at the northwest of the site.

The results of laboratory root identification indicate that the roots in Area 5 predominantly belong to *Acer* (includes maple/sycamore), *Fraxinus* (ash), *Lonicera* (includes honeysuckles/snowberry) and *Ilex* (holly) *spp.* trees. The *Lonicera* and *Ilex* roots are considered to belong to low level vegetation in the area.

**Photo 10;** severed and damaged roots of *Acer/Fraxinus spp* in Area 5.

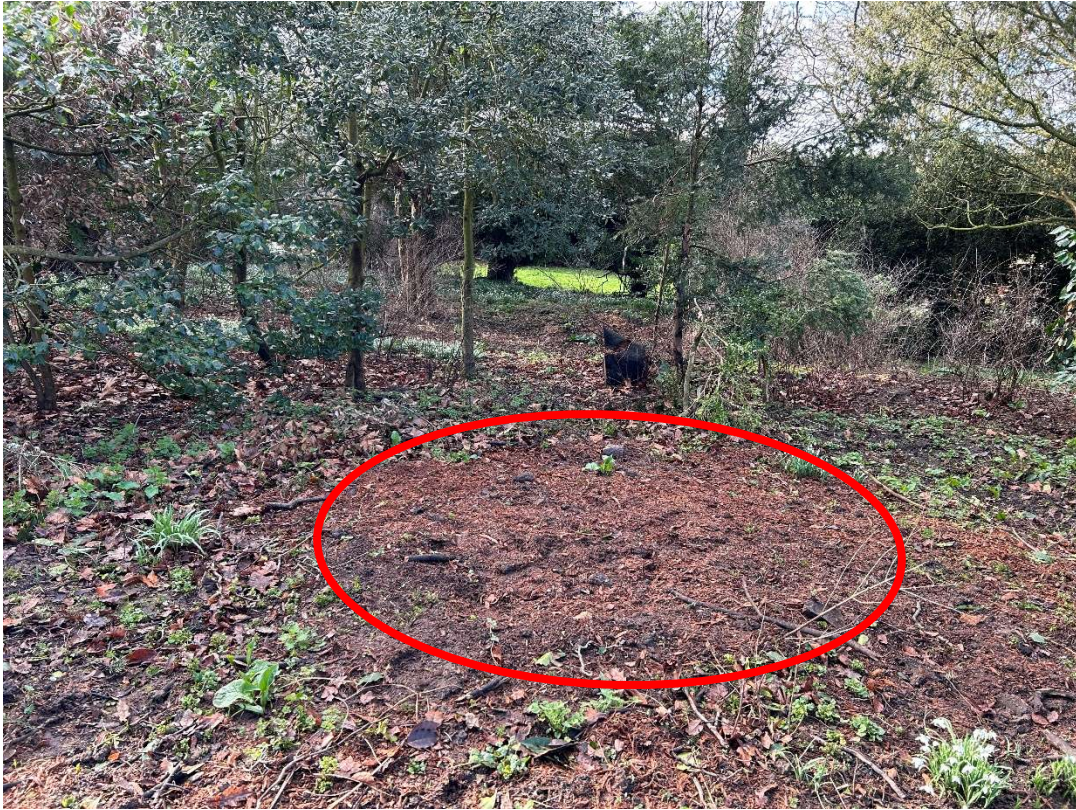
The section of RPA belonging to T15 which extends into the area of proposed swimming pool terrace is in the location of a previously removed and ground out sycamore tree stump. From the findings within the site excavations and extent of stump grinding it is considered very unlikely that significant roots belonging to T15 will be present within the area.

**Photo 11;** southwest corner of site. Stump grinding area in RPA of T15 circled in red.

It is considered unlikely that significant roots belonging to T15 will be present in the area of proposed development, given the amount of soil disturbance relating to the removal of a large sycamore stump.
