# Structural Appraisal

Barn at Hen Fache Fach  
Llanrhaeadr Ym Mochnant  
POWYS  
SY10 0DD

25 Jul. 23

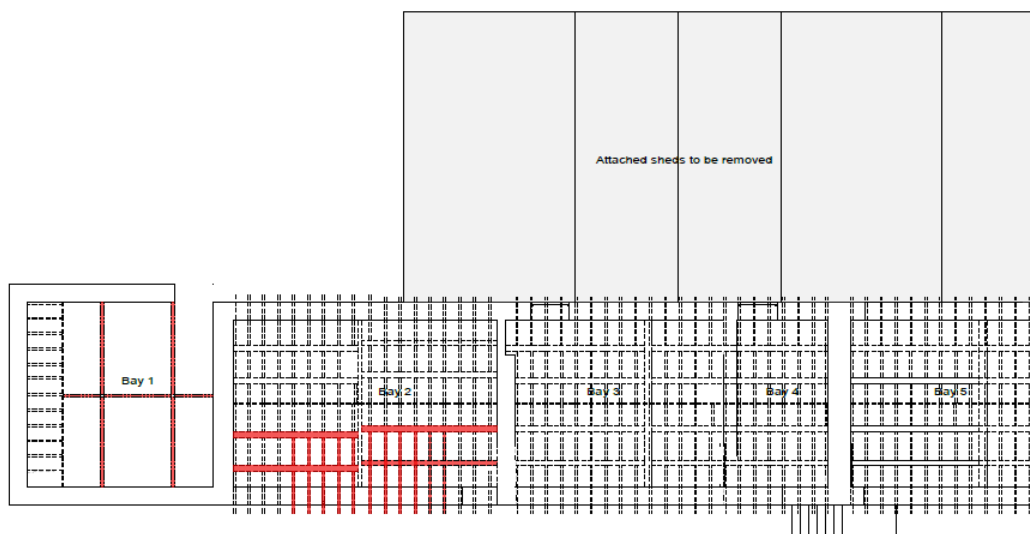
Localised damage has been caused by water ingress over Bay 2. A number of common rafters and two purlins to this area will need to be replaced.

Timbers shaded red on the plan below will need to be replaced. Remaining timbers will be retained.

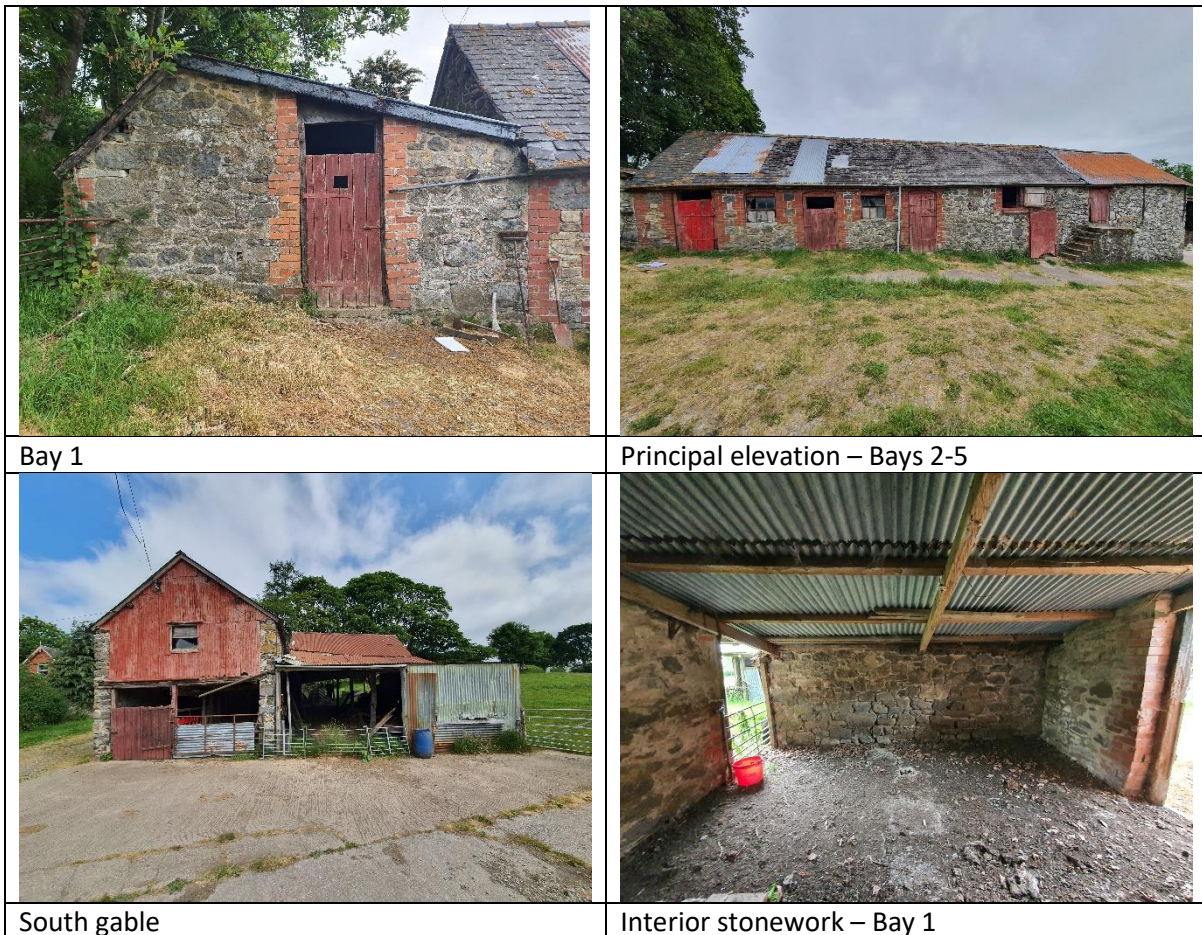
Two openings to the rear elevation are “modern” and lack the brick detailing otherwise present.
