Project: TheVincent-23_VTA_10_35
Site: The Vincent, Redland Hill, Redland, Bristol, BS6 6BJ
Client: Lifestory Group

Document Title:	Tree Safety Survey & Management Plan
Document Author:	Peter Haine FDS Arb, MA ArborA
Project Manager:	Peter Haine
Project Title:	The Vincent, Redland Hill, Redland, Bristol, BS6 6BJ

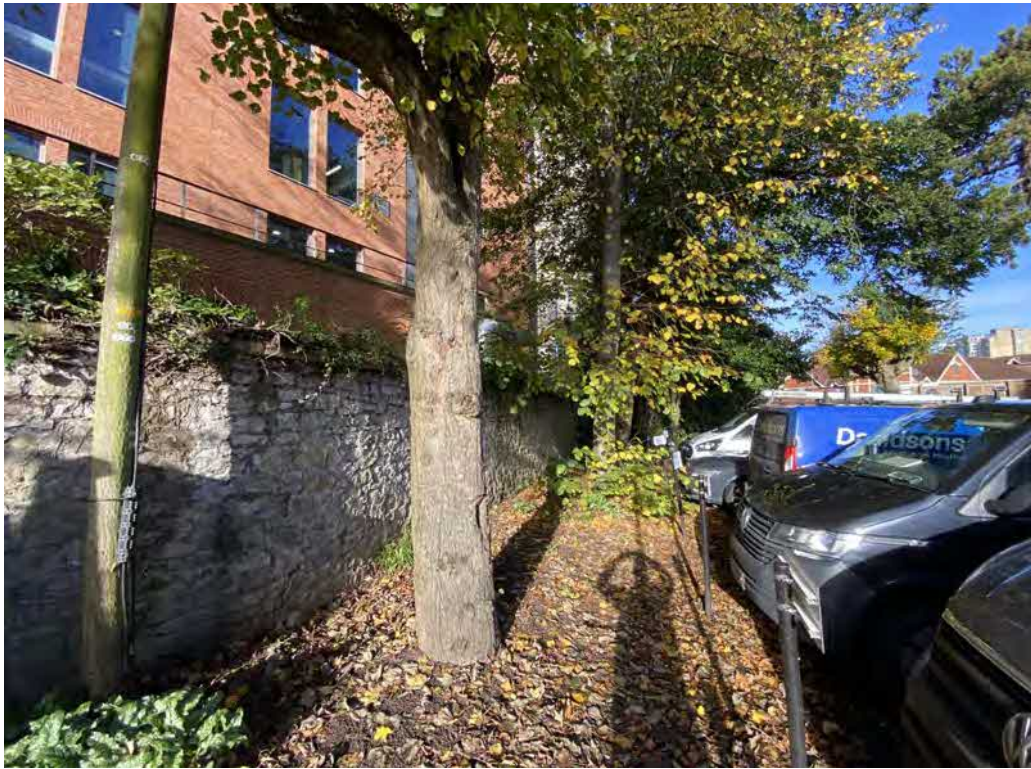
Photographic plate showing the base of T41424 on the west of the carpark. (ROAVR, 2023)

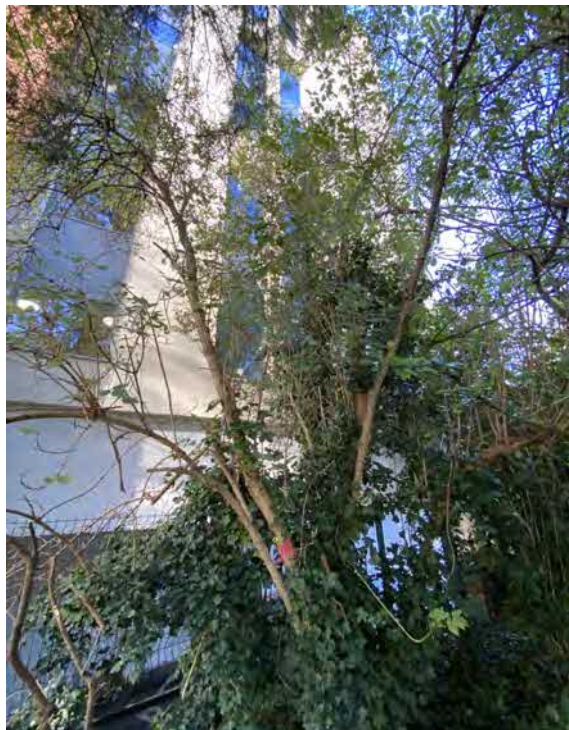
Photographic plate showing in decline T41429 overhanging the western boundary towards offsite flats. (ROAVR, 2023)

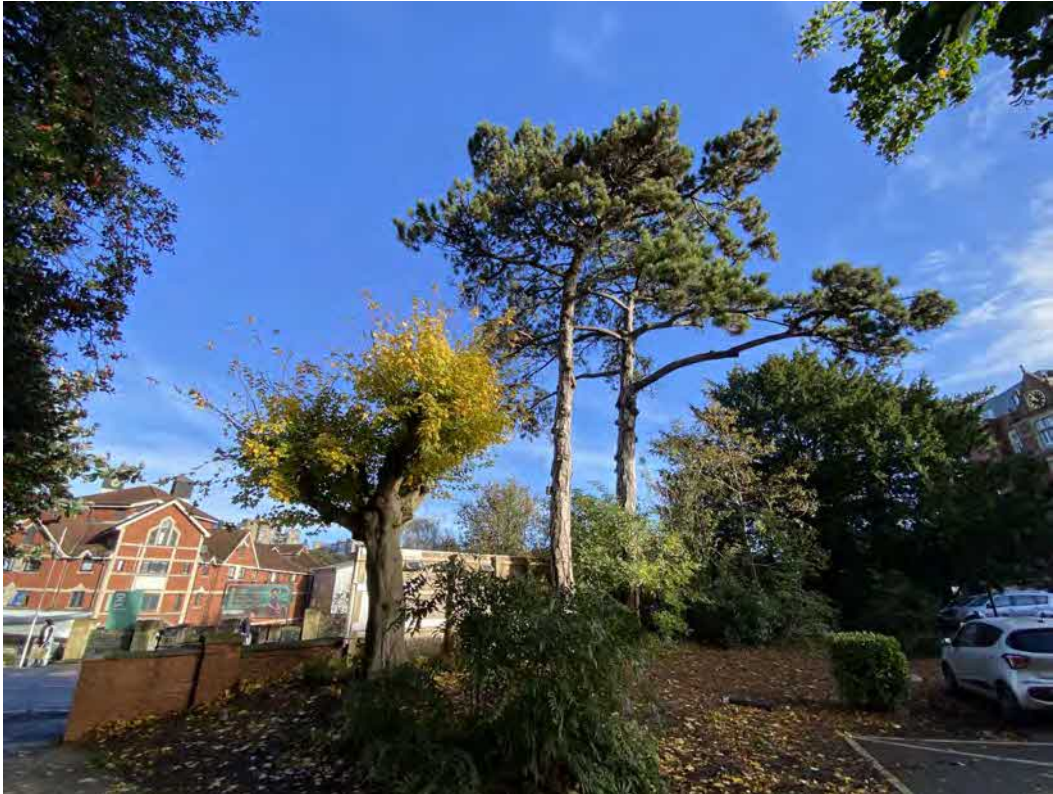
Photographic plate showing T41436, T41437 and T41438 on the northern boundary line. (ROAVR, 2023)

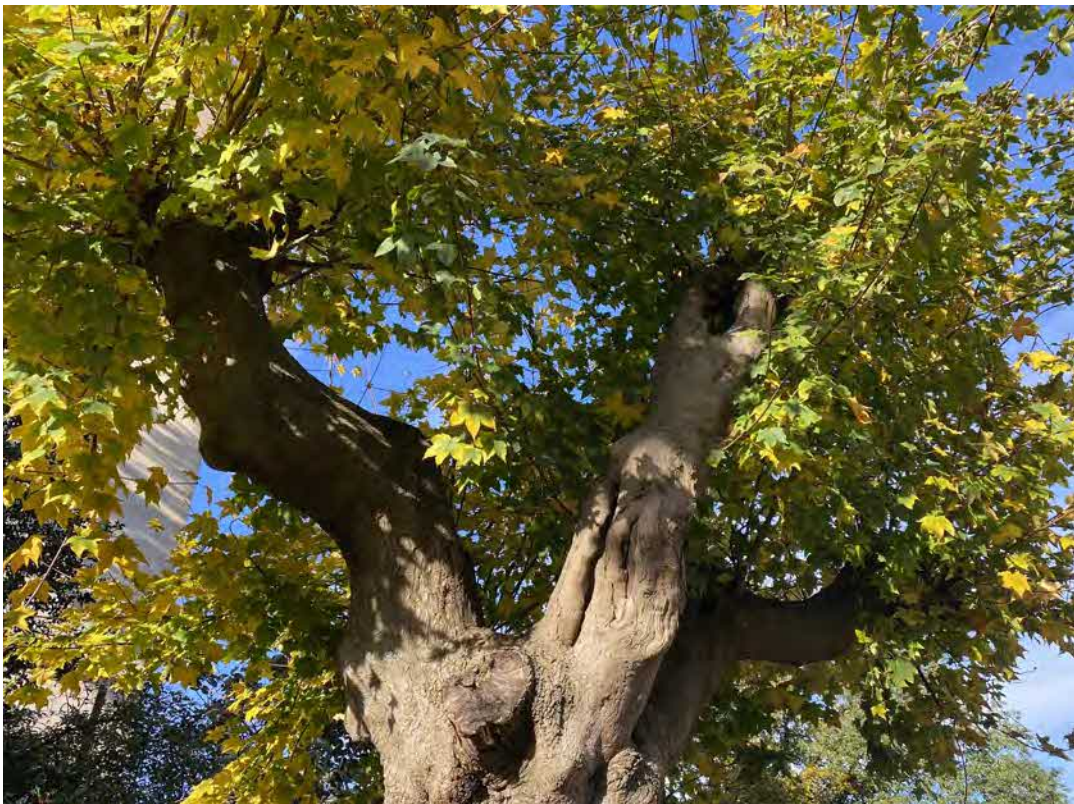
Photographic plate showing pollarded T41436 which has multiple cavities on all 4 stems. (ROAVR, 2023)

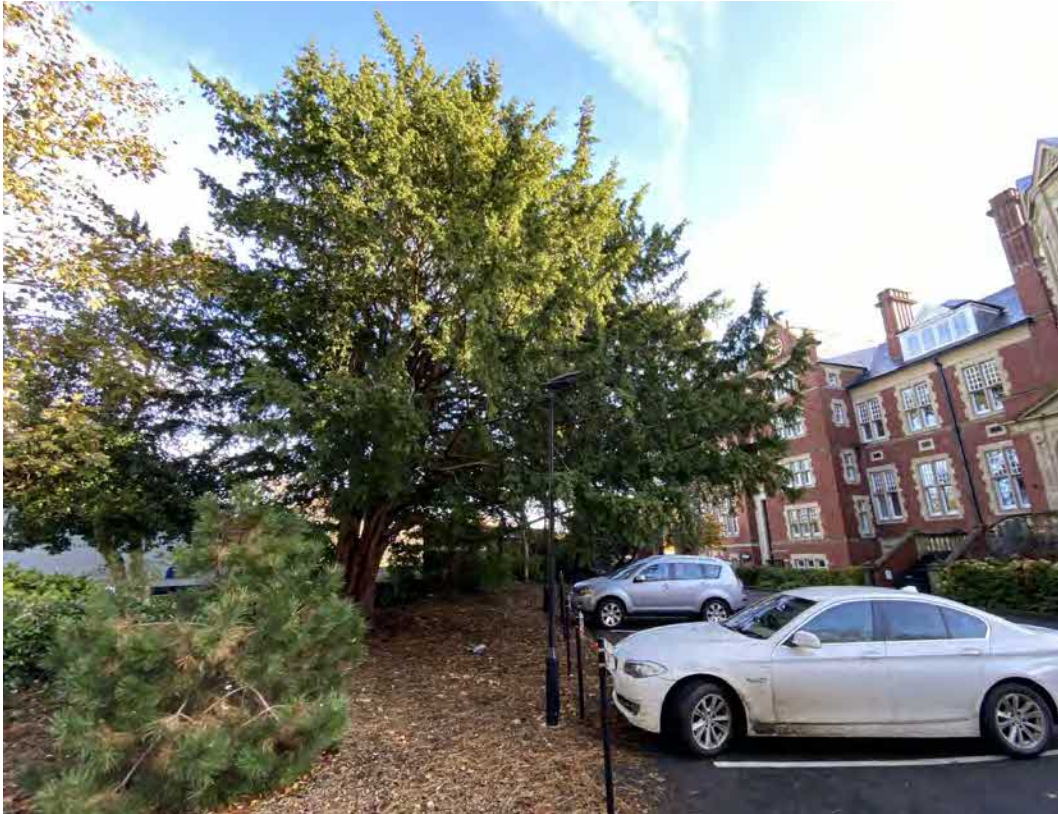
Photographic plate showing T41441 overhanging car park on the south of the tree, crown lift to 3m to clear parked cars. (ROAVR, 2023)

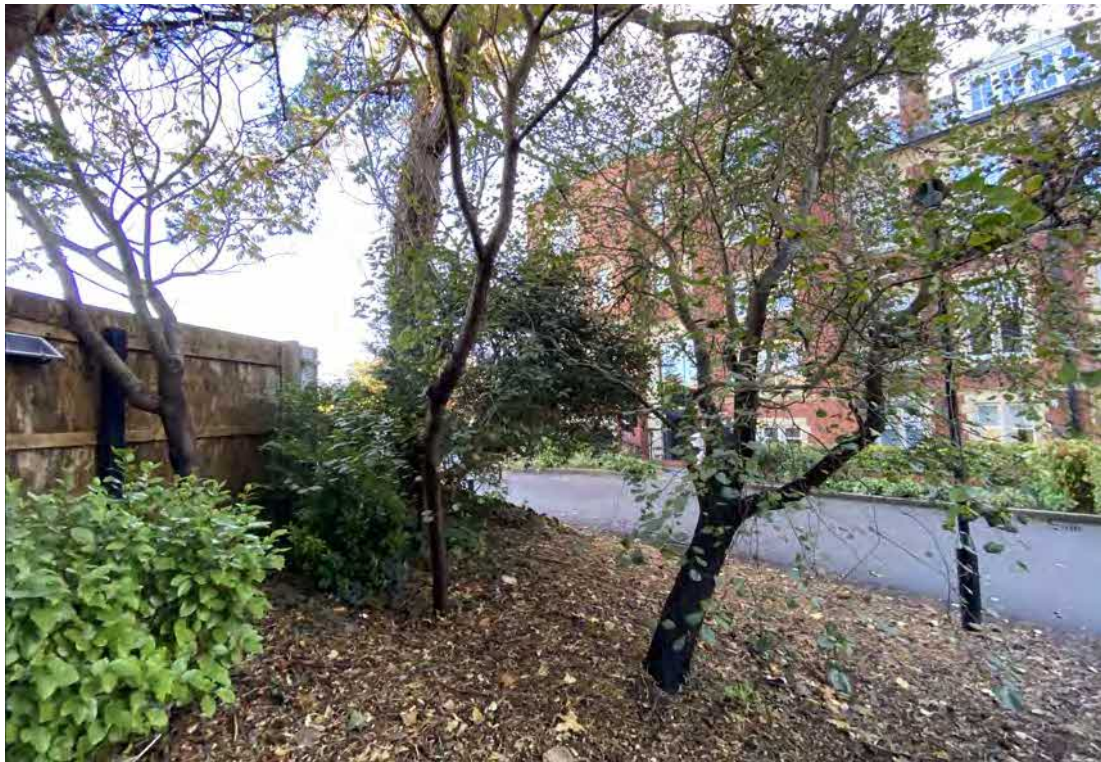
Photographic plate showing T41443, T41444, T41445 and T41446. (ROAVR, 2023)

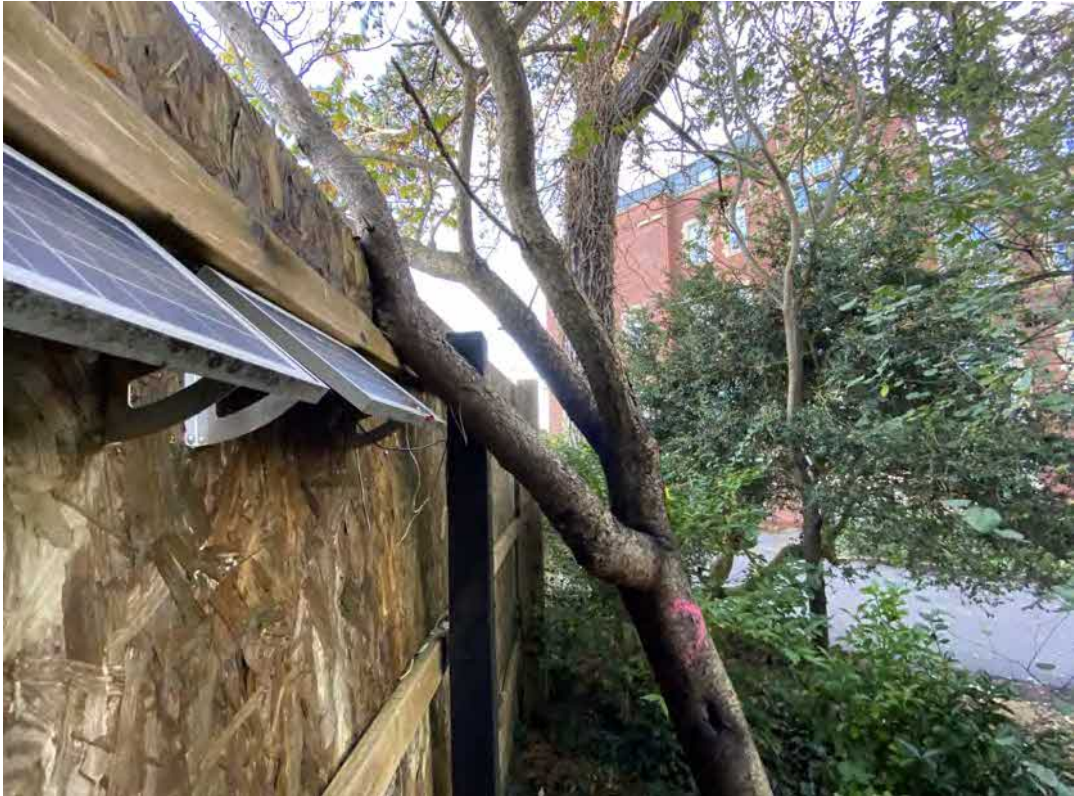
Photographic plate showing T41444, dead and leaning north damaging fencing and overhanging public footpath. (ROAVR, 2023)

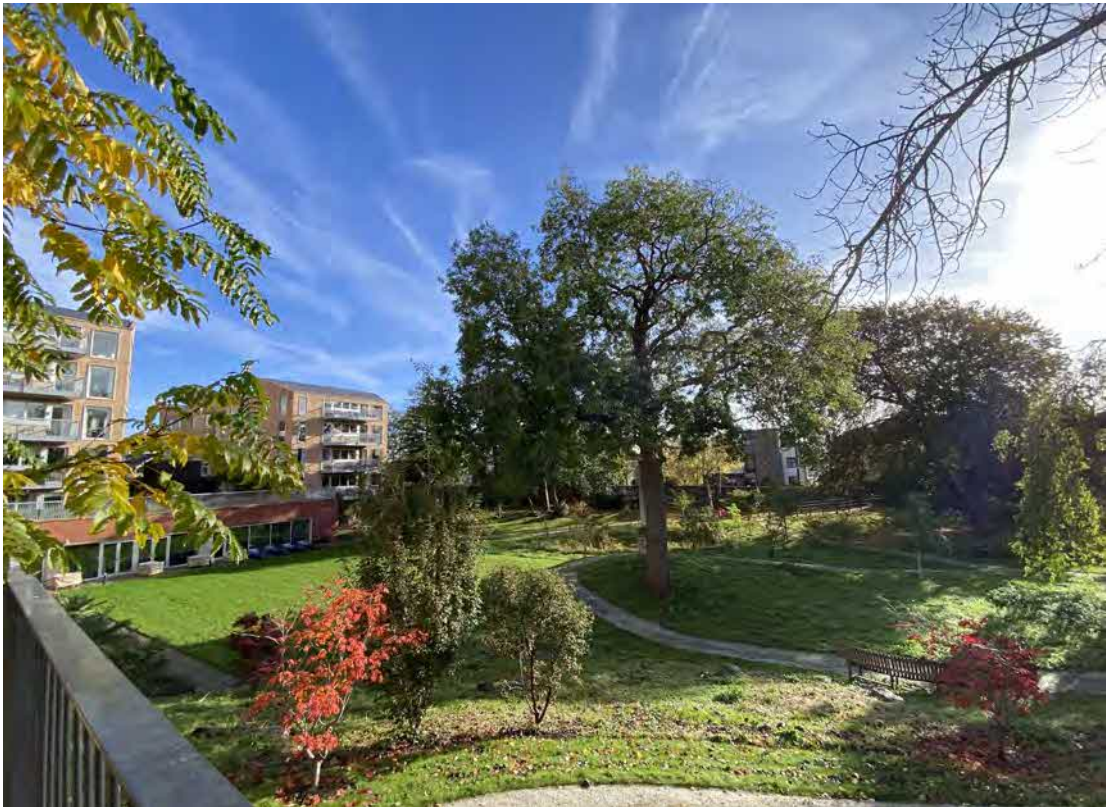
Photographic plate showing the wild garden to the south of the site with mature trees throughout and T41469 in the centre of the frame. (ROAVR, 2023)

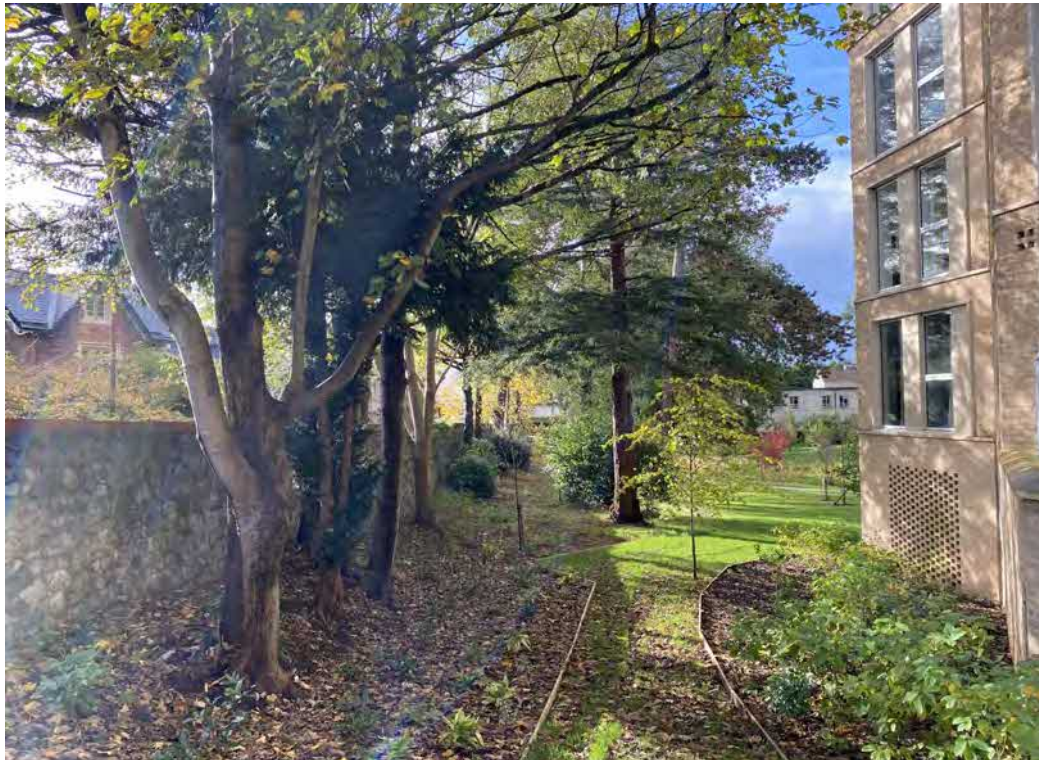
Photographic plate showing linear feature of trees following the southern boundary line with T41450 at the start of the feature. (ROAVR, 2023)

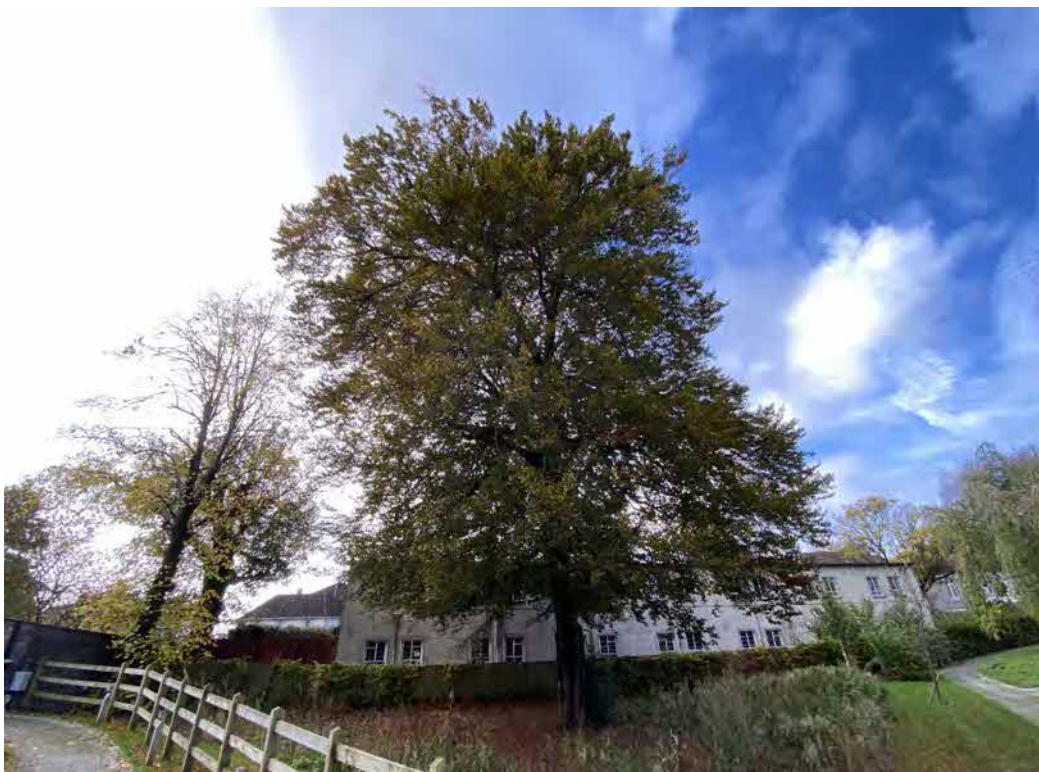
Photographic plate showing T41466 to the south and T41467 in the centre of the frame. (ROAVR, 2023)

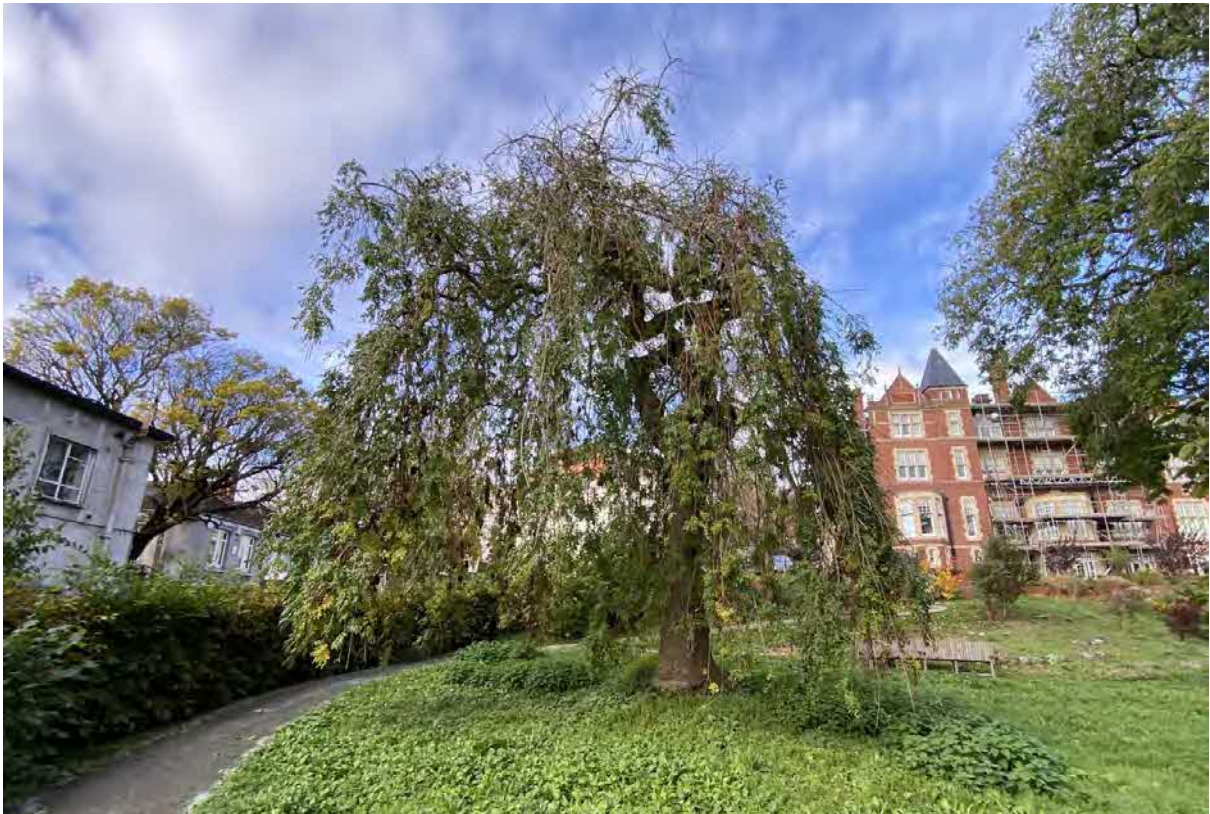
*Photographic plate showing in decline Ash T41468, which has multiple cavities throughout.
(ROAVR, 2023)*

T41467	<i>Fagus sylvatica</i> (Beech)	17	M	20+	Good	Cavity on stem. Major bark wounding on stem. Mechanical Damage.	no flare at base.	n/a	n/a
T41468	<i>Fraxinus excelsior</i> (Ash)	6	M	10+	Fair	Poor shape & form. Low vitality. Declining. Cavity on stem. Major bark wounding on stem. Mechanical Damage. Dieback in crown.	Multiple cavity on stems.	Monitor annually	Every 12 months
T41469	<i>Fraxinus excelsior</i> (Ash)	21	M	20+	Good	Broken branches in crown.	n/a	Remove broken/damaged branches.	0-3 months
T41470	<i>Tilia X europaea</i> (Common Lime)	11	M	20+	Good	Mechanical Damage.	n/a	n/a	n/a
