Photographs 1: Kitchen window to be replaced

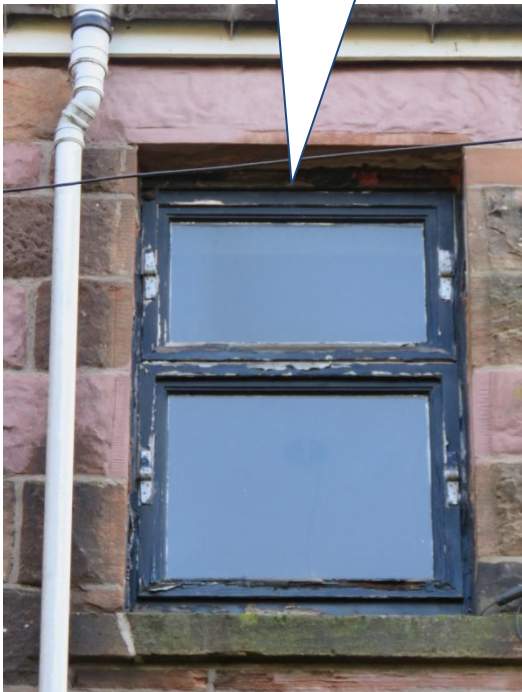
Zoom view showing style
and deterioration

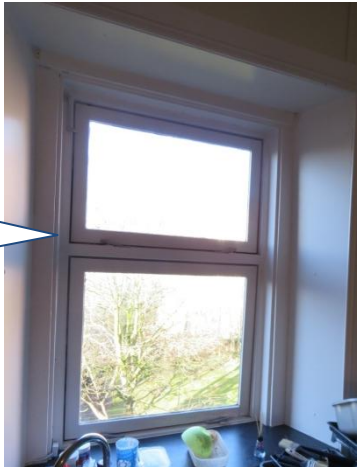
Internal view
showing style

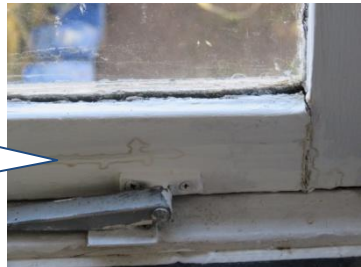
Internal view
showing rot and
leakage
