Geotechnical Survey Report

FSI Ref: 27168
Issue Date: August 2023

Risk Address: 25 Kingston Hill
Kingston Upon Thames
Surrey
KT2 7PW

Company: Claims Consortium Group
Claim Ref: KH21292818

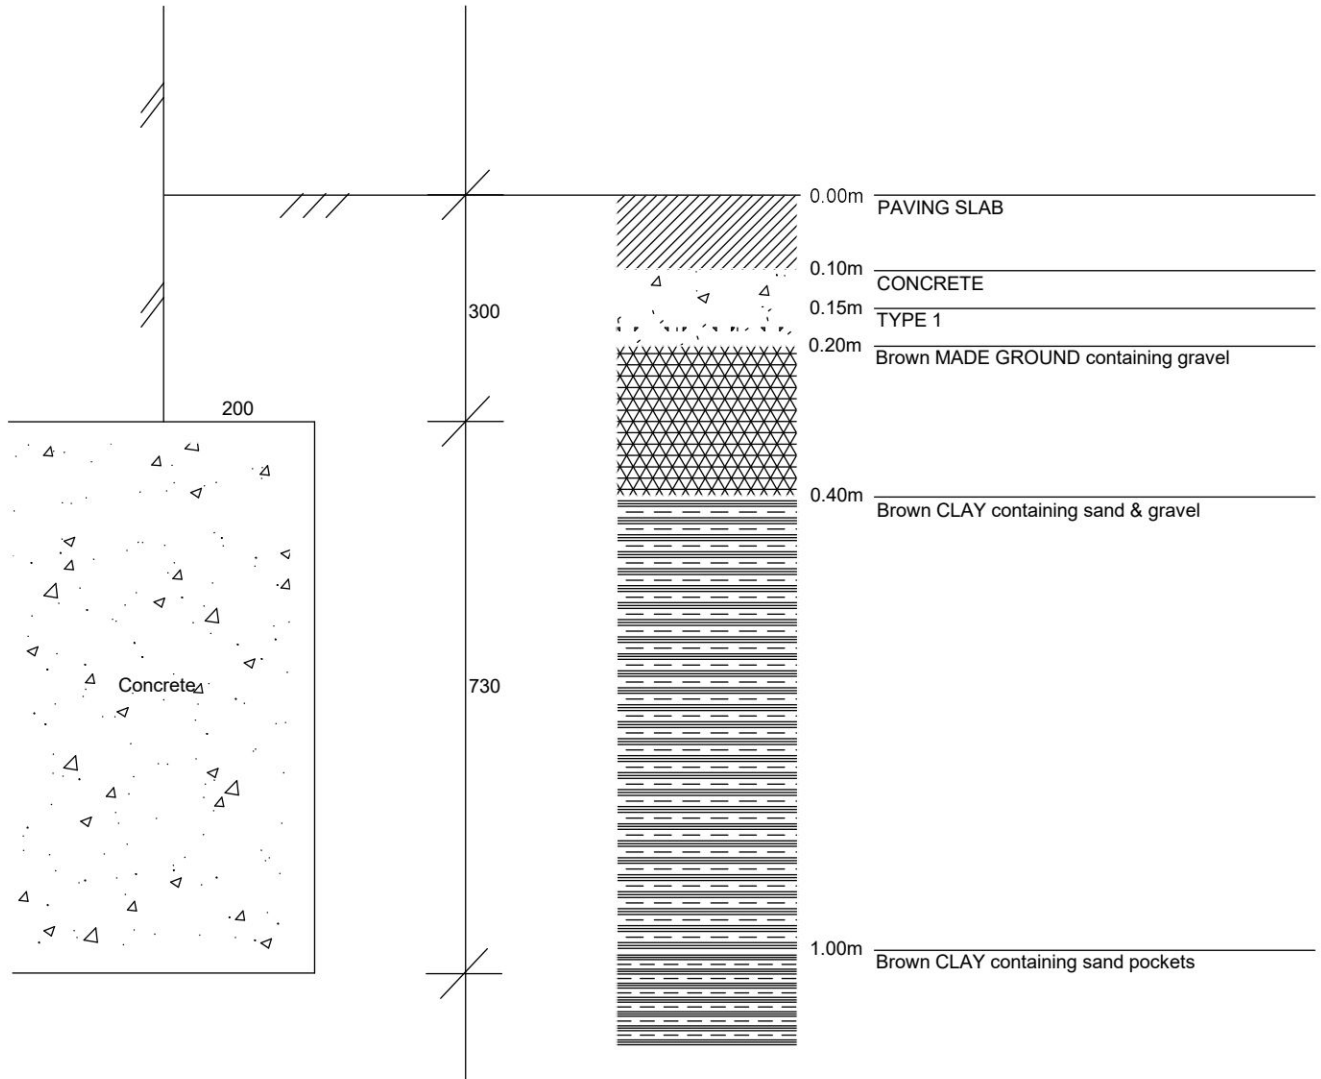
TRIAL PIT 3

D1 @ F.L. (1.03m)
MP=100/35mm
Founding strata: Brown CLAY containing sand pockets
