# Addendum Arboricultural Report

## Subsidence Damage Investigation at:

25 Kingston Hill  
Kingston Upon Thames  
KT2 7PW

CLIENT:	Claims Consortium Group
CLIENT REF:	287492
MWA REF:	SUB230119-12061Rev01
MWA CONSULTANT:	██████████ BSc (Hons) MSc
REPORT DATE:	08/03/2024

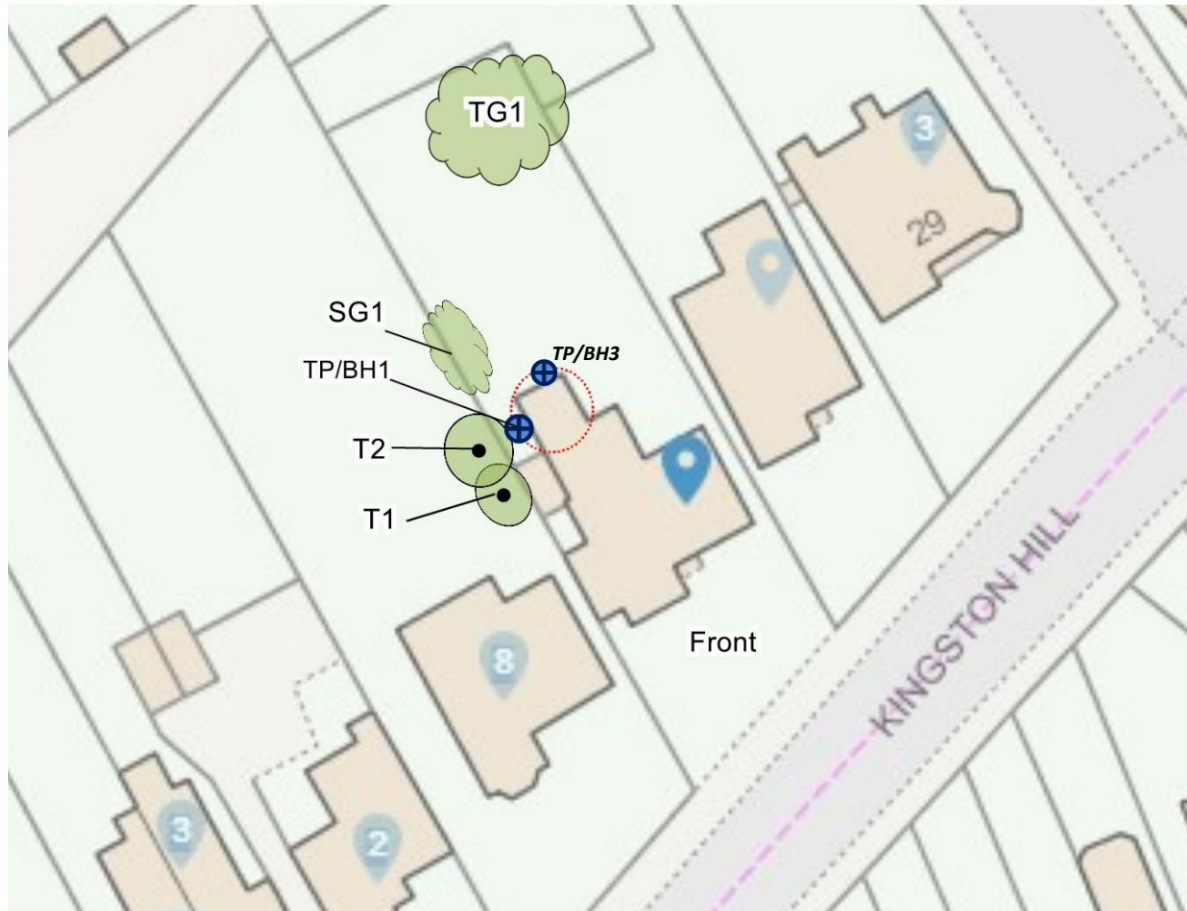
Site Plan

Approximate areas of damage

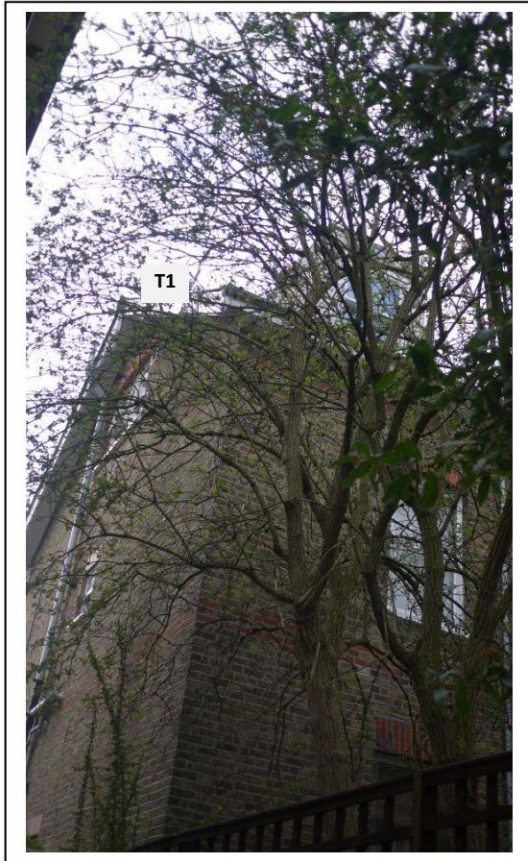
The initial ground investigation recorded roots to a depth of 2000m bgl in TP/BH1 and recovered samples were positively identified (using anatomical analysis) as *Sambucus spp.*, the origin of which will be the Elderberry (T1).

Based on the technical reports currently available, engineering opinion and our own site assessment we conclude the damage is consistent with shrinkage of the clay subsoil related to moisture abstraction by vegetation. Having considered the information currently available, it is our opinion that T1 and T2 are the principal cause of the damage with a secondary influence from TG1.

View of T1

If an arboricultural solution is to be implemented to mitigate the influence of the implicated trees/vegetation we recommend that T1, T2 and both trees in TG1 are removed.

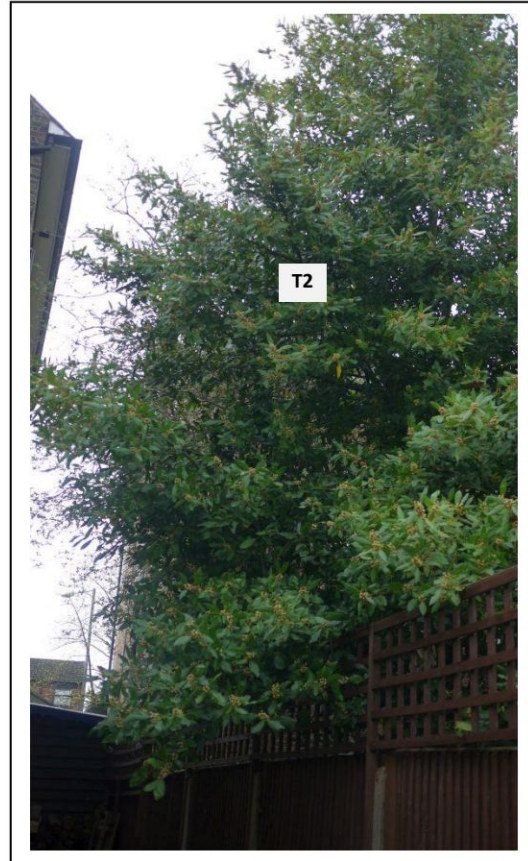
View of T2

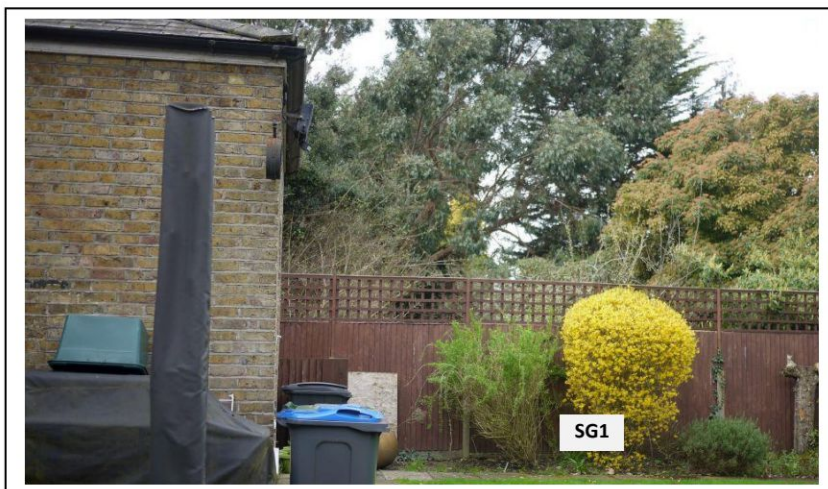
Other vegetation recorded presents a potential future risk to building stability and management is therefore recommended.

View of SG1

Tree No.	Species	Ht (m)	Dia (mm)	Crown Spread (m)	Dist. to building (m)	Age Classification	Ownership
SG1	Shrubs including Forsythia	2	25 Ms *	2	2.7	Younger than the property	Policy Holder
Management history		Subject to past management/pruning.					
Recommendation		Maintain broadly at no more than current dimensions by periodic pruning.

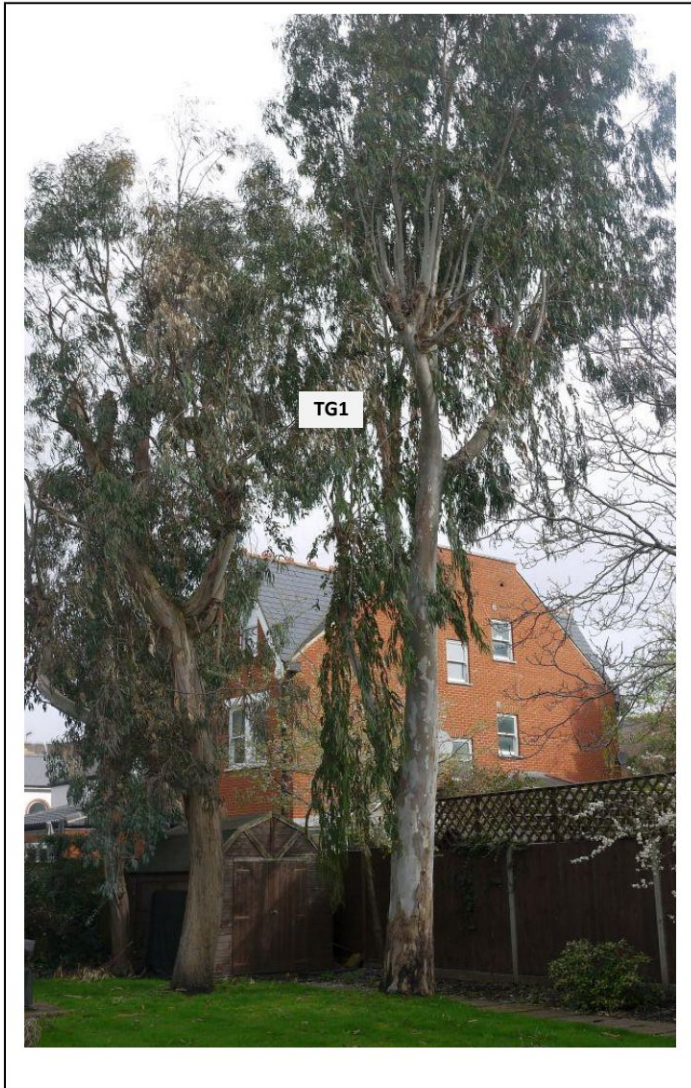
Irrespective of the identification of recovered root samples, the roots of the bay tree (T2) and eucalyptus (TG1) were considered likely to be present below foundation level in proximity to the area of movement/damage and influencing soil moisture and volumes. The second investigation recovered eucalyptus roots confirming our initial opinion. These roots will originate from TG1.

View of TG1
