# Arboricultural Survey Report 2023

57 The Crescent, Canterbury, Kent CT2 7AW

**Report Ref:** AS0255/10-23

**Report Date:** 10<sup>th</sup> October 2023 (valid for one year from survey date)

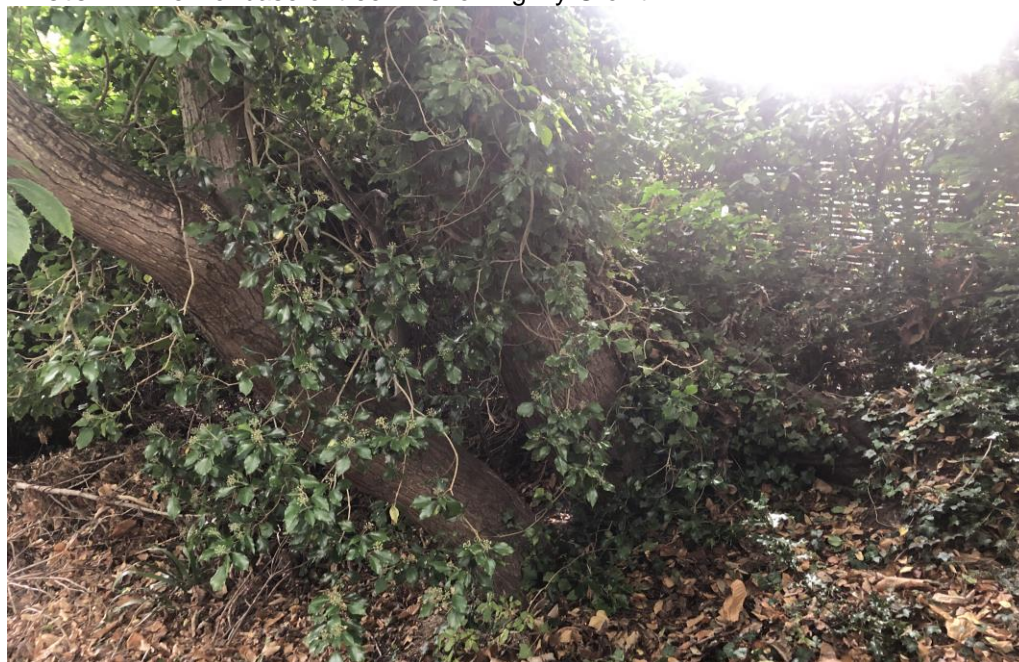
Tree No	Species	Ht (M)	Crown Spread (M)	Age	Phys Cond.	Condition/Comments	Recommendations	Work Priority	Next Insp
T1	Sweet Chestnut (Castanea sativa)	13	7	Mat	F	Twin forked at ground level. Stem to south heavily Ivy clad hindering full assessment. <b>(please refer to photo 1 below)</b> Slight lean towards the north. Partly suppressed by adjacent Ash tree to north and larger Sweet Chestnut T2 to west, causing asymmetric crown towards the east. General foliage/leaf size, density and colour reasonable for the species although Ivy coverage has smothered much of the lower foliage/branches.	Cut and remove Ivy growth from around main stem/trunks using hand tools only, allowing inner Ivy growth to die to aid in fuller inspection. <b>Note:</b> Removal of Ivy growth from a protected tree does not require any formal consent from the Local Authority.	Med	12

Photo 1 – View of base of tree T1 showing Ivy Growth.

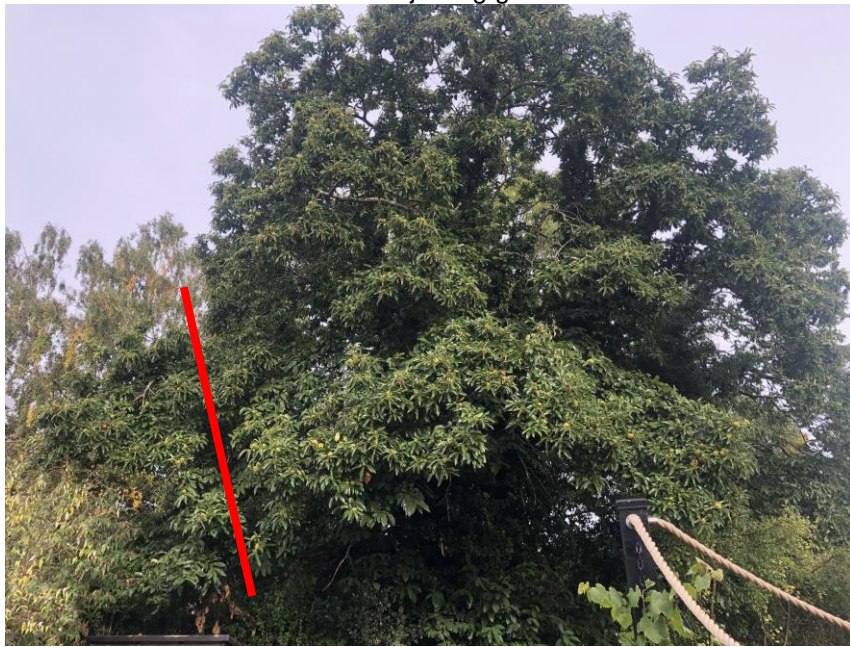
Tree No	Species	Ht (M)	Crown Spread (M)	Age	Phys Cond.	Condition/Comments	Recommendations	Work Priority	Next Insp
T2	Sweet Chestnut (Castanea sativa)	14	8	Mat	G	Twin forked at 1m. Large basal suckers and Ivy growth on main stems hindered a full inspection. Very one-sided asymmetric crown towards south over garden of no.19 Moorfields, due to growth of adjacent Ash tree to the north. Moderate sized dead branch in crown centre and Lower dead branch over garden of no. 19 Moorfields. <b>(Please refer to photo 2 below)</b> General foliage/leaf size, density and colour good for the species. Crown generally becoming low and suppressive over garden of no 19 Moorfields.	*Cut and remove Ivy growth from around main stem/trunks using hand tools only, allowing inner Ivy growth to die to aid in fuller inspection.	Med	12

Photo 2 – View of T2 from the adjoining garden of 19 Moorfields.

**Remove major dead branches* in crown over 25mm dia or 1m+ in length.	High	
							***Reduce crown over garden of No. 19 Moorfields (south) by no more than 2.5m leaving a crown spread of not less than 5.5m. Reduce overextended branch to west back to red line as shown in Photo 2 below. No height reduction.	Med

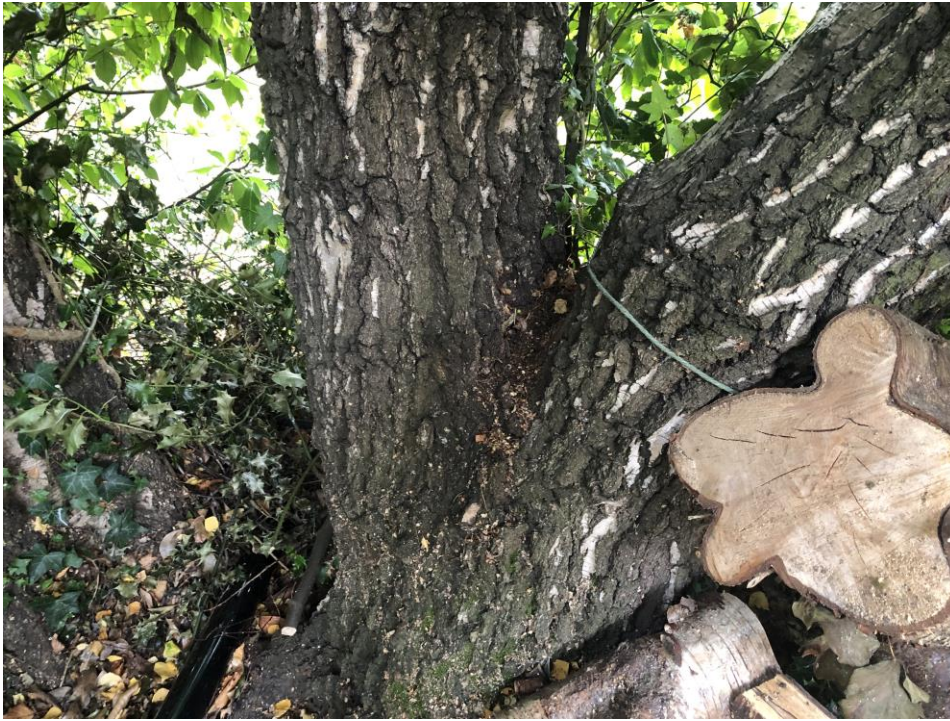
Tree No	Species	Ht (M)	Crown Spread (M)	Age	Phys Cond.	Condition/Comments	Recommendations	Work Priority	Next Insp
T3	Silver Birch (Betula pendula)	15	6	Mat	G	Located in garden of no. 55 the Crescent. Twin forked co-dominant stems at 0.4m with stem to the east being more upright in habit. <b>(Please refer to photo 3 below)</b> Twin fork displays no indication of any significant compression associated with weak forks (please refer to VTA diagram at Appendix C) and when probed the fork centre did not reveal any signs of internal or surface decay. Typical pendulous crown for species with no associated visible defects noted.	No immediate works required.	N/A	12

**Photo 3** – View of the main fork of T3 taken from the garden of 55 The Crescent.
